## status report

| vehicle data | | | |
|---|---|---|---|
| <b>Cupra Ateca Basis</b> | | | |
| Vehicle identification number | <b>VSSZZZ5F6R6522462</b> | mileage read: | <b>18908 km</b> |

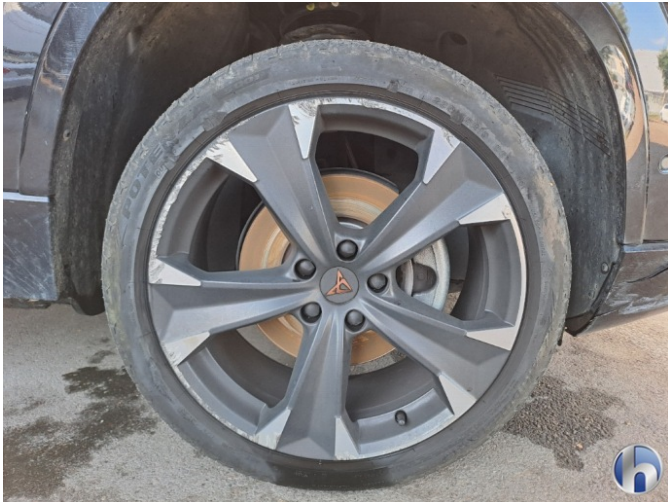
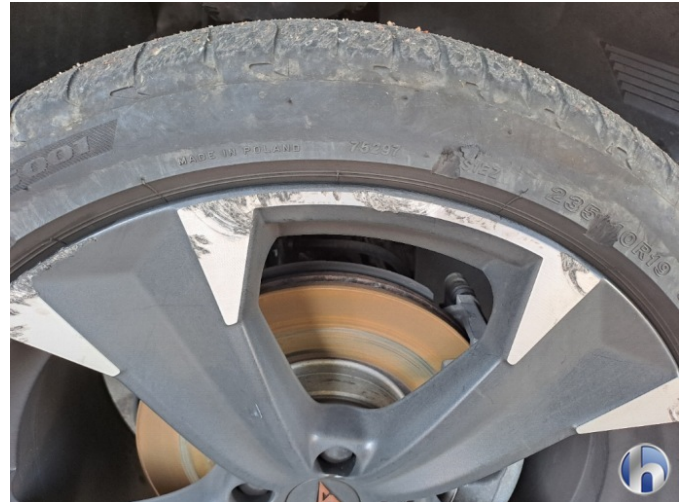
1. Rim front - right

| | component | Damage | Rep kind |
|---|---|---|---|
| 1. | Rim front - right | Damaged | Replace |

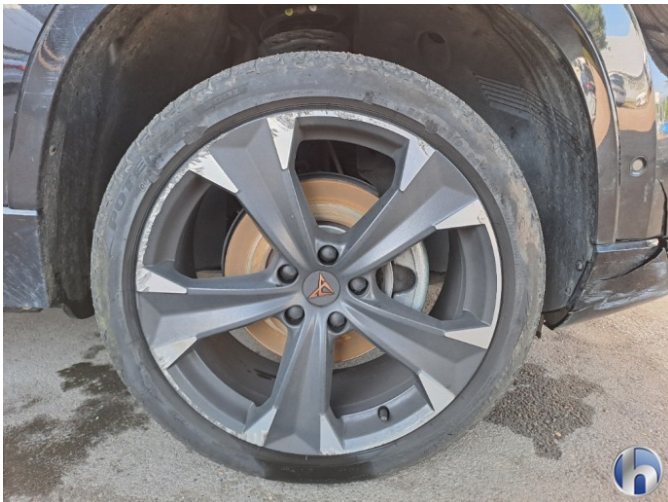
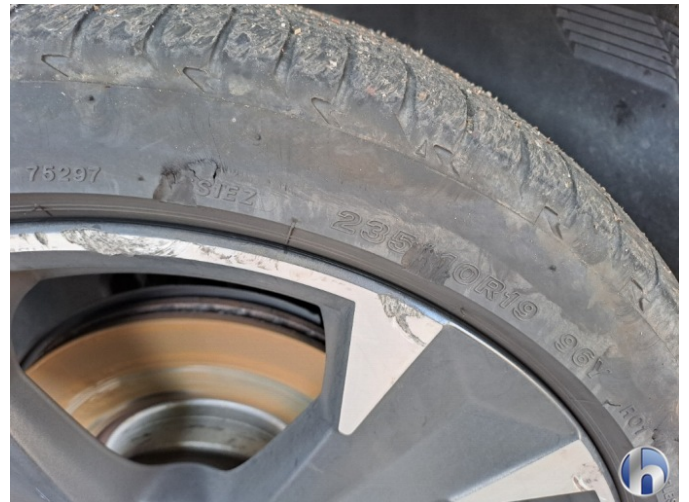
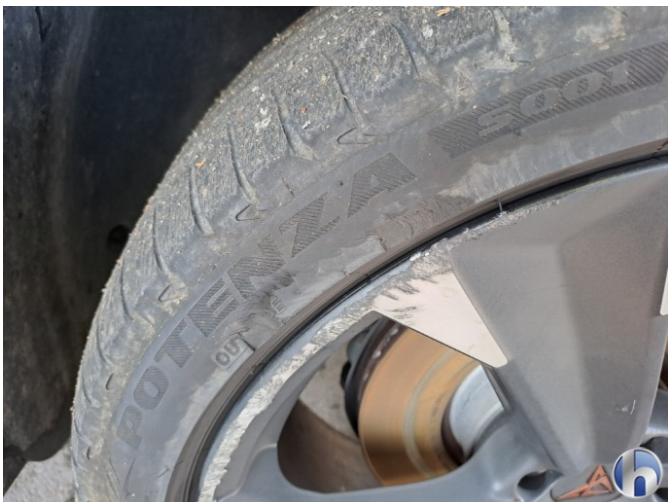
2. tire front - right

| <b>Note Road Safe:</b> | Vordere Bereifung beschädigt. |

| | component | Damage | Rep kind |
|---|---|---|---|
| 2. | tire front - right | Damaged | Replace |

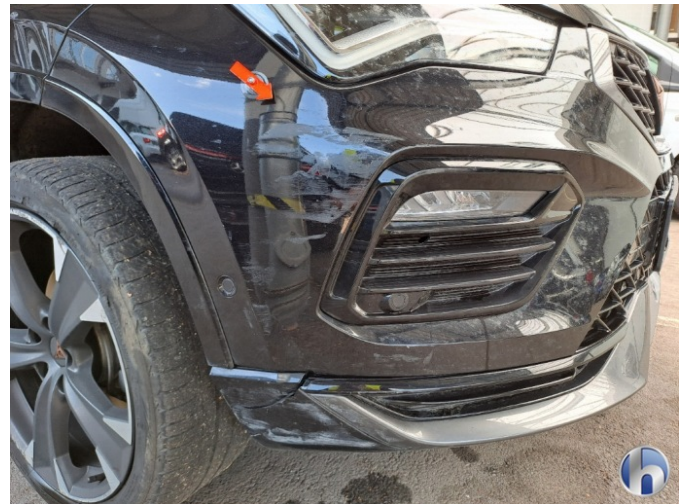
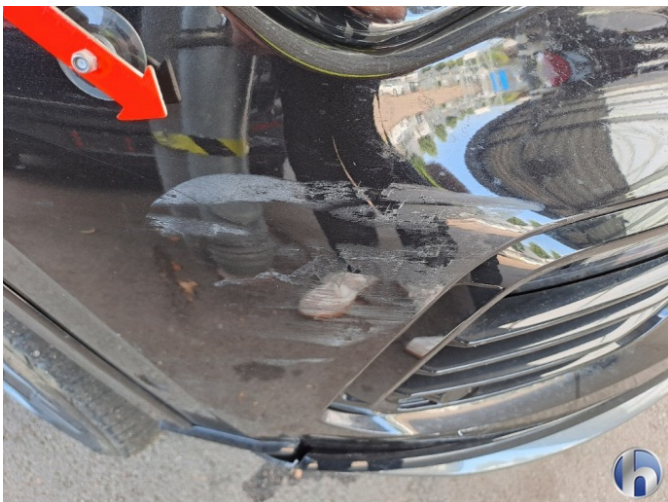
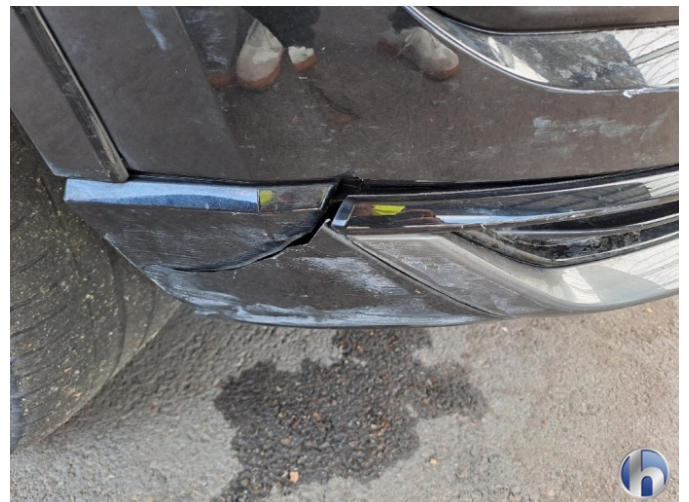
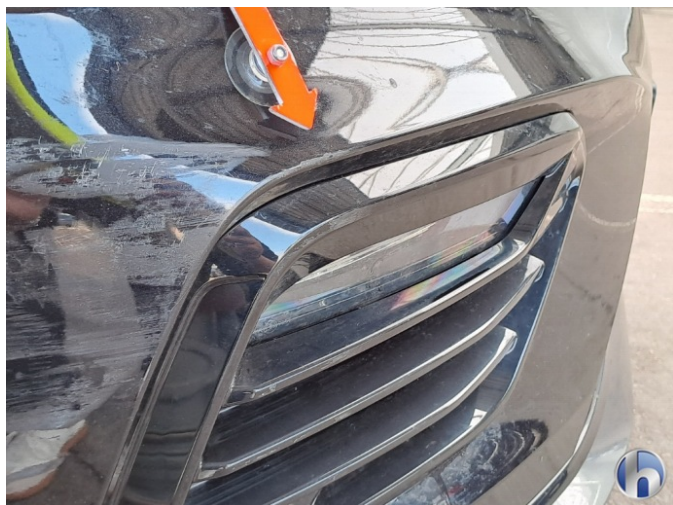
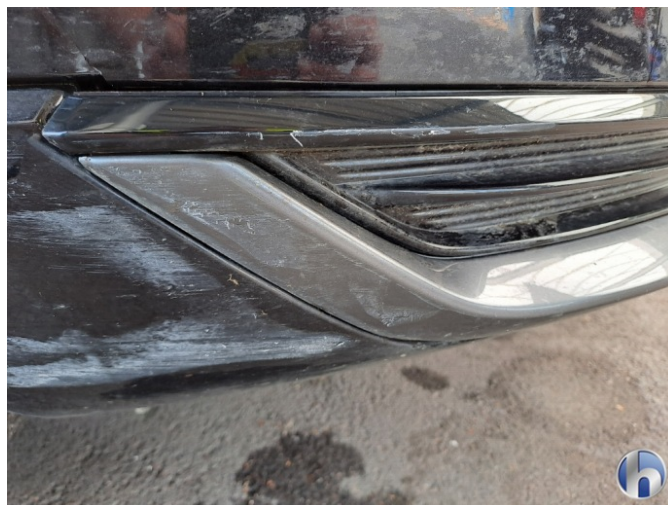
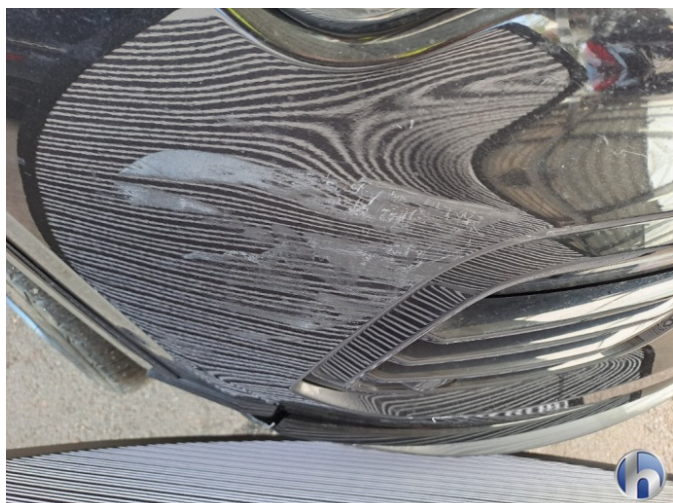
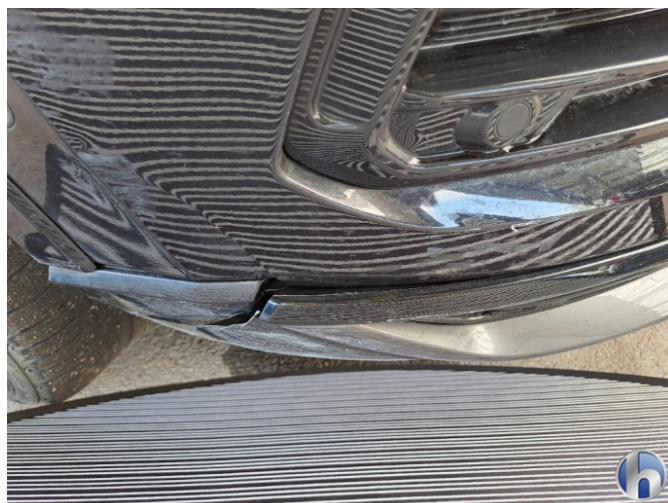
5. Front bumper

| | component | Damage | Rep kind |
|---|---|---|---|
| 5. | Front bumper | Accident damage | Replace |

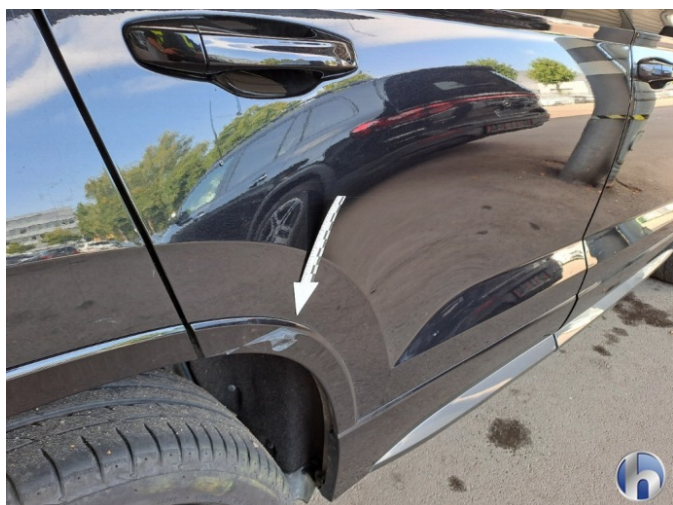
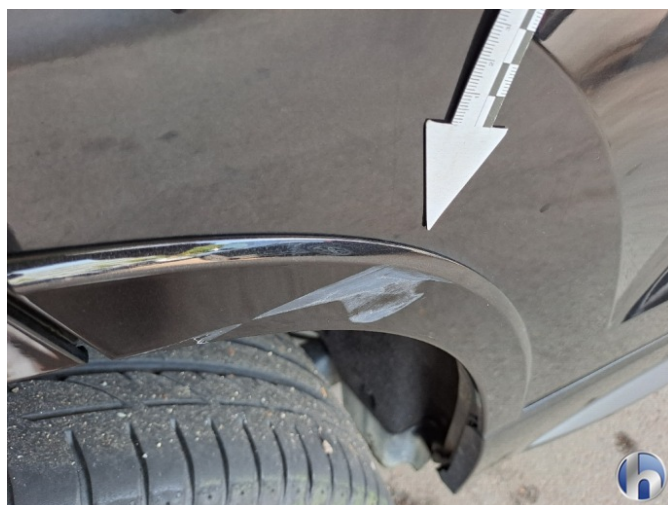
6. Zierleiste Tür Hinten - Rechts

| | component | Damage | Rep kind |
|---|---|---|---|
| 6. | Zierleiste Tür Hinten - Rechts | Scratch(es) | Paint |

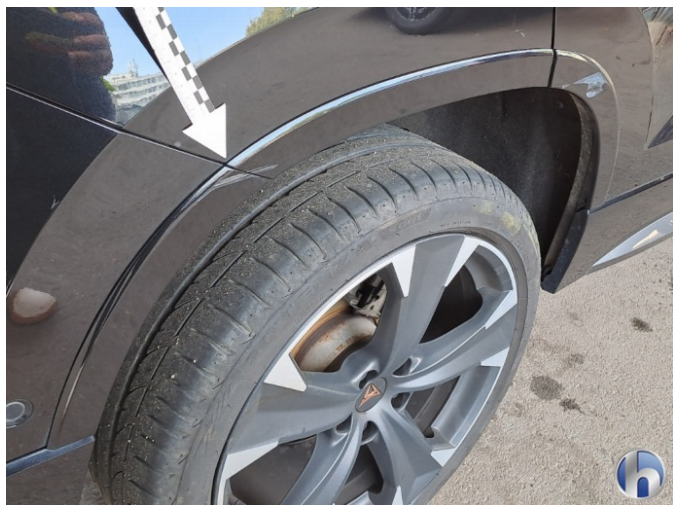
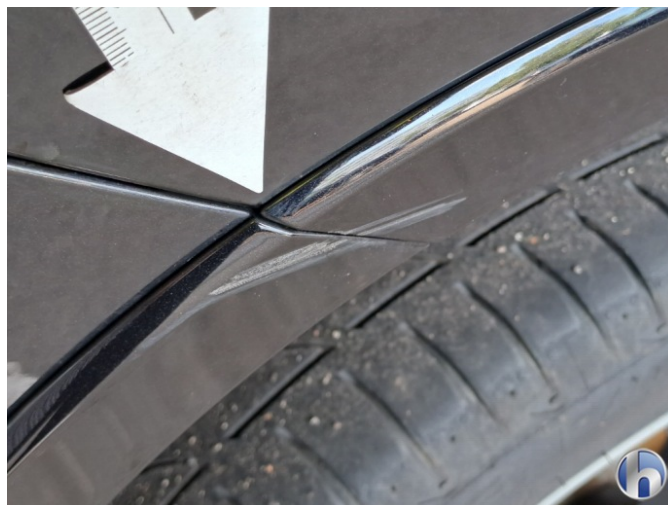
| | component | Damage | Rep kind |
|---|---|---|---|
| 7. | | Scratch(es) | Paint |

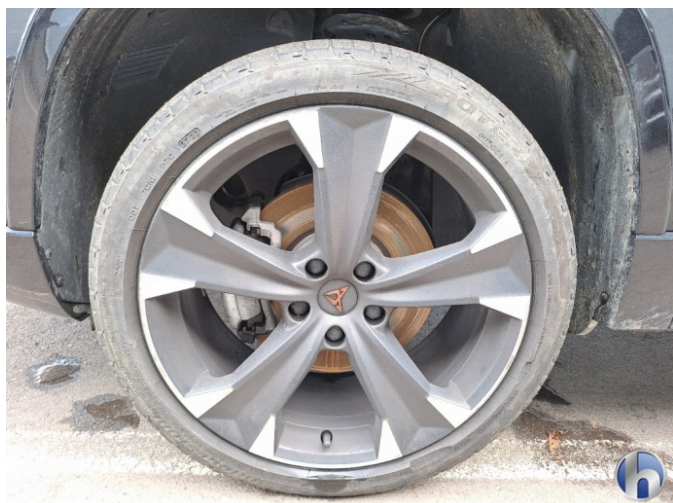
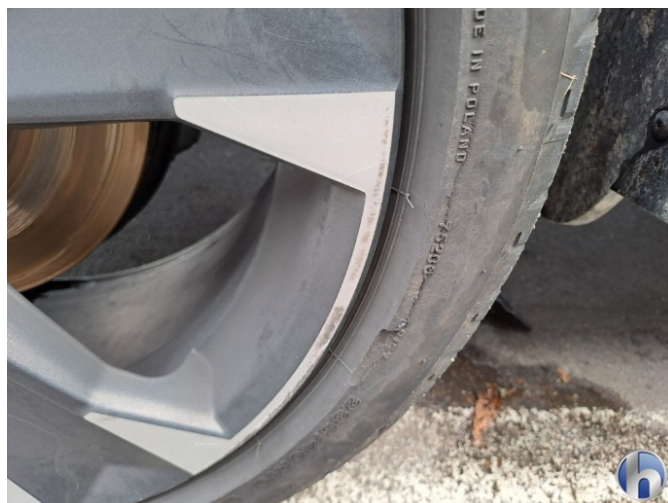
8. Rim front - left

| | component | Damage | Rep kind |
|---|---|---|---|
| 8. | Rim front - left | Damaged | Replace |

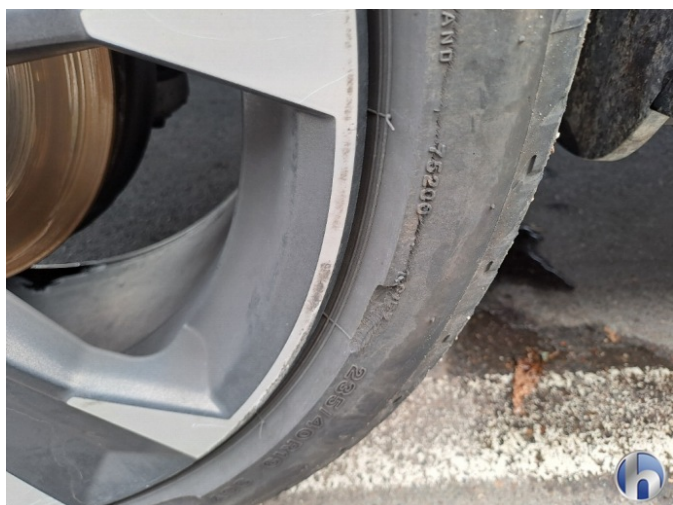
9. tire front - left

| | component | Damage | Rep kind |
|---|---|---|---|
| 9. | tire front - left | Damaged | Replace |

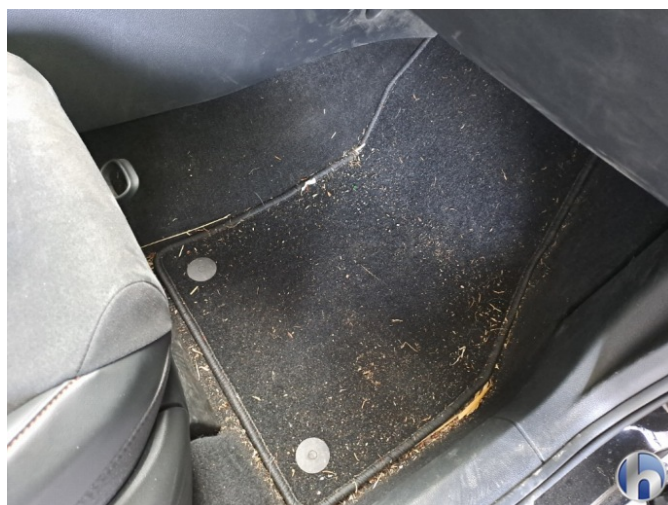
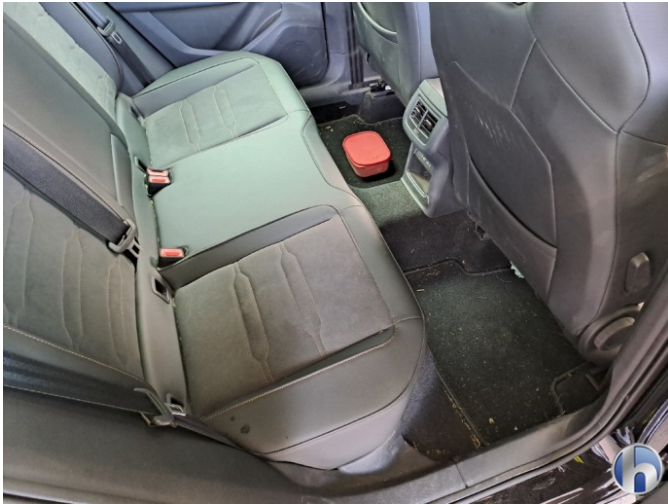
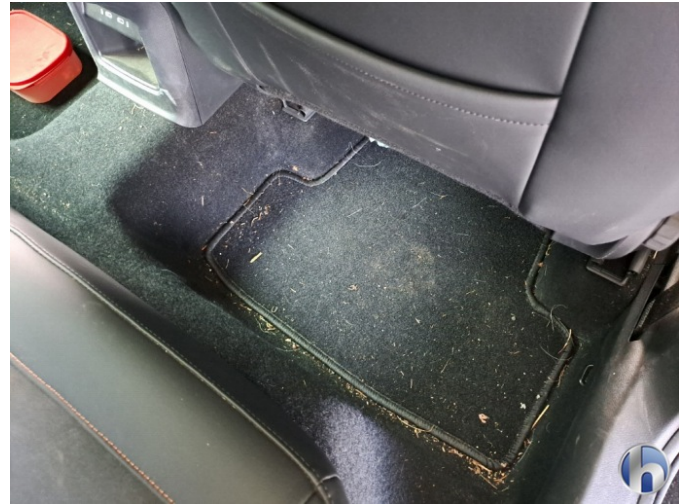
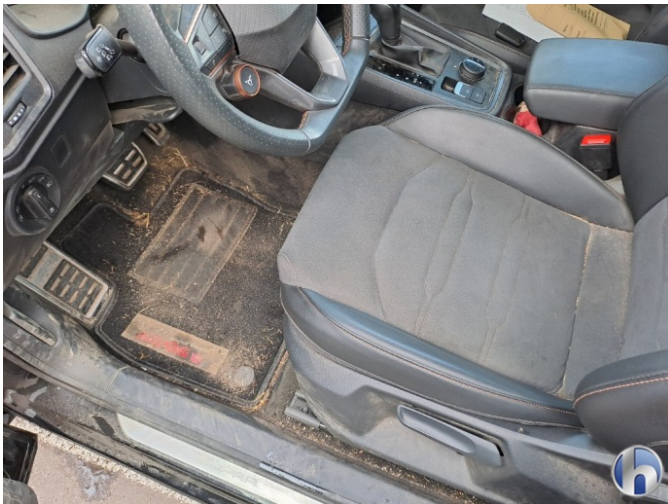
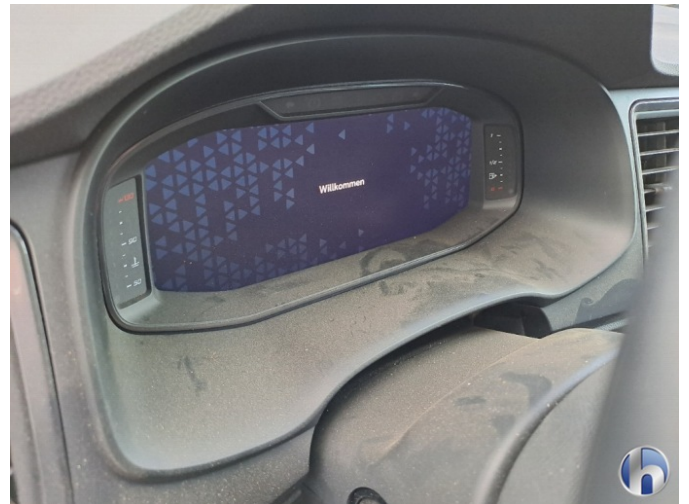
| | component | Damage | Rep kind |
|---|---|---|---|
| 10. | | Dirty | |

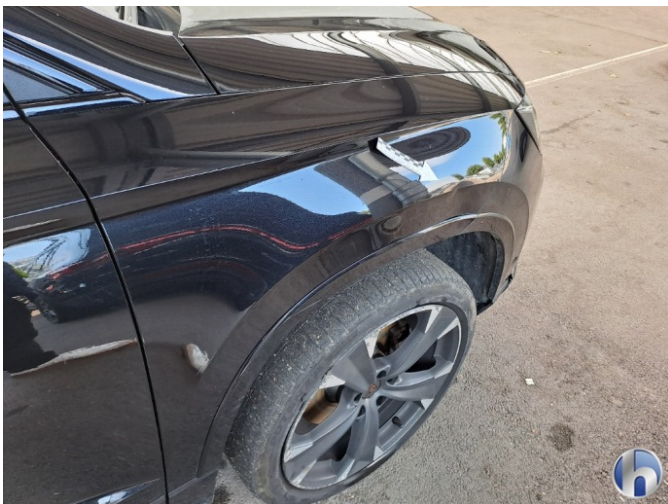
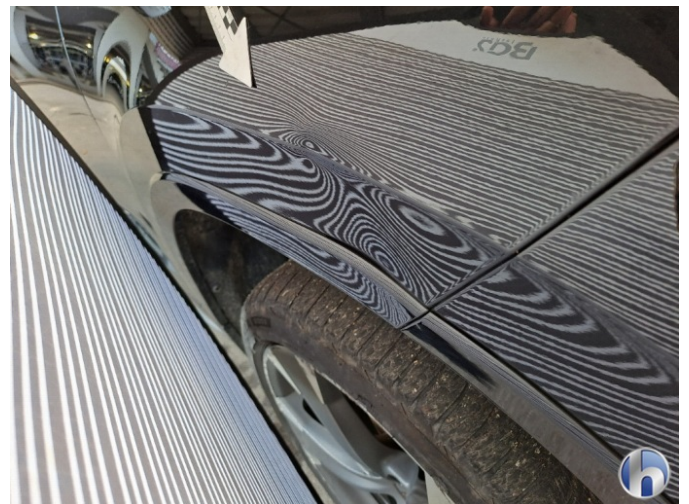
11. Front fender - right

| | component | Damage | Rep kind |
|---|---|---|---|
| 11. | Front fender - right | Damaged | Refurbish and paint |
