SEAT Ateca

Ateca 2.0 TDI 4Drive DSG

Inspection Report Summary

Customer	BCA Online	Report Number	P20251009101130
Inspection Date / Place	2025-10-09 / SULOJA Brackel	Cosmetic Grade	3

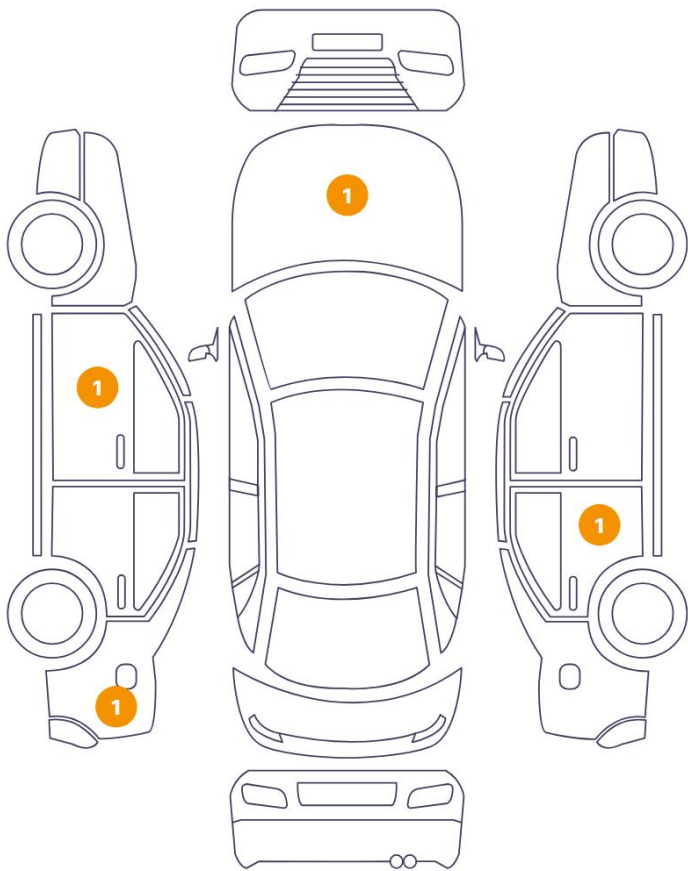
4 Schäden

Component		Damage	Comments
1	Side Panel / Back Left	Paint / Poor Previous Repair	
2	Door / Back Right	Paint / Scratch / Scuff	
3	Hood	Bodywork / Dent / Dent	
4	Door / Front Left	Paint / Scratch / Scuff

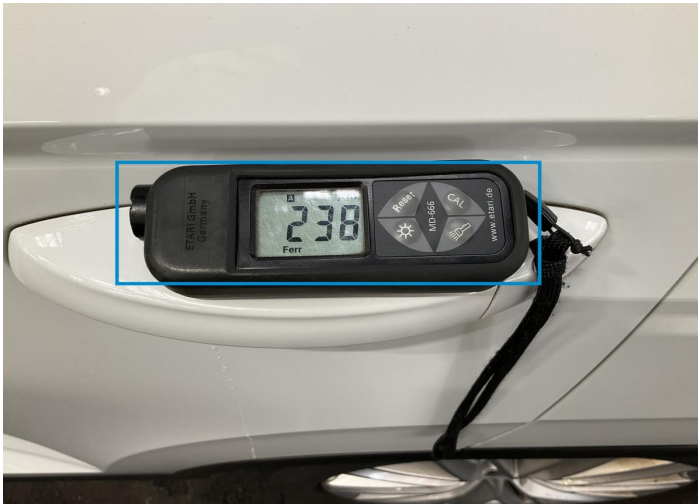
1. Side Panel / Back Left
Paint / Poor Previous Repair -

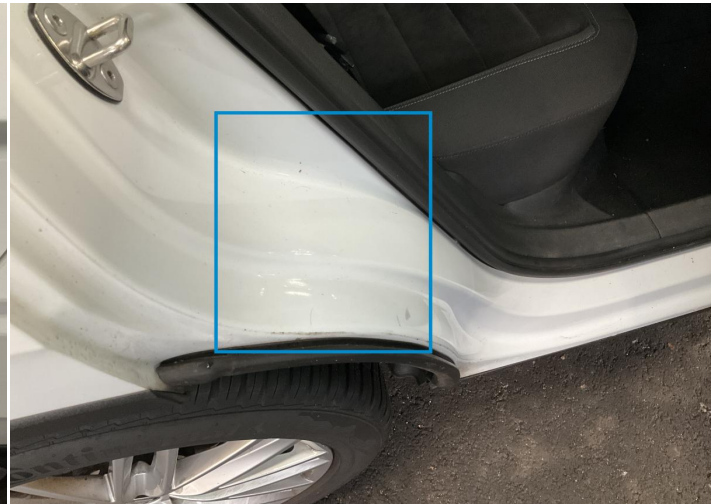
2. Door / Back Right
Paint / Scratch / Scuff -

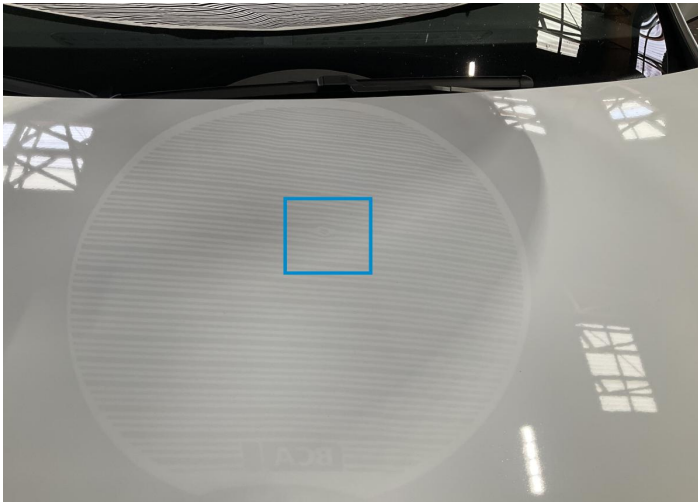
3. Hood
Bodywork / Dent / Dent -

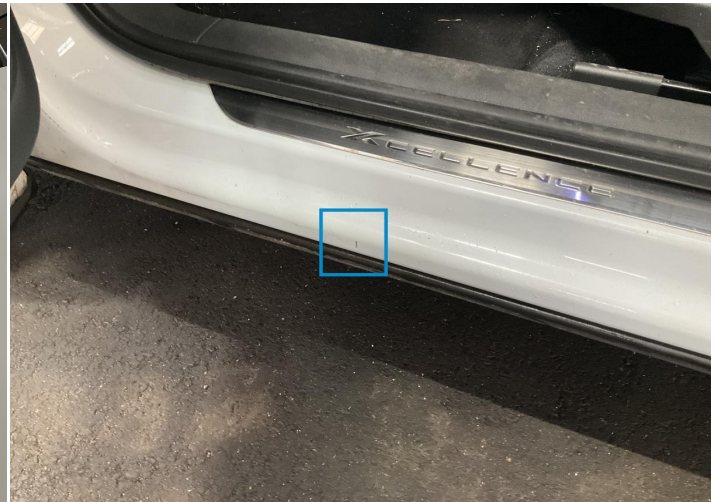
4. Door / Front Left
Paint / Scratch / Scuff -
