## status report

#### Seat Leon ST Cupra 300 4Drive

| Vehicle identification number | VSSZZZ5FZJR006379 | mileage read: | 79333 km |

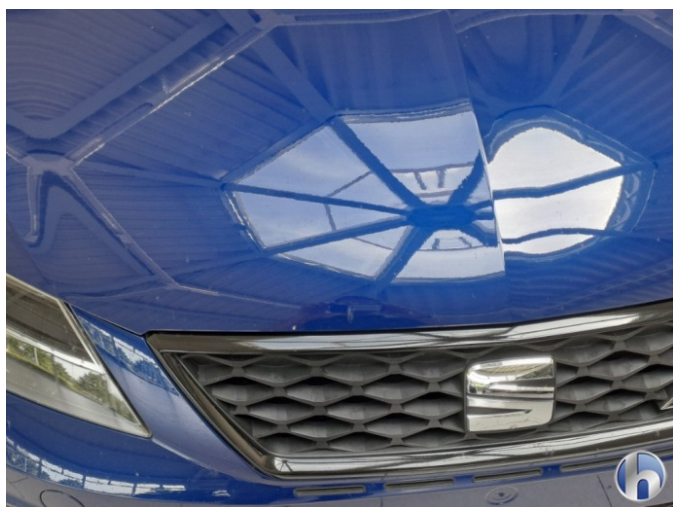
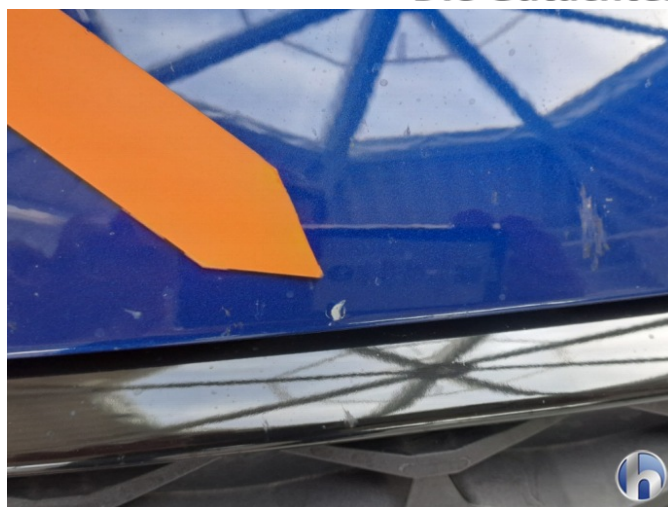
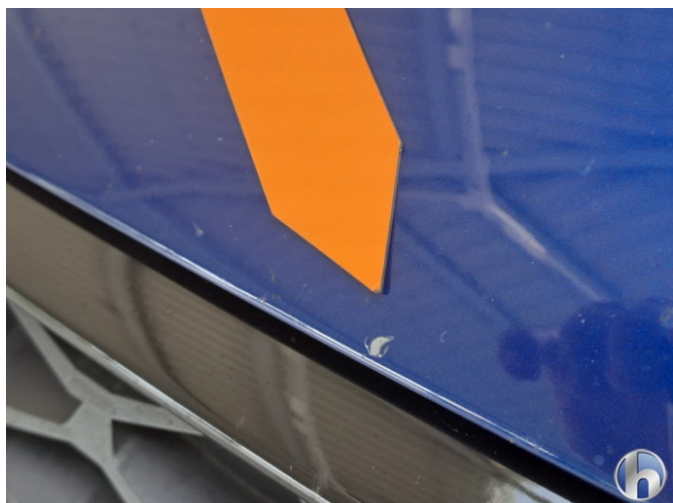
| component | Damage | Rep kind |
|---|---|---|
| 1. Motorhaube | Chipping from stones | Smart repair |

1. Motorhaube

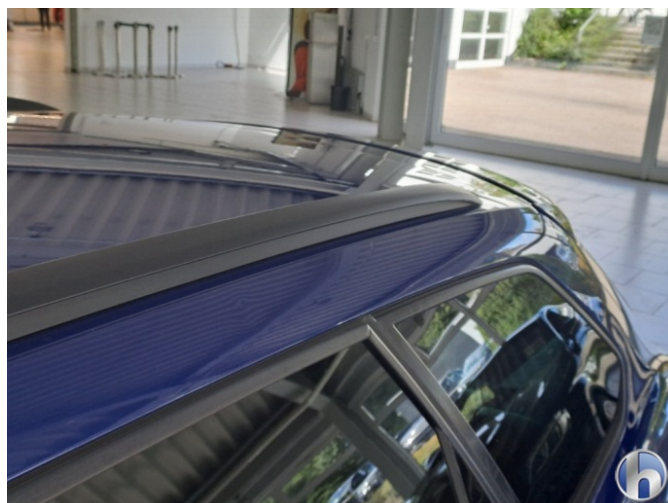
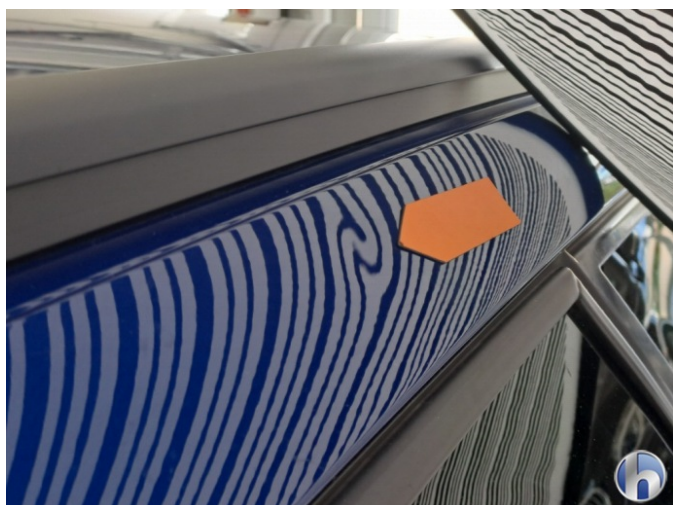
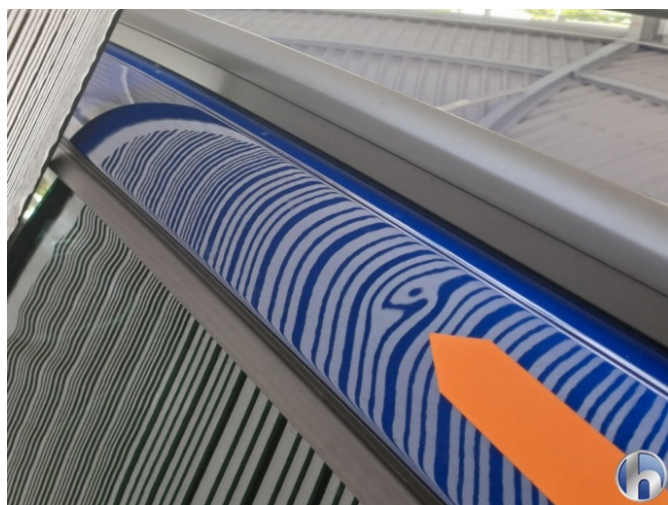
| component | Damage | Rep kind |
|---|---|---|
| 2. Dachholm links | Delle | Gentle refurbishing |

2. Dachholm links

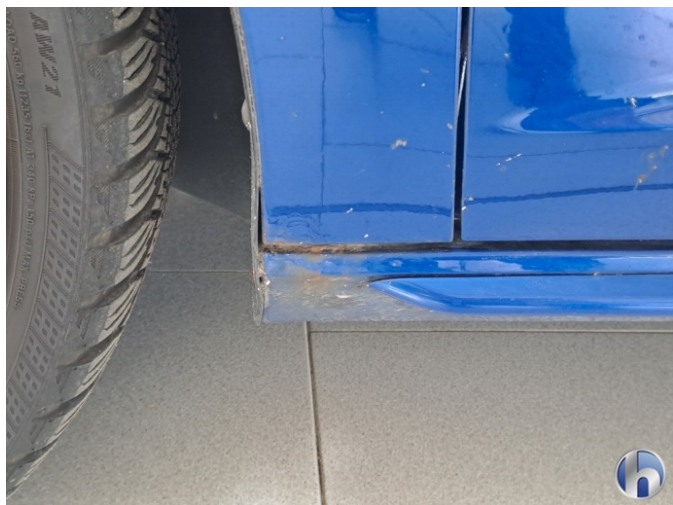
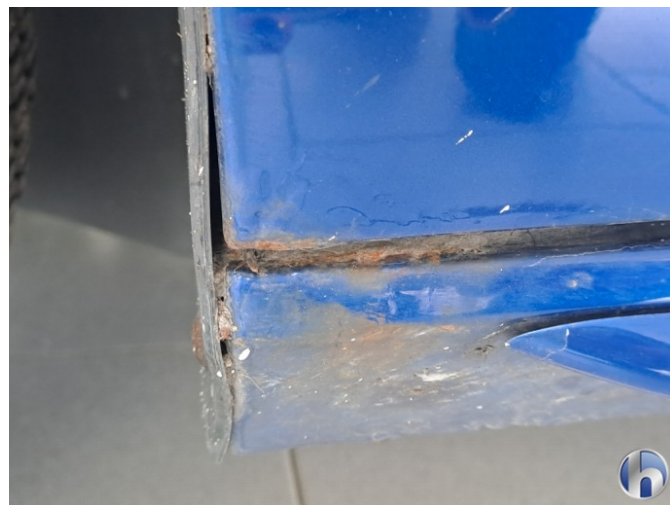
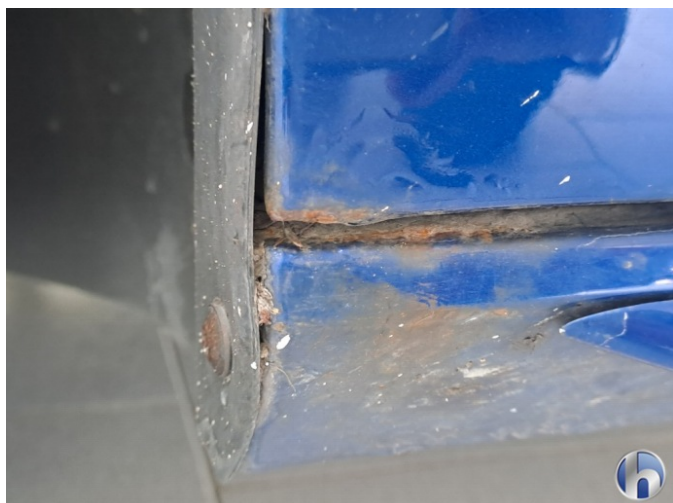
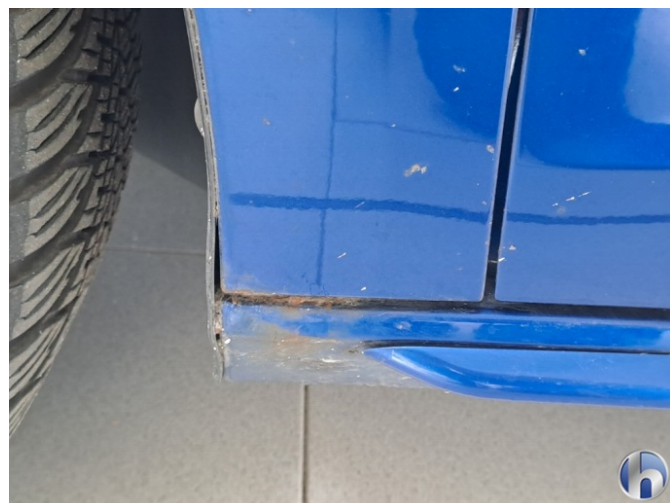
| component | Damage | Rep kind |
|---|---|---|
| 3. side skirt - left | Rust | Refurbish and paint |

3. side skirt - left

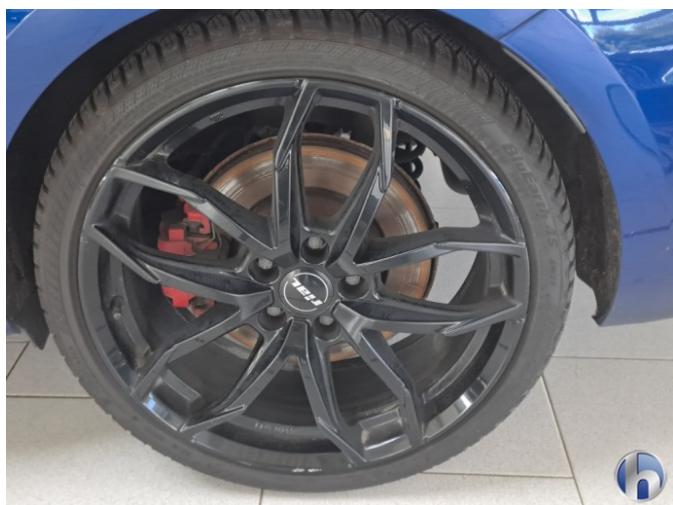
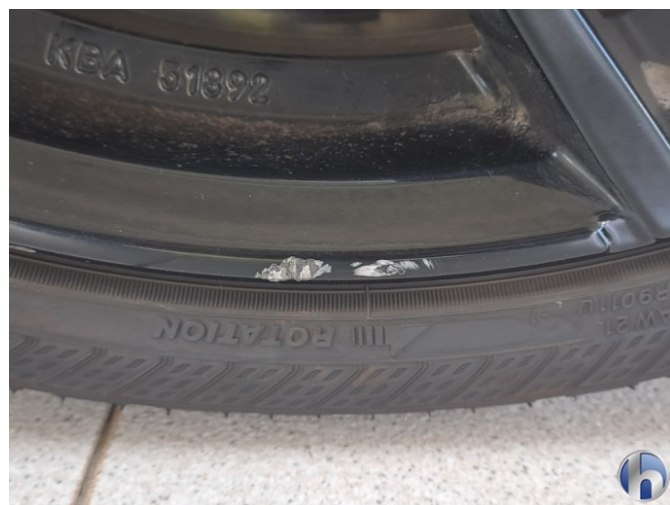
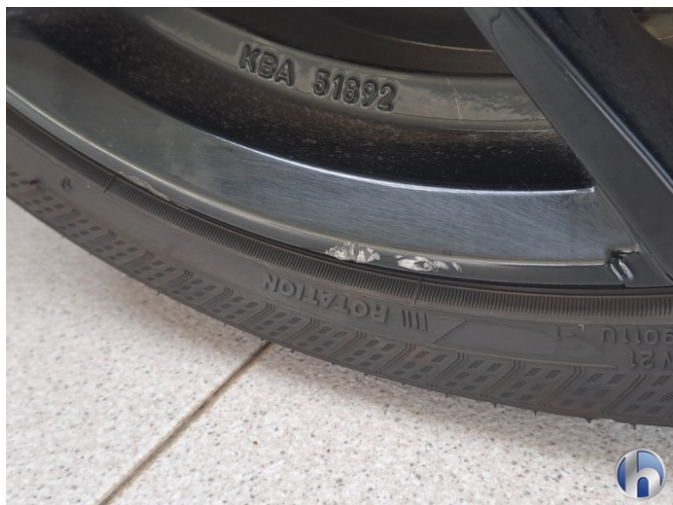
| component | Damage | Rep kind |
|---|---|---|
| 4. Felge hinten links | Scratch(es) | Paint |

4. Felge hinten links

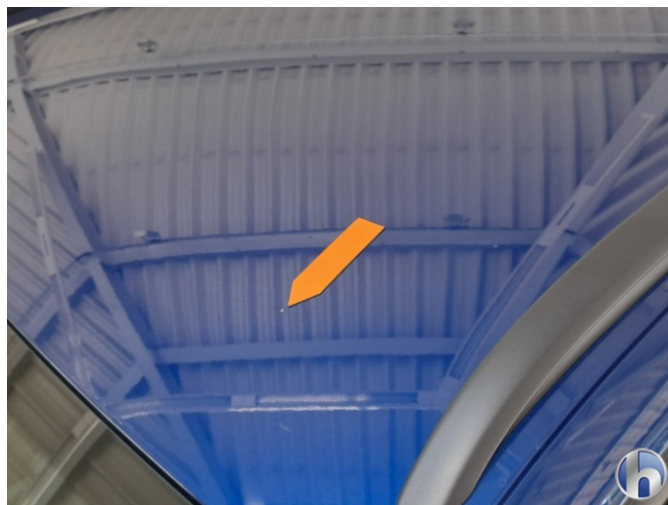
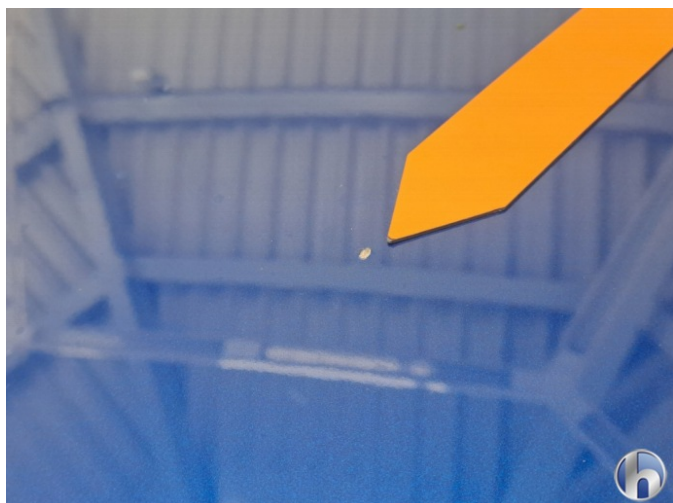
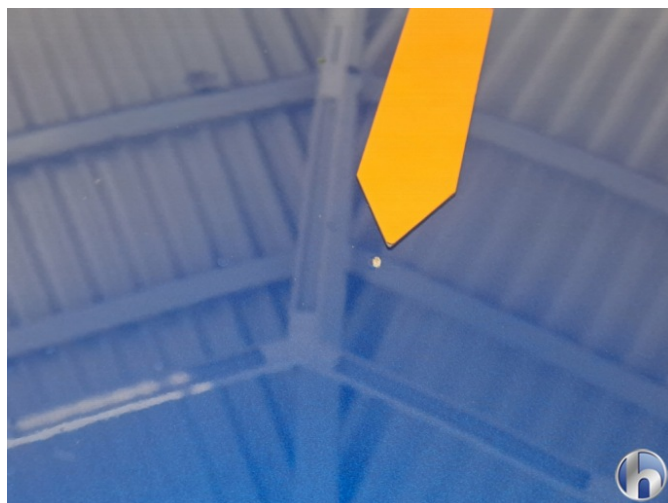
| component | Damage | Rep kind |
|---|---|---|
| 5. Dach | Chipping from stones | Smart repair |

5. Dach
