# SEAT Leon

## Leon 2.0 TDI DPF Start&Stop

VIN NO VSSZZZ5FZJR149707  
Registration Number FZJR149707

### Inspection Report Summary

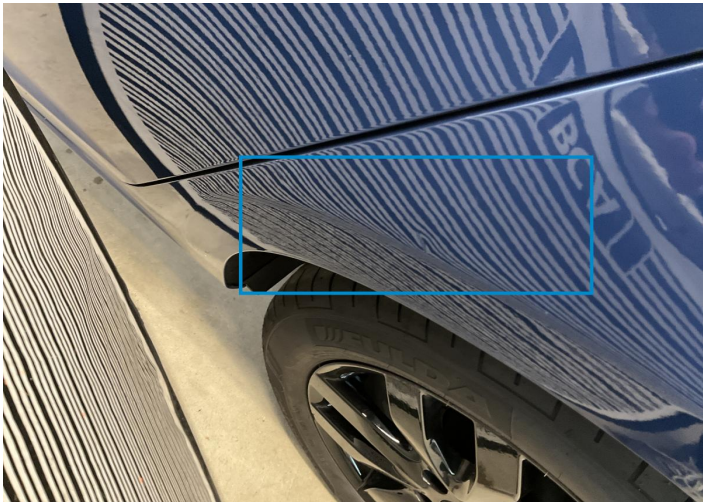
| Component | | Damage | Comments |
|---|---|---|---|
| 3 | Fender / Back Left | Bodywork / Dent / Dent | |

3. Fender / Back Left  
Bodywork / Dent / Dent -
