# SEAT Leon

## Leon 2.0 TDI DPF Start&Stop

### Inspection Report Summary

Customer	BCA Online	Report Number	P20250909112222
Inspection Date / Place	2025-09-09 / ARS Altmann AG Riedstadt	Cosmetic Grade	3

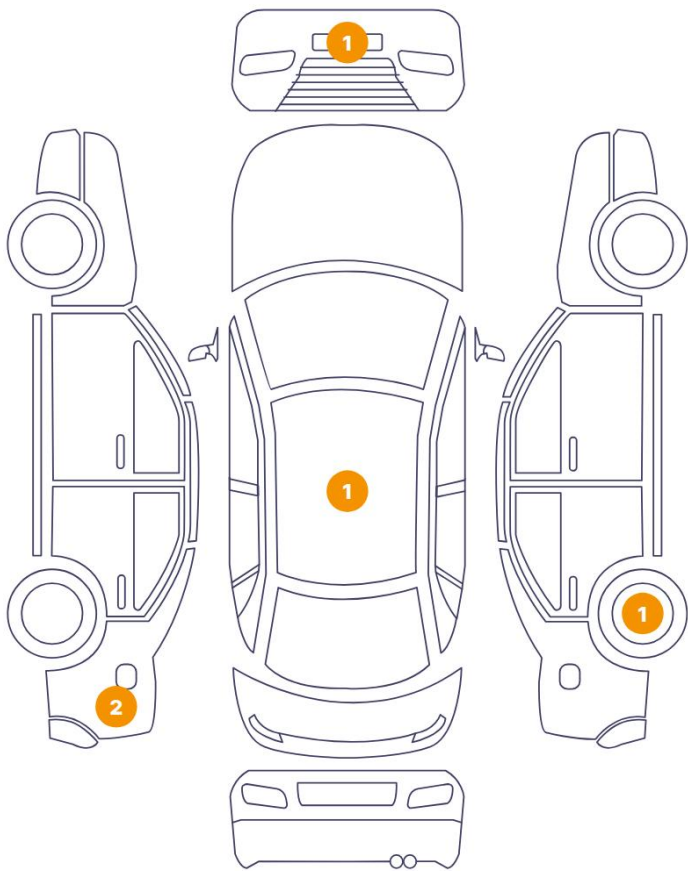
5 Schäden

Component	Damage	Comments
1 Bumper / Front	Paint / Scratch / Scuff	
2 Roof	Bodywork / Dent / Dent	
3 Fender / Back Left	Bodywork / Dent / Dent	
4 Rim / Back Right	Out of Bodywork / Scratch	
5 Side Panel / Back Left	Paint / Poor Previous Repair

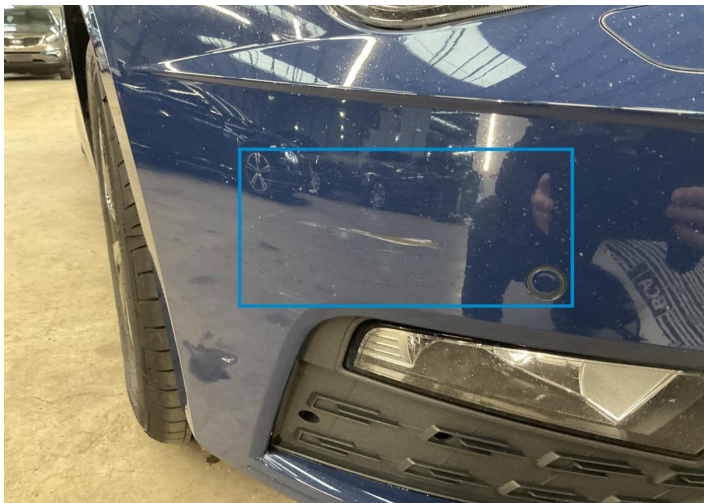
1. Bumper / Front  
Paint / Scratch / Scuff -

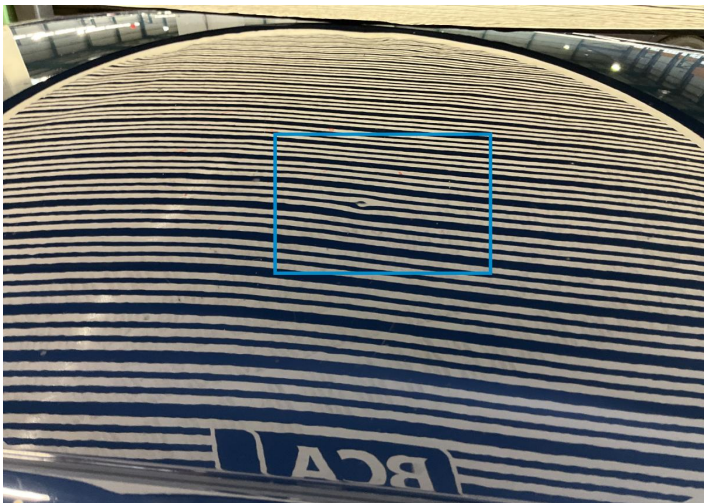
2. Roof  
Bodywork / Dent / Dent -

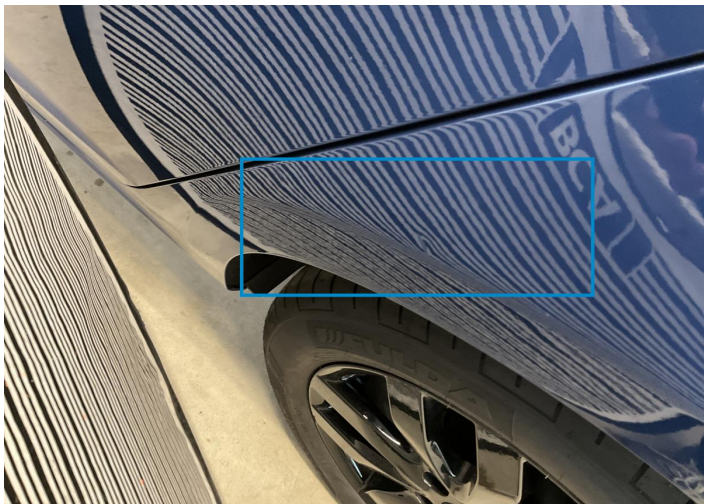
3. Fender / Back Left  
Bodywork / Dent / Dent -

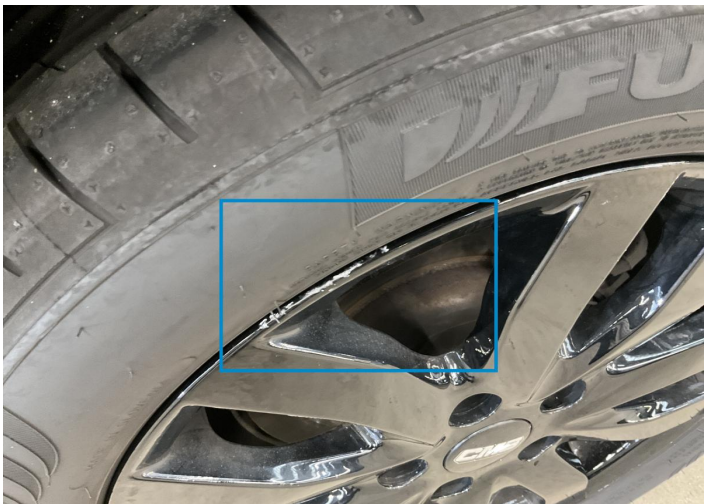
4. Rim / Back Right  
Out of Bodywork / Scratch -

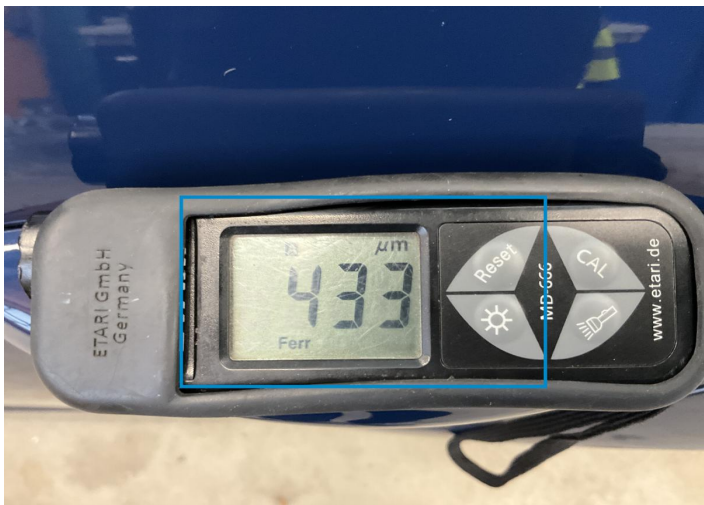
5. Side Panel / Back Left  
Paint / Poor Previous Repair -
