# SEAT Leon

## Leon 2.0 TDI DPF Start&Stop

VIN NO VSSZZZ5FZJR149707  
Registration Number FZJR149707

### Inspection Report Summary

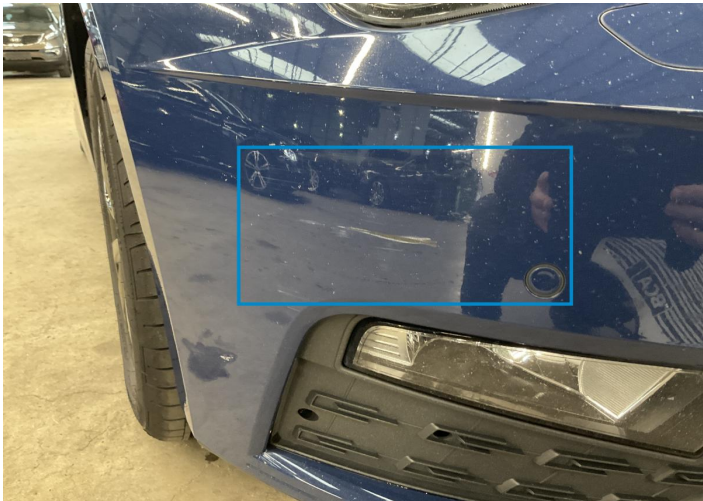
| Component | Damage | Comments |
|---|---|---|
| 1 Bumper / Front | Paint / Scratch / Scuff | |

1. Bumper / Front  
Paint / Scratch / Scuff -

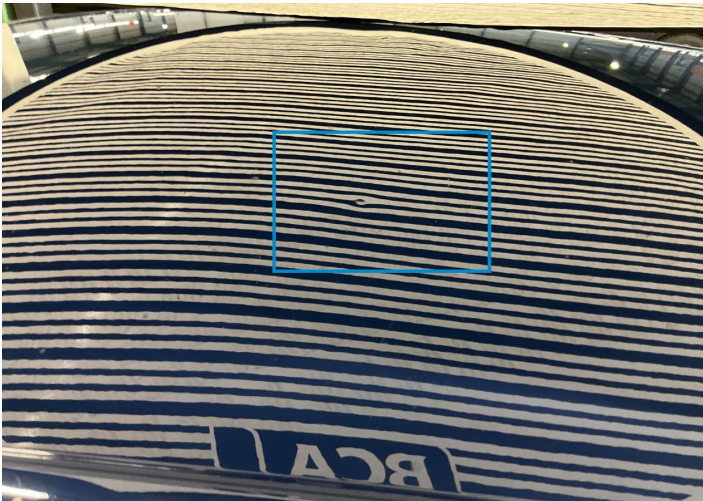
| Component | Damage | Comments |
|---|---|---|
| 2 Roof | Bodywork / Dent / Dent | |

2. Roof  
Bodywork / Dent / Dent -

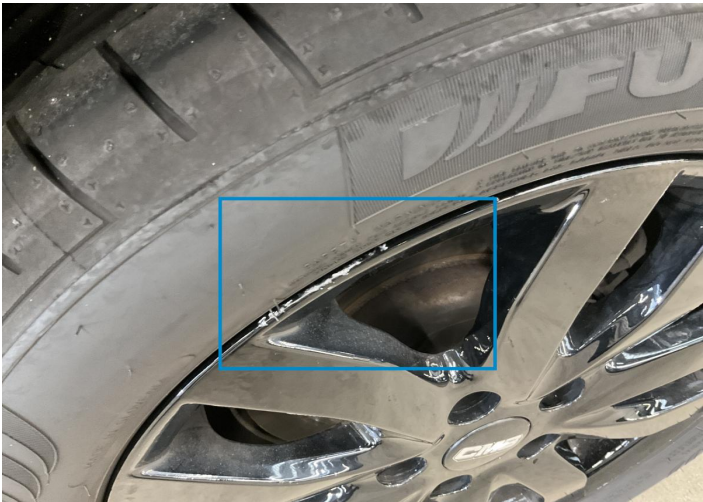
| Component | Damage | Comments |
|---|---|---|
| 4 Rim / Back Right | Out of Bodywork / Scratch | |

4. Rim / Back Right  
Out of Bodywork / Scratch -

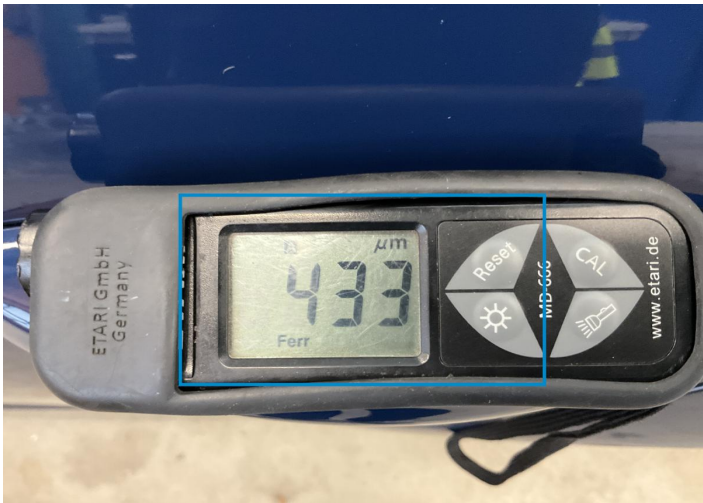
| Component | Damage | Comments |
|---|---|---|
| 5 Side Panel / Back Left | Paint / Poor Previous Repair | |

5. Side Panel / Back Left  
Paint / Poor Previous Repair -
