SEAT Leon

Leon 2.0 TDI DPF Start&Stop

Inspection Report Summary

Customer	BCA Online	Report Number	P20250909112222
Inspection Date / Place	2025-09-09 / ARS Altmann AG Riedstadt	Cosmetic Grade	3

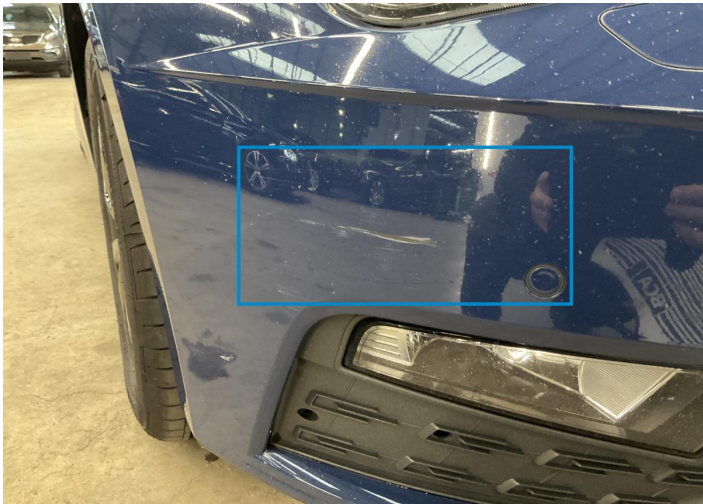
1. Bumper / Front
Paint / Scratch / Scuff -

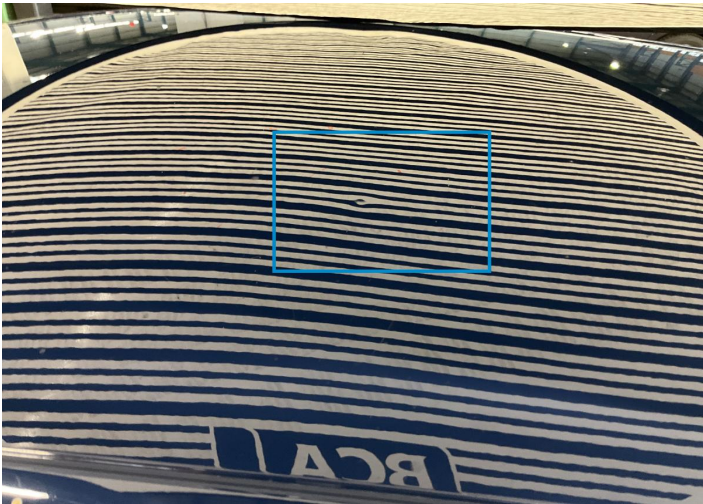
2. Roof
Bodywork / Dent / Dent -

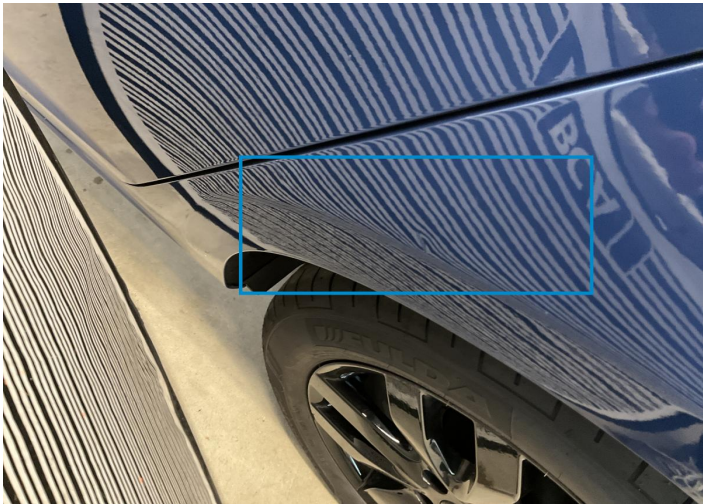
3. Fender / Back Left
Bodywork / Dent / Dent -

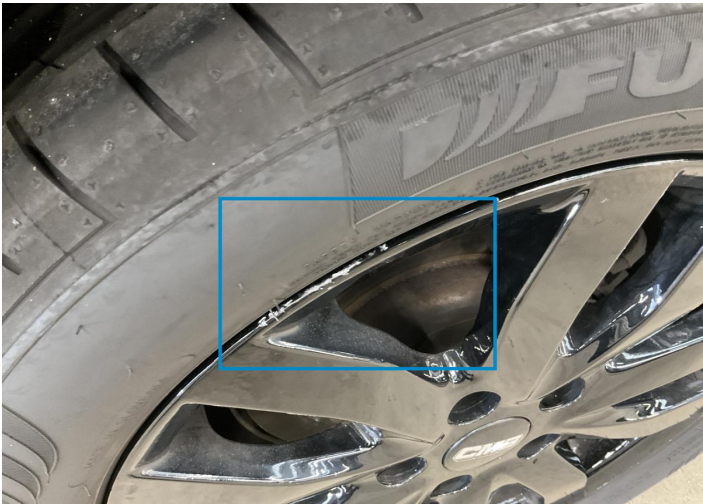
4. Rim / Back Right
Out of Bodywork / Scratch -

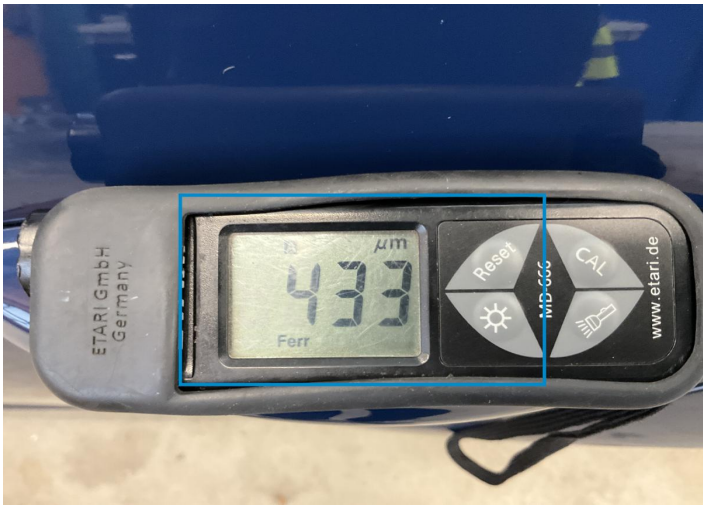
5. Side Panel / Back Left
Paint / Poor Previous Repair -
