# **Expertise**

Protocol number: 41168457 Order No. / Reference: 25057030 Inspection date: 22 Aug 2025

Manufacturer: Seat Model: Ateca 2.0 TDI DSG FR

VIN: VSSZZZ5FZL6558844

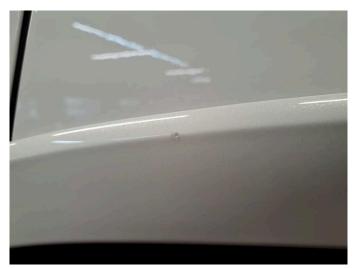
No.	Component group	Description
1	Side panel - rear left side	Wheel well extension - Stone chips - Smart repair
2	Trim / covers	Door trim - rear left side - Stone chips - Smart repair

Damage 1: Side panel - rear left side: Wheel well extension - Stone chips - Smart repair

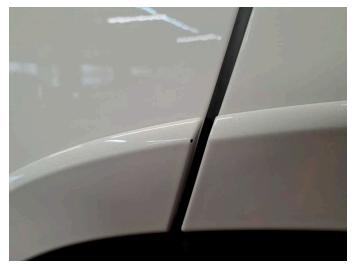
Damage 1: Side panel - rear left side: Wheel well extension - Stone chips - Smart repair

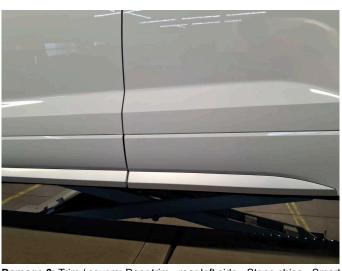
**Damage 1:** Side panel - rear left side: Wheel well extension - Stone chips - Smart repair

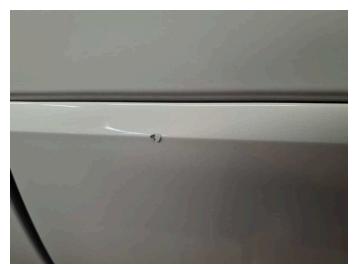
Damage 2: Trim / covers: Door trim - rear left side - Stone chips - Smart repair

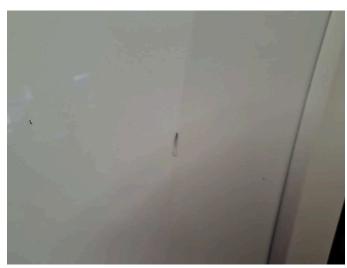
No.	Component group	Description
1	Bonnet	Bonnet - Stone chips - No deduction
2	Vehicle glazing	Windscreen - Stone chips - No deduction
3	Interior	Interior - Soiled - No deduction
4	Front bumper	Front bumper - Scratch(es) - Paint
The	vehicle shows signs of wear	commensurate with its age and use.

Wear and tear 4: Front bumper: Front bumper - Scratch(es) - Paint
