Expertise

Protocol number: 41346955
Order No. / Reference: 25019366
Inspection date: 1 Sept 2025

Manufacturer: Seat

Model: Leon 1.6 TDI Start&Stop Style

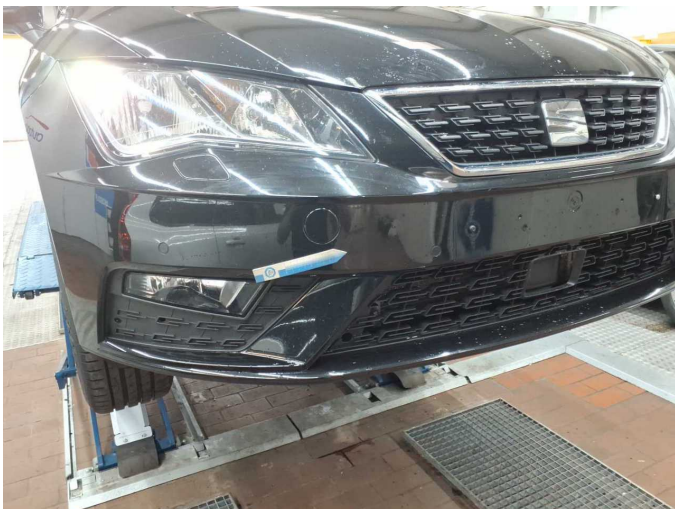
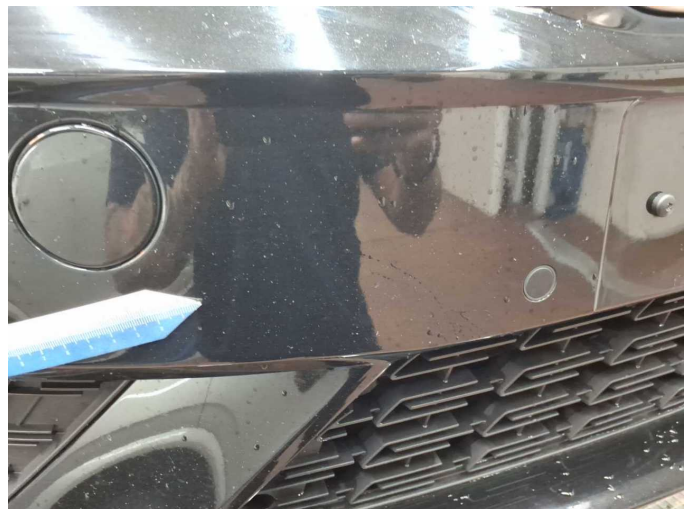
No.	Component group	Description
1	Front bumper	Front bumper (Übermäßige Steinschläge) - Stone chips - Paint
2	Side panel - rear left side	Side panel - Scratch(es) - Paint
3	Bonnet	Bonnet (Übermäßige Steinschläge) - Stone chips - Paint
4	Door - rear left side	Door - Dent / paintcoat damage - Repair and paint

Damage 1: Front bumper: Front bumper (Übermäßige Steinschläge) - Stone chips - Paint

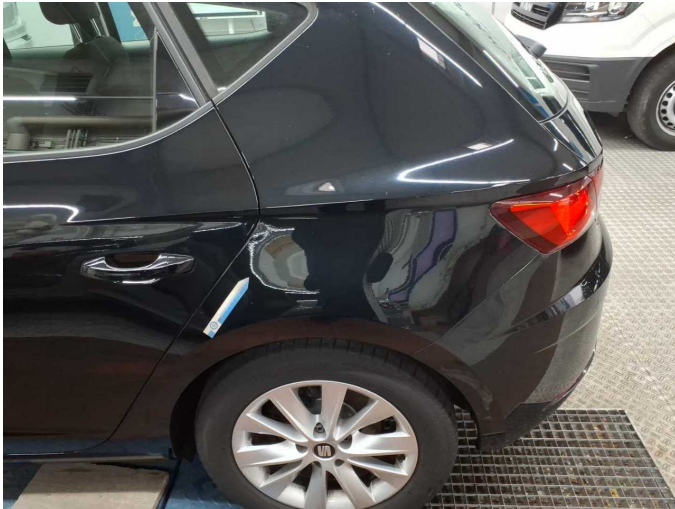
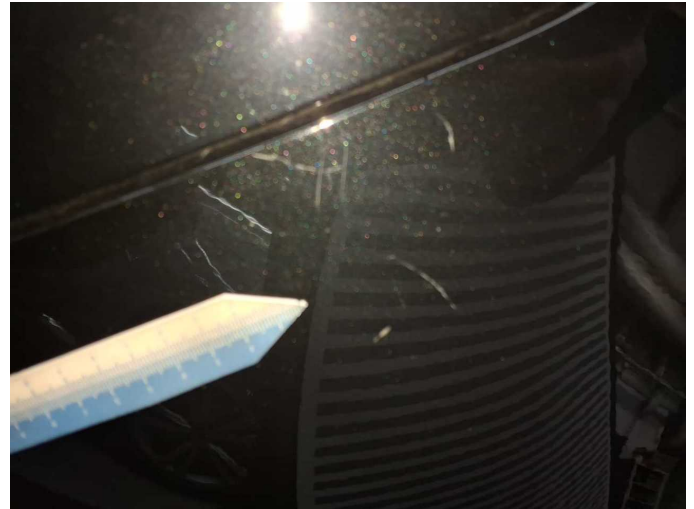
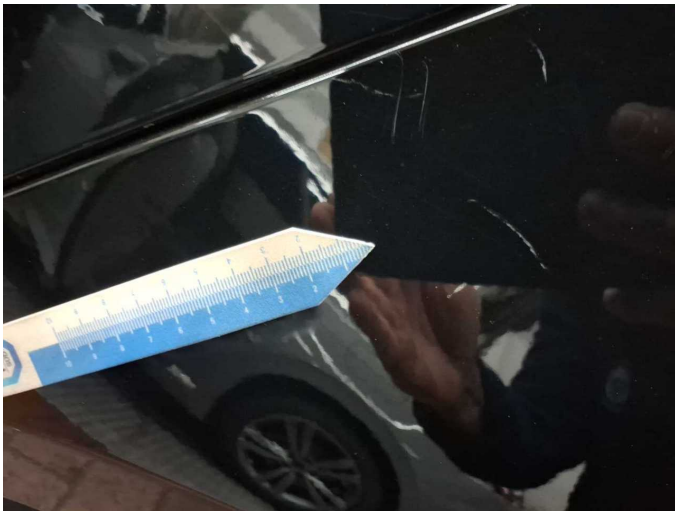
Damage 2: Side panel - rear left side: Side panel - Scratch(es) - Paint

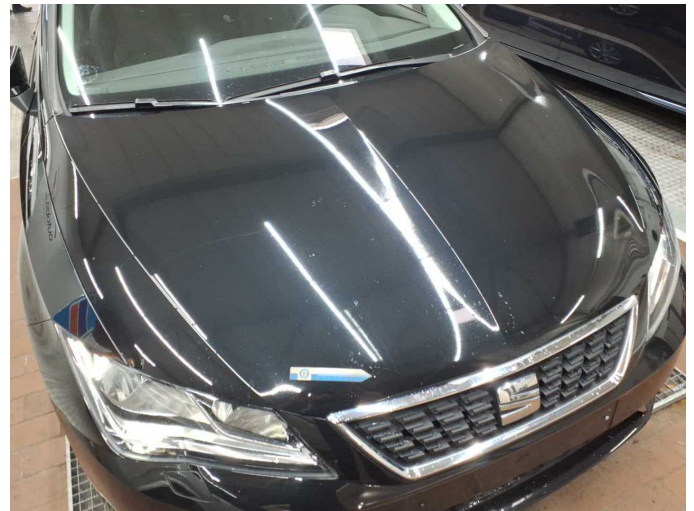
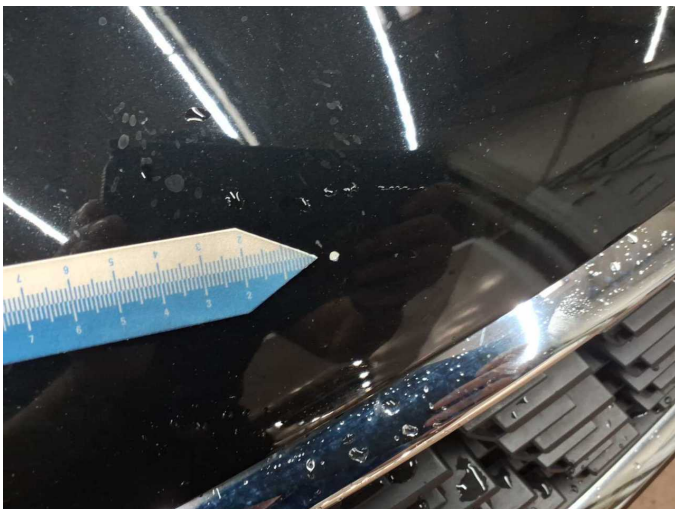
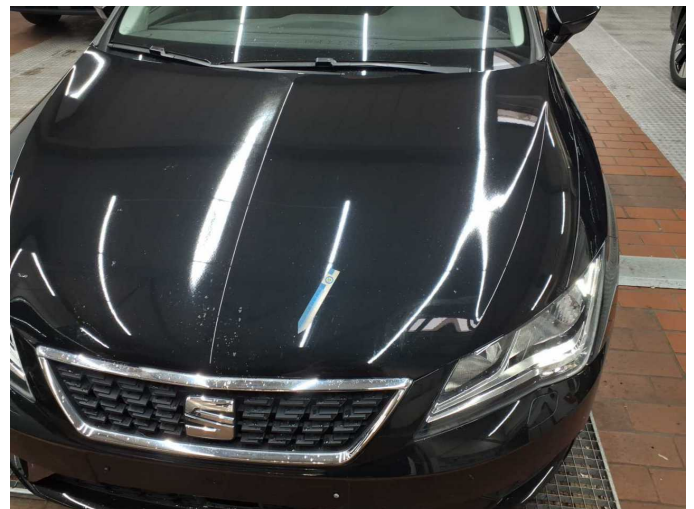
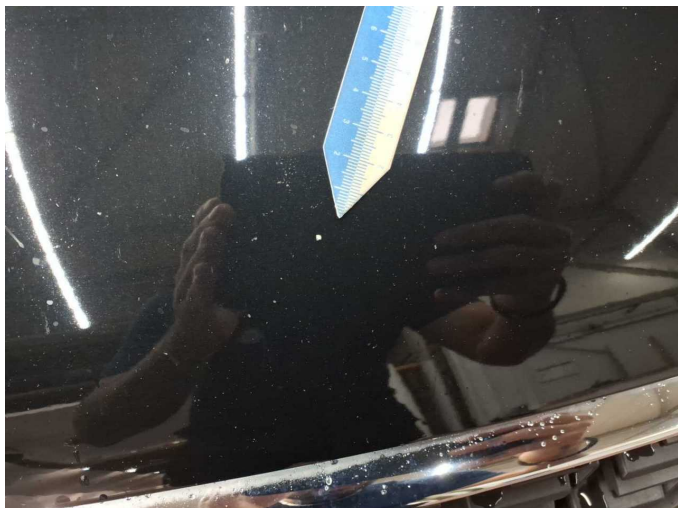
Damage 3: Bonnet: Bonnet (Übermäßige Steinschläge) - Stone chips - Paint

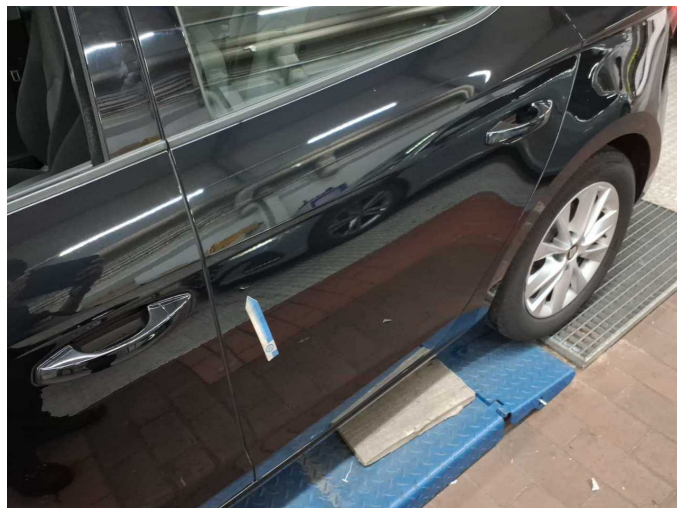
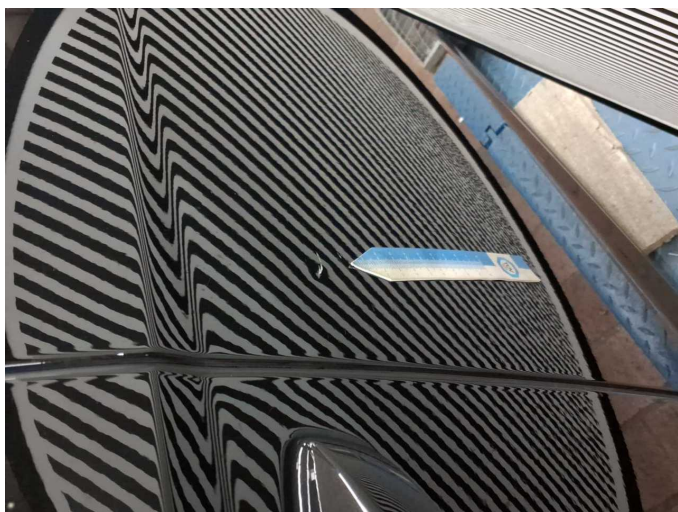
Damage 4: Door - rear left side: Door - Dent / paintcoat damage - Repair and paint
