## status report

| <b>customer:</b> | <b>Bank 11, Neuss</b> |

| vehicle data | | | |
|---|---|---|---|
| <b>Seat Leon FR</b> | | | |
| Vehicle identification number | <b>VSSZZZ5FZLR082176</b> | mileage read: | <b>42101 km</b> |

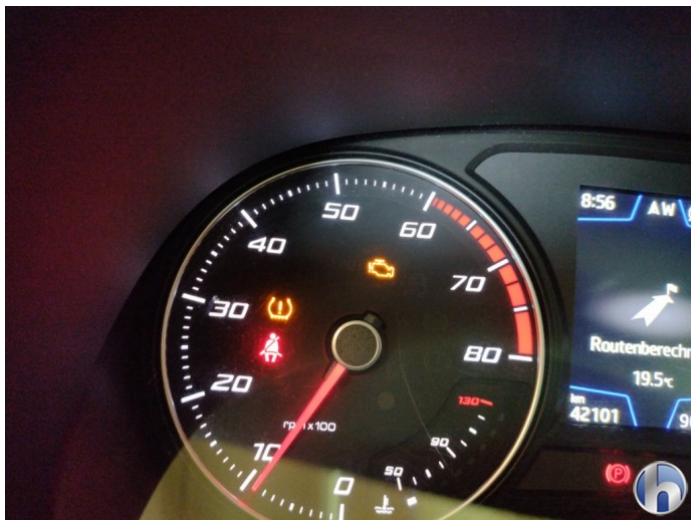
| Performed testing technology | |
|---|---|
| <b>engine running:</b> | A field test of the engine had to acoustic or visual defects for visiting time .<br>**Engine warning light. |

| component | Damage | Rep kind |
|---|---|---|
| 1. Motorkontrollleuchte | Error message | Carry out a fault diagnosis |

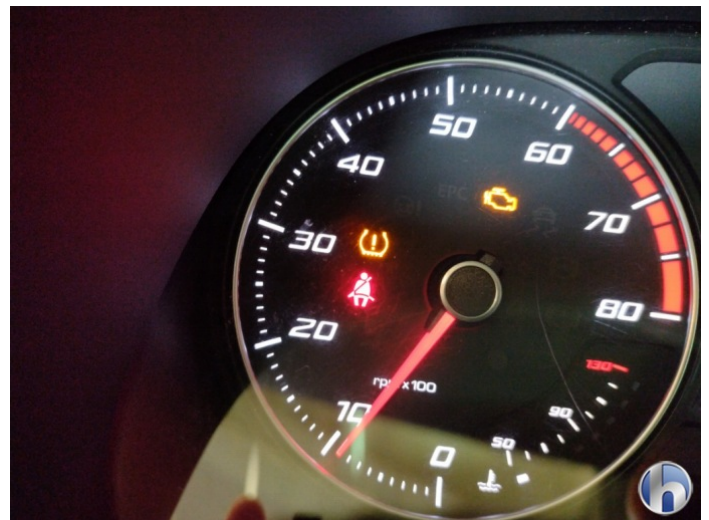
| component | Damage | Rep kind |
|---|---|---|
| 2. Reifendruckkontrollleuchte | Error message | Carry out a fault diagnosis |

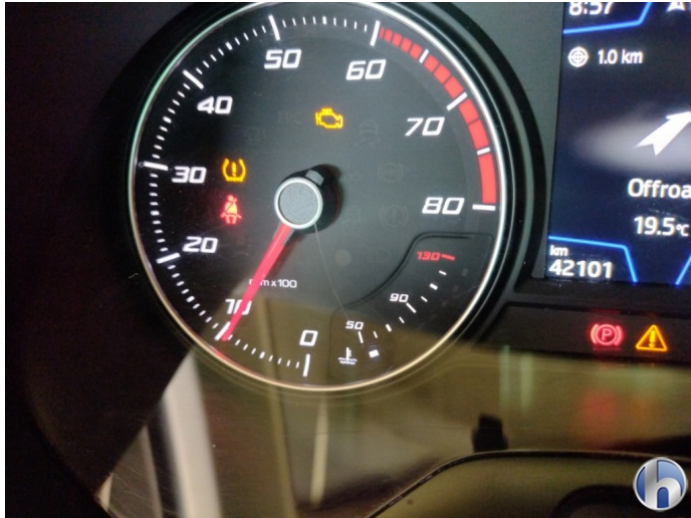
| component | Damage | Rep kind |
|---|---|---|
| 3. instrument cluster | Wear and tear | acceptable |

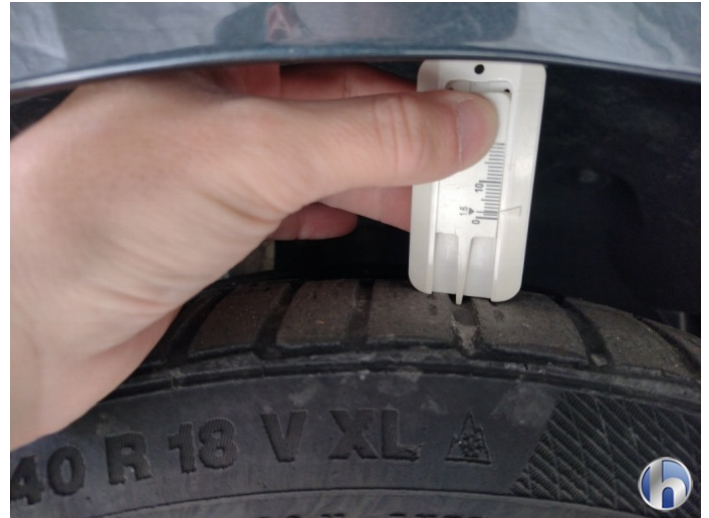
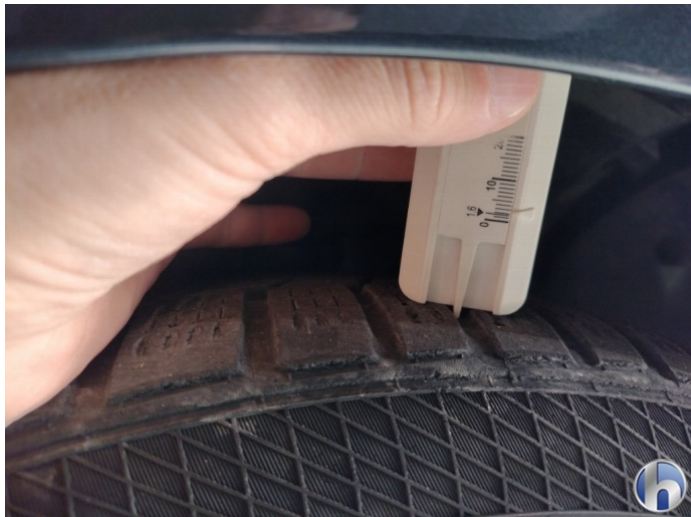
| mounted tires | | |
|---|---|---|
| 1st axis - Left / states . | <b>Continental</b> | <b>225/40/R18/92V 2 mm</b> |
| 1st axis - right / states . | <b>Continental</b> | <b>225/40/R18/92V 2 mm</b> |

| component | Damage | Rep kind |
|---|---|---|
| 5. Beide Reifen Vorne | Worn | Replace |

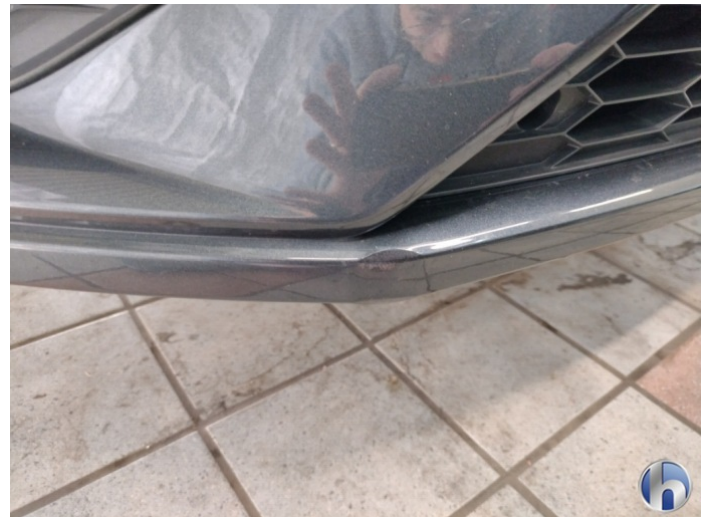
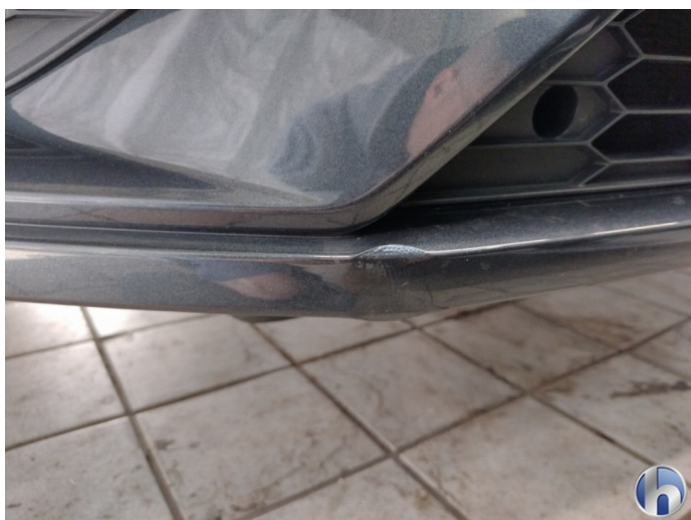
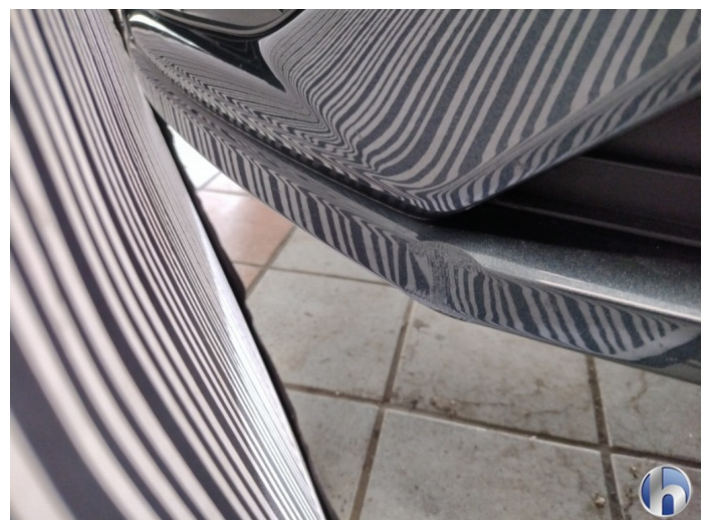
| component | Damage | Rep kind |
|---|---|---|
| 6. Front bumper | Damaged | Refurbish and paint |

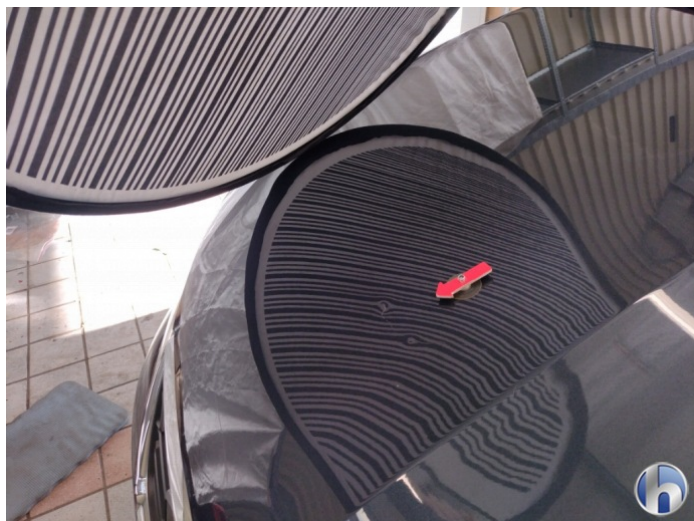
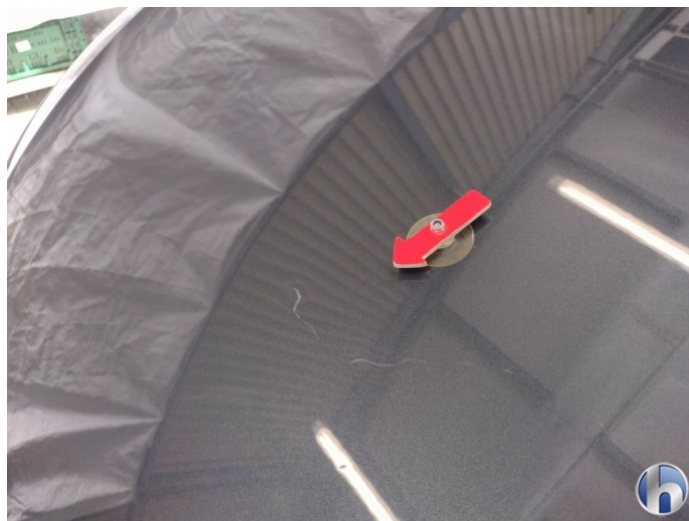
| component | Damage | Rep kind |
|---|---|---|
| 7. hood | Damaged | Refurbish and paint |

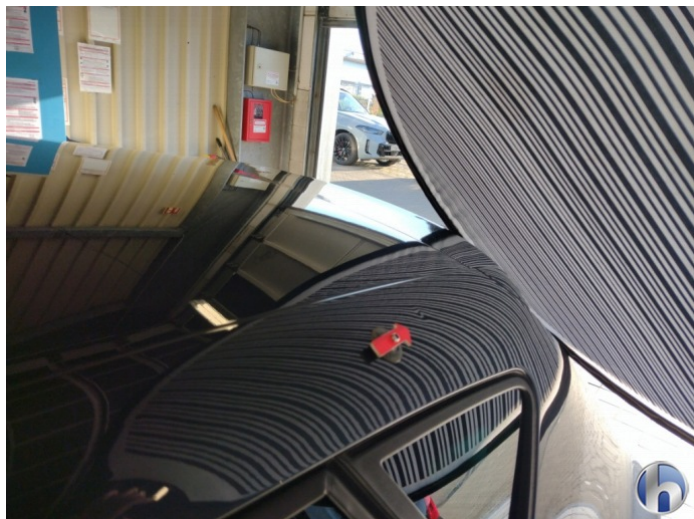
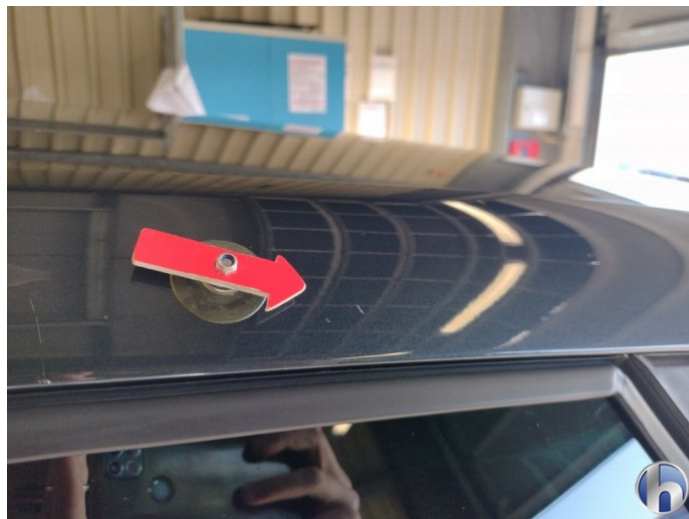
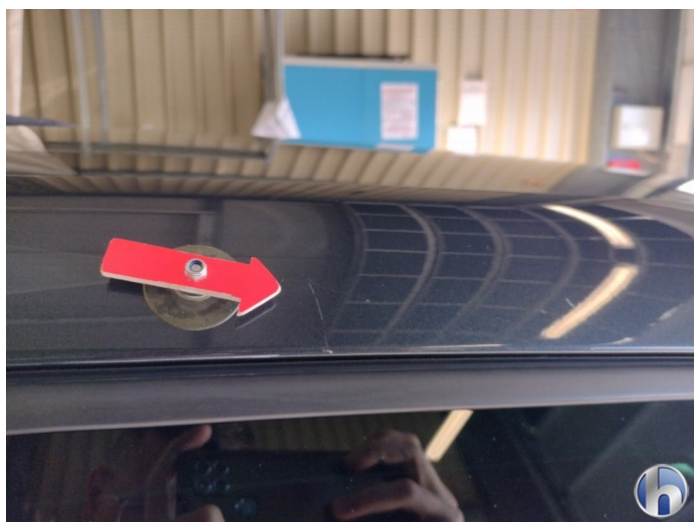
| component | Damage | Rep kind |
|---|---|---|
| 8. Roof frame - left | Damaged | Refurbish and paint |

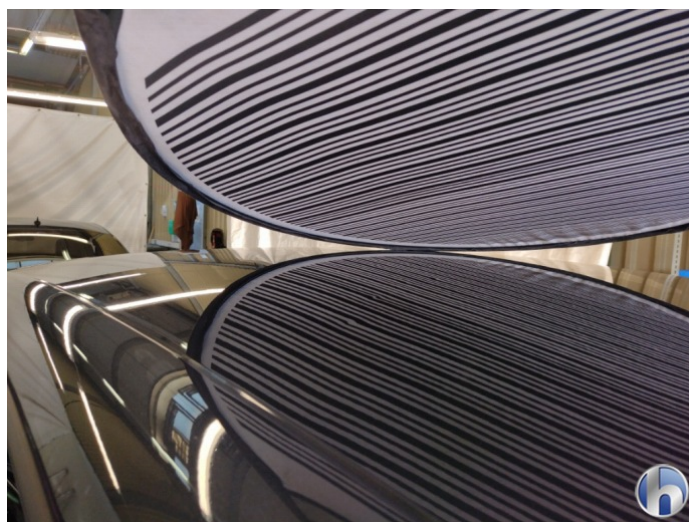
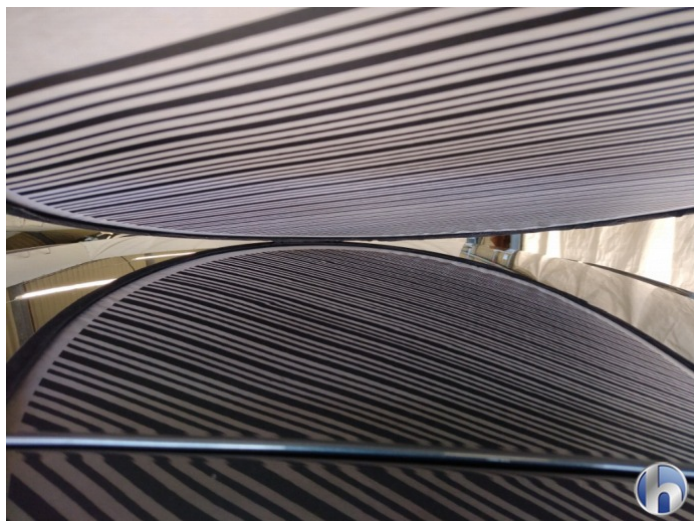
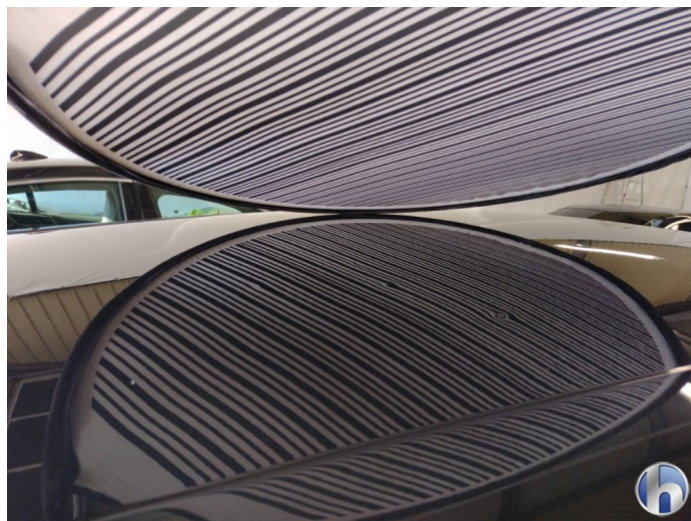
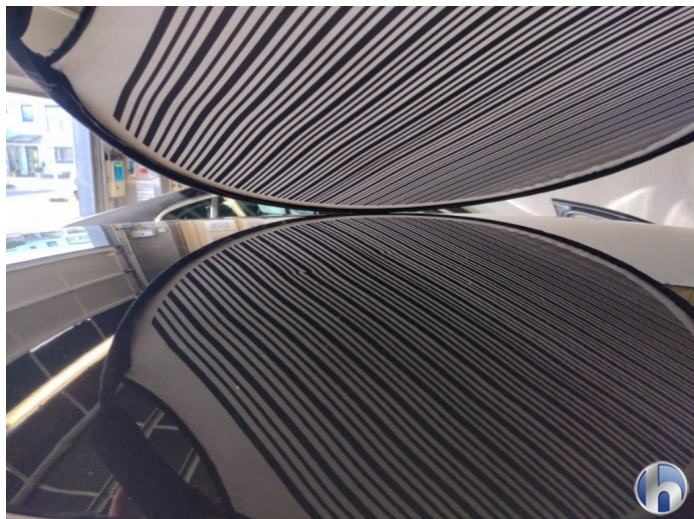
| Performed testing technology | |
|---|---|
| <b>reference:</b> | *Fahrzeug hat Alter und Laufleistungs bedingte Gebrauchsspuren innen und außen. Fahrzeug mit bestehendem Hagelschaden, zur Schadensermittlung wurden keine Demontagearbeiten durchgeführt, verborgen gebliebene Schäden können nicht ausgeschlossen werden. Hagelschaden Kosten wurden überschlägig Kalkuliert, Kostenerweiterung möglich. |

| component | Damage | Rep kind |
|---|---|---|
| 9. Dach 58x 10-20mm | Hail damage | Gentle refurbishing |

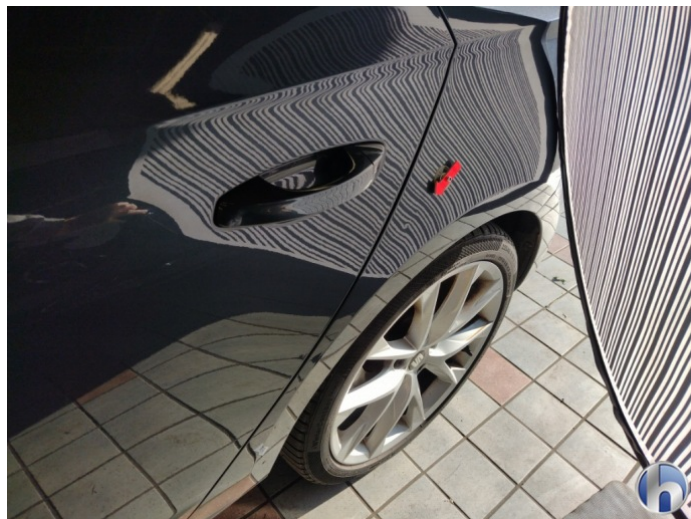
| component | Damage | Rep kind |
|---|---|---|
| 10. Sidewall - Rear - Left | | Smart repair |

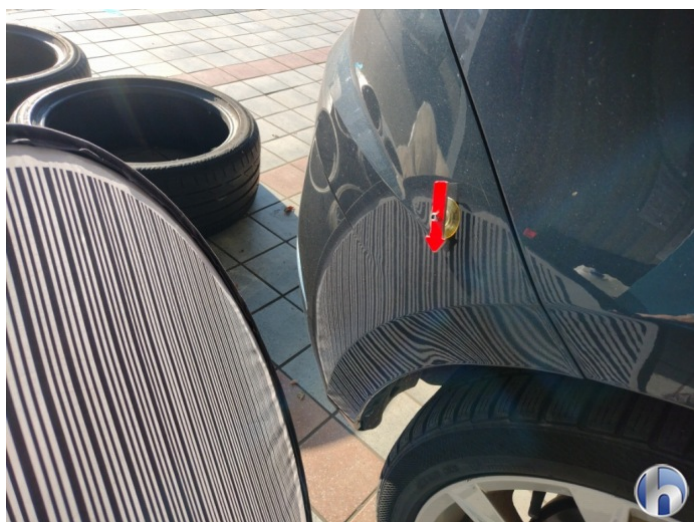
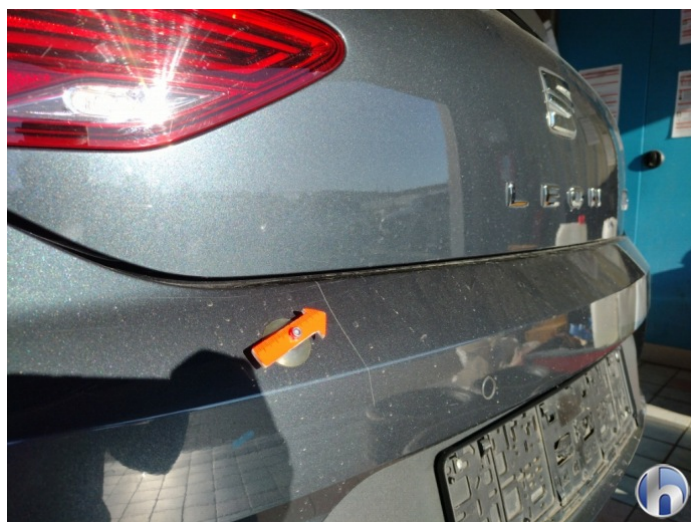
| component | Damage | Rep kind |
|---|---|---|
| 11. Rear bumper | Damaged | Refurbish and paint |

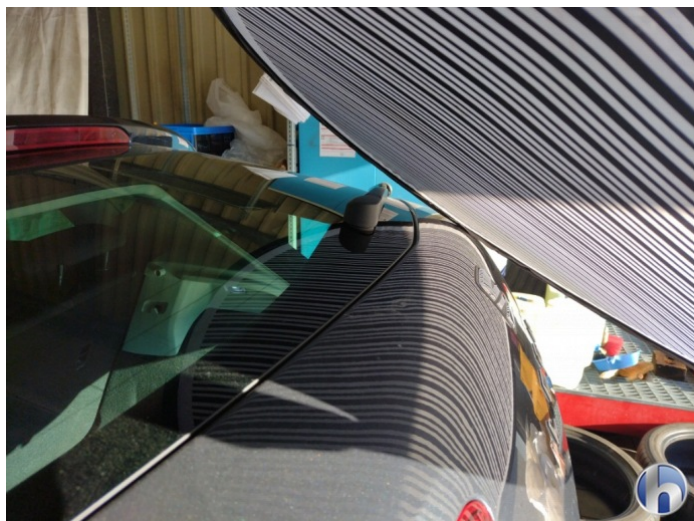
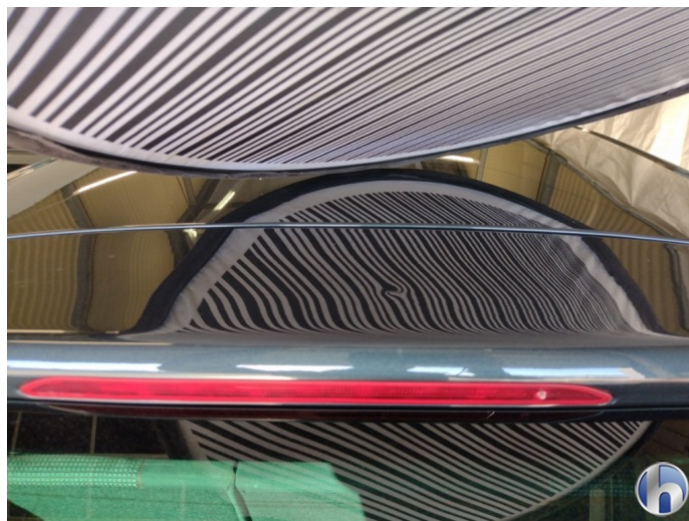
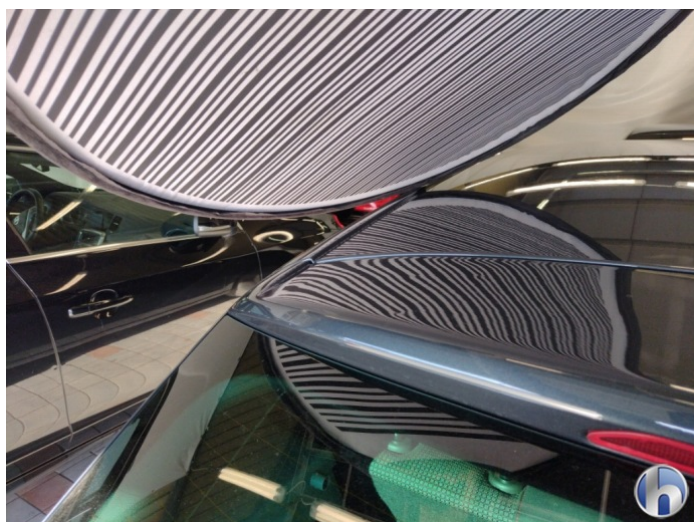
| component | Damage | Rep kind |
|---|---|---|
| 12. Heckklappe 7x 10-20mm | Hail damage | Gentle refurbishing |

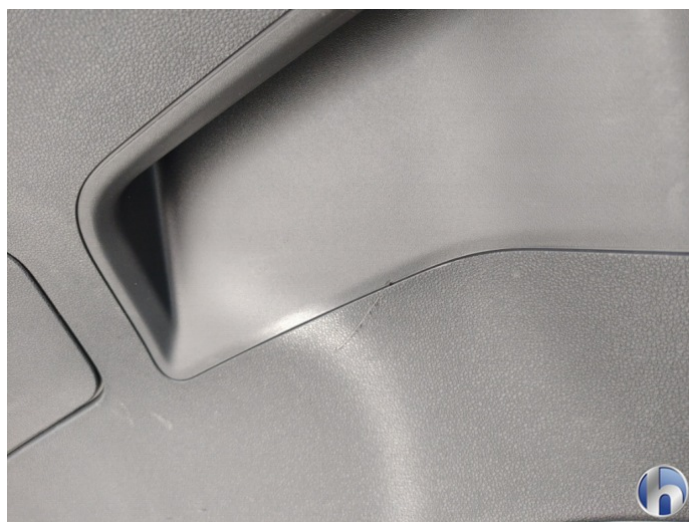
| component | Damage | Rep kind |
|---|---|---|
| 13. tailgate trim | Damaged | Smart repair |

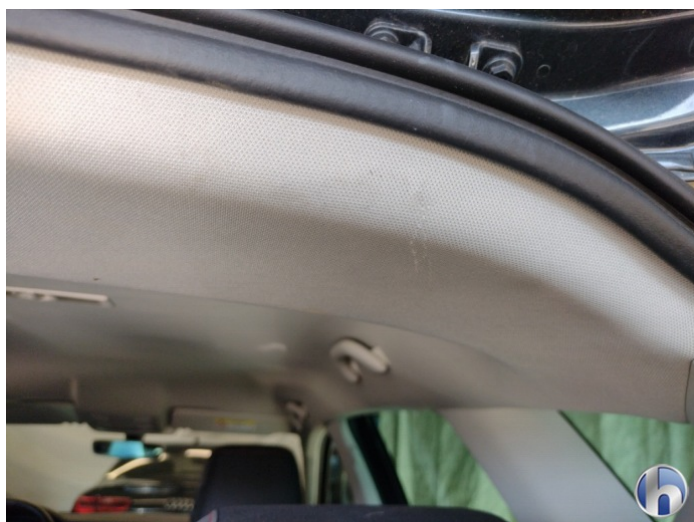
| component | Damage | Rep kind |
|---|---|---|
| 14. headlining | Damaged | Smart repair |

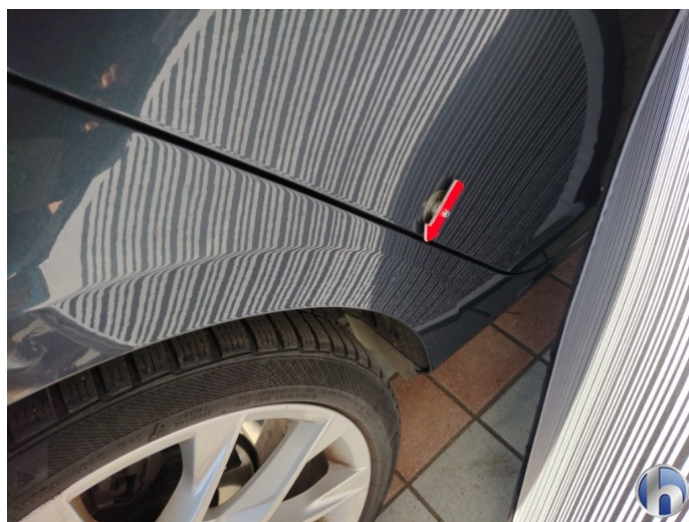
| component | Damage | Rep kind |
|---|---|---|
| 15. Sidewall - Rear - right | Delle | Smart repair |

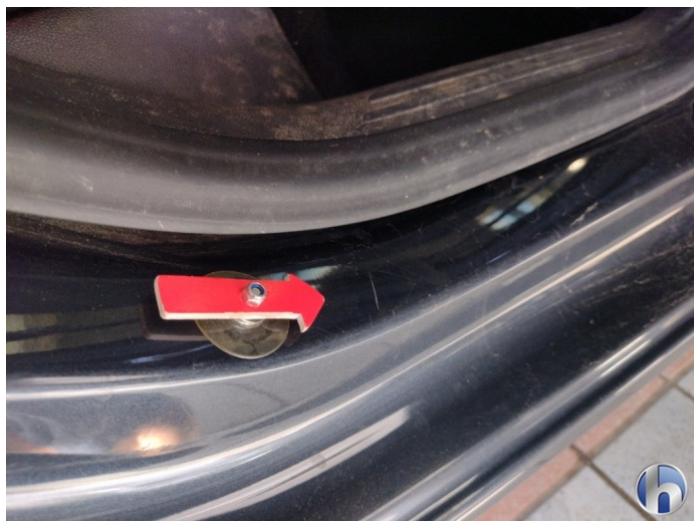
| component | Damage | Rep kind |
|---|---|---|
| 16. Türeinstieg Hinten - Rechts | Scratch(es) | Paint |

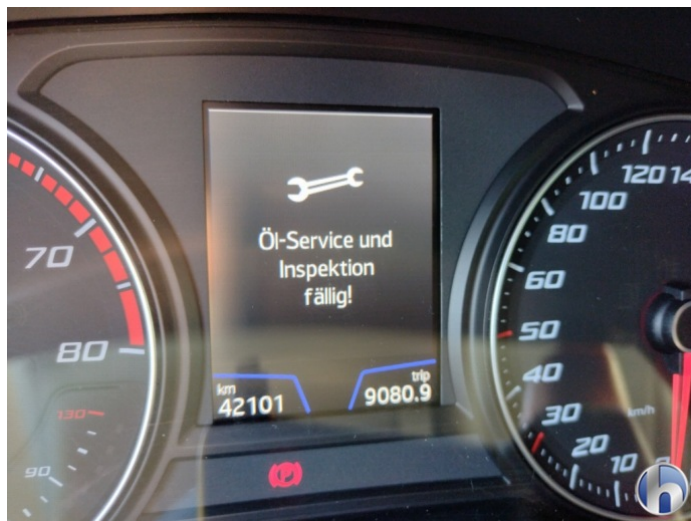
| component | Damage | Rep kind |
|---|---|---|
| 18. maintenance | Due | Replace |
