Expertise

Protocol number: 41277202
Order No. / Reference: 25134574
Inspection date: 27 Aug 2025

Model: Ateca 2.0 TDI DSG Style

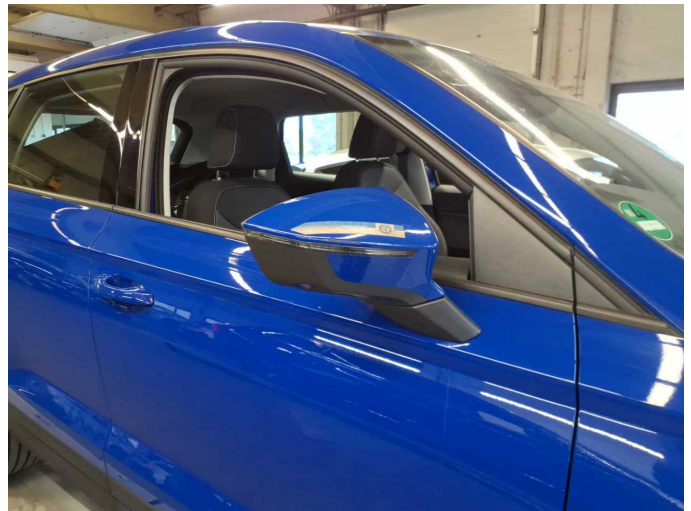
Damage 1: Wing mirror - right side: Cap - Scratch(es) - Smart repair

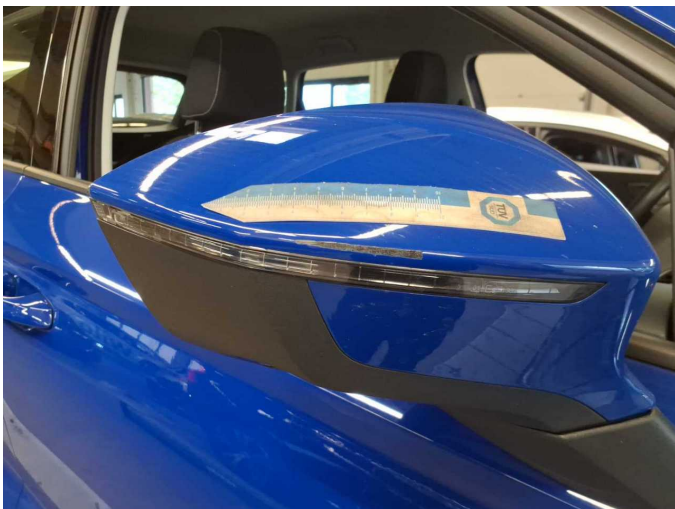
Damage 1: Wing mirror - right side: Cap - Scratch(es) - Smart repair

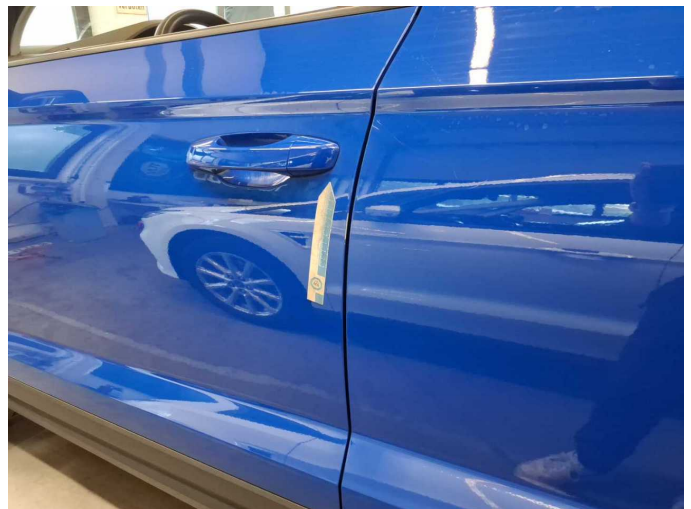
Damage 2: Door - front left side: Door edge - Scratch(es) - Smart repair

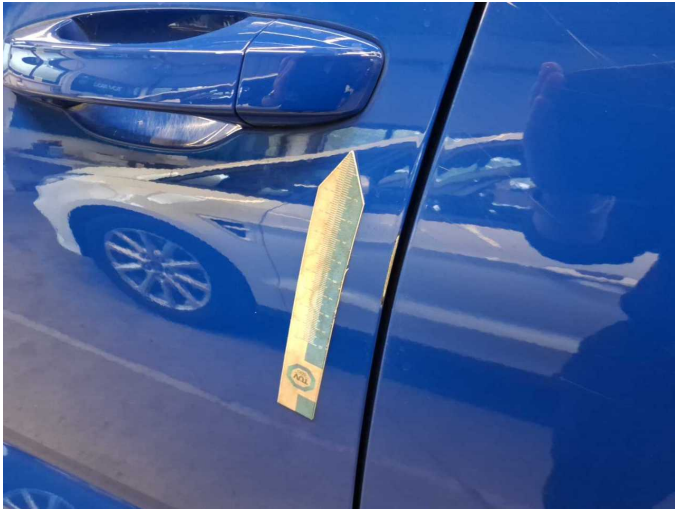
Damage 2: Door - front left side: Door edge - Scratch(es) - Smart repair

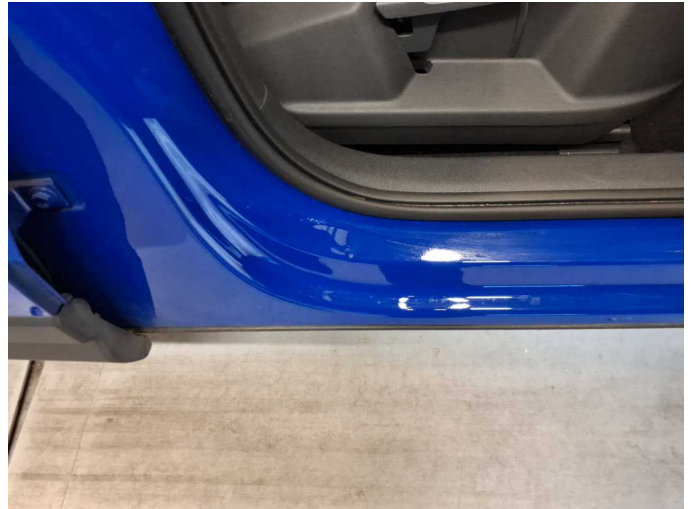
Damage 3: Sill - right side: Sill - Dent / paintcoat damage - Smart repair

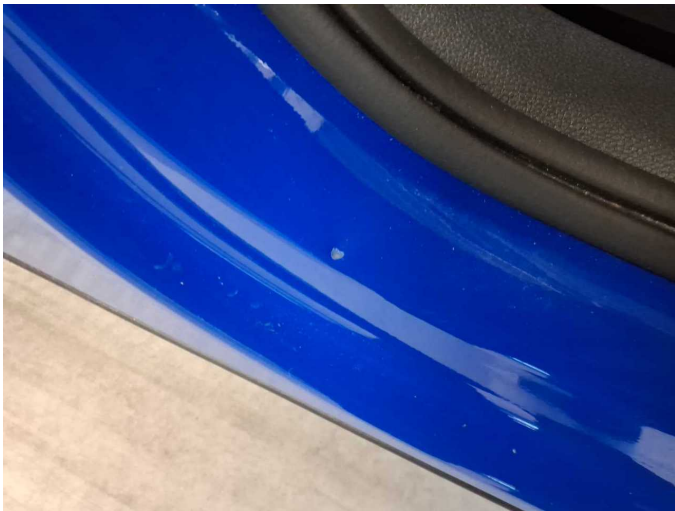
Damage 3: Sill - right side: Sill - Dent / paintcoat damage - Smart repair

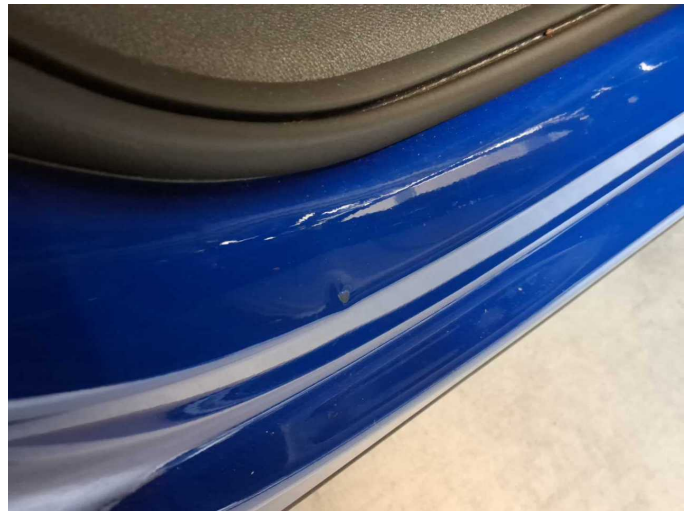
Damage 3: Sill - right side: Sill - Dent / paintcoat damage - Smart repair

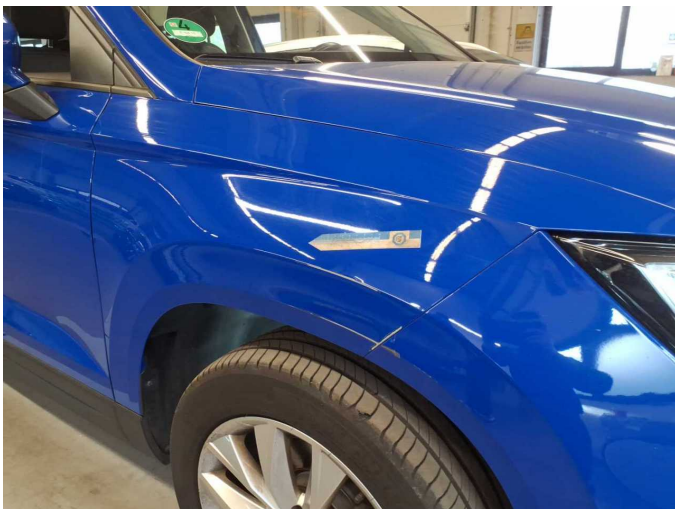
Damage 4: Mudguard - right side: Mudguard - right side - Scratch(es) - Paint

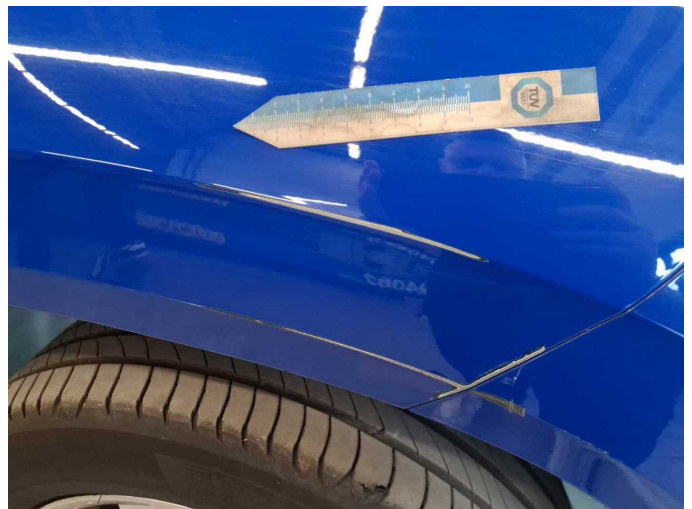
Damage 4: Mudguard - right side: Mudguard - right side - Scratch(es) - Paint

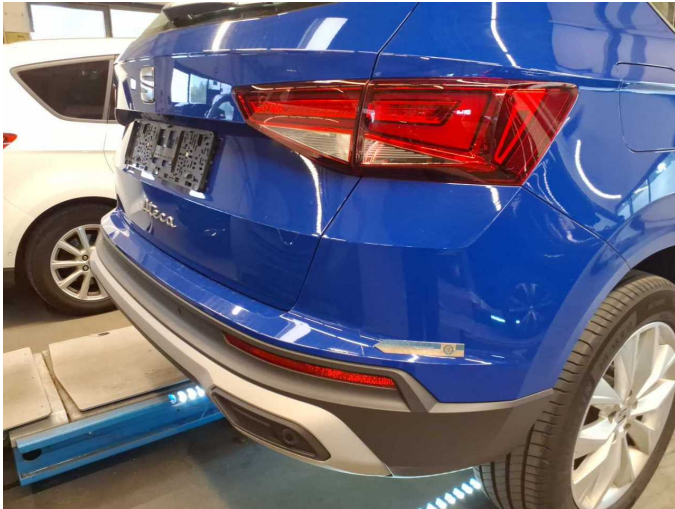
Damage 5: Rear bumper: Rear bumper - Scratch(es) - Paint

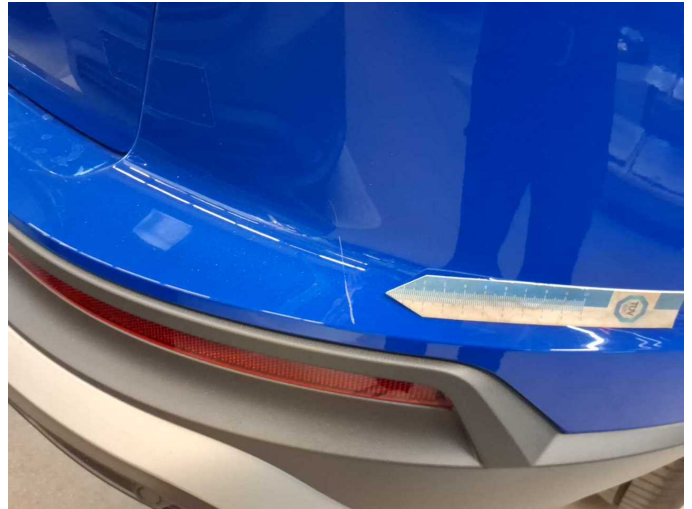
Damage 5: Rear bumper: Rear bumper - Scratch(es) - Paint

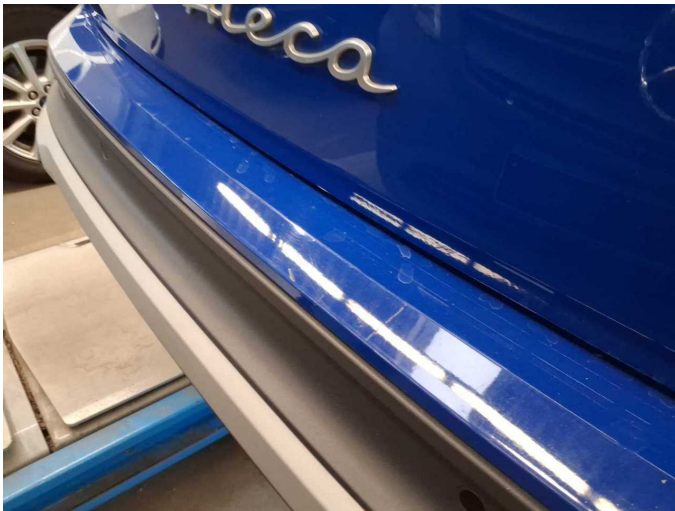
Damage 5: Rear bumper: Rear bumper - Scratch(es) - Paint

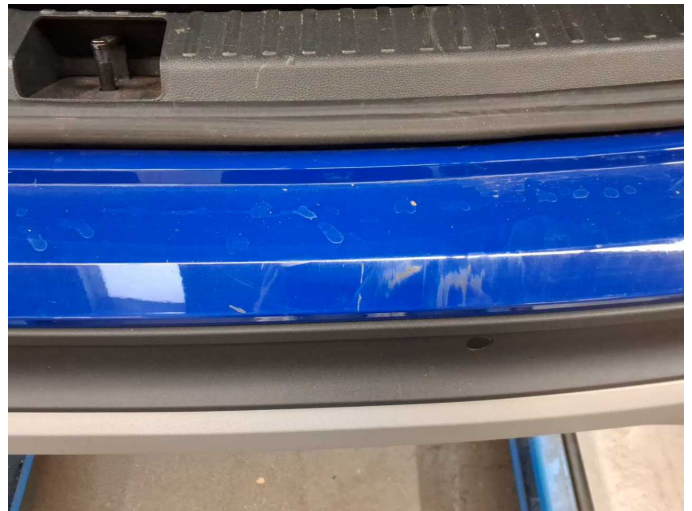
Damage 5: Rear bumper: Rear bumper - Scratch(es) - Paint

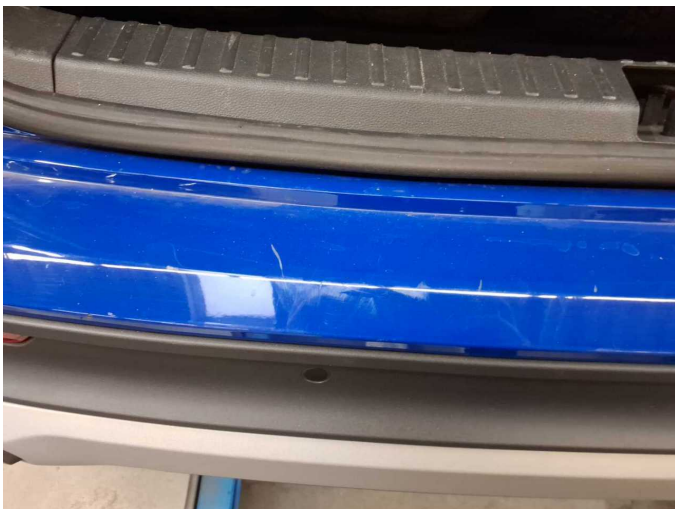
Damage 5: Rear bumper: Rear bumper - Scratch(es) - Paint

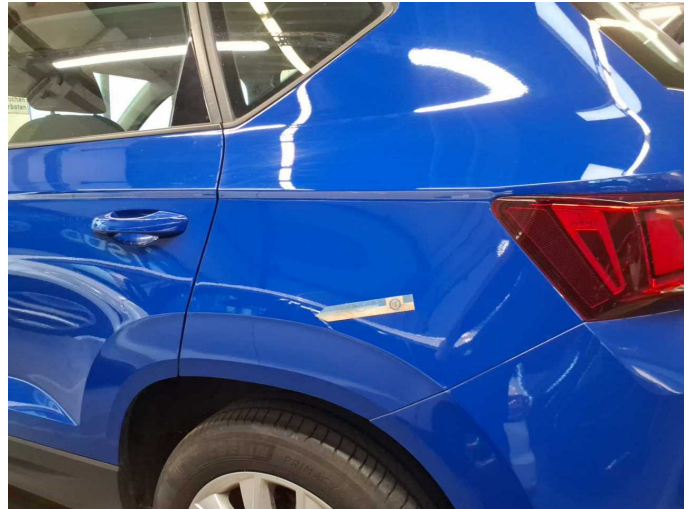
Damage 7: Side panel - rear left side: Side panel - Scratch(es) - Paint

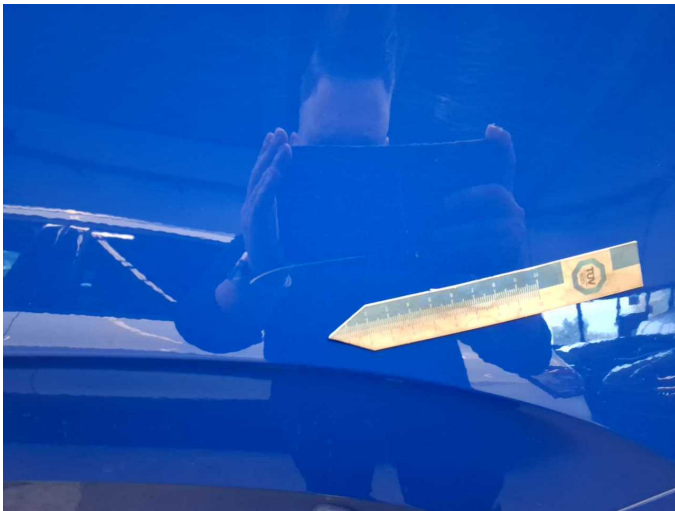
Damage 7: Side panel - rear left side: Side panel - Scratch(es) - Paint

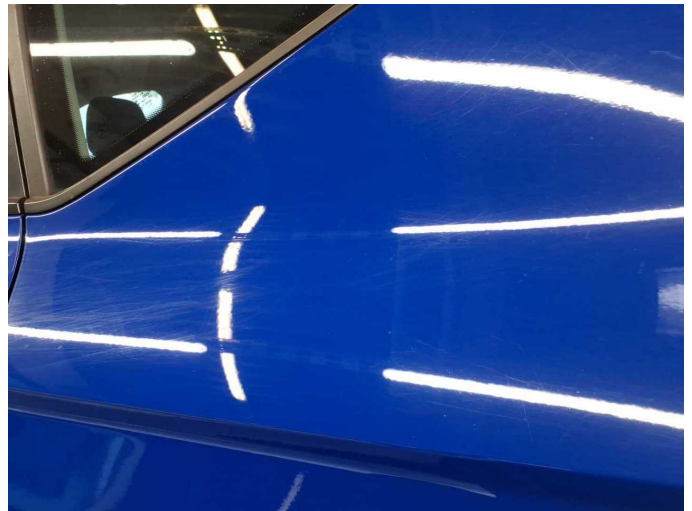
Damage 7: Side panel - rear left side: Side panel - Scratch(es) - Paint

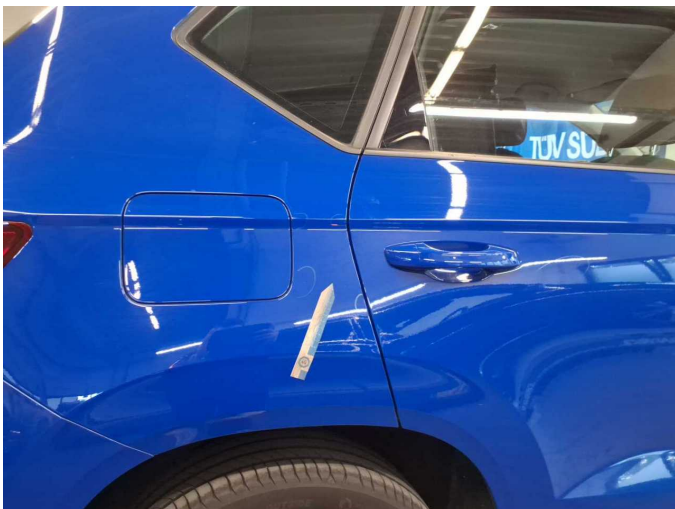
Damage 8: Side panel - rear right side: Side panel - Scratch(es) - Paint

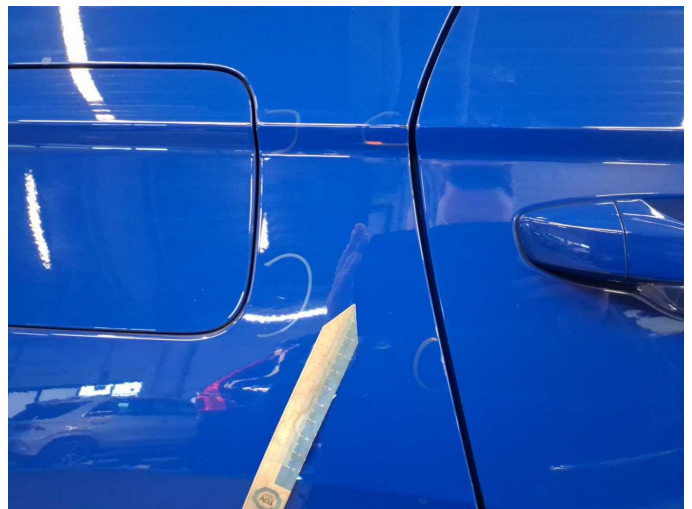
Damage 8: Side panel - rear right side: Side panel - Scratch(es) - Paint

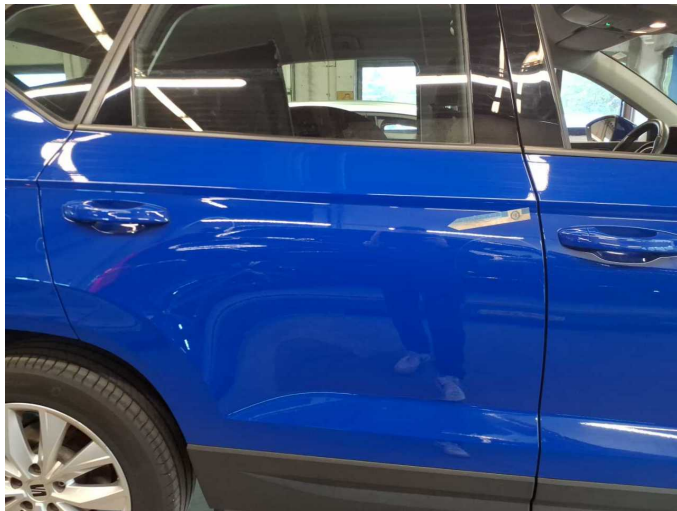
Damage 9: Door - rear right side: Door - Scratch(es) - Paint

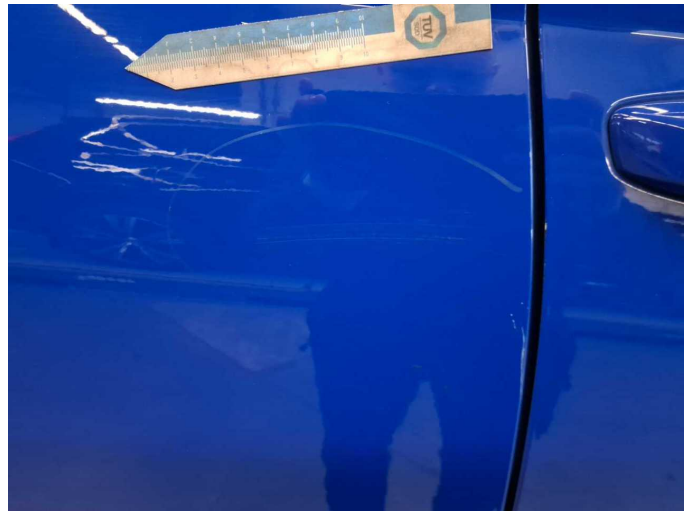
Damage 9: Door - rear right side: Door - Scratch(es) - Paint

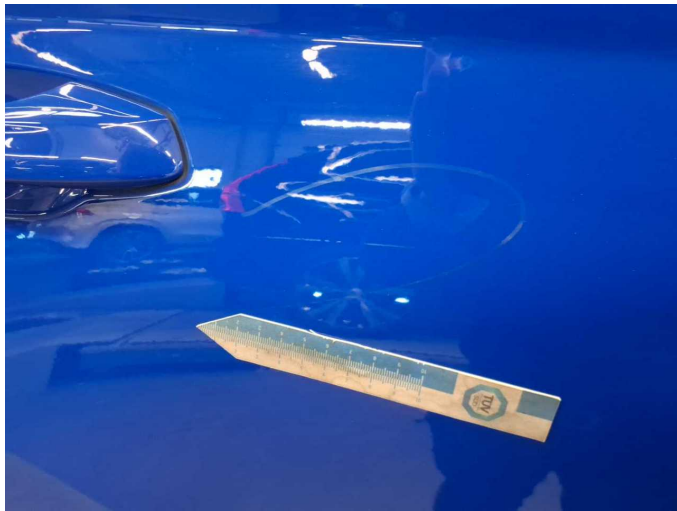
Damage 9: Door - rear right side: Door - Scratch(es) - Paint

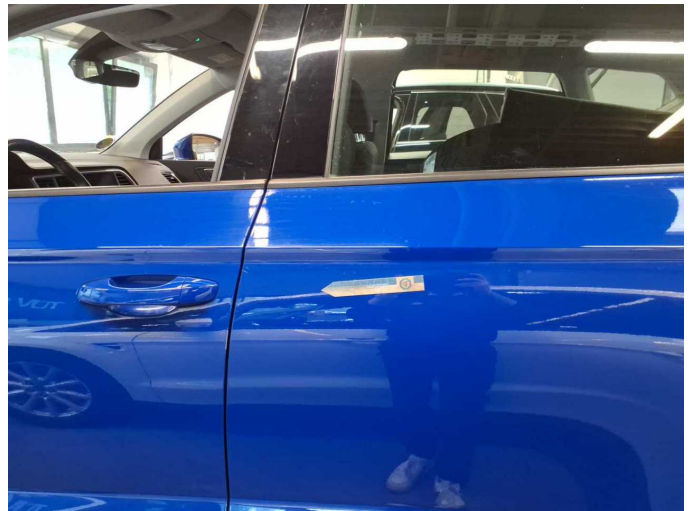
Damage 10: Door - rear left side: Door - Scratch(es) - Paint

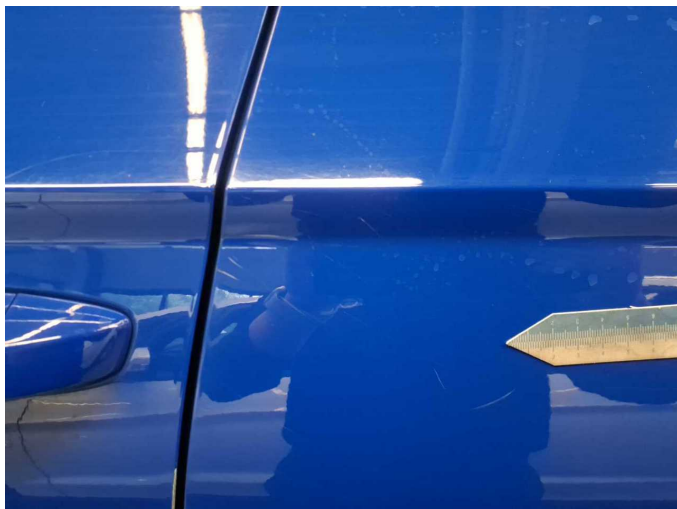
Damage 10: Door - rear left side: Door - Scratch(es) - Paint

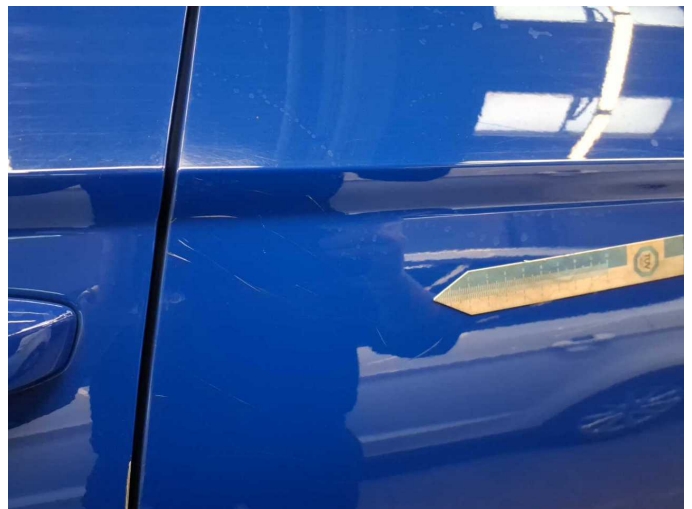
Damage 10: Door - rear left side: Door - Scratch(es) - Paint
