# SEAT Ateca

## Ateca 2.0 TDI DSG

VIN NO VSSZZZ5FZM6543039  
Registration Number FZM6543039

### Inspection Report Summary

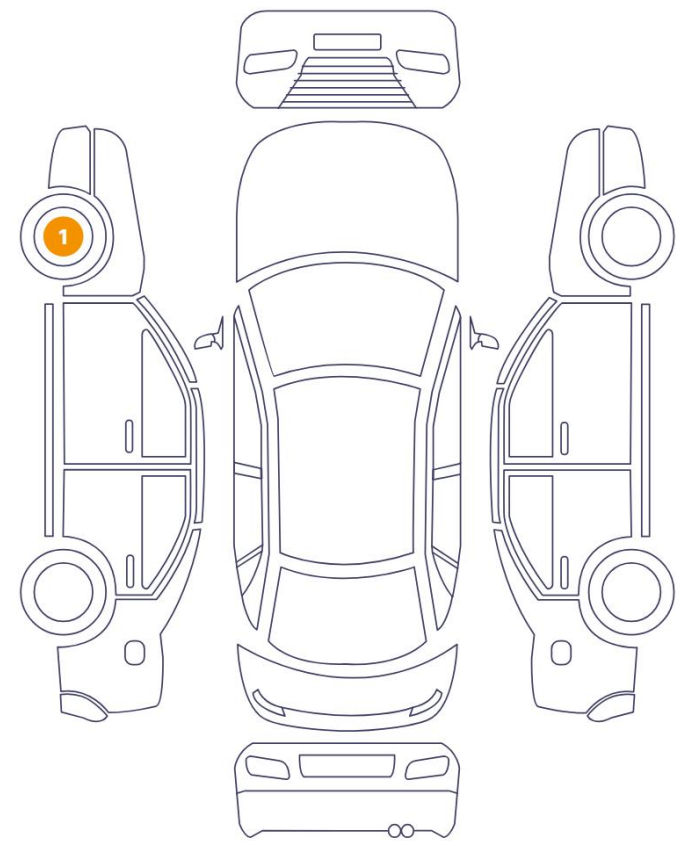
1 Schäden

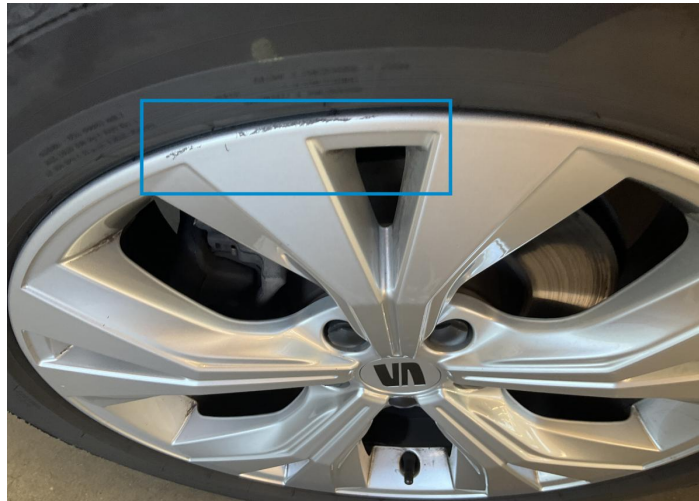
| Component | | Damage | Comments |
|---|---|---|---|
| 1 | Rim / Front Left | Out of Bodywork / Scratch | |

1. Rim / Front Left  
Out of Bodywork / Scratch -
