SEAT Arosa Arosa 1.0 VIN NO VSSZZZ6HZ3R005657

Inspection Report Summary

Customer	BCA Online	Report Number	P20250922141047
Inspection Date / Place	2025-09-22 / Dello Lübeck	Cosmetic Grade	3

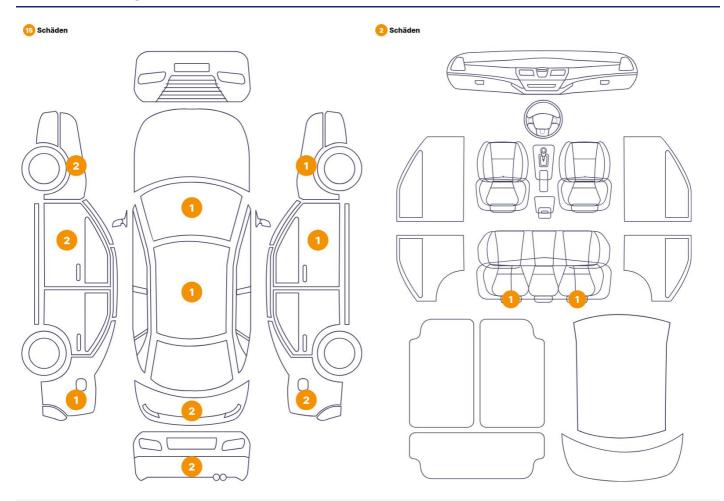
Component	Damage	Comments
1	Tailgate	Paint / Poor Previous Repair	
2	Fender / Front Right	Paint / Poor Previous Repair	
3	Fender / Front Left	Bodywork / Dent / Deformation	
4	Door / Front Left	Bodywork / Dent / Deformation	
5	Fender / Back Left	Bodywork / Dent / Deformation	
6	Roof	Bodywork / Dent / Deformation	
7	Fender / Back Right	Bodywork / Dent / Deformation	
8	Door / Front Right	Bodywork / Dent / Deformation	
9	Fender / Front Left	Paint / Corrosion	
10	Windshield / Front	Paint / Chipping	
11	Door / Front Left	Paint / Chipping	
12	Bumper / Back	Paint / Scratch / Scuff

13	Bumper / Back	Paint / Scratch / Scuff
14	Fender / Back Right	Paint / Scratch / Scuff
15	Headrest / Back Left	Interior / Missing
16	Headrest / Back Right	Interior / Missing
17	Tailgate	Paint / Chipping

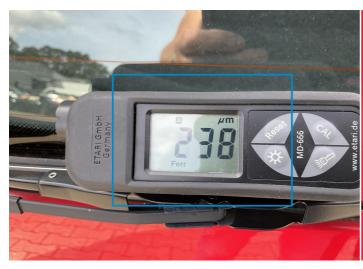
1. Tailgate Paint / Poor Previous Repair -

2. Fender / Front Right Paint / Poor Previous Repair -

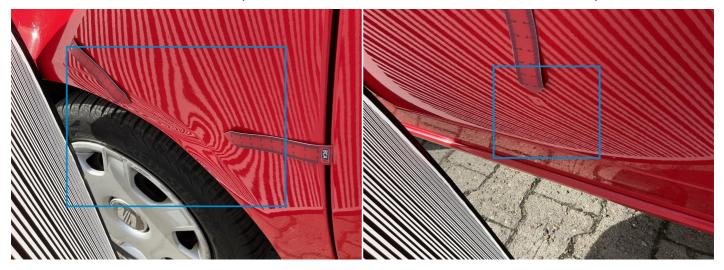
3. Fender / Front Left Bodywork / Dent / Deformation -

4. Door / Front Left Bodywork / Dent / Deformation -

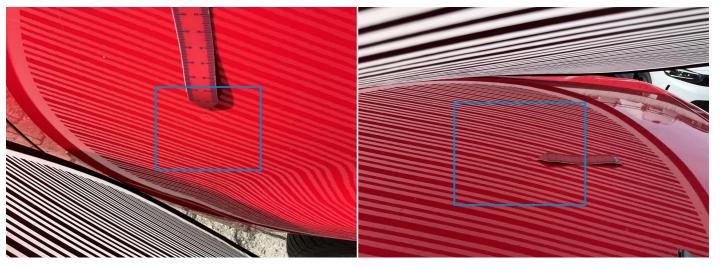
5. Fender / Back Left Bodywork / Dent / Deformation -

6. Roof Bodywork / Dent / Deformation -

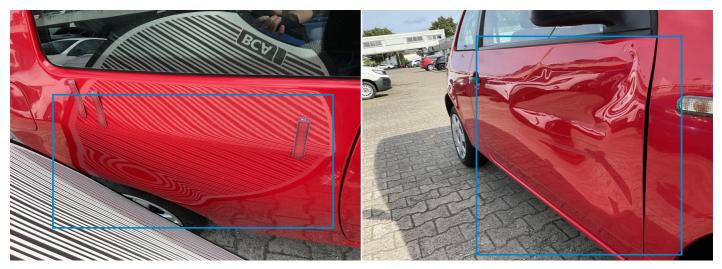
7. Fender / Back Right Bodywork / Dent / Deformation -

8. Door / Front Right Bodywork / Dent / Deformation -

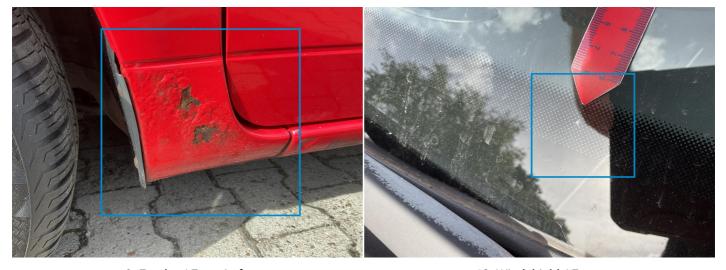
9. Fender / Front Left Paint / Corrosion -

10. Windshield / Front Paint / Chipping -

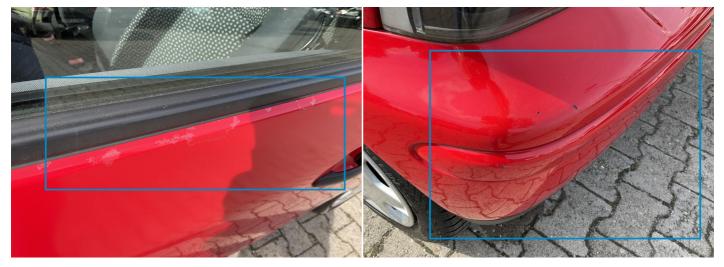
11. Door / Front Left Paint / Chipping -

12. Bumper / Back Paint / Scratch / Scuff -

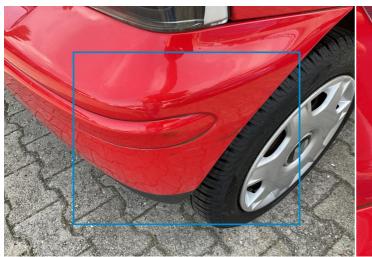
13. Bumper / Back Paint / Scratch / Scuff -

14. Fender / Back Right Paint / Scratch / Scuff -

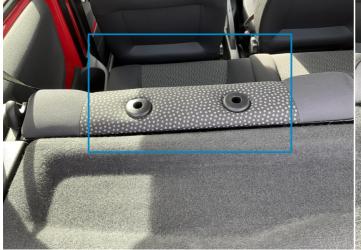
15. Headrest / Back Left Interior / Missing -

16. Headrest / Back Right Interior / Missing -

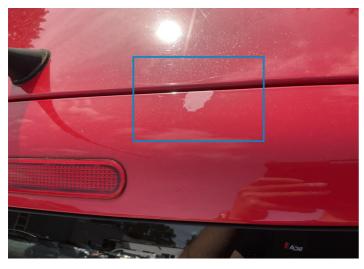
17. Tailgate Paint / Chipping -
