Expertise

Protocol number: 39606946
Order No. / Reference: 24751493
Inspection date: 5 May 2025

Manufacturer: Seat

Model: Leon Sportstourer 2.0 TDI DSG Xcellence

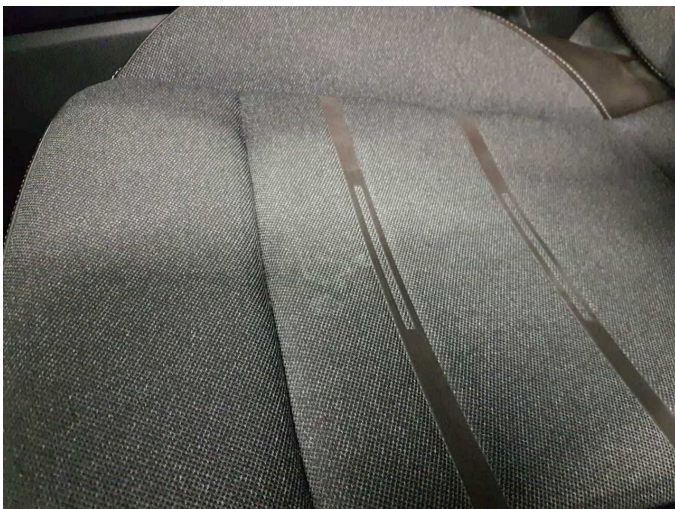
Damage 1: Seat - front: Seat cover - left side - Soiled - Clean

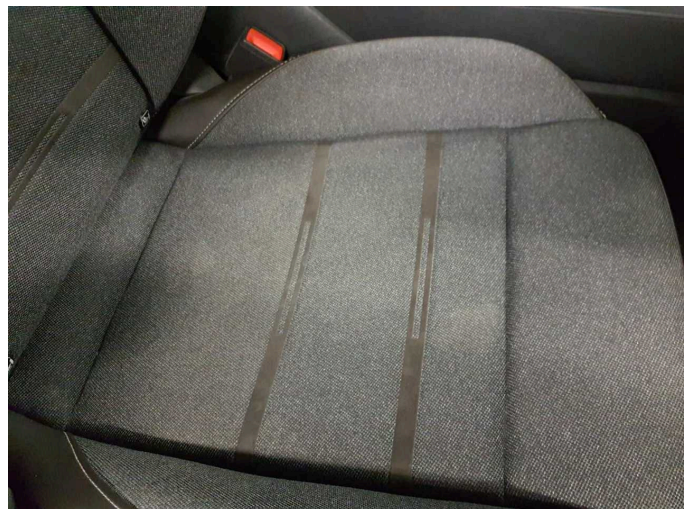
Damage 2: Seat - front: Seat cover - right side - Soiled - Clean

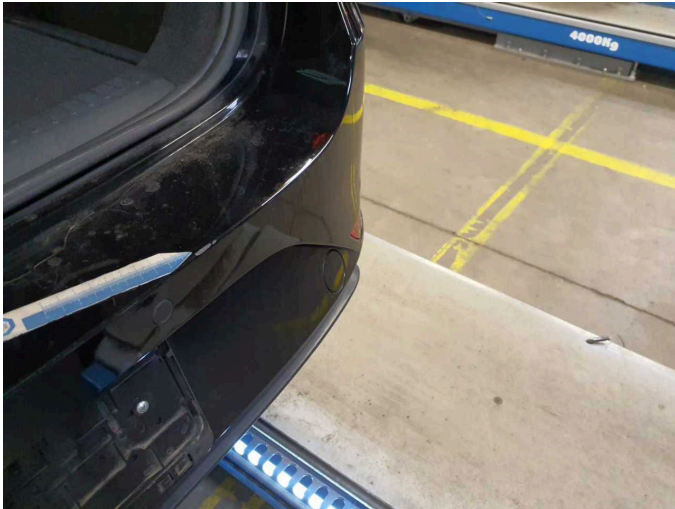
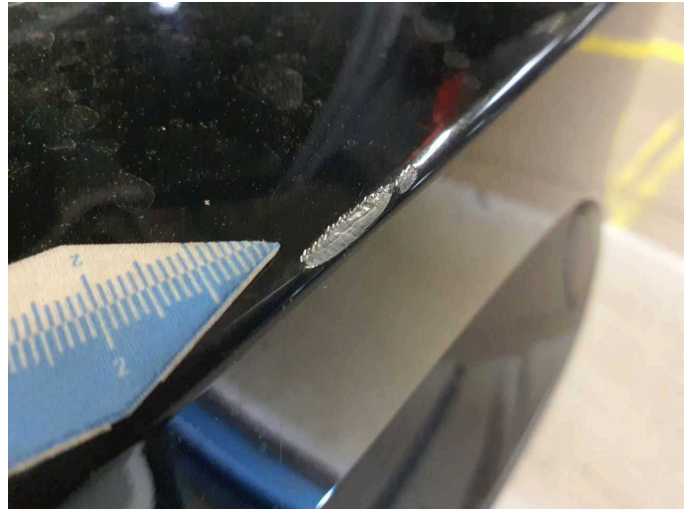
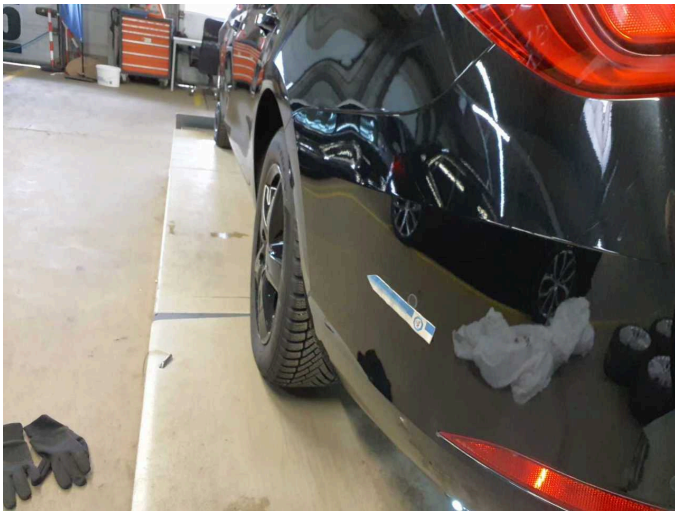
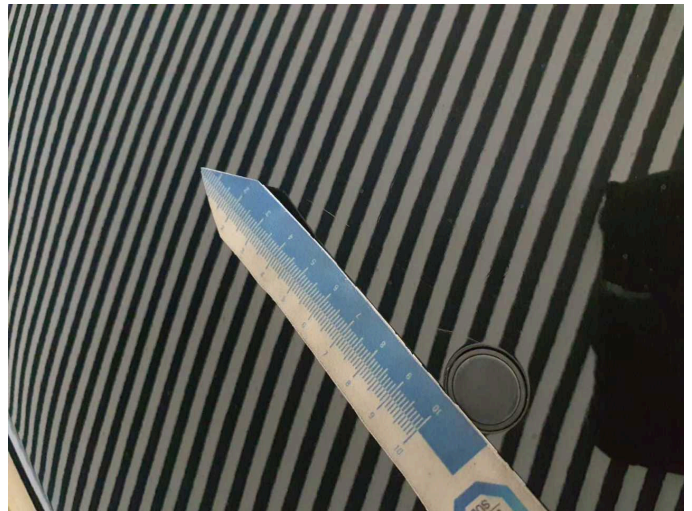
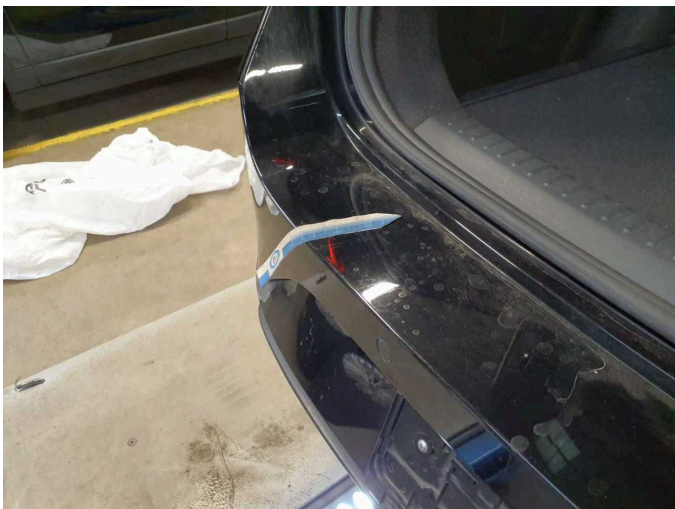
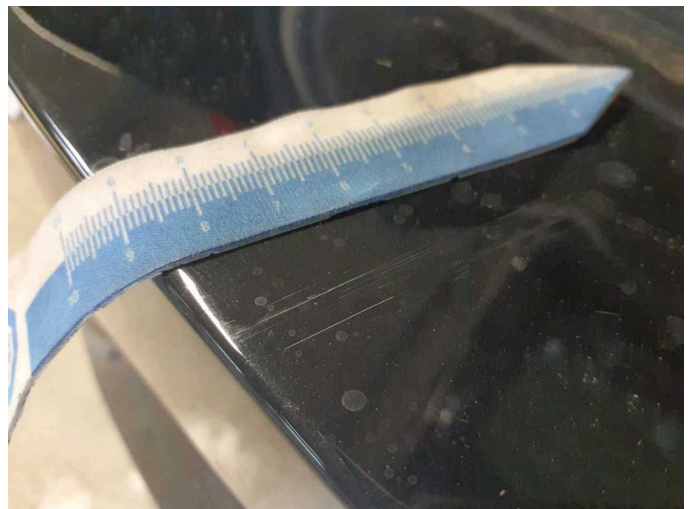
Damage 3: Rear bumper: Rear bumper - Scratched - Paint

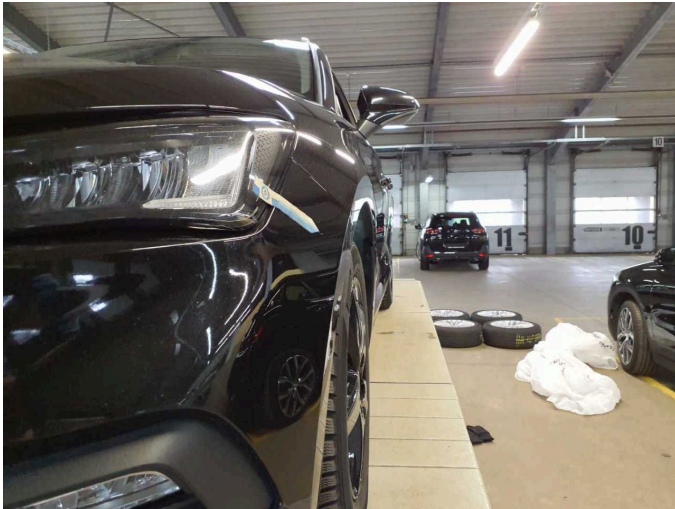
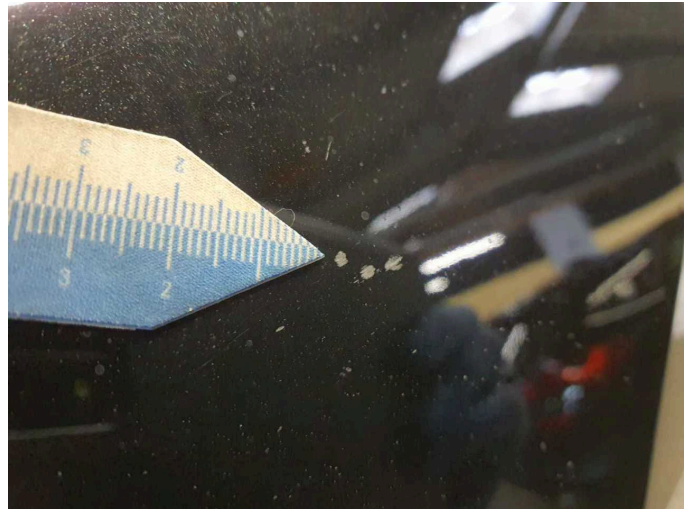
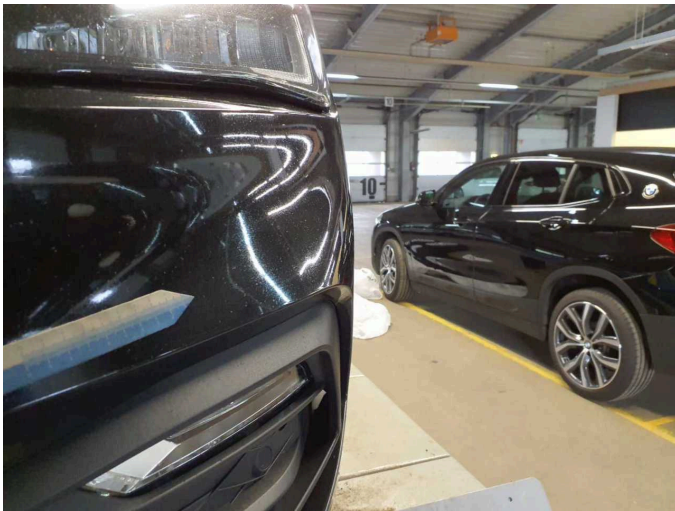
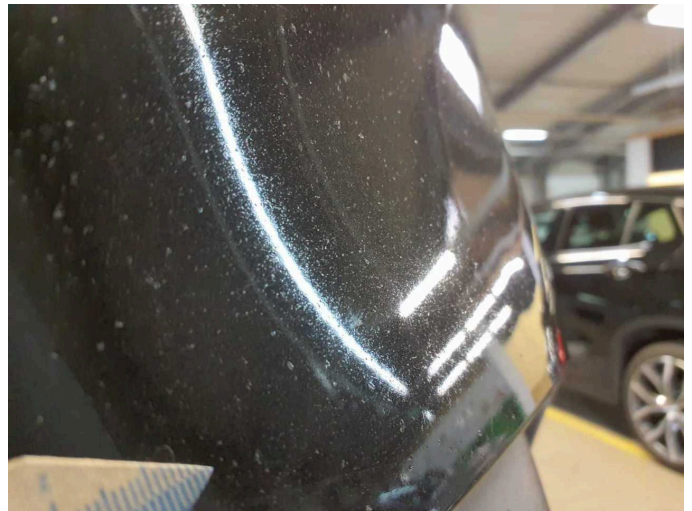
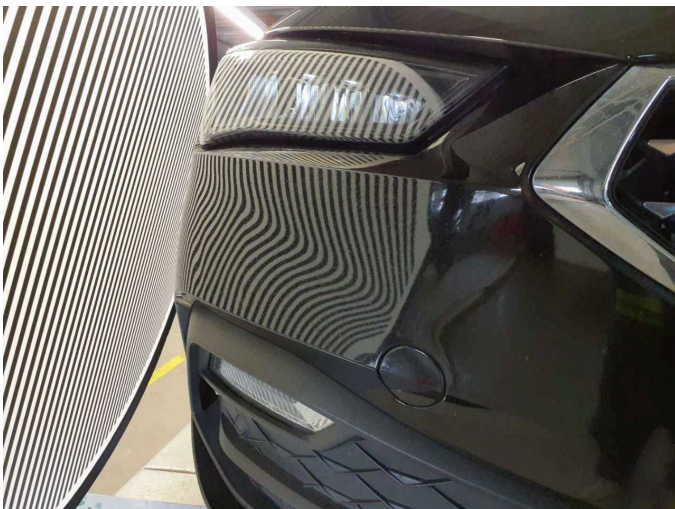
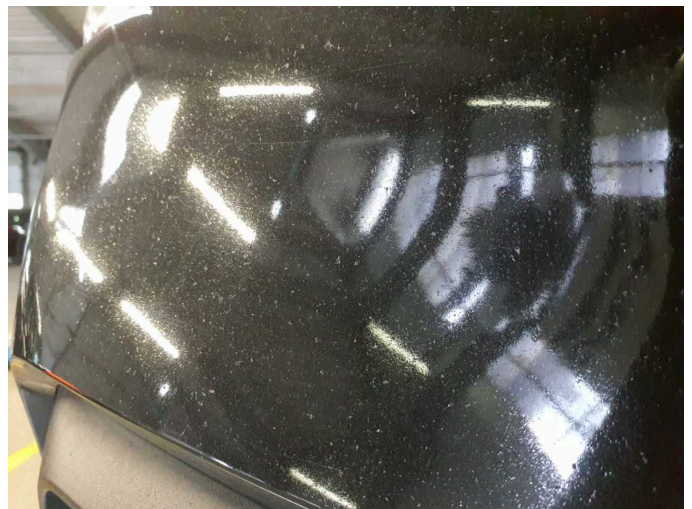
Damage 4: Front bumper: Front bumper (Steinschlag) - Scratched - Paint

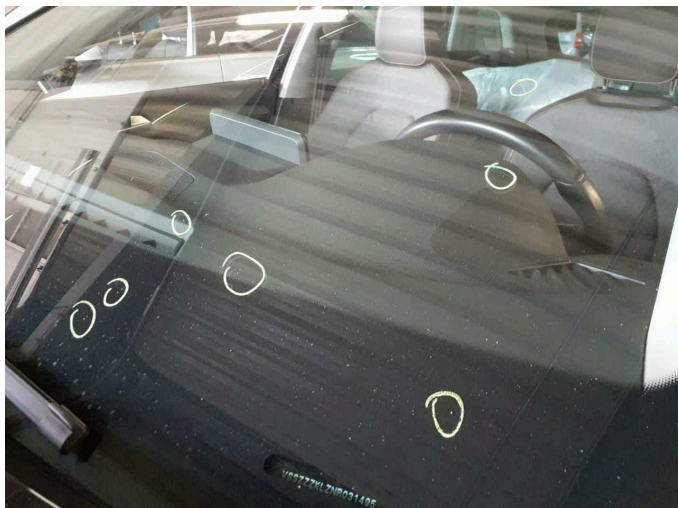
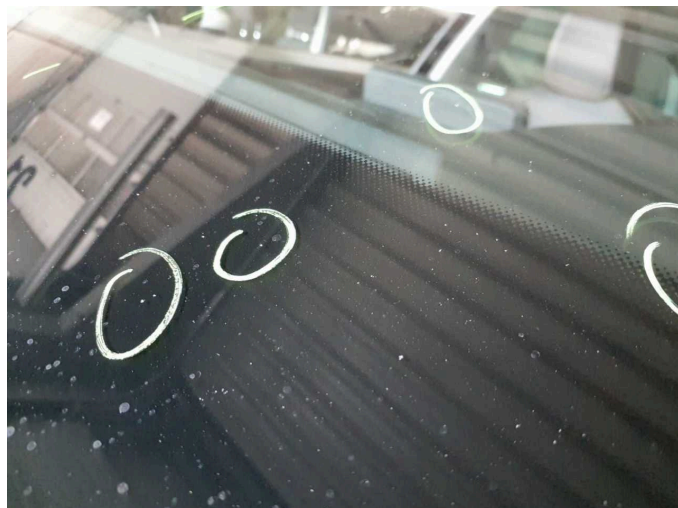
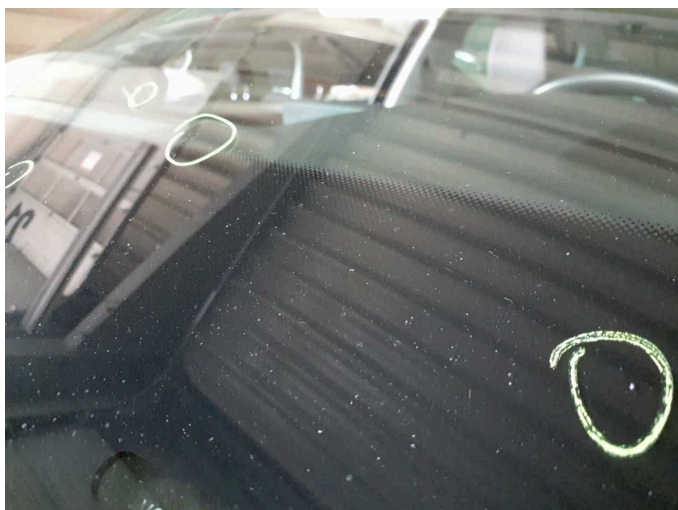
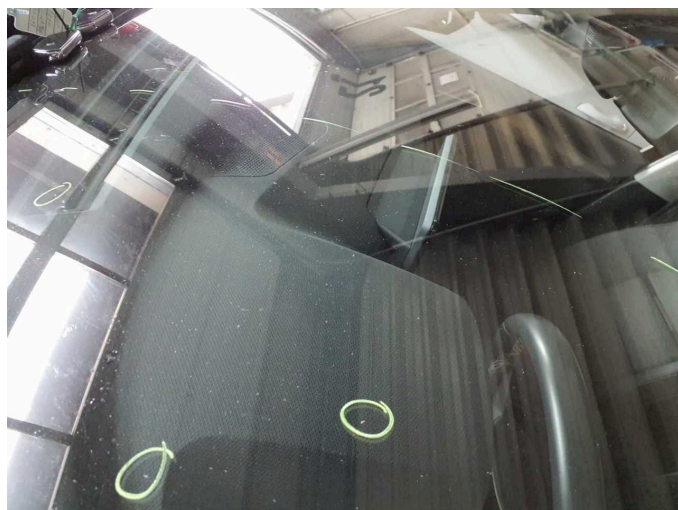
Damage 5: Vehicle glazing: Windscreen (Sandstrahleffekt) - Stone chips
- Replace

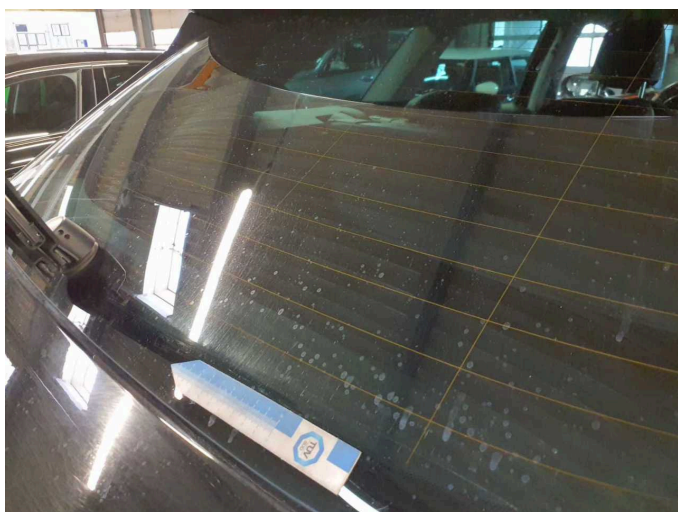
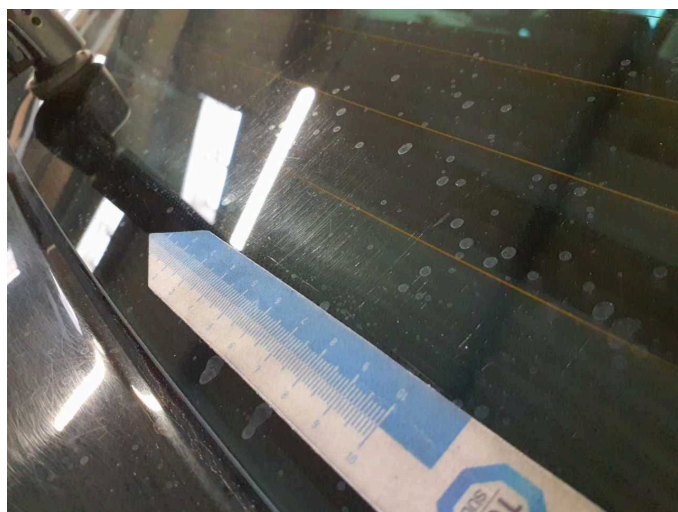
Wear and tear 5: Vehicle glazing: Rear window - Scratched - Loss in value
