Expertise

Protocol number: 41419630
Order No. / Reference: 25196922
Inspection date: 9 Sept 2025

Manufacturer: Opel	Model: Vivaro 1.5 D Cargo M Edition
VIN: VXEVBYHVKM7829536

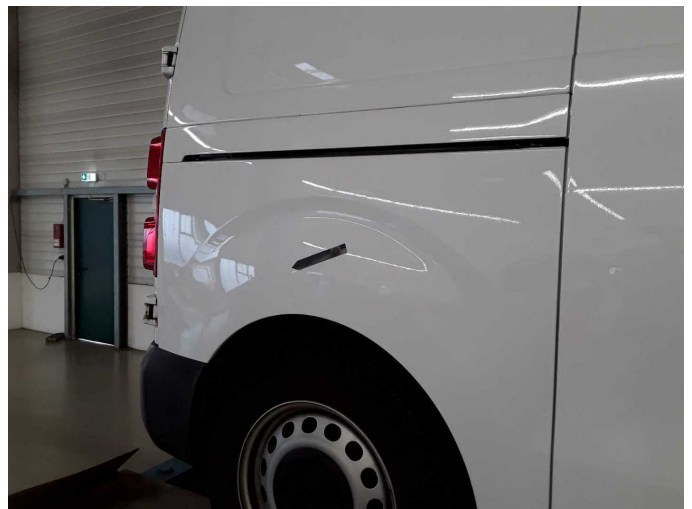
Damage 1: Side panel - rear right side: Side panel - dent(s) - Smart repair

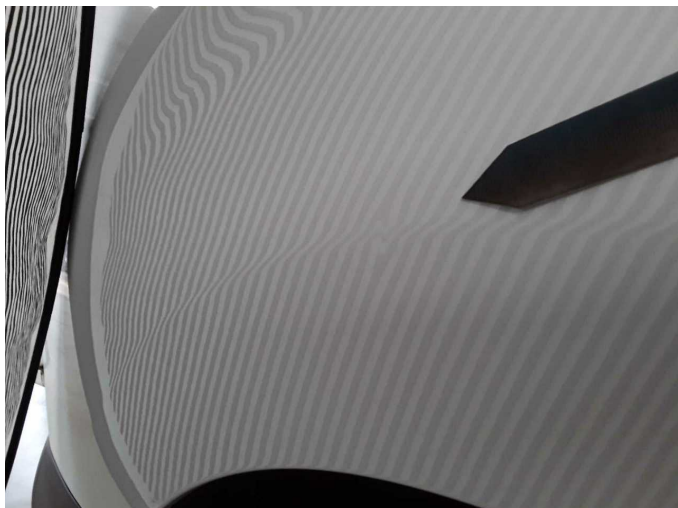
Damage 1: Side panel - rear right side: Side panel - dent(s) - Smart repair

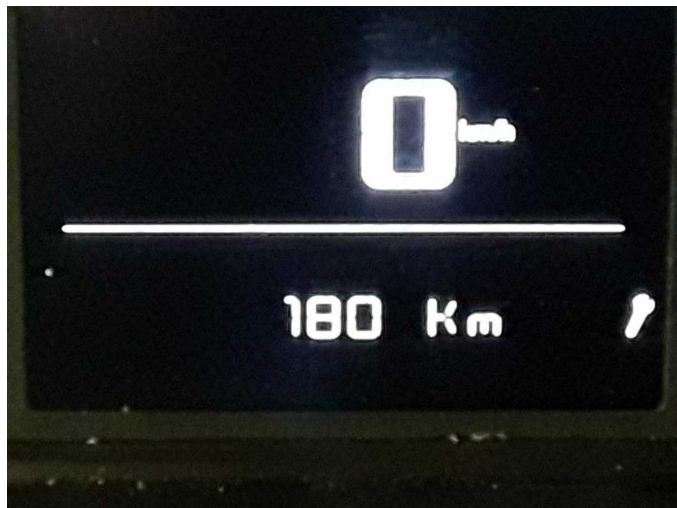
Damage 4: Misc.: Inspection / maintenance - Due - Perform
