# **Expertise**

Protocol number: 39180077 Order No. / Reference: 24558854 Inspection date: 4 Apr 2025

Model: Zafira Life 2.0 D M Aut. Elegance

VIN: VXEVEEHZ7MZ114863

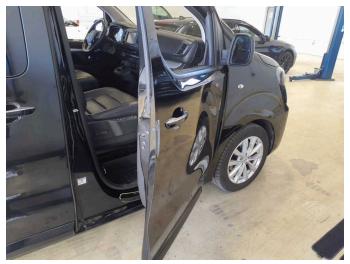
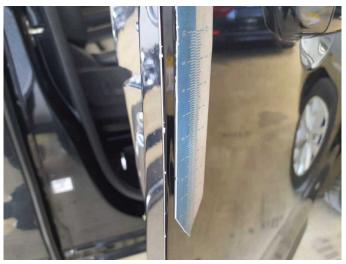
Damage 1: Door - front right side: Door edge - Scratch(es) - Smart repair Damage 1: Door - front right side: Door edge - Scratch(es) - Smart repair

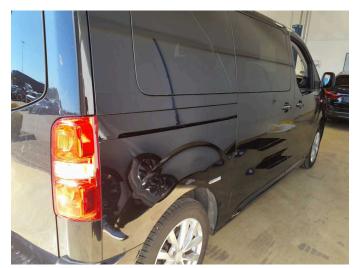
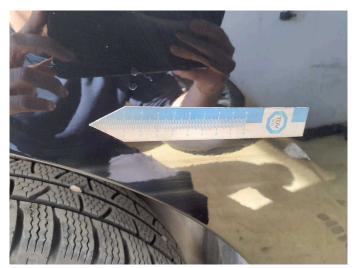
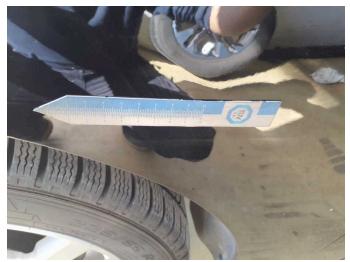
Damage 2: Side panel - rear right side: Side panel (Polieren) - Scratch(es) - Cover / polish

Damage 2: Side panel - rear right side: Side panel (Polieren) -Scratch(es) - Cover / polish

**Damage 2:** Side panel - rear right side: Side panel (Polieren) - Scratch(es) - Cover / polish

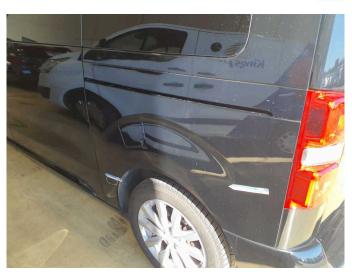
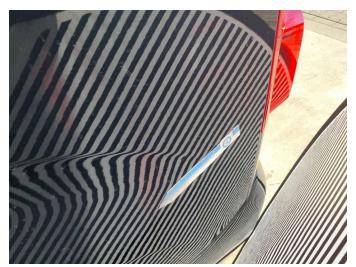
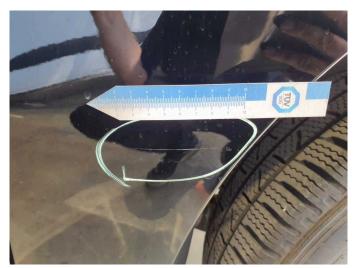
Damage 4: Side panel - rear left side: Side panel - Scratch(es) - Smart repair

**Damage 4:** Side panel - rear left side: Side panel - Scratch(es) - Smart repair

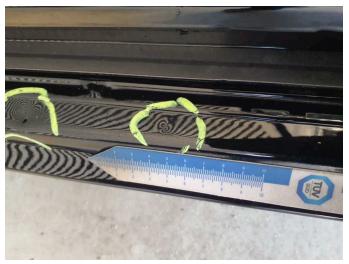
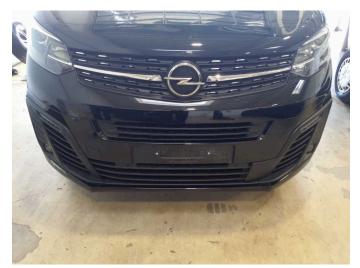
Damage 5: Sill - left side: Sill - Dent / paintcoat damage - Smart repair

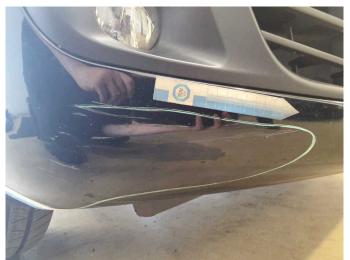
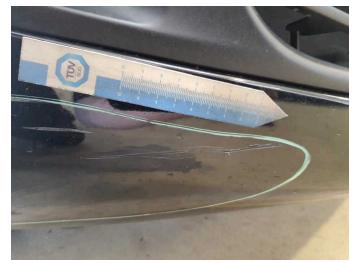
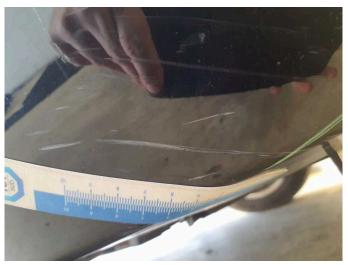
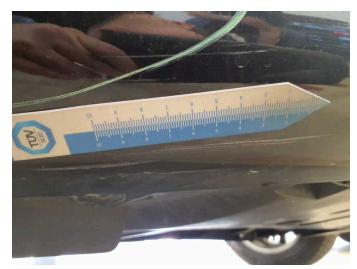
Damage 6: Front bumper: Front bumper - Paint defect - Repair and paint Damage 6: Front bumper: Front bumper - Paint defect - Repair and paint

Damage 6: Front bumper: Front bumper - Paint defect - Repair and paint
