Expertise

Protocol number: 41516936
Order No. / Reference: 25212786
Inspection date: 15 Sept 2025

Model: Vivaro 2.0 D Cargo L EHZ Edition

VIN: VXEVFAHXKMZ038240

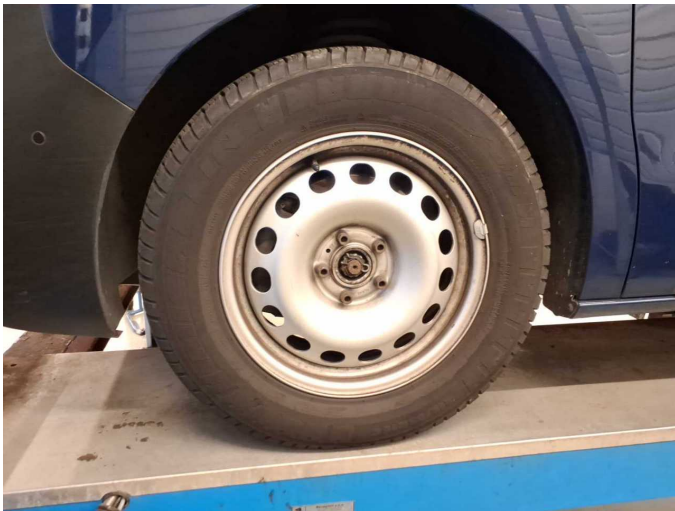
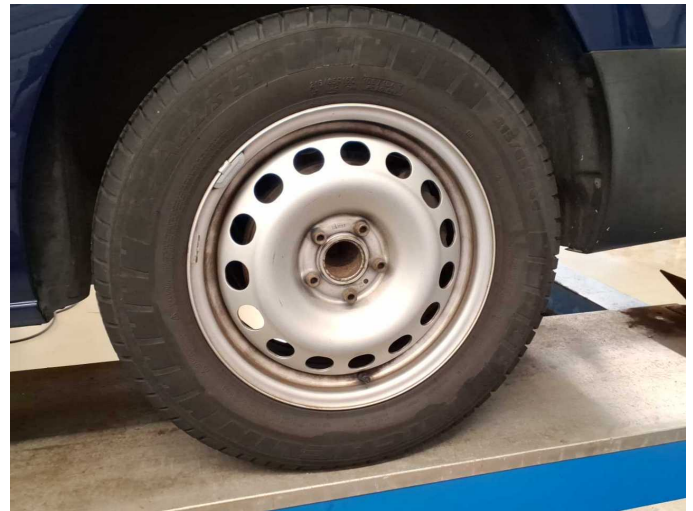
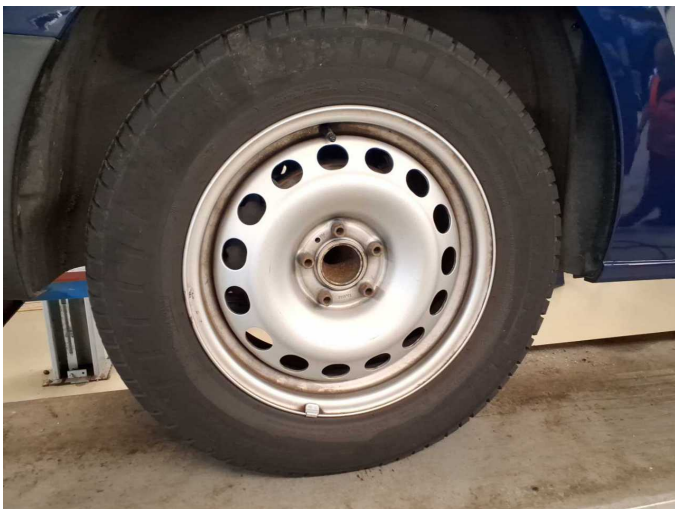
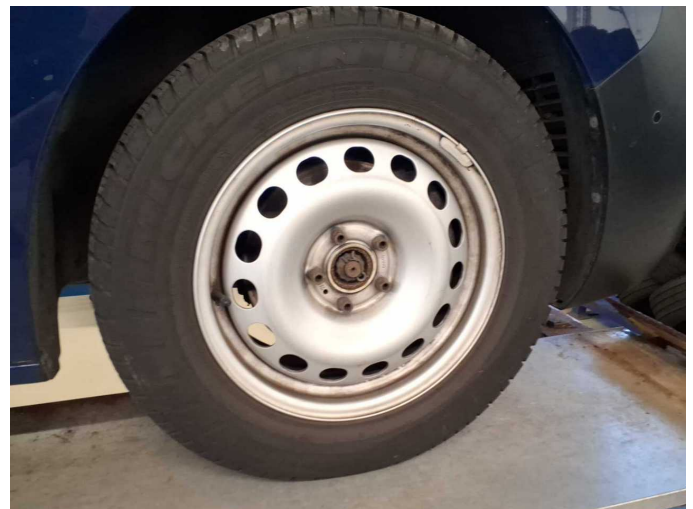
Damage 1: Wheel / tyres: Hubcap (4x) - Missing - Replace

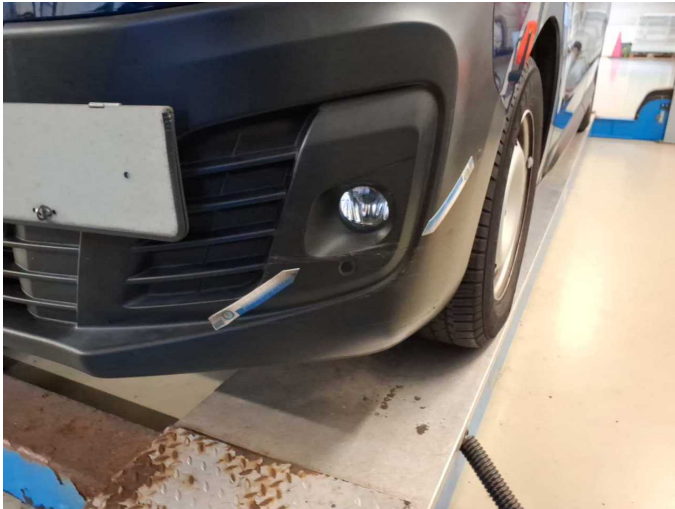
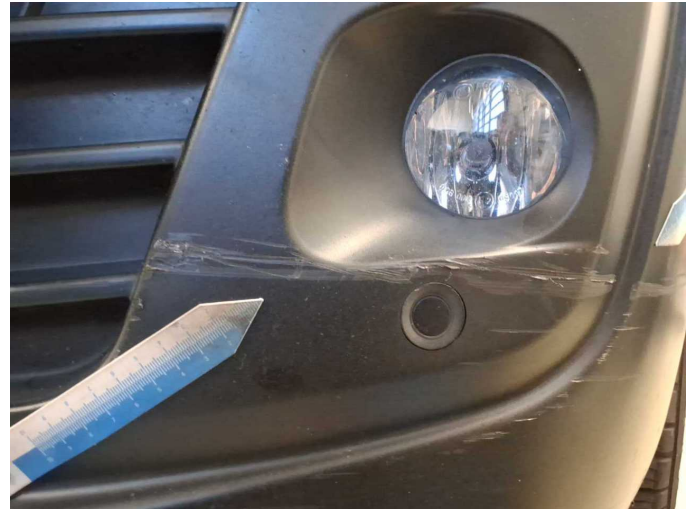
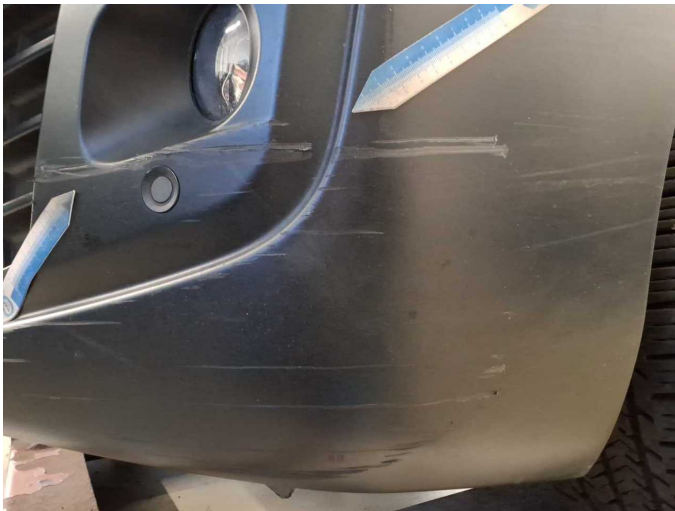
Damage 2: Front bumper: Bumper with Parktronic - Scratched - Loss in value

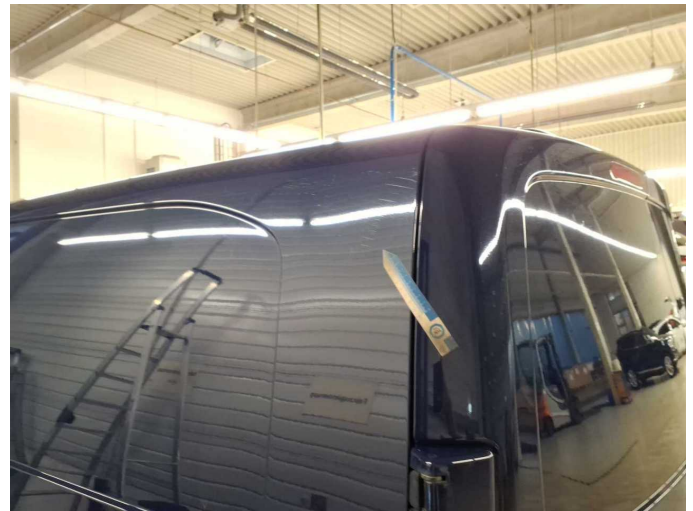
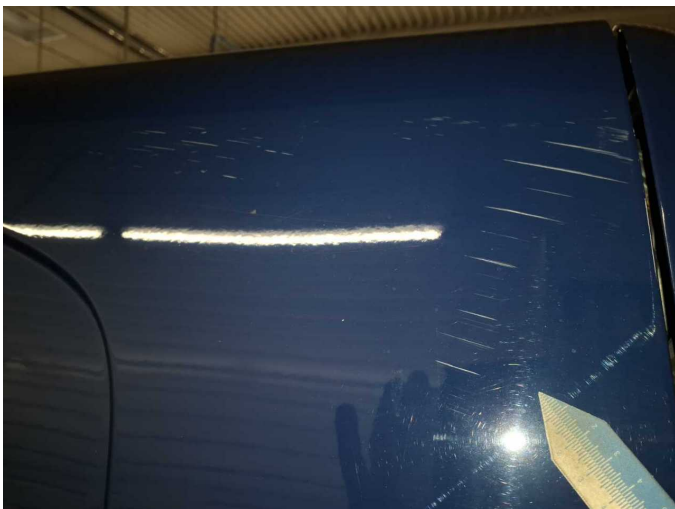
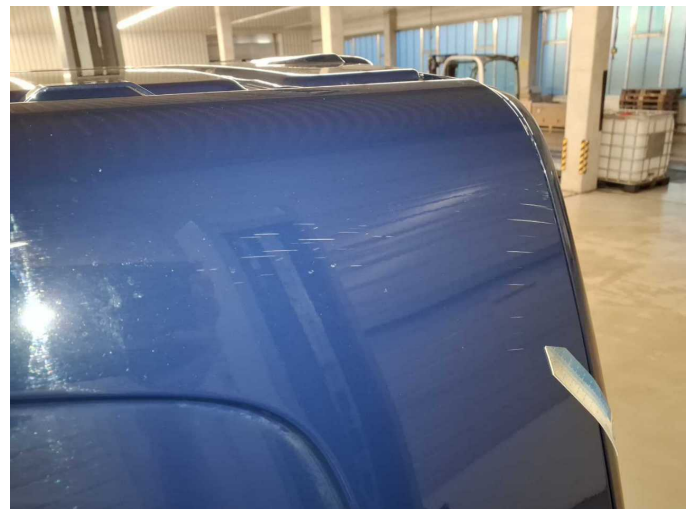
Damage 3: Side panel - rear left side: Side panel - Scratch(es) - Smart repair

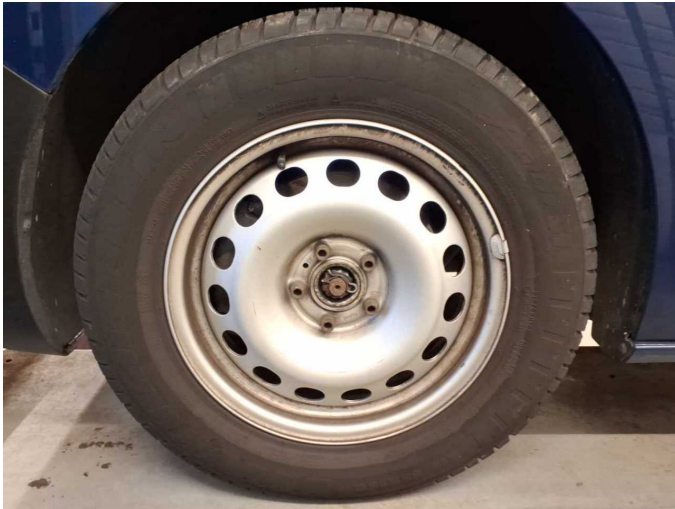
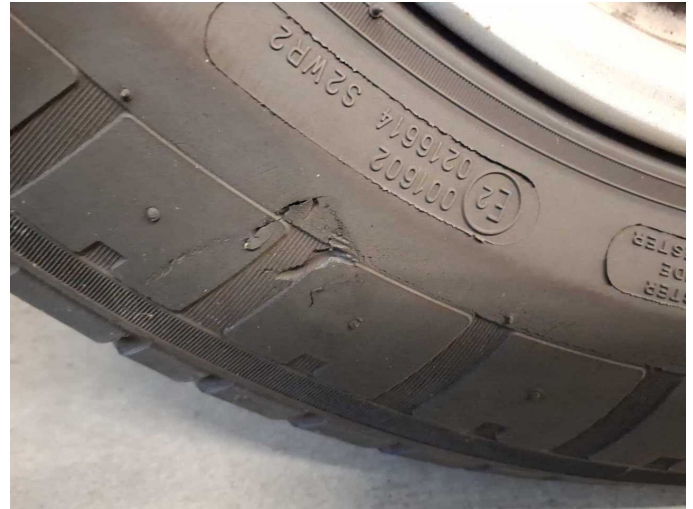
Damage 4: Wheel / tyres: Tyre - front left side - Damaged - Replace

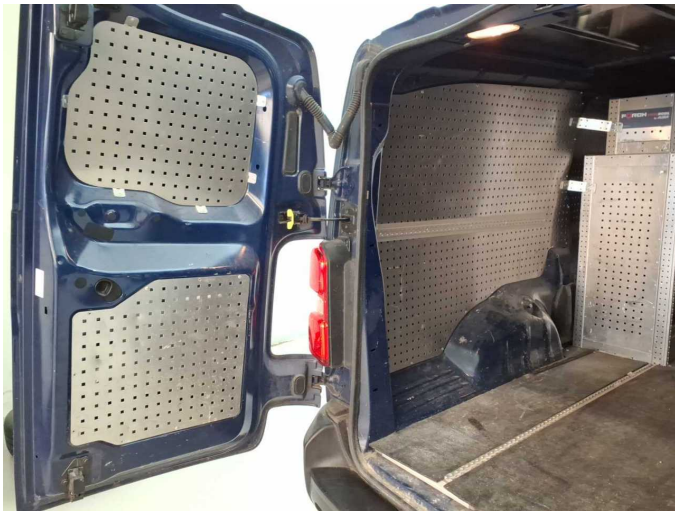
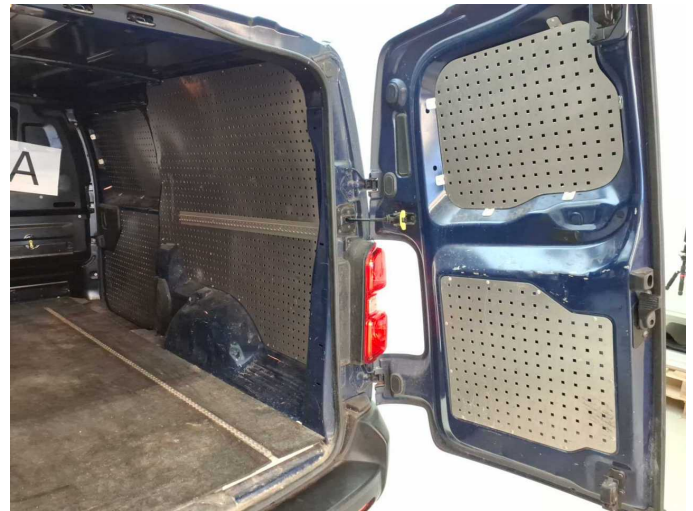
Damage 5: Misc.: Misc. (Laderaum) - Dent / paintcoat damage - Loss in value

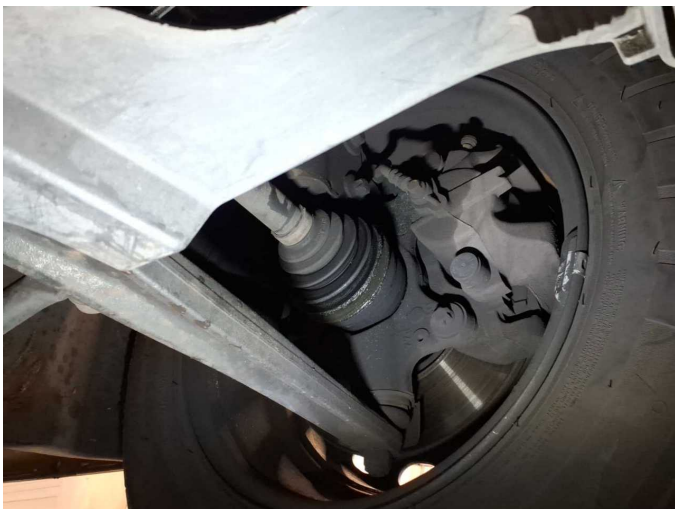
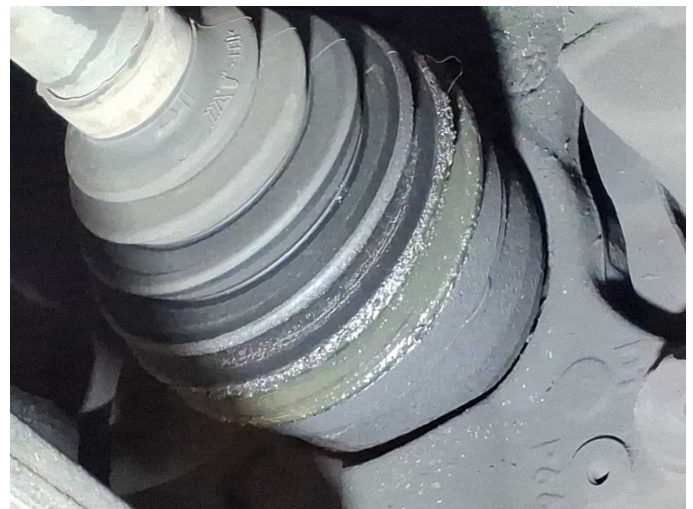
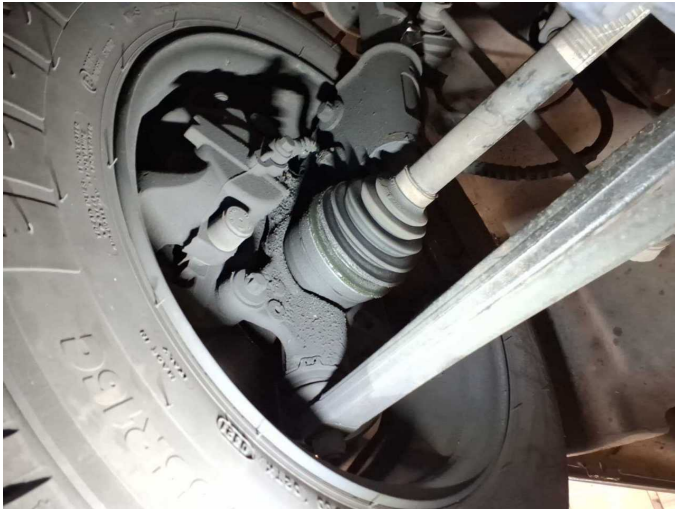
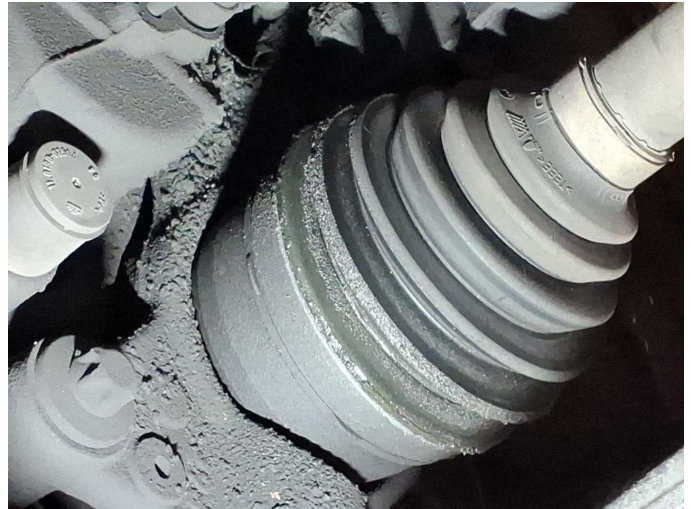
Damage 6: Drive train: Sleeve prop shaft - front left side (+ vorn rechts aussen) - Leaking - Replace

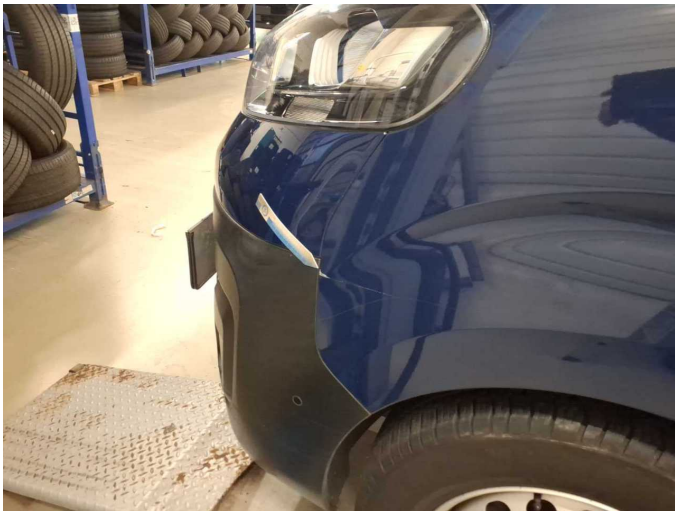
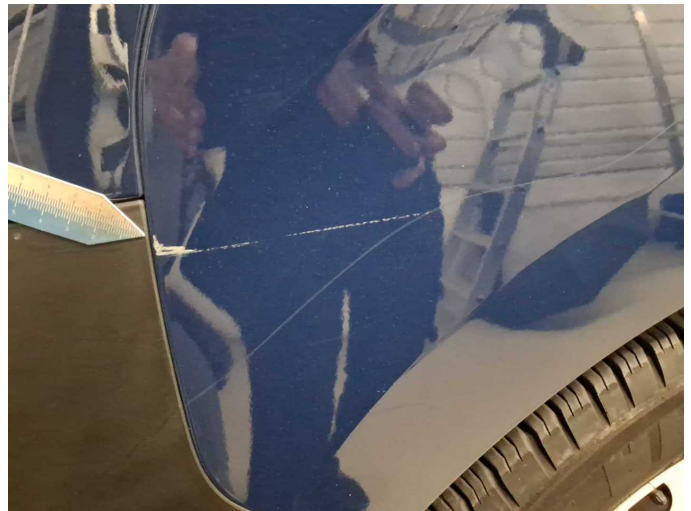
Damage 7: Mudguard - left side: Mudguard - left side - Scratch(es) - Paint

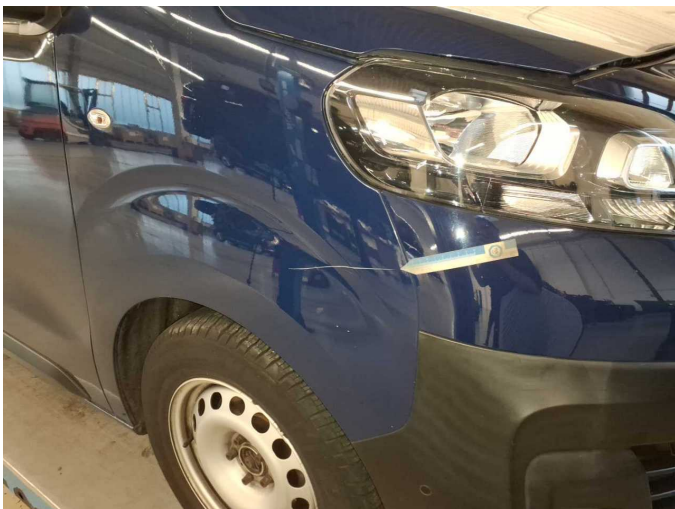
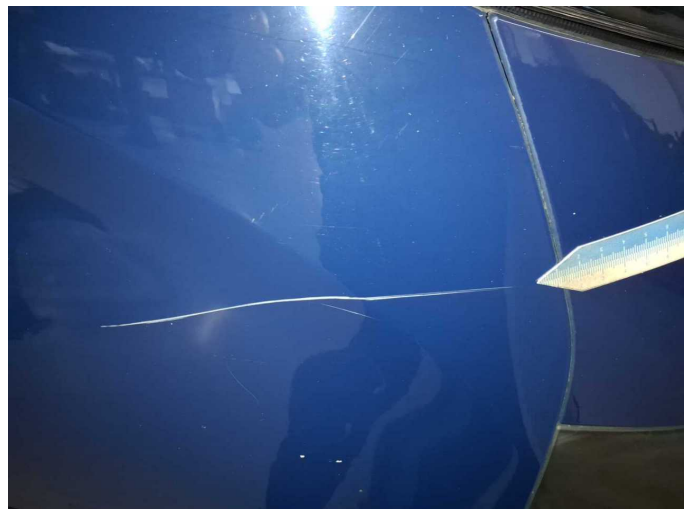
Damage 8: Mudguard - right side: Mudguard - right side - Scratch(es) - Paint

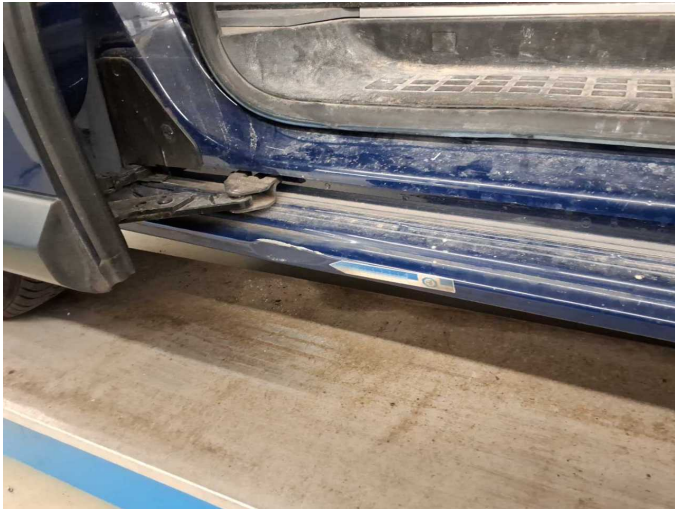
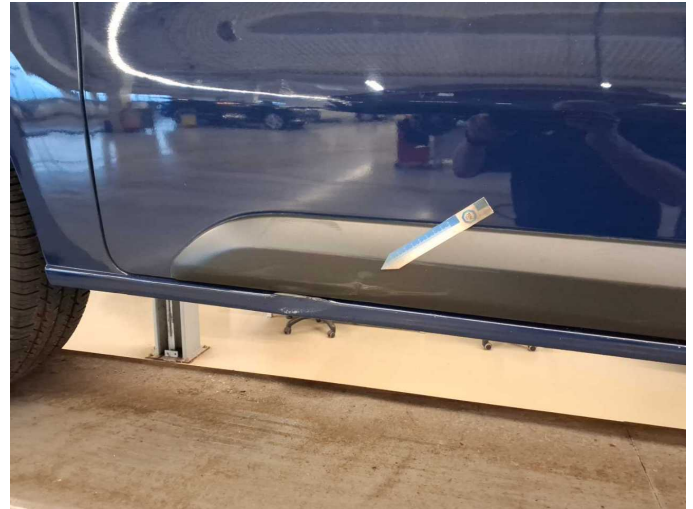
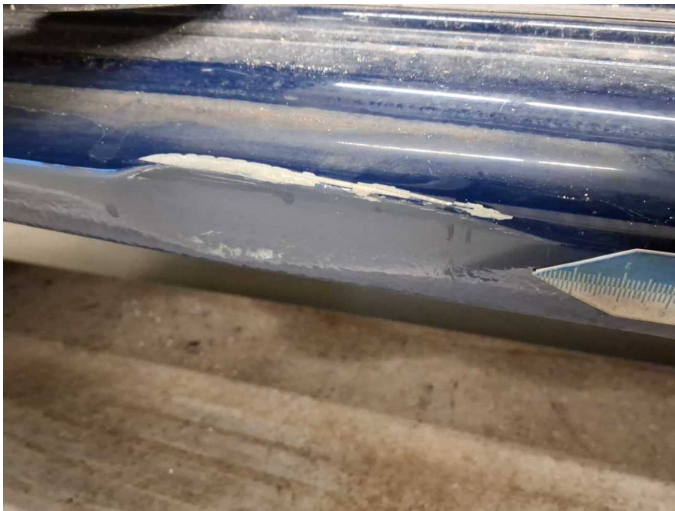
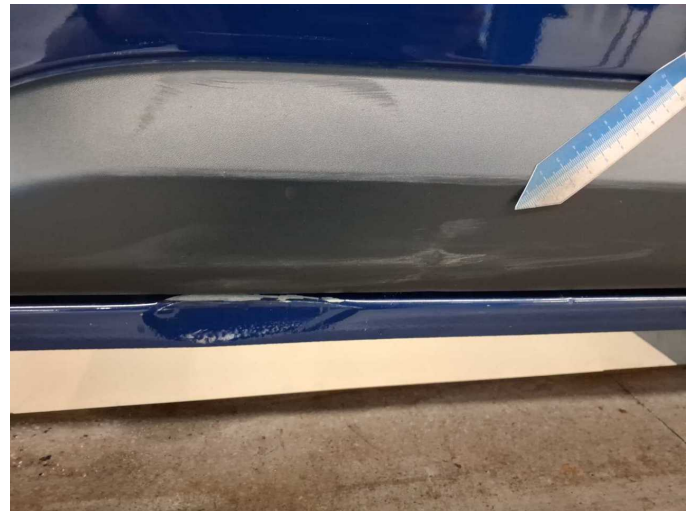
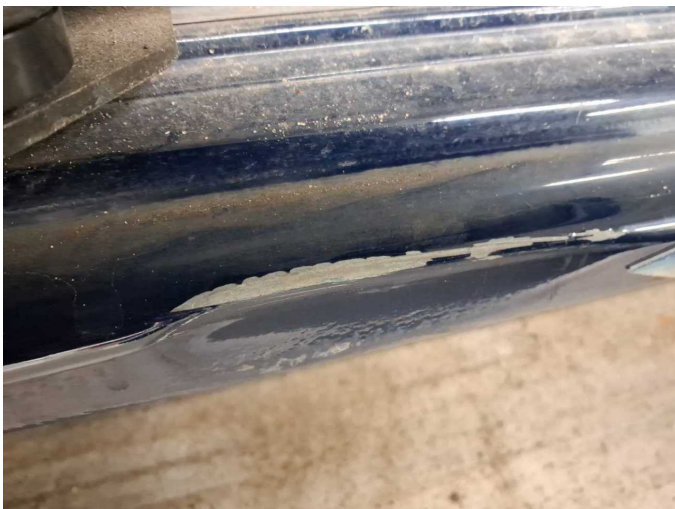
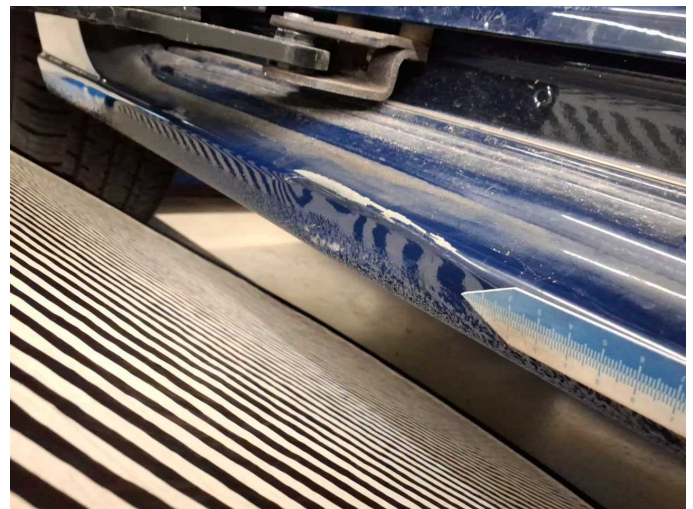
Damage 9: Sill - right side: Sill - Deformed - Repair and paint

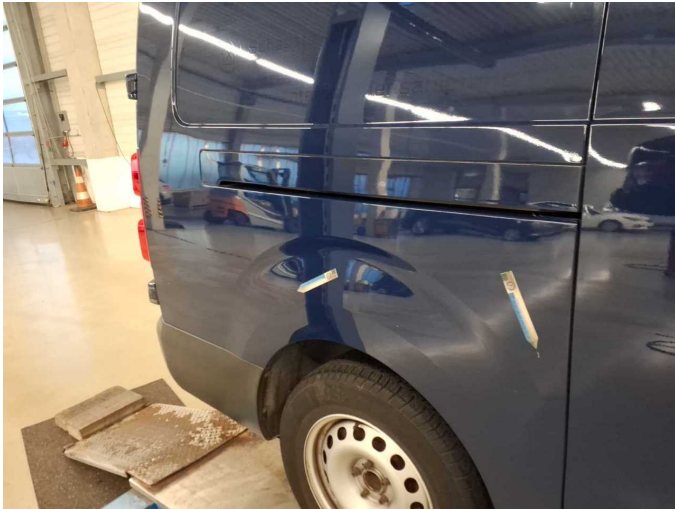
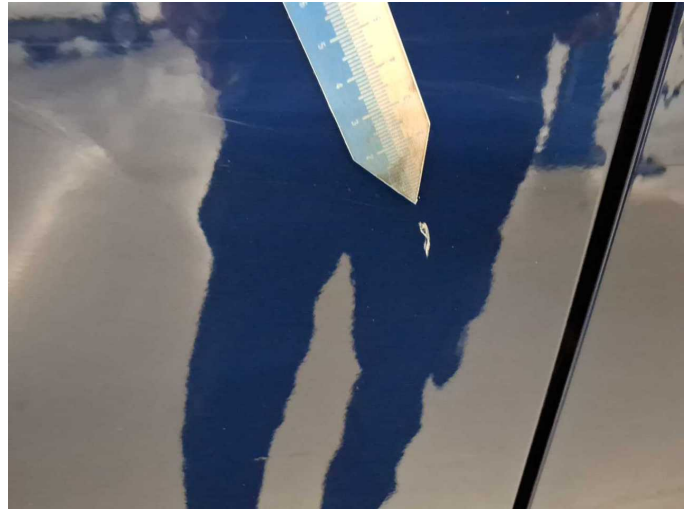
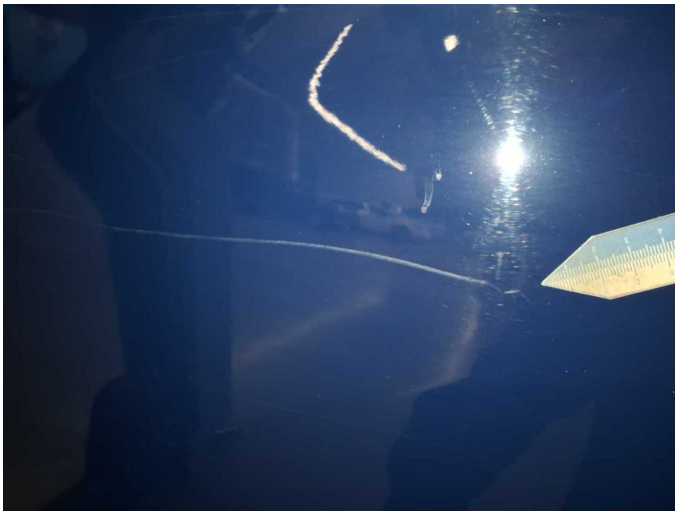
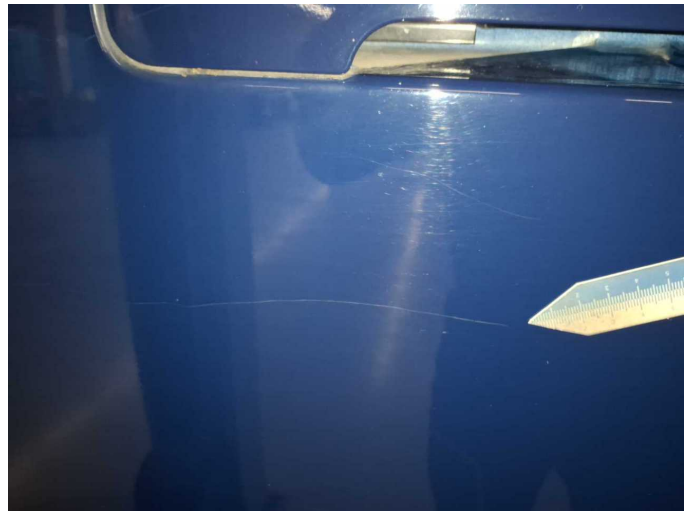
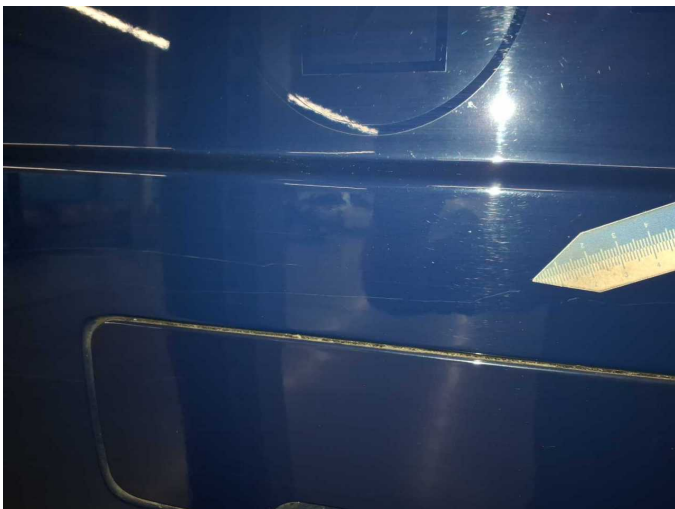
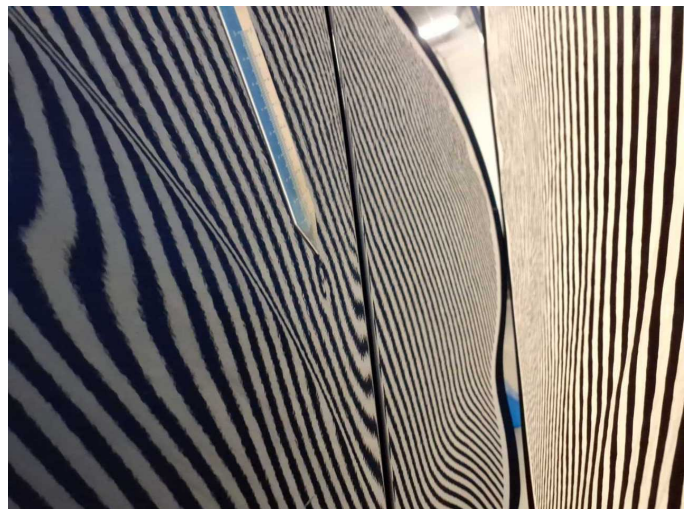
Damage 10: Side panel - rear right side: Side panel - Dent / paintcoat damage - Repair and paint

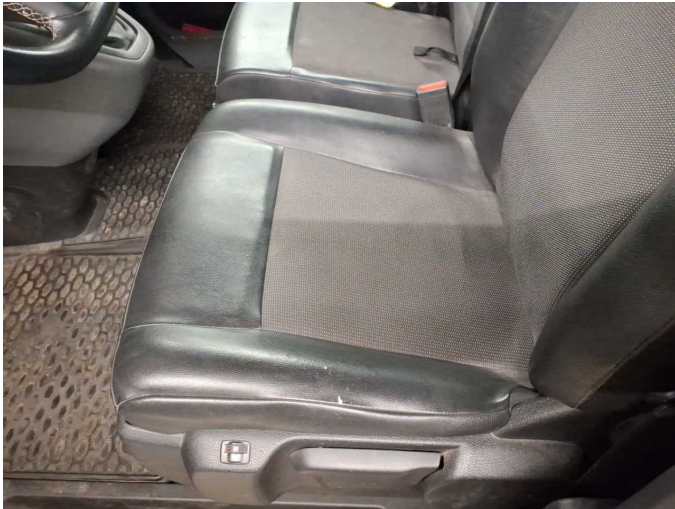
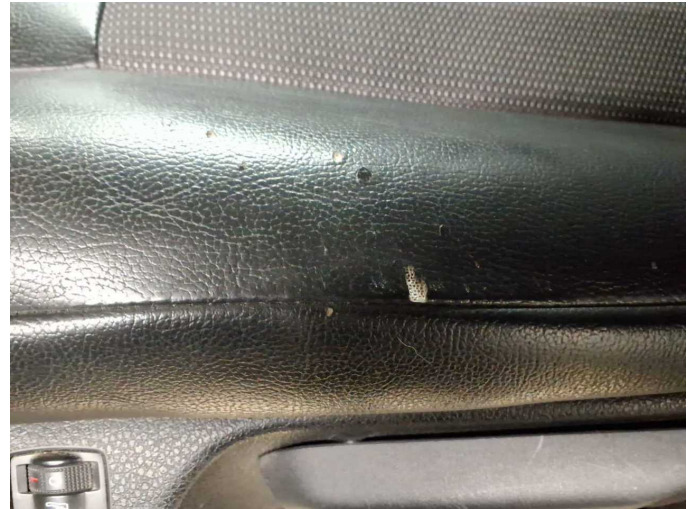
Damage 11: Seat - front: Seat cover - left side - Damaged - Replace

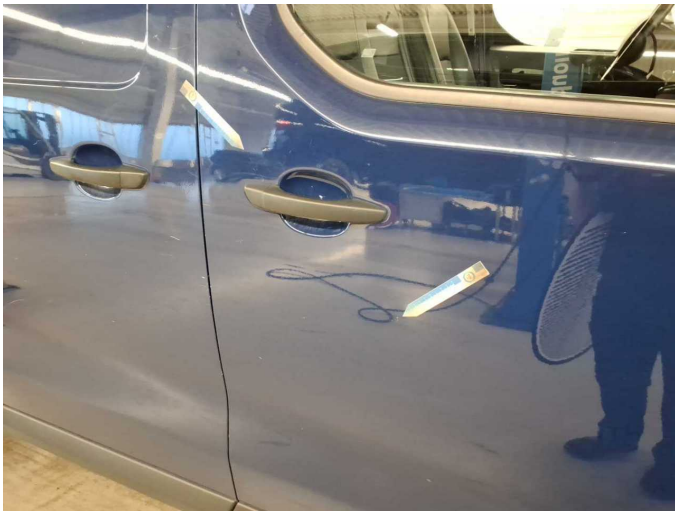
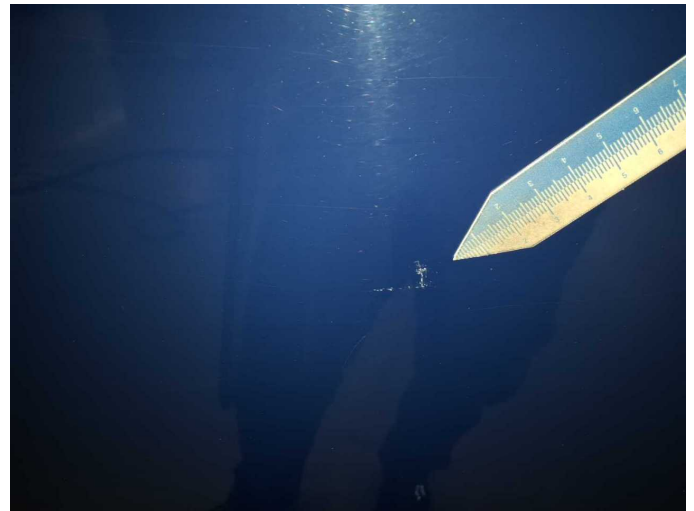
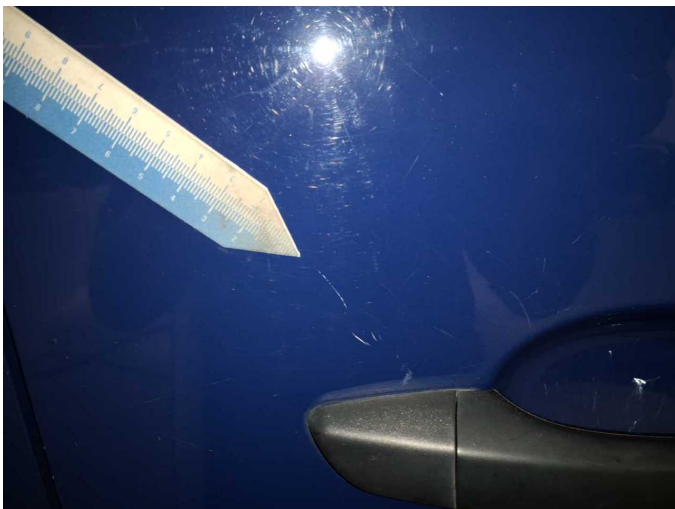
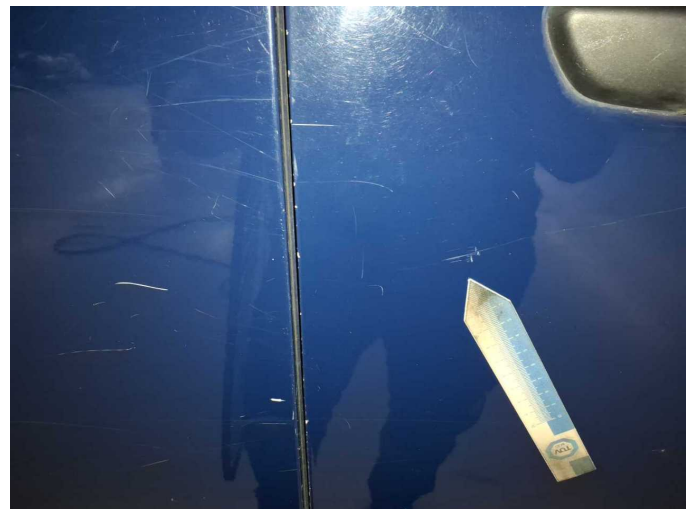
Damage 12: Door - front right side: Door - Scratch(es) - Paint

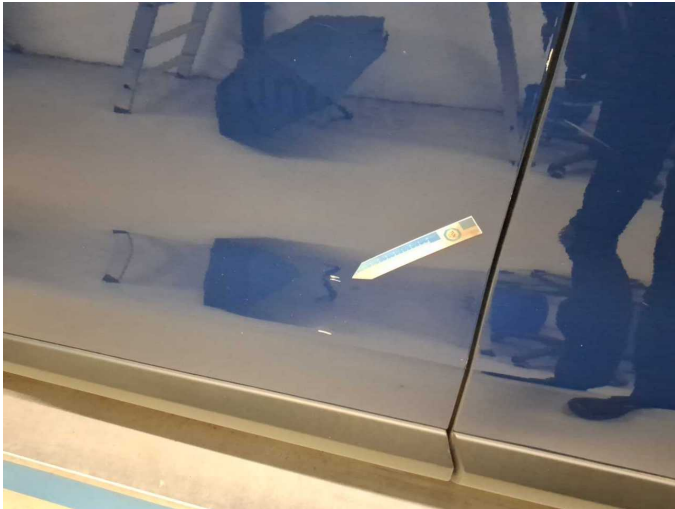
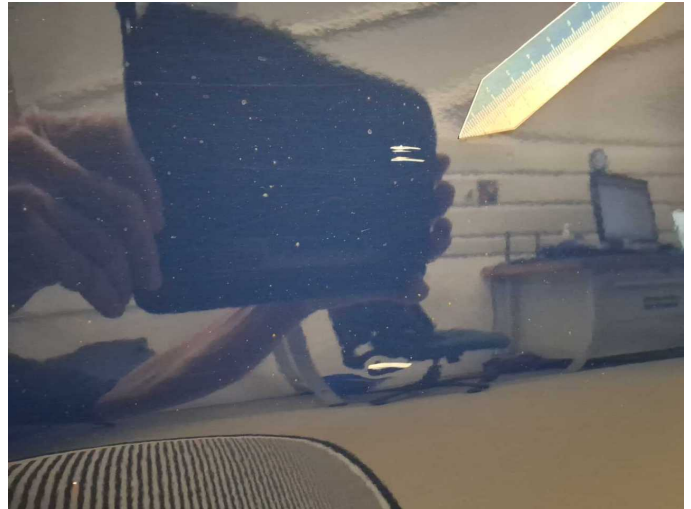
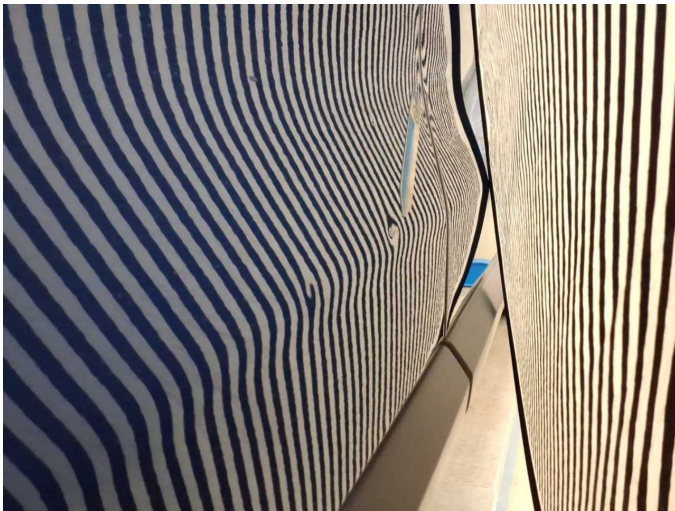
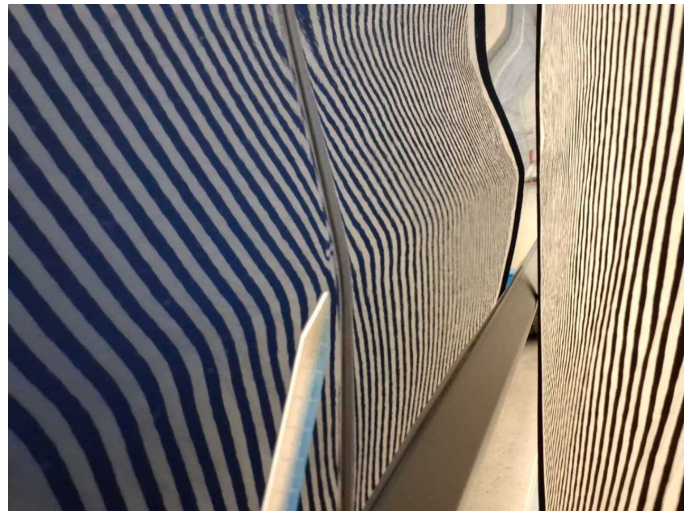
Damage 13: Door - front left side: Door - Dent / paintcoat damage - Repair and paint

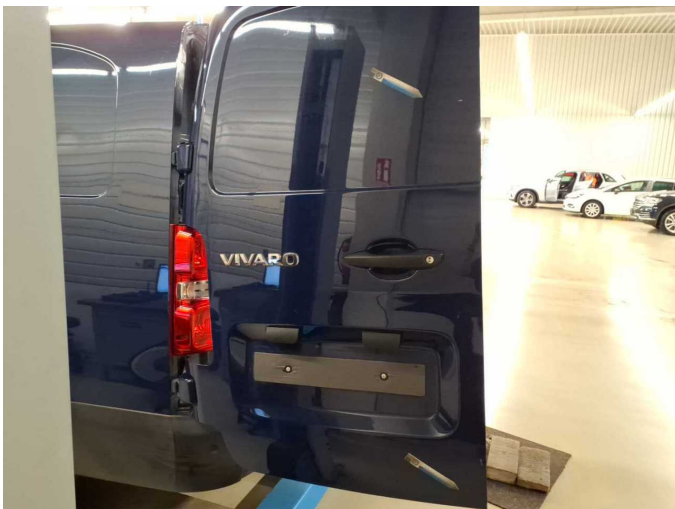
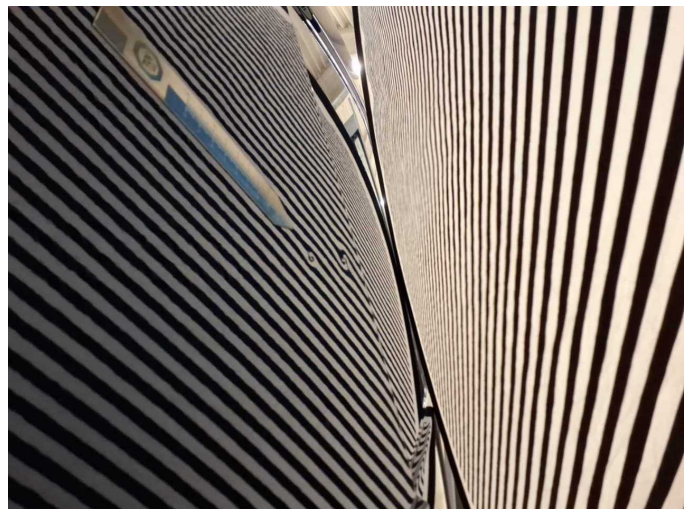
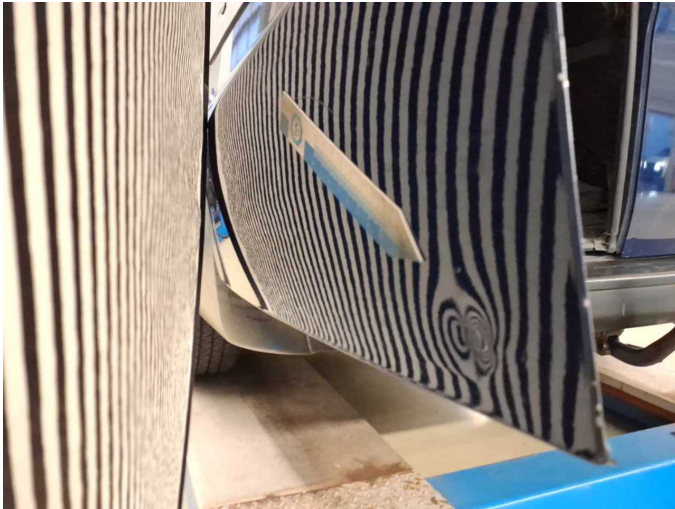
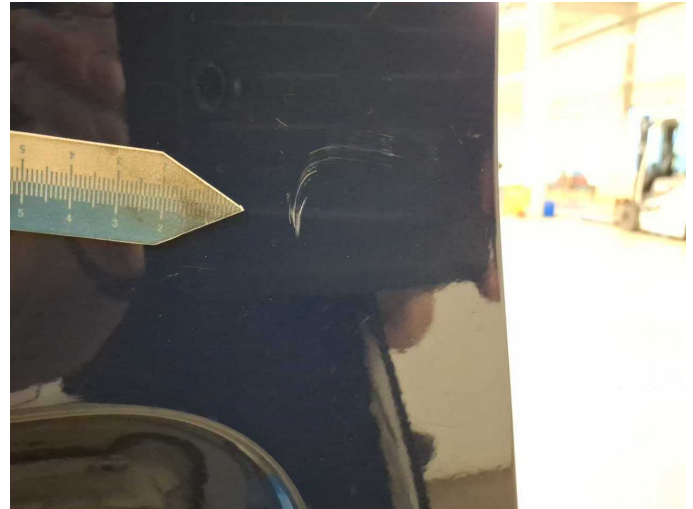
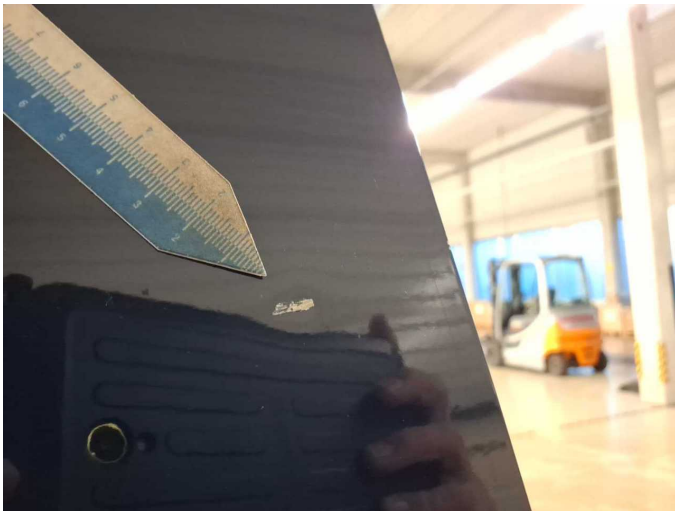
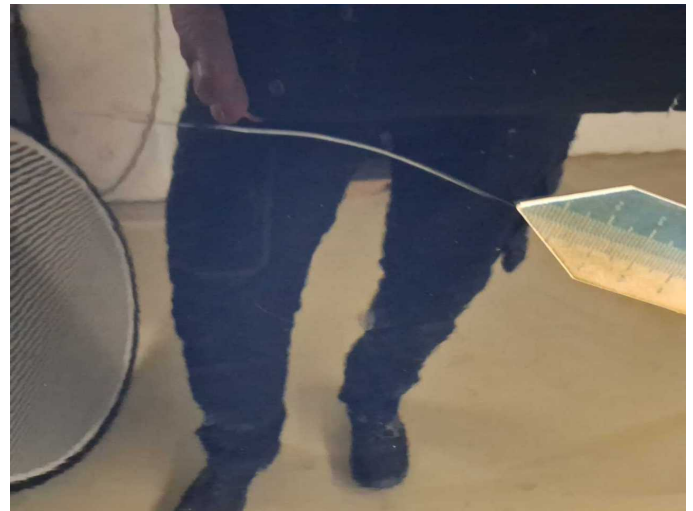
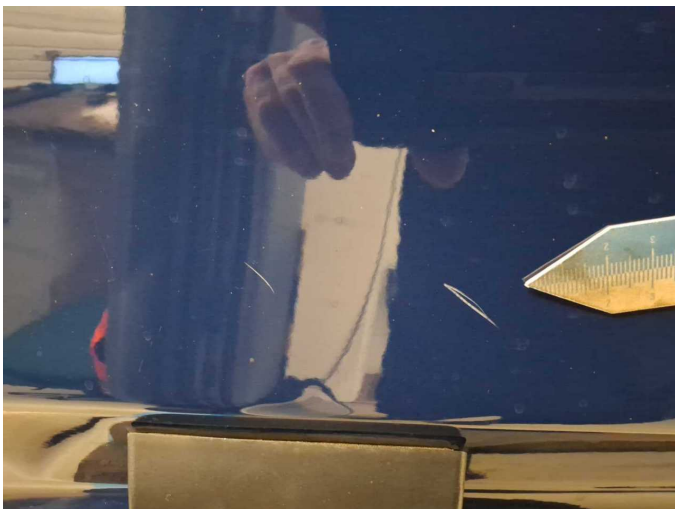
Damage 14: Boot lid / rear door: Rear door - left side - Dent / paintcoat damage - Repair and paint

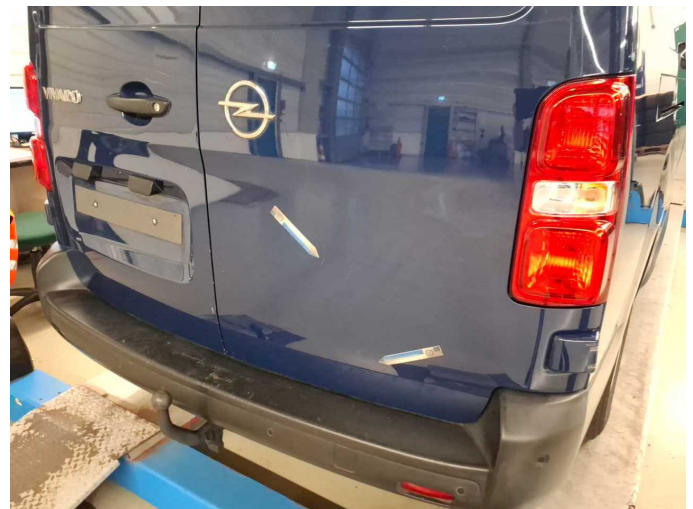
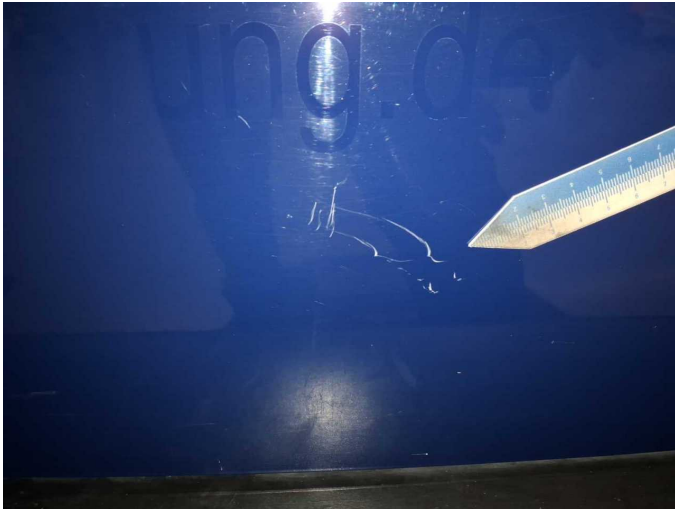
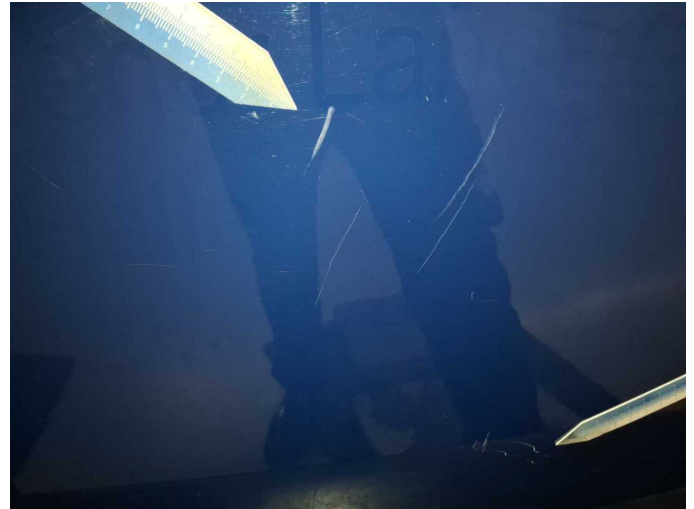
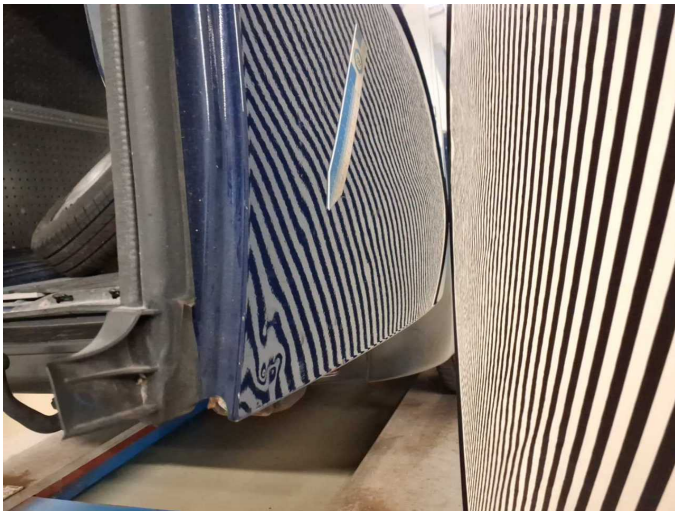
Damage 15: Boot lid / rear door: Rear door - right side - Dent / paintcoat damage - Repair and paint

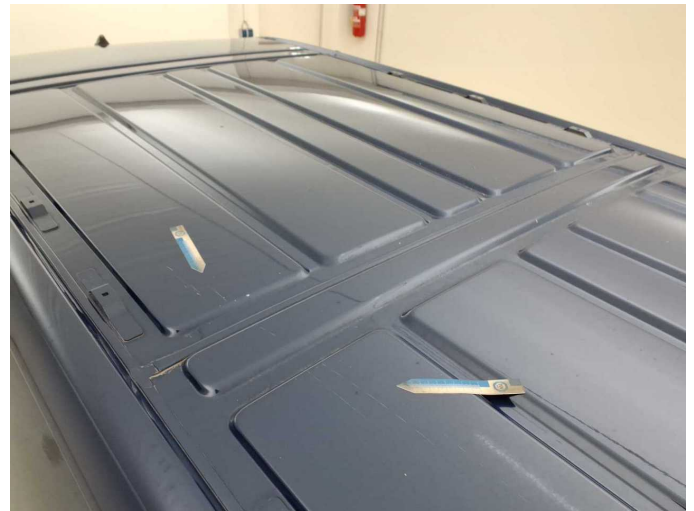
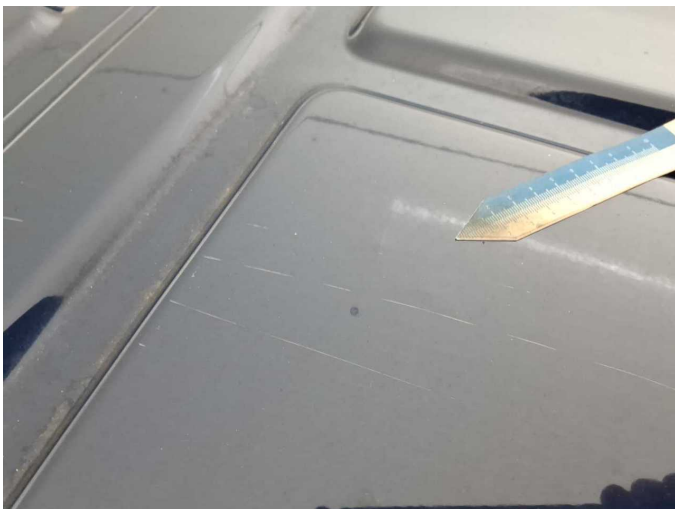
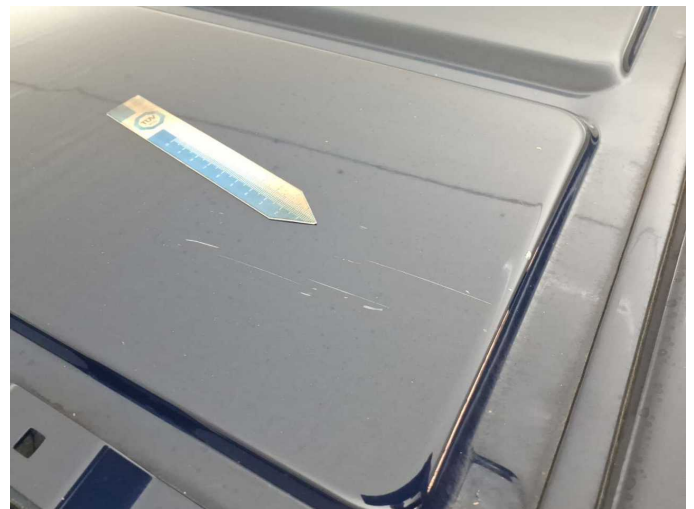
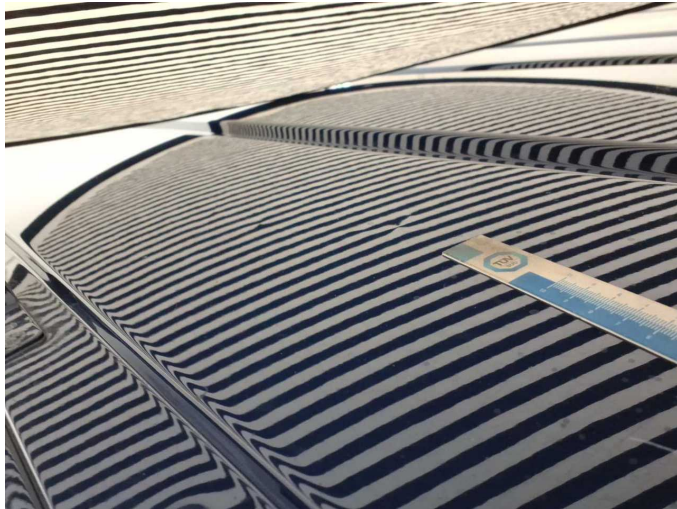
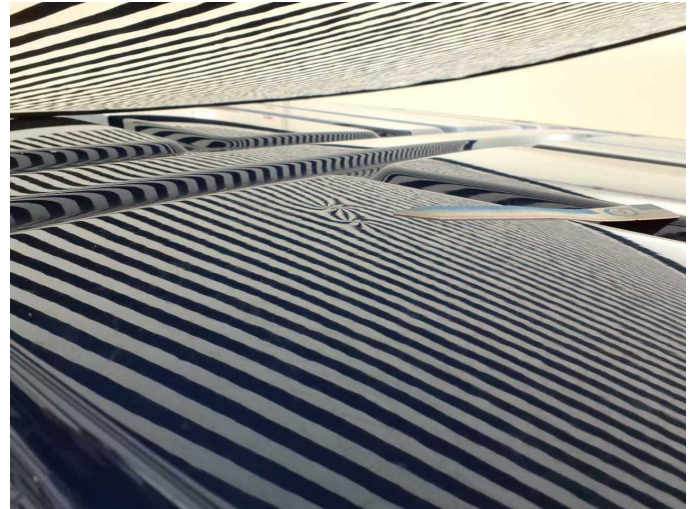
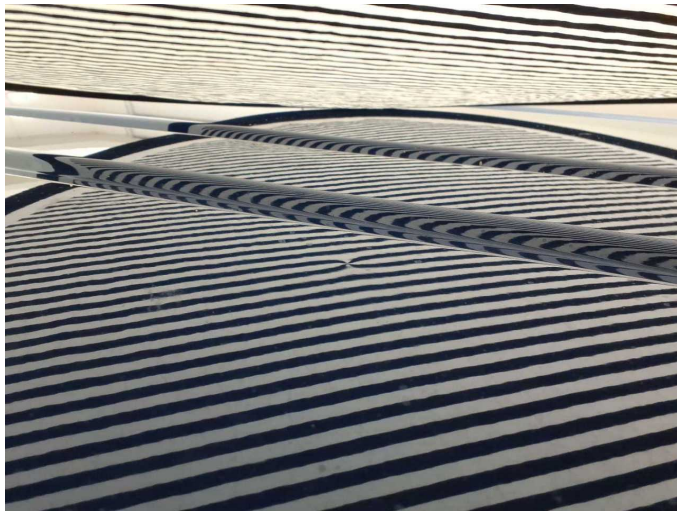
Damage 16: Roof: Roof - Dent / paintcoat damage - Repair and paint
