Expertise

Protocol number: 41516936
Order No. / Reference: 25212786
Inspection date: 15 Sept 2025

Model: Vivaro 2.0 D Cargo L EHZ Edition

VIN: VXEVFAHXKMZ038240

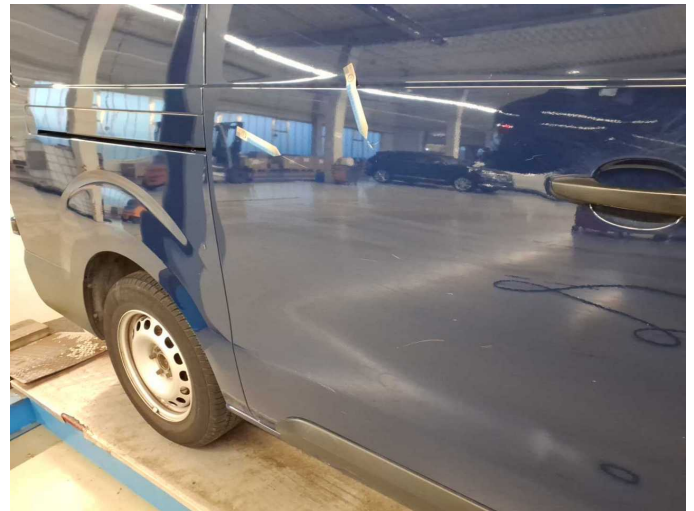
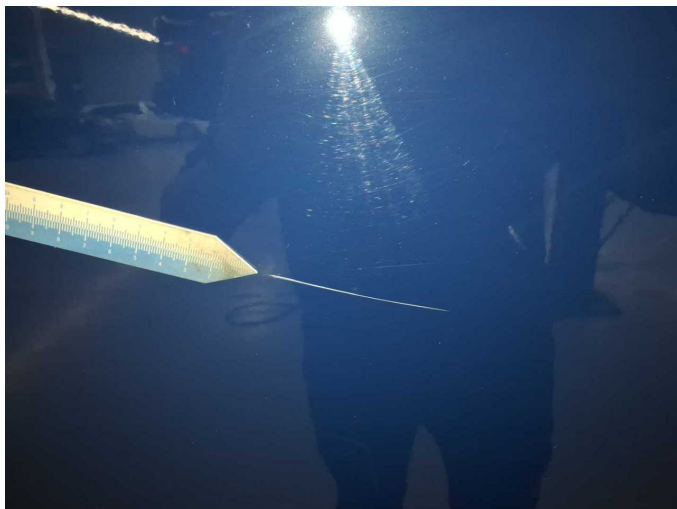
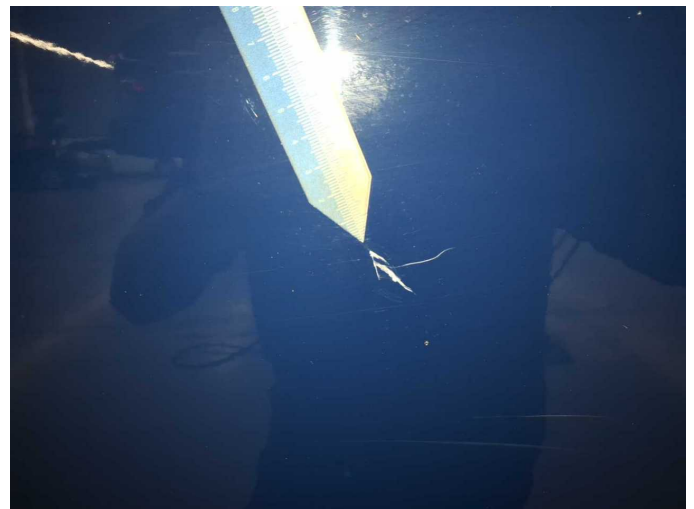
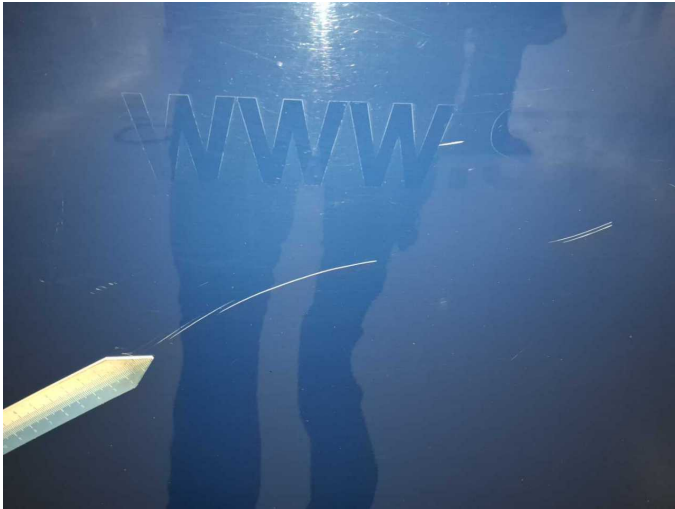
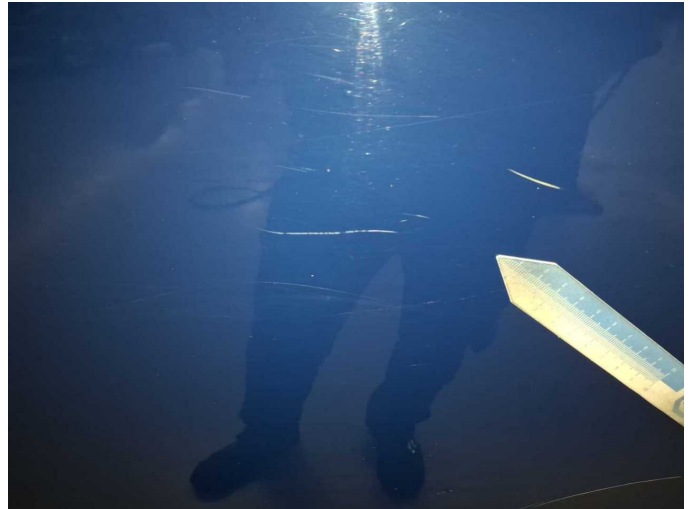
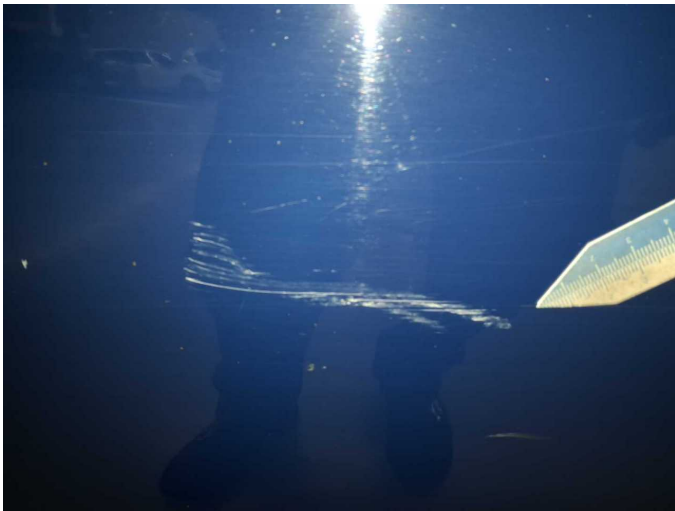
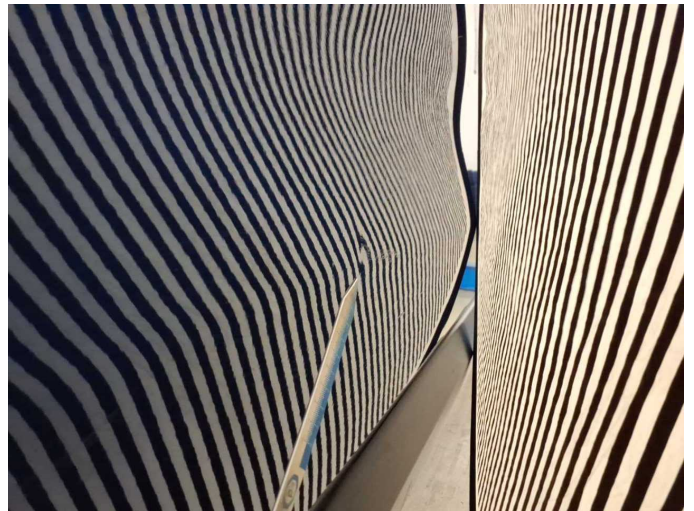
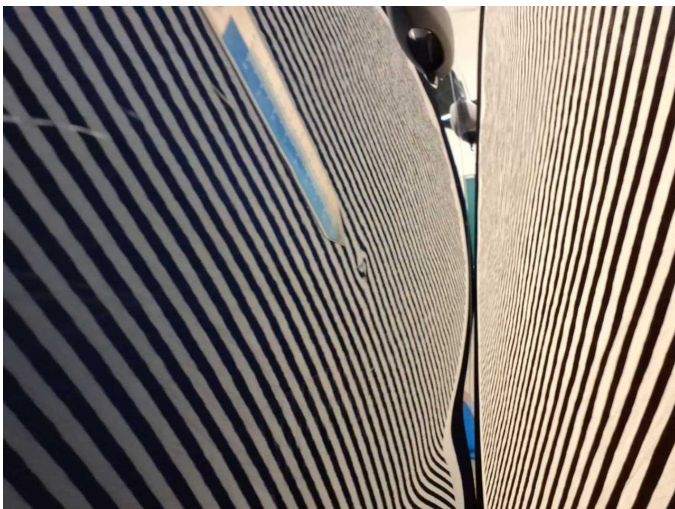
Damage 17: Sliding door, right: Sliding door - Dent / paintcoat damage - Repair and paint
