Expertise

Protocol number: 41764144
Order number / reference: 25236963
Inspection date: 30 Sept 2025

Manufacturer: Opel

Model: Vivaro 2.0 D Cargo M Autm. Elegance

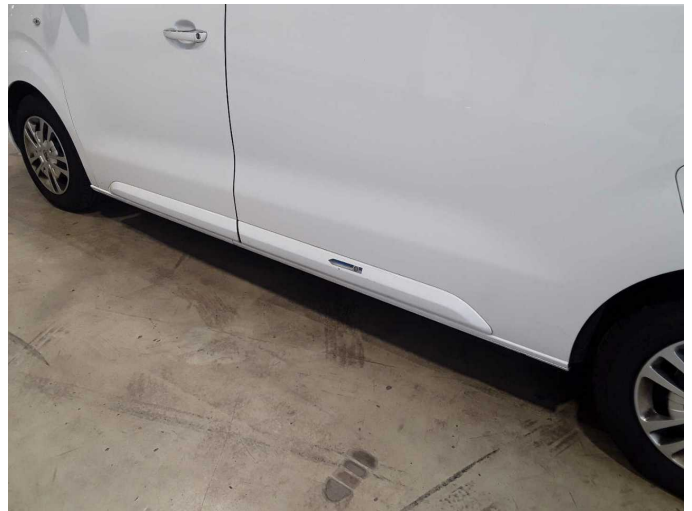
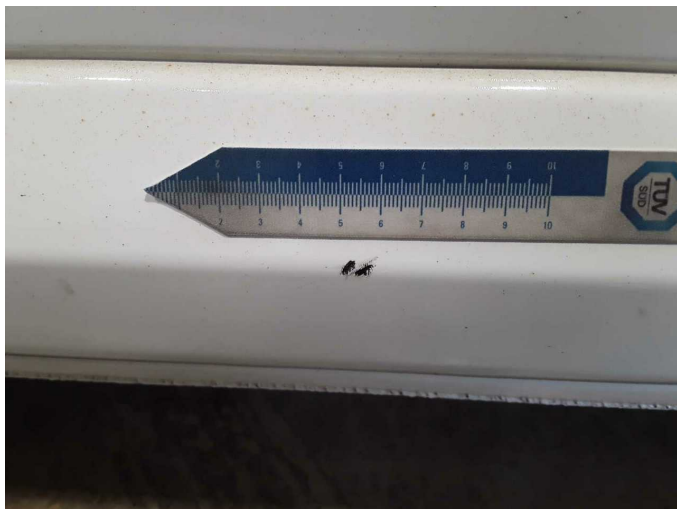
Damage 1: Side panel - rear left side: Brightware - Scratched - Paint

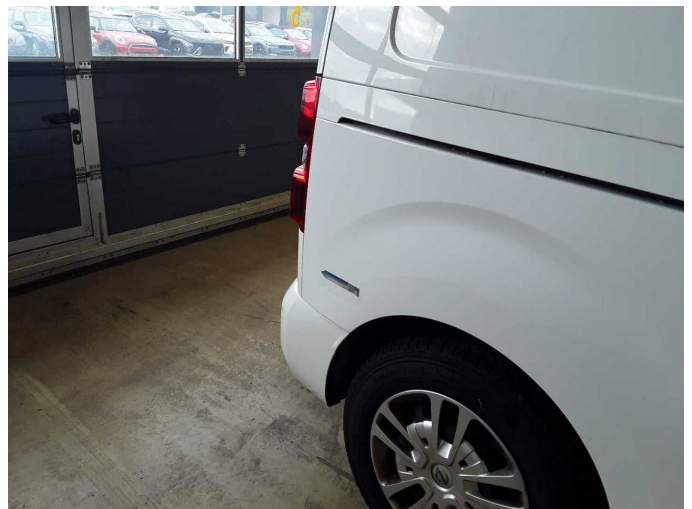
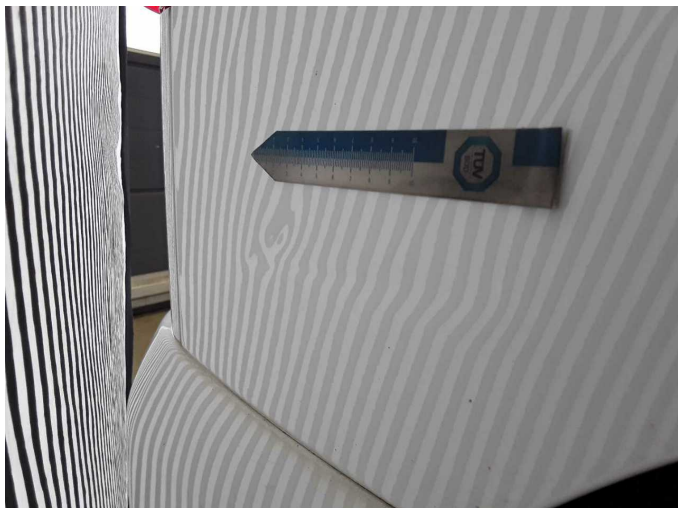
Damage 2: Side panel - rear right side: Side panel - dent(s) - Repair and paint

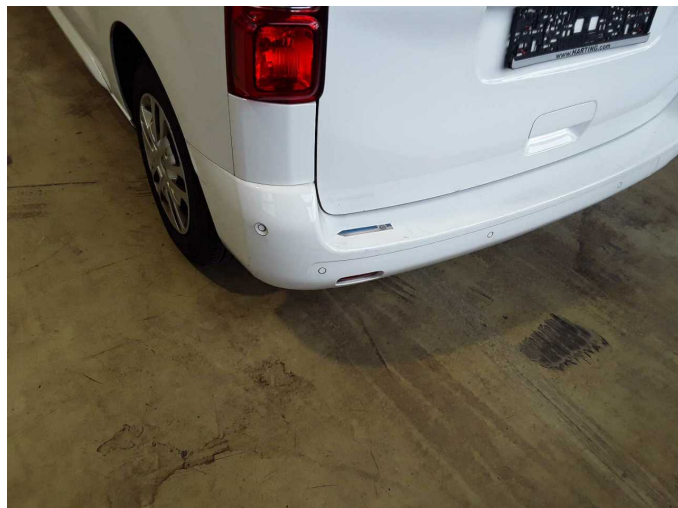
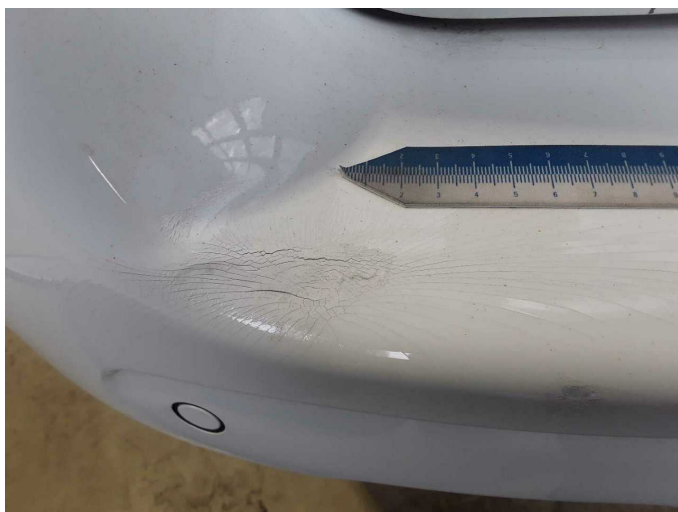
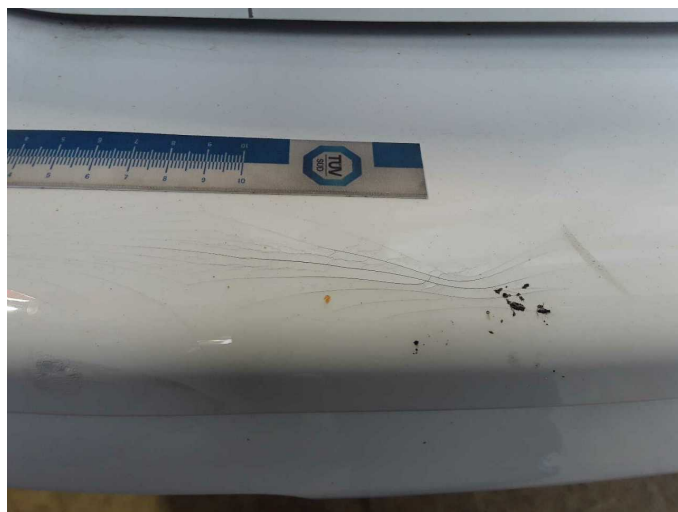
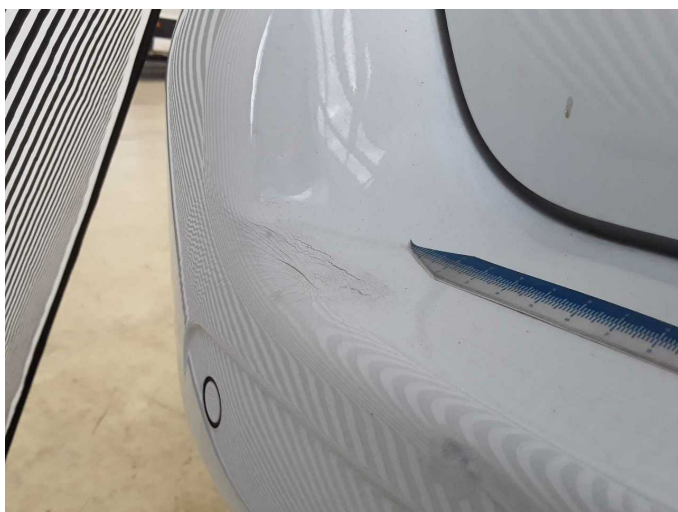
Damage 3: Rear bumper: Rear bumper - Deformed - Replace
