Expertise

Protocol number: 41528815  
Order No. / Reference: 25208892  
Inspection date: 15 Sept 2025

Manufacturer: Opel

Model: Vivaro 2.0 D Cargo M Autm. Elegance

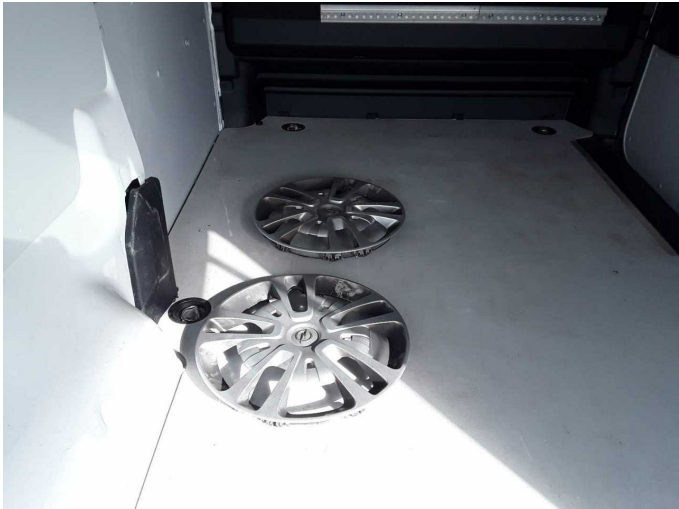
No.	Component group	Description
1	Wheel / tyres	Wheel cover set - complete (2 fehlen) - Incomplete - Replace
2	Rear bumper	Rear bumper - Scratched - Paint
3	Seat - front	Seat cover - left side (mit Sitzpolster) - Burn hole (cigarettes) - Replace

Damage 1: Wheel / tyres: Wheel cover set - complete (2 fehlen) - Incomplete - Replace

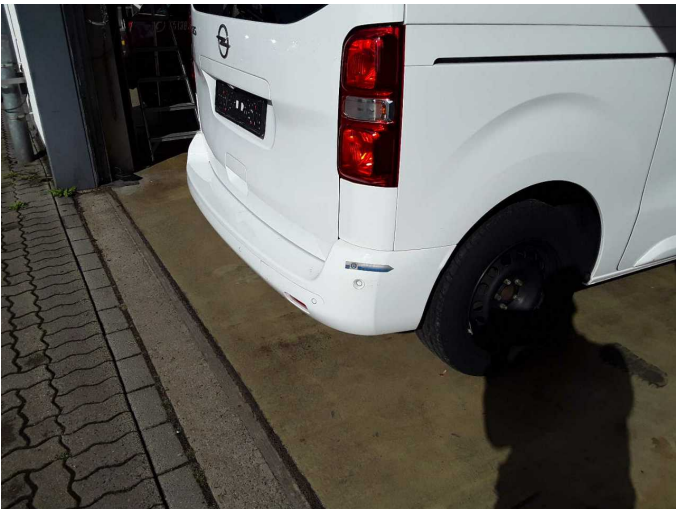
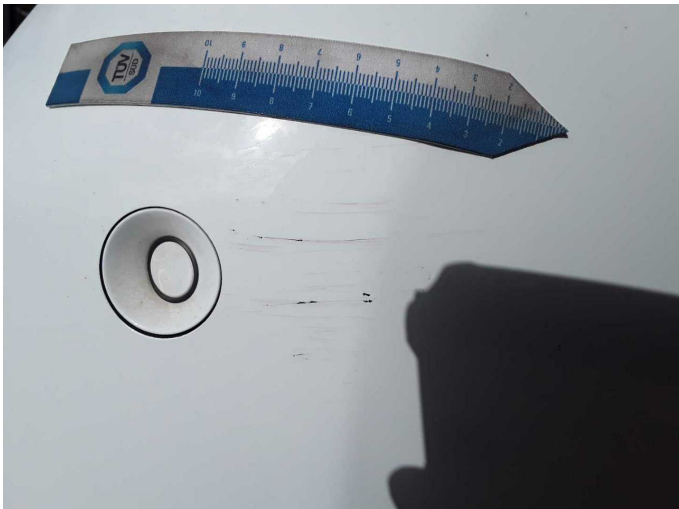
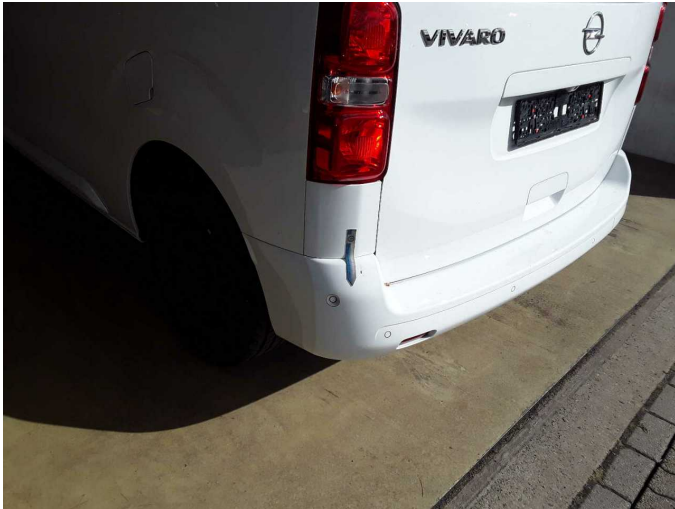
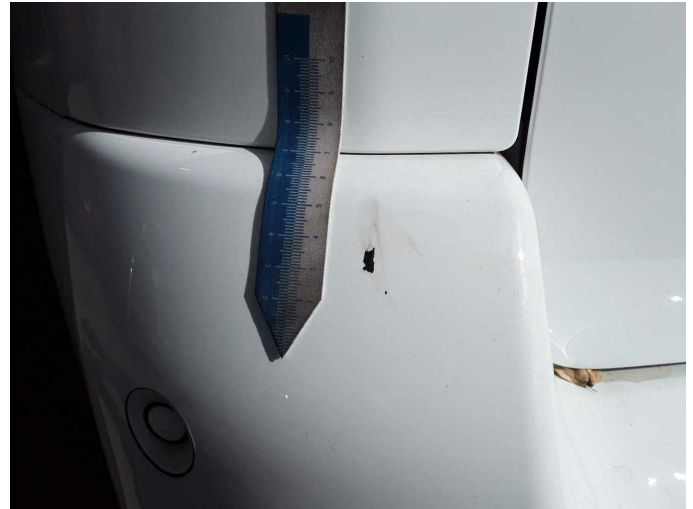
Damage 2: Rear bumper: Rear bumper - Scratched - Paint

**Damage 2:** Rear bumper: Rear bumper - Scratched - Paint

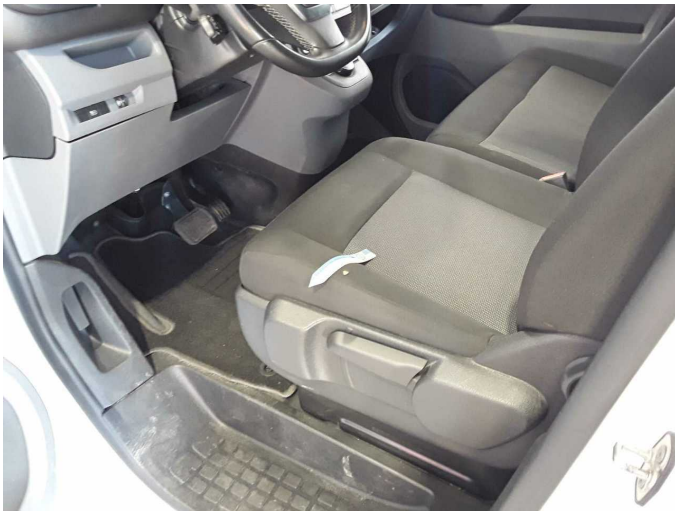
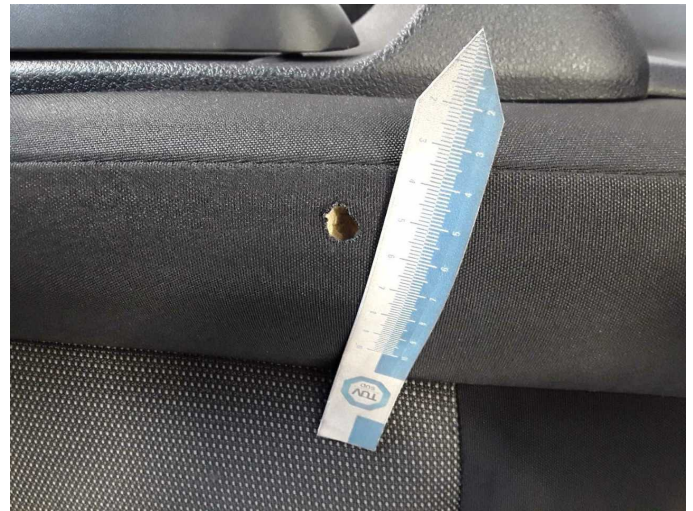
**Damage 3:** Seat - front: Seat cover - left side (mit Sitzpolster) - Burn hole (cigarettes) - Replace

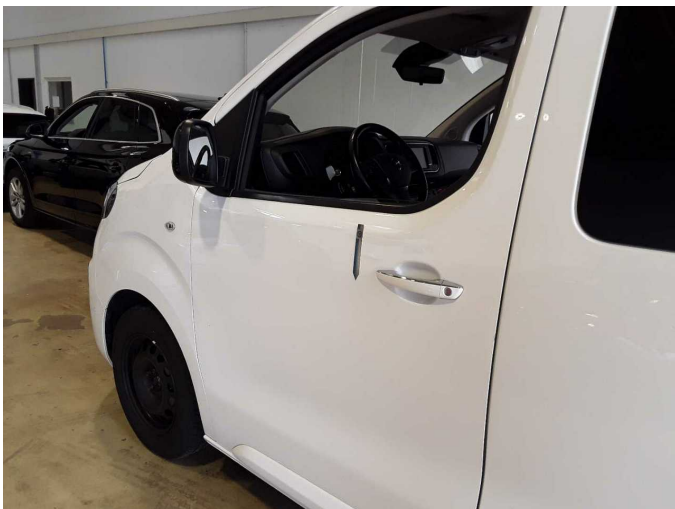
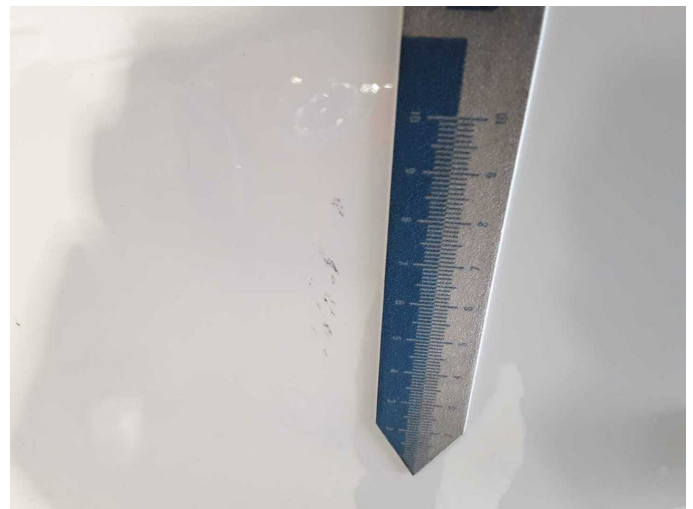
**Wear and tear 3:** Door - front left side: Door - Scratch(es) - No deduction

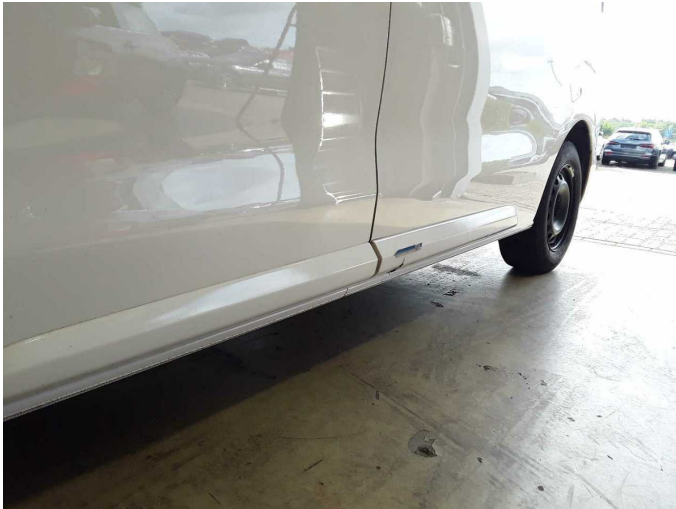
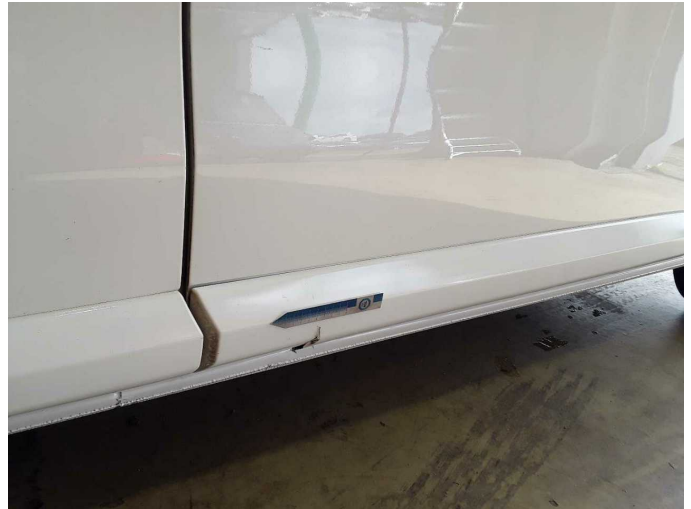
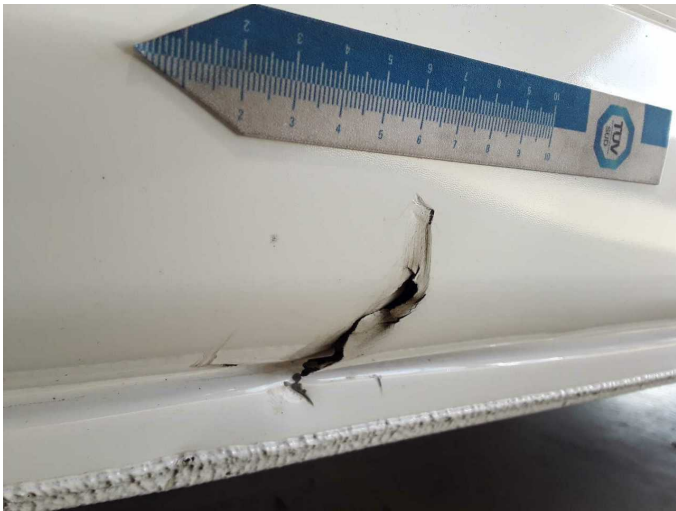
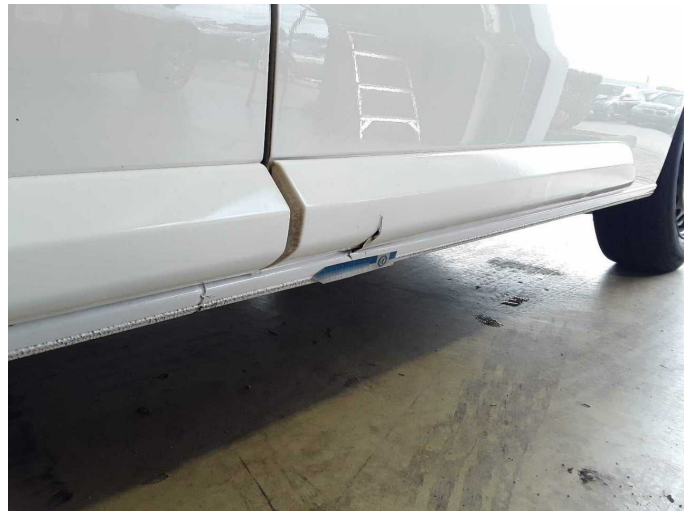
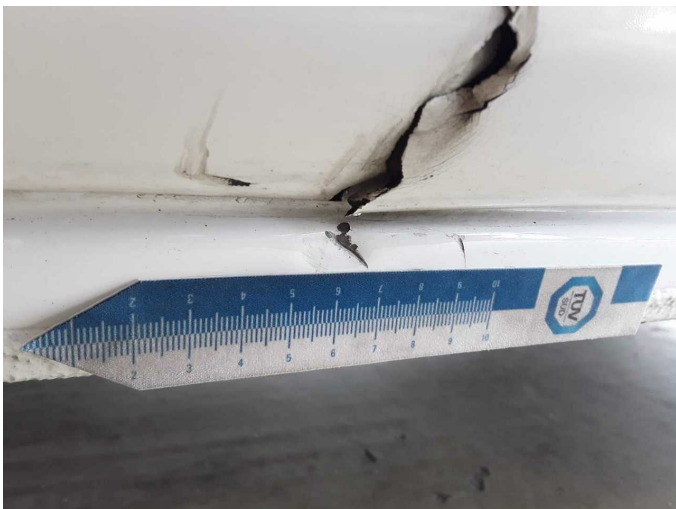
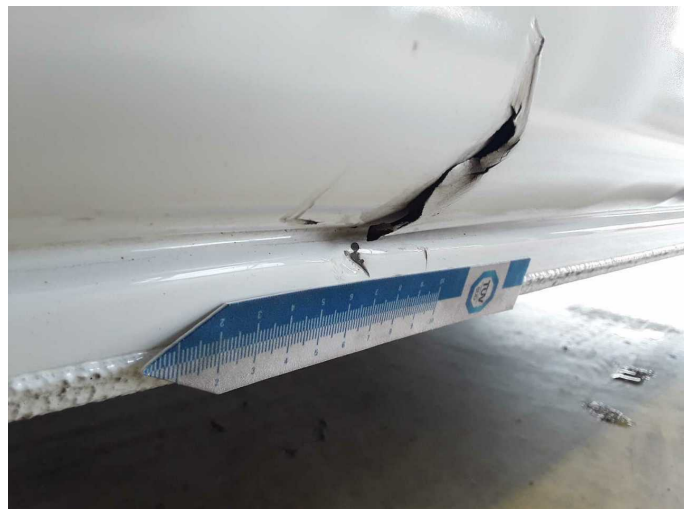
No.	Accident
1	Side - left

**Accident 1: Side - left**
