Expertise

Protocol number: 41811315  
Order number / reference: 25237098  
Inspection date: 25 Sept 2025

Manufacturer: Opel

Model: Vivaro 2.0 D Cargo M Autm. Elegance

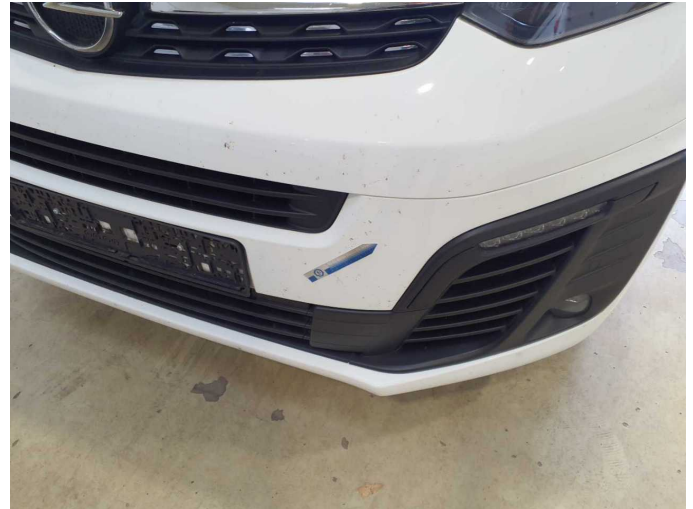
No.	Component group	Description
1	Front bumper	Front bumper - Scratch(es) - Smart repair
2	Wheel / tyres	Tyre - front right side - Damaged - Replace
3	Rear bumper	Rear bumper - Scratched - Repair and paint

**Damage 1:** Front bumper: Front bumper - Scratch(es) - Smart repair

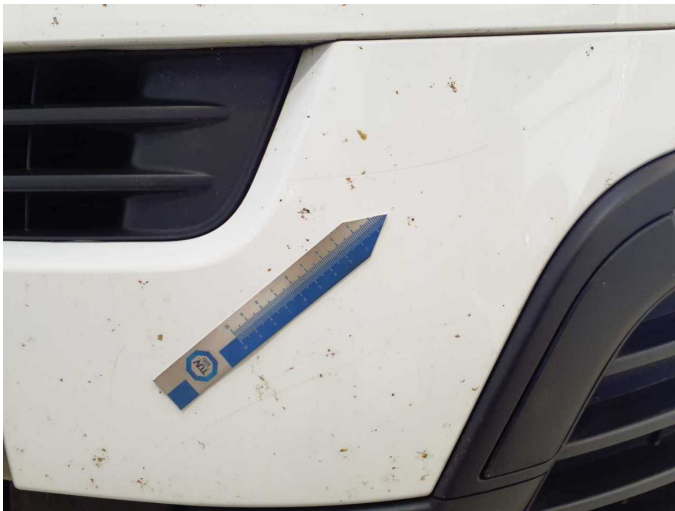
**Damage 1:** Front bumper: Front bumper - Scratch(es) - Smart repair

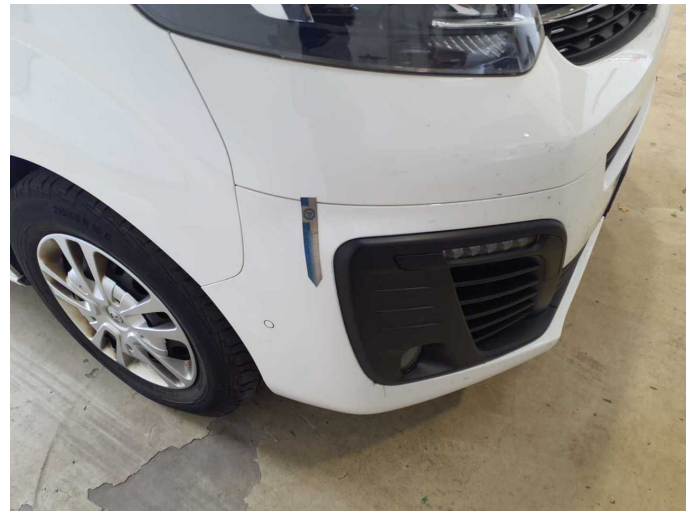
**Damage 1:** Front bumper: Front bumper - Scratch(es) - Smart repair

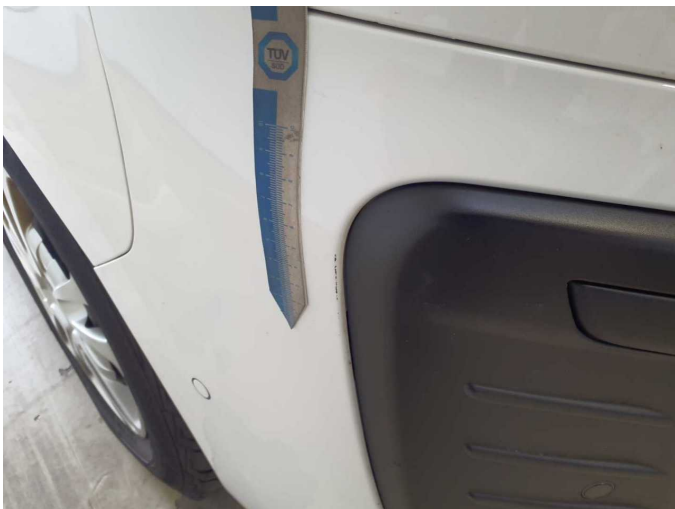
**Damage 1:** Front bumper: Front bumper - Scratch(es) - Smart repair

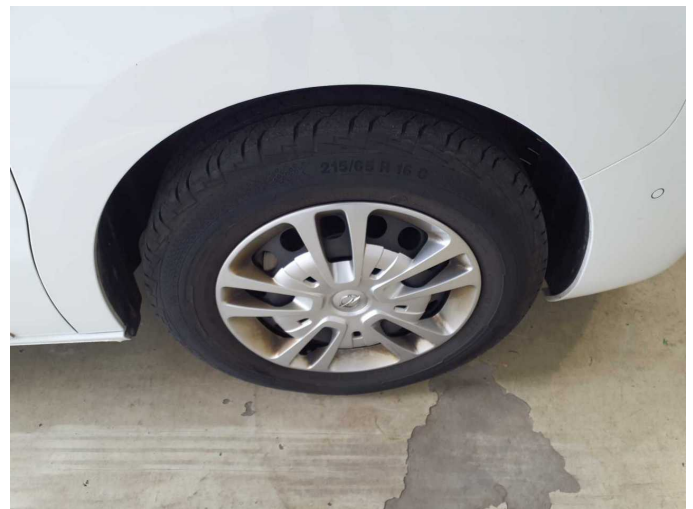
**Damage 2:** Wheel / tyres: Tyre - front right side - Damaged - Replace

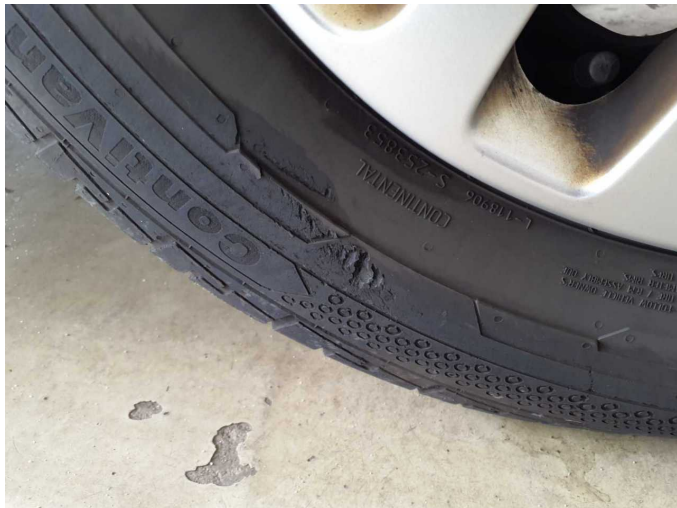
**Damage 2:** Wheel / tyres: Tyre - front right side - Damaged - Replace

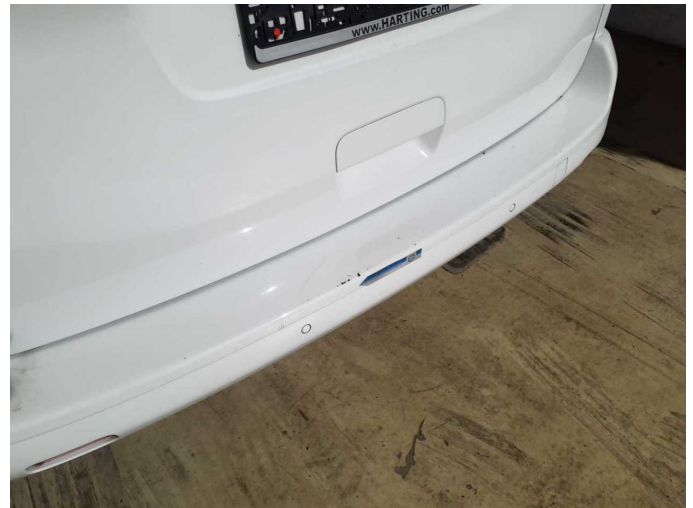
**Damage 3:** Rear bumper: Rear bumper - Scratched - Repair and paint

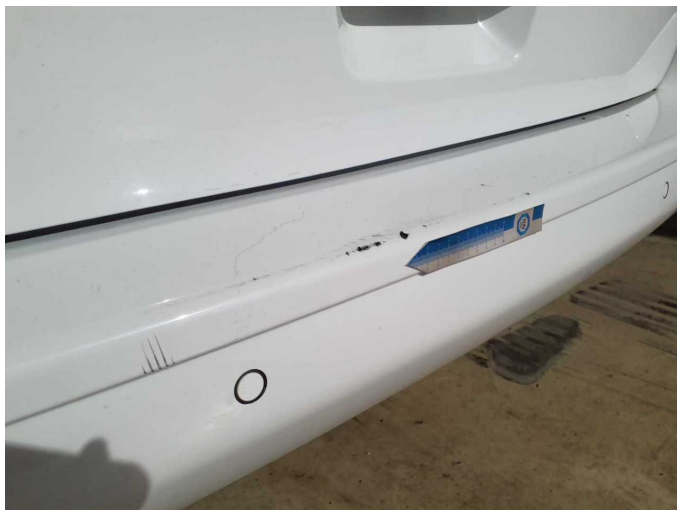
**Damage 3:** Rear bumper: Rear bumper - Scratched - Repair and paint

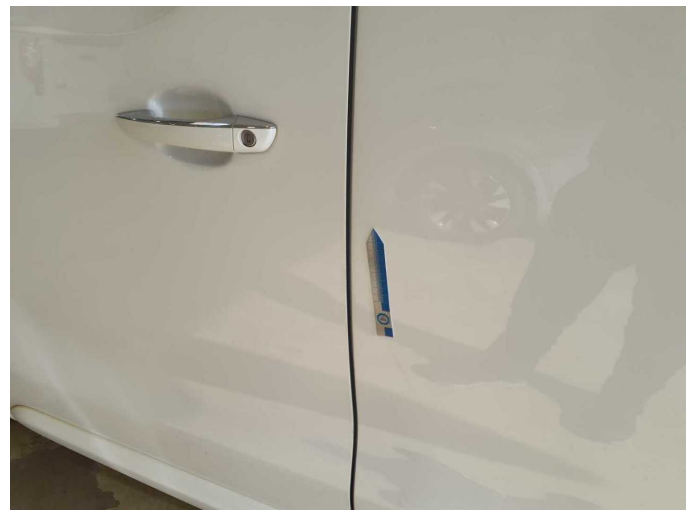
No.	Component group	Description
1	Vehicle glazing	Windscreen with lane departure assistant - Stone chips - No deduction
2	Side panel - rear left side	Side panel - Scratch(es) - No deduction
3	Door - front left side	Door edge - Scratch(es) - No deduction
4	Door - front right side	Door - Scratch(es) - No deduction

**Wear and tear 2:** Side panel - rear left side: Side panel - Scratch(es) - No deduction

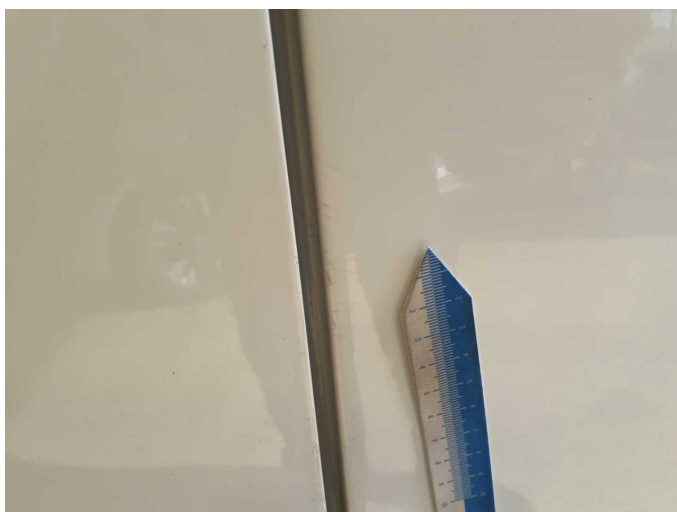
**Wear and tear 2:** Side panel - rear left side: Side panel - Scratch(es) - No deduction

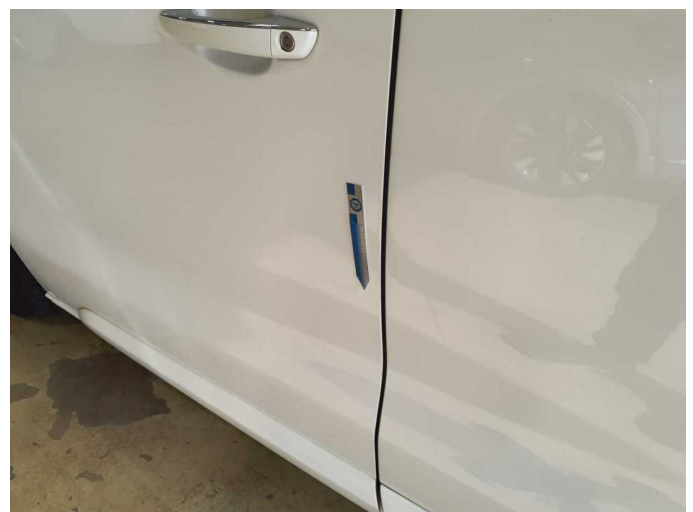
**Wear and tear 3:** Door - front left side: Door edge - Scratch(es) - No deduction

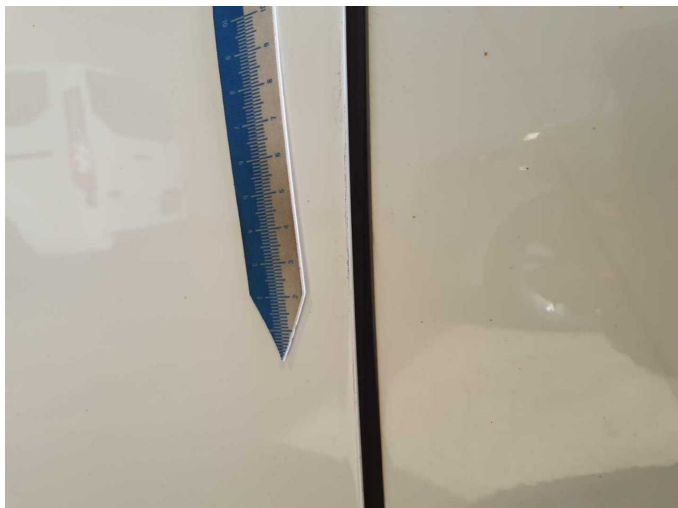
**Wear and tear 3:** Door - front left side: Door edge - Scratch(es) - No deduction

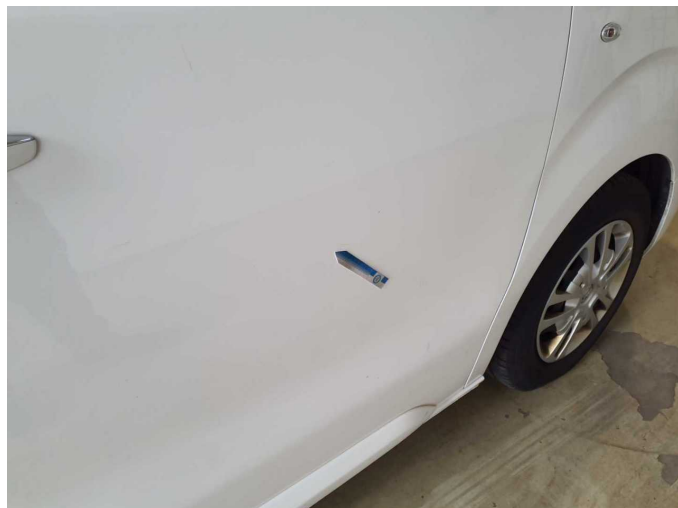
**Wear and tear 4:** Door - front right side: Door - Scratch(es) - No deduction

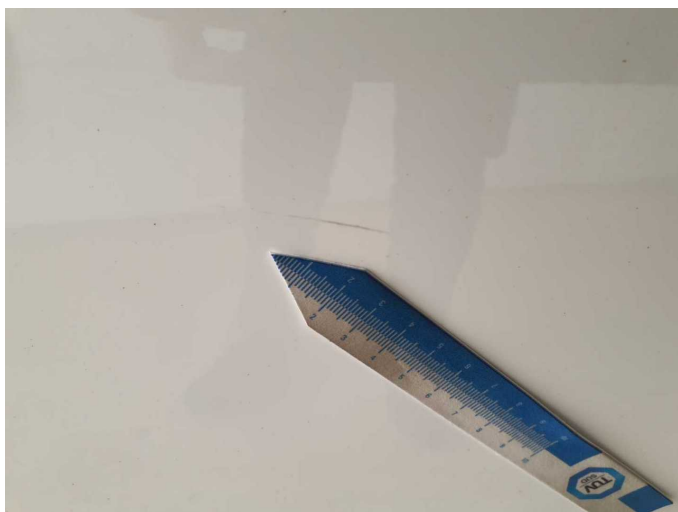
**Wear and tear 4:** Door - front right side: Door - Scratch(es) - No deduction
