## status report

| <b>customer:</b> | <b>BCA Autoauktionen GmbH</b> |

| vehicle data | | | |
|---|---|---|---|
| <b>Opel Movano C Kasten Ka L1H1 3,5t Edition</b> | | | |
| Vehicle identification number | <b>VXEYCBPFA12W06877</b> | mileage read: | <b>40203 km</b> |

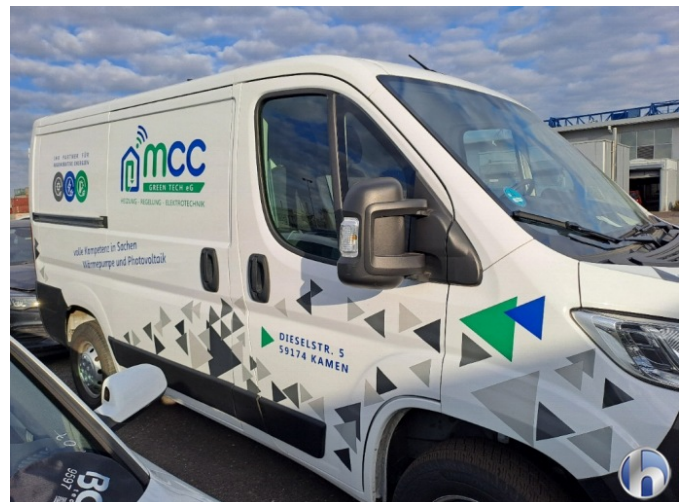
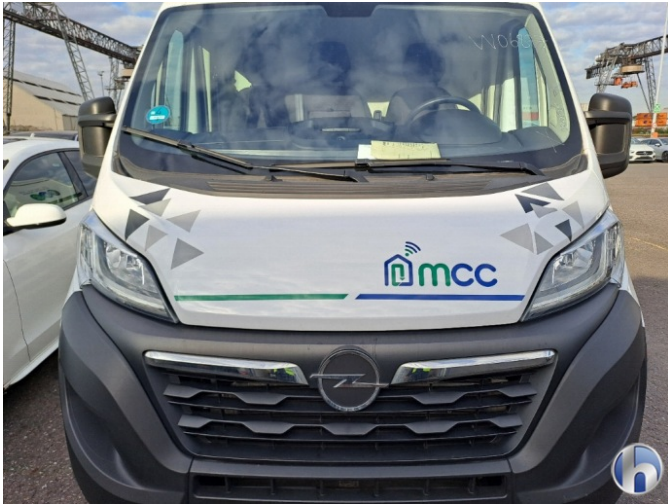
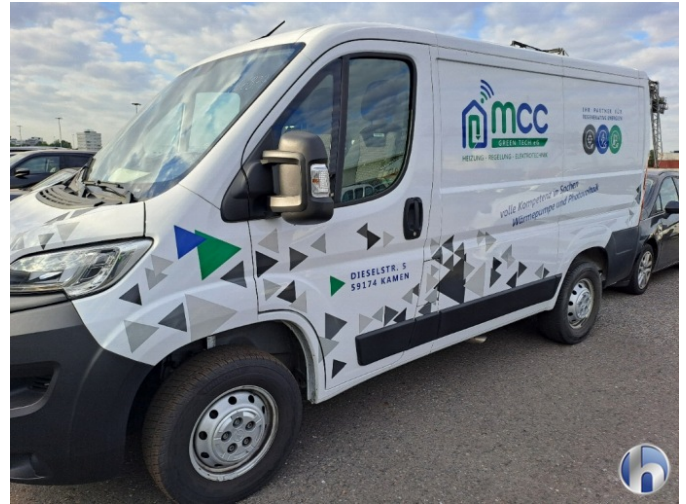
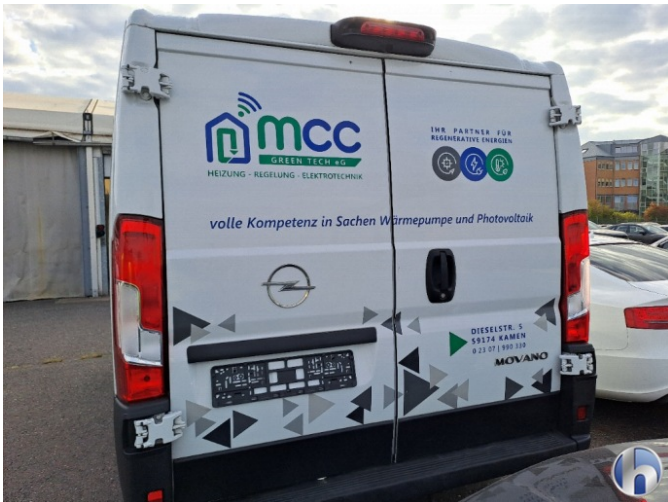
| component | Damage | Rep kind |
|---|---|---|
| 1. exterior body | Sticker | |

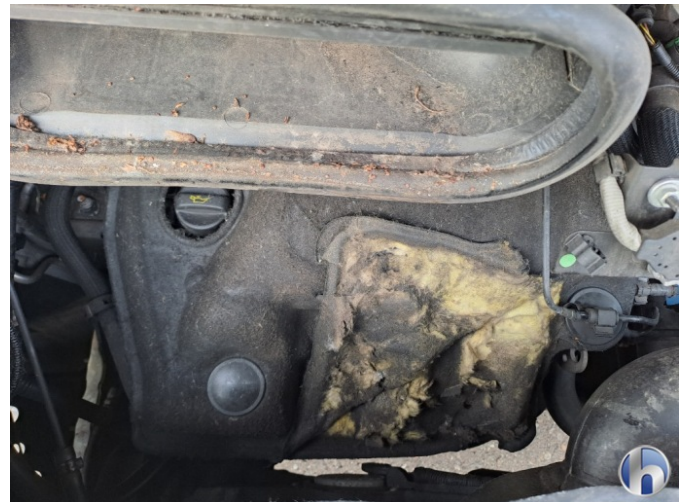
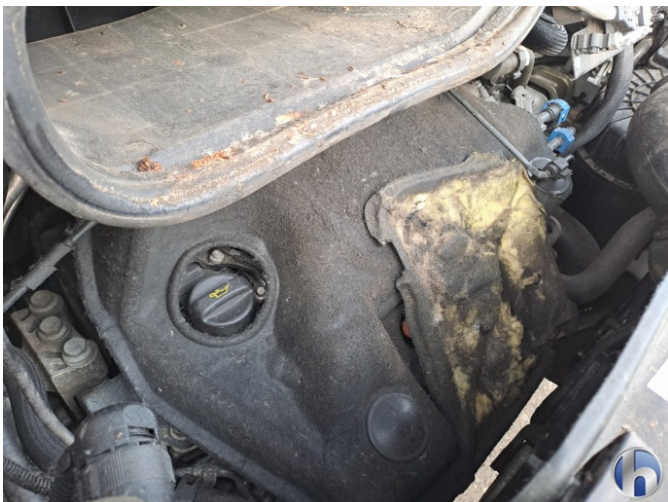
| component | Damage | Rep kind |
|---|---|---|
| 2. Motorabdeckung | | Replace |

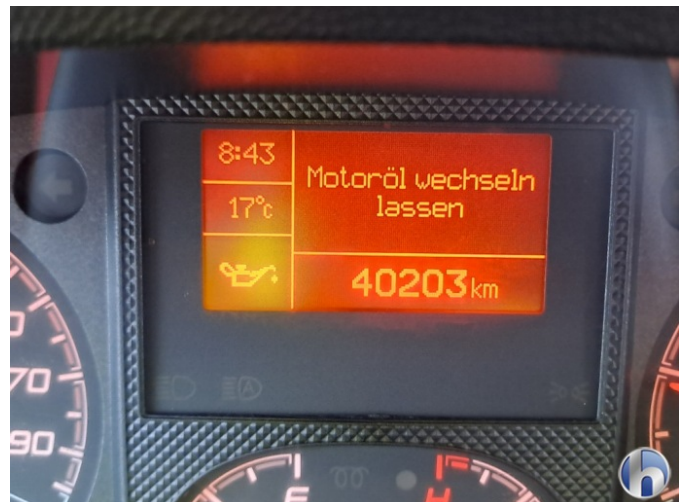
| component | Damage | Rep kind |
|---|---|---|
| 3. maintenance | Due | Replace |

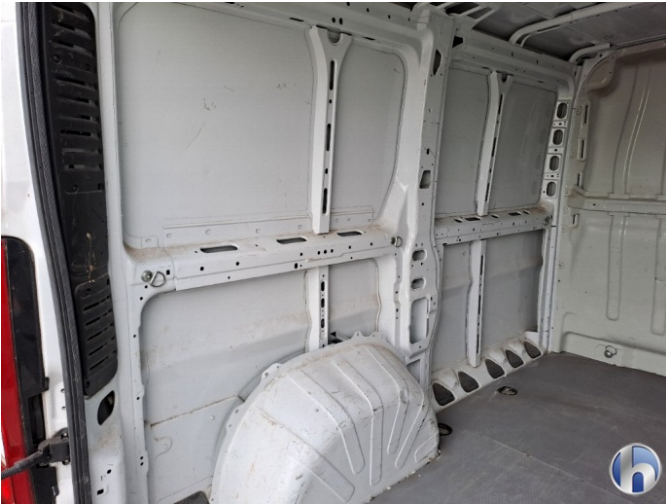
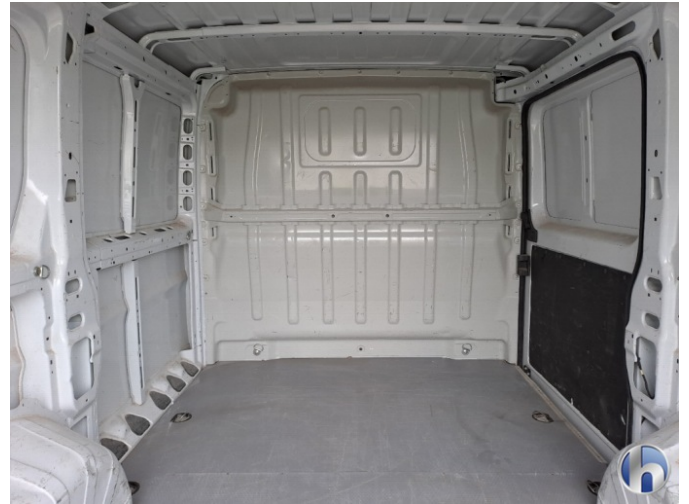
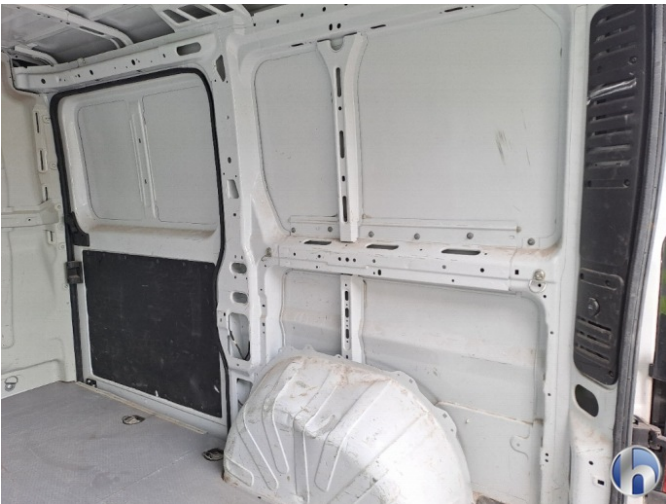
| component | Damage | Rep kind |
|---|---|---|
| 4. | Wear and tear | acceptable |

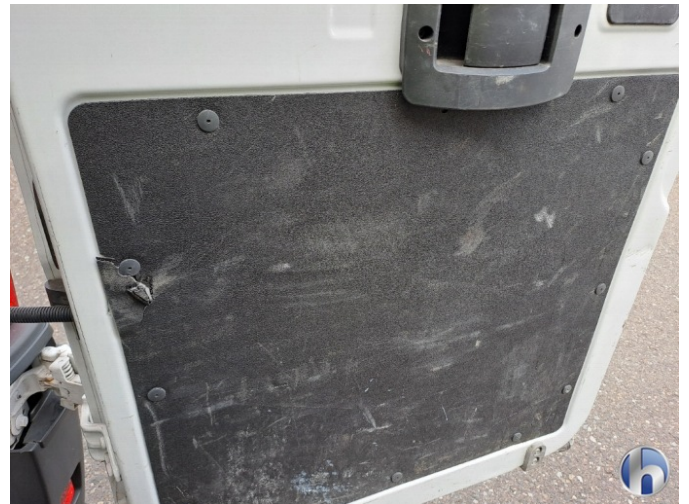
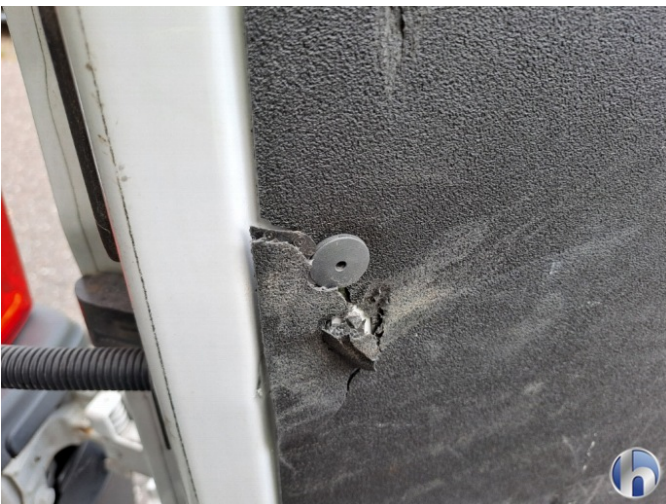
| component | Damage | Rep kind |
|---|---|---|
| 5. Hecktürverkleidung Rechts | Breakage | Replace |

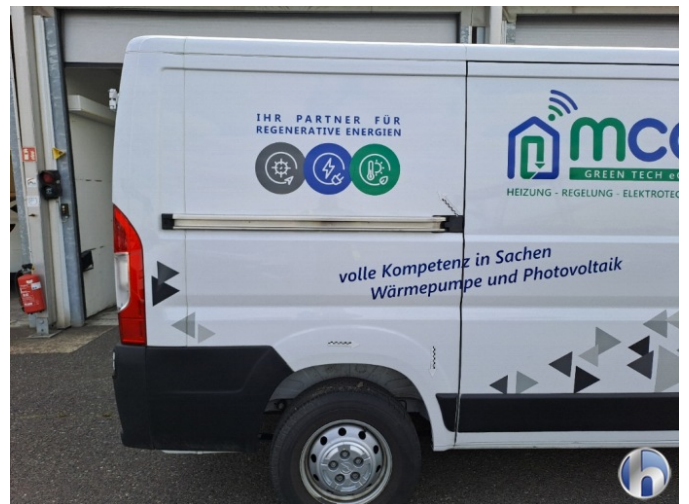
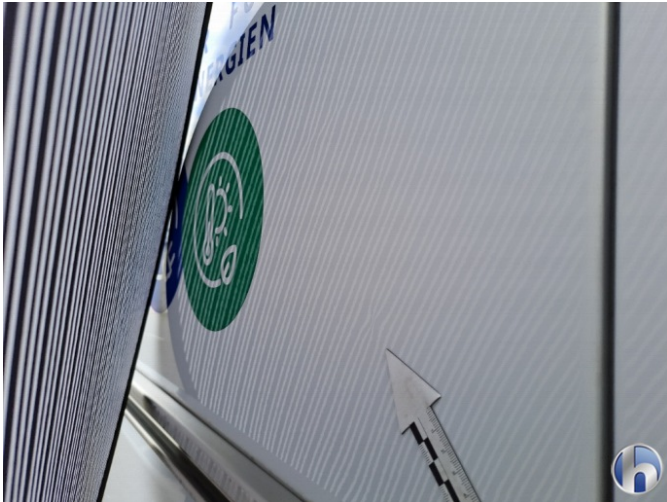
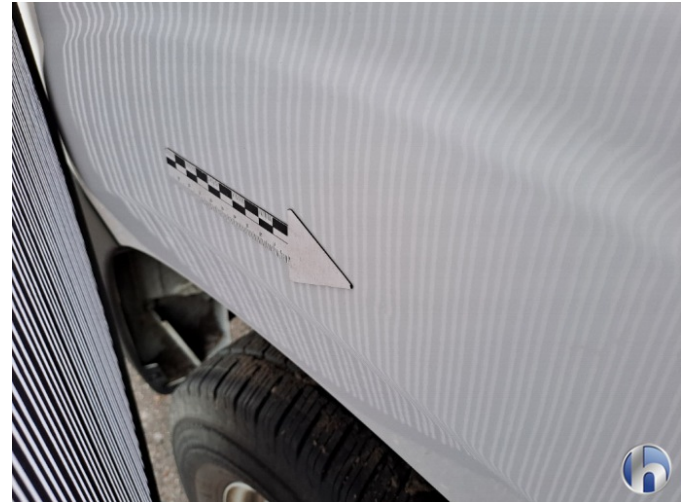
| component | Damage | Rep kind |
|---|---|---|
| 6. Sidewall - Rear - right | Damaged | Refurbish and paint |

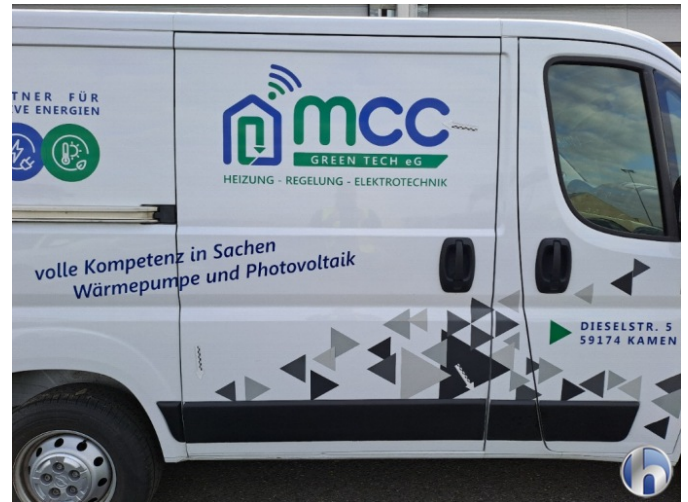
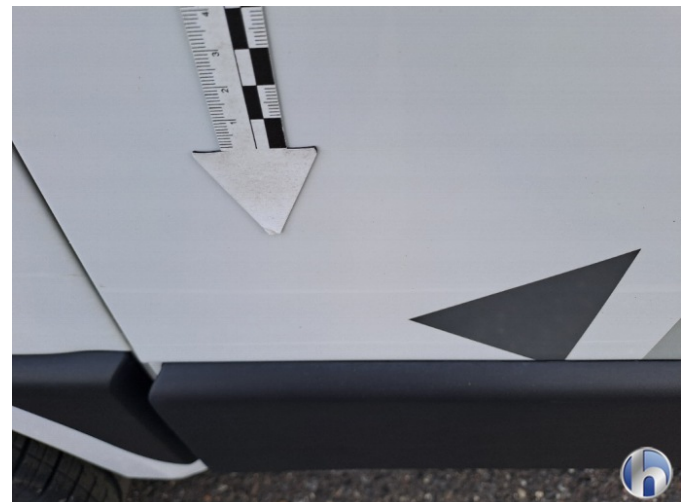
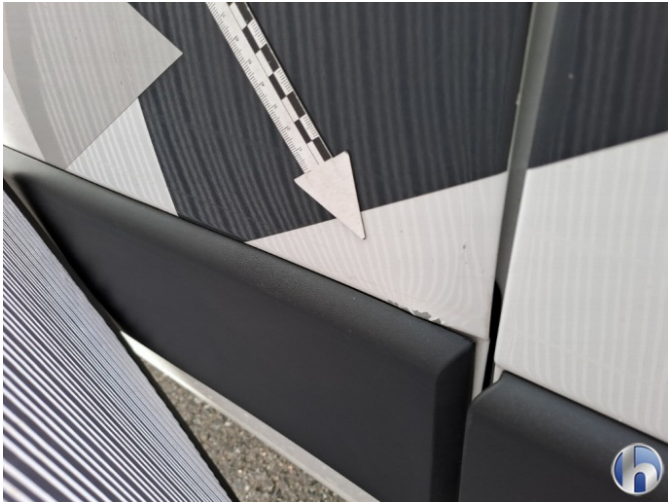
| component | Damage | Rep kind |
|---|---|---|
| 7. Sliding door - right | Damaged | Refurbish and paint |

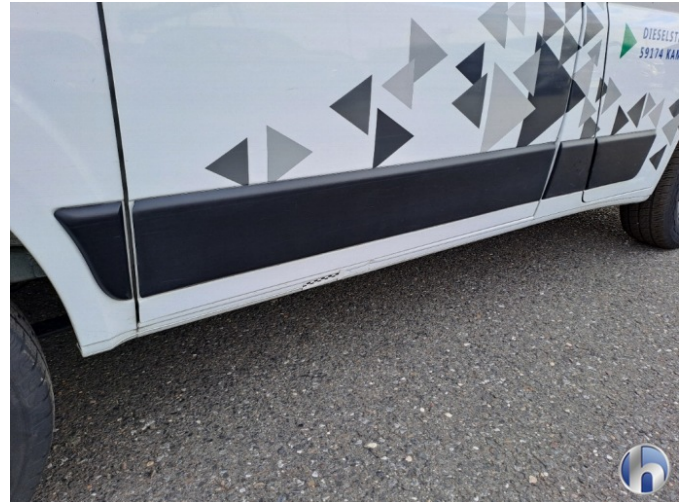
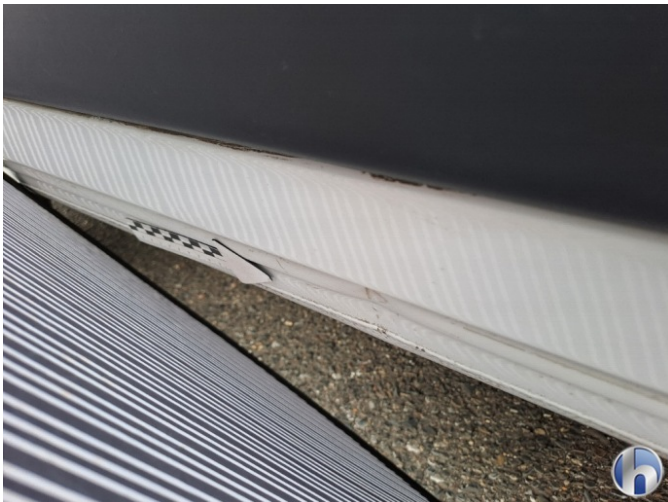
| component | Damage | Rep kind |
|---|---|---|
| 8. side skirt - right | Deformed | Refurbish and paint |

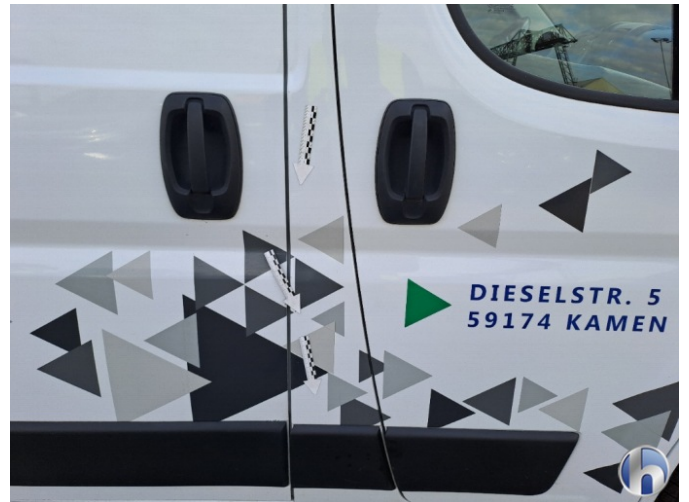
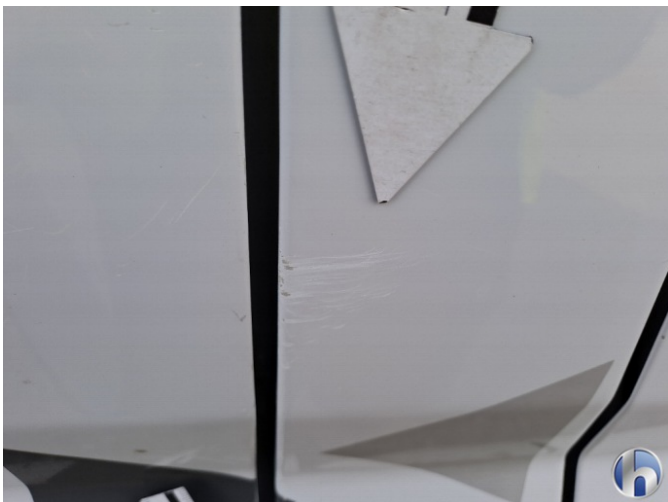
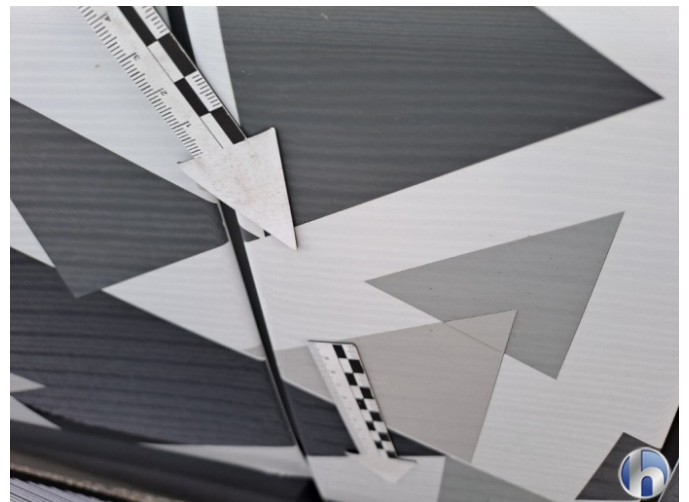
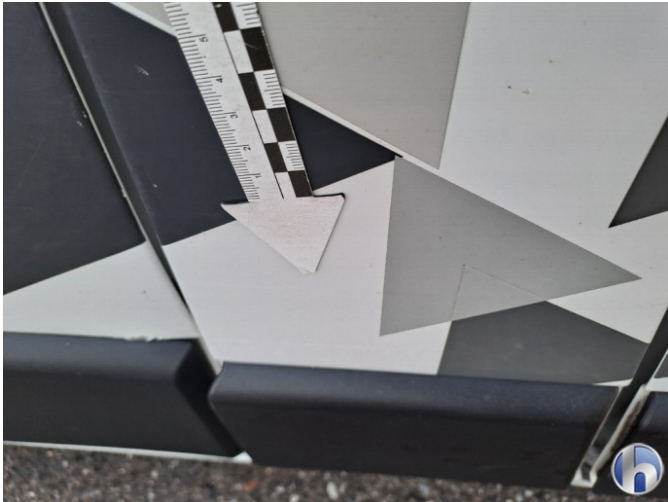
| component | Damage | Rep kind |
|---|---|---|
| 9. B-pillar center - right | Delle | Refurbish and paint |

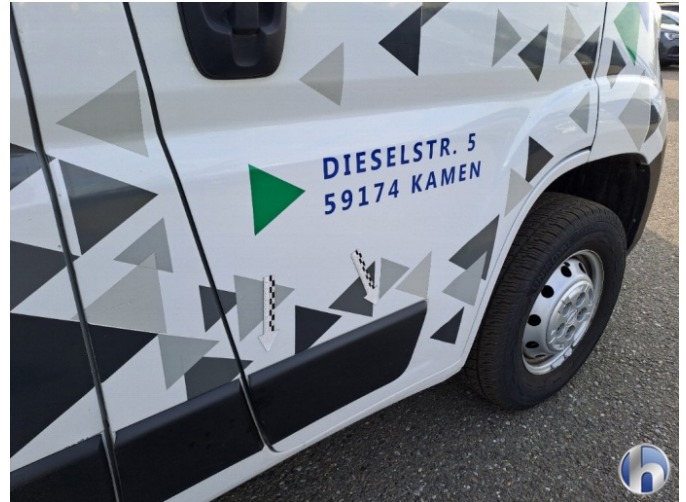
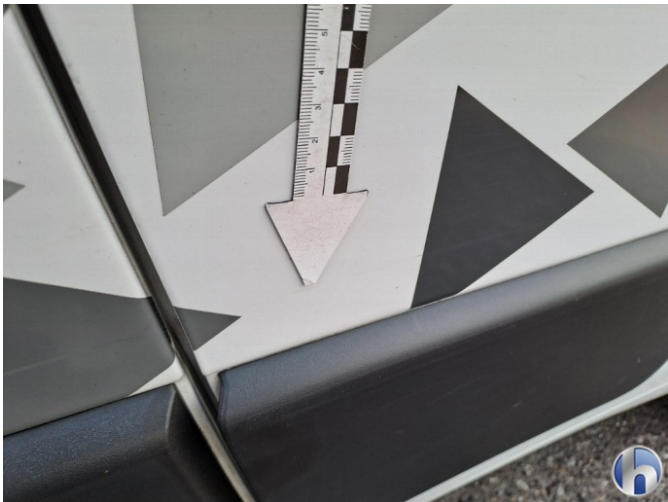
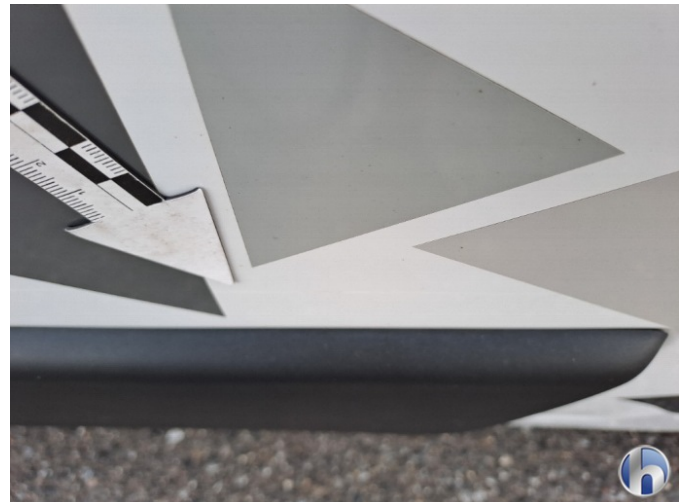
| component | Damage | Rep kind |
|---|---|---|
| 10. Front door - right | Scratch(es) | Paint |

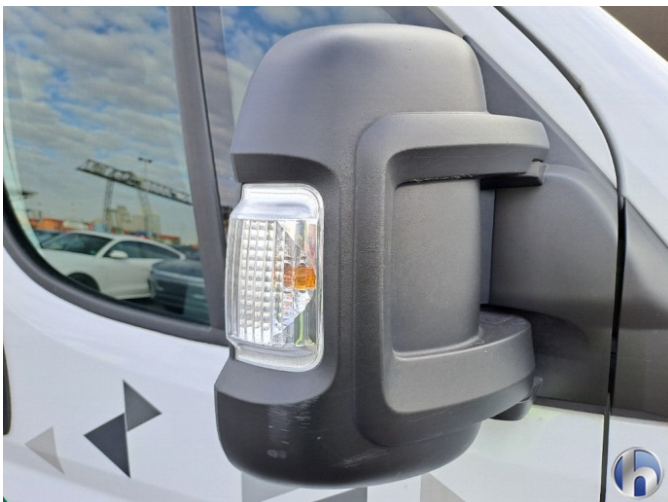
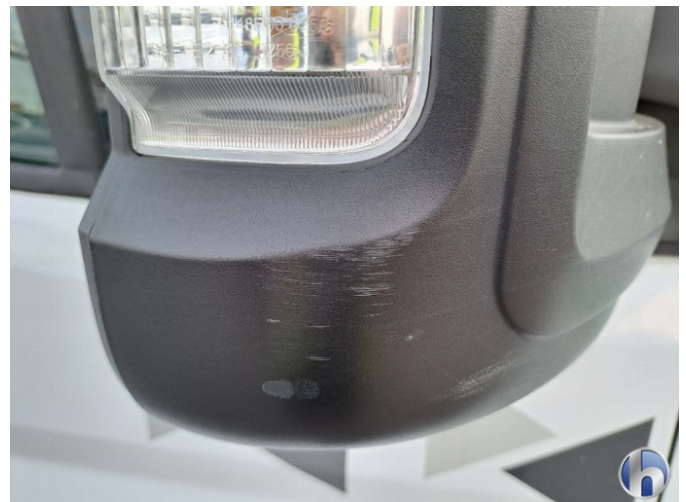
| component | Damage | Rep kind |
|---|---|---|
| 11. | Scrape | Replace |

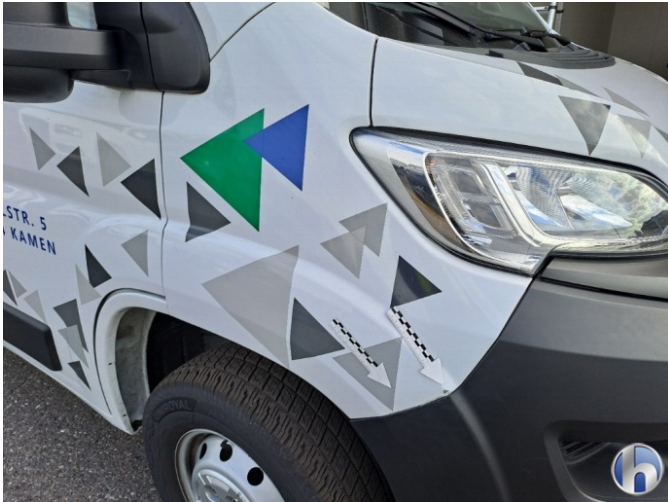
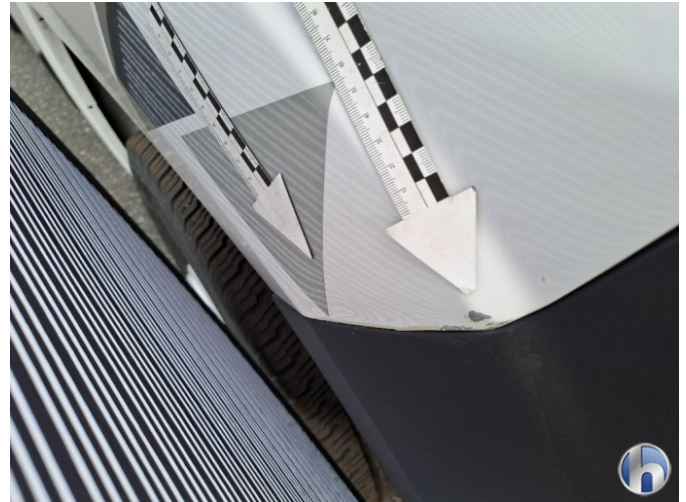
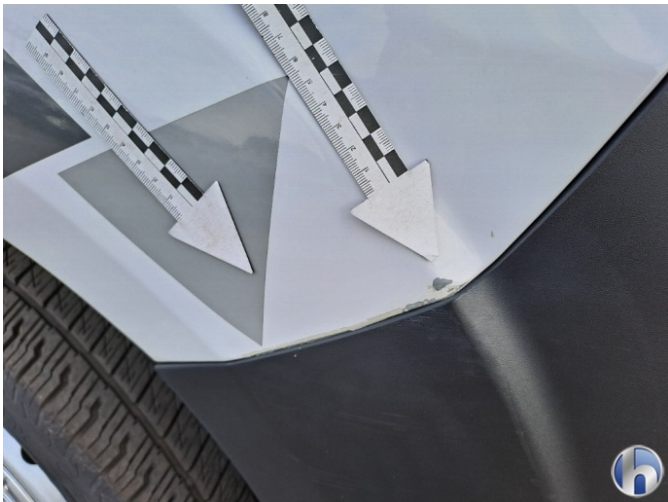
| component | Damage | Rep kind |
|---|---|---|
| 12. Front fender - right | Damaged | Refurbish and paint |

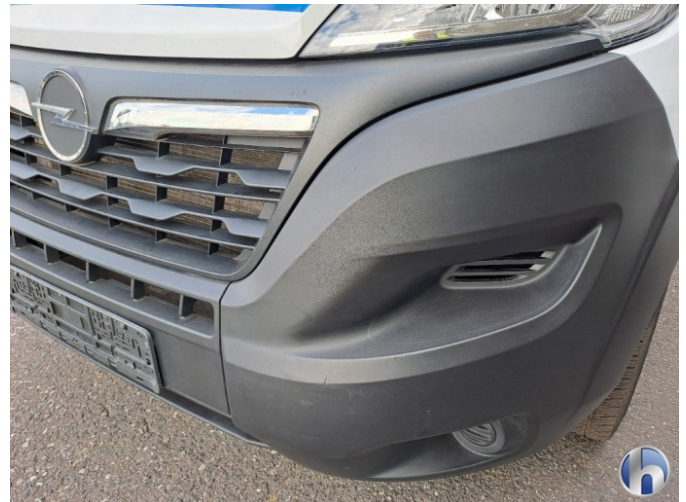
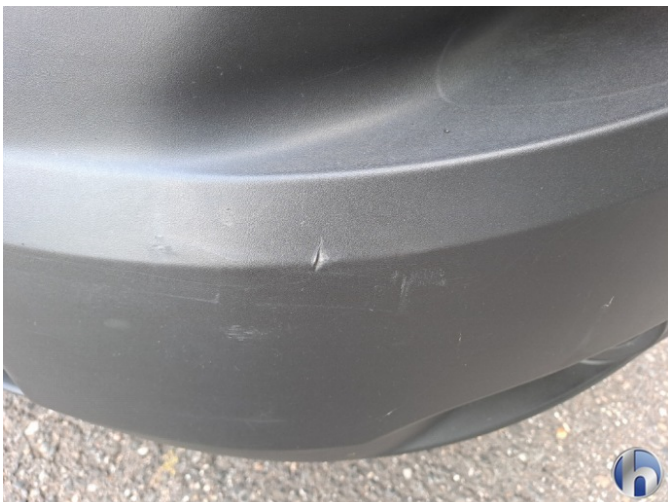
| component | Damage | Rep kind |
|---|---|---|
| 13. Front bumper | Damaged | Replace |

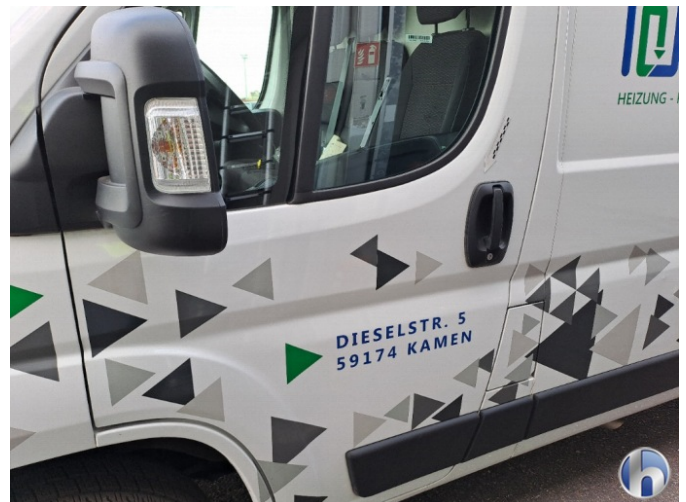
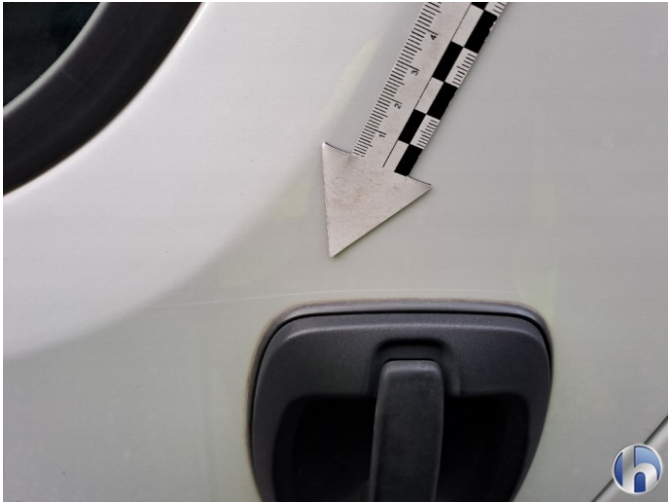
| component | Damage | Rep kind |
|---|---|---|
| 14. Front door - left | Scratch(es) | Smart repair |

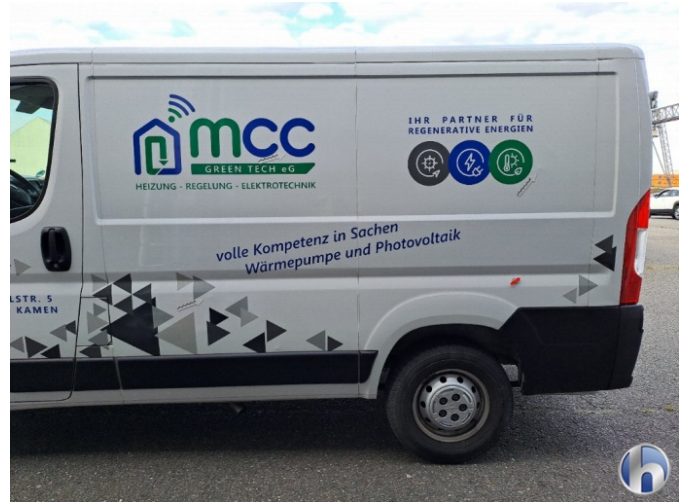
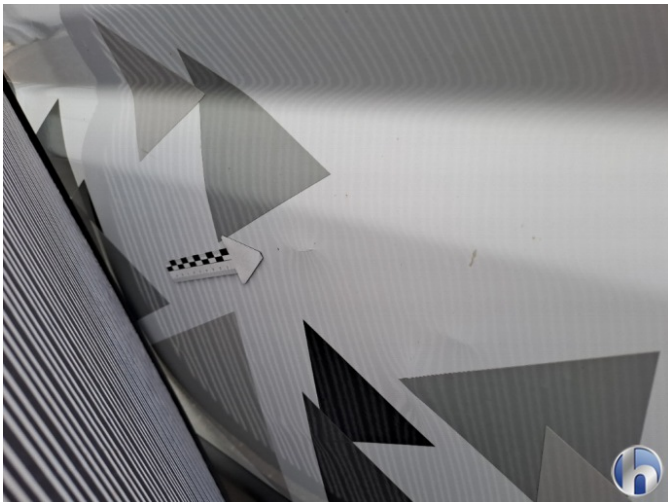
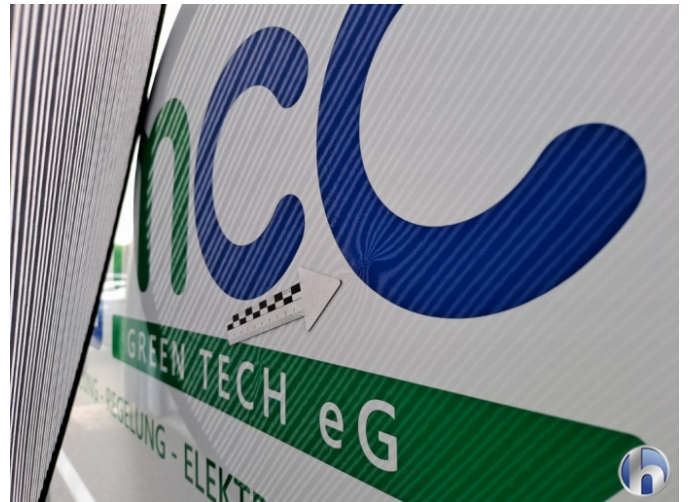
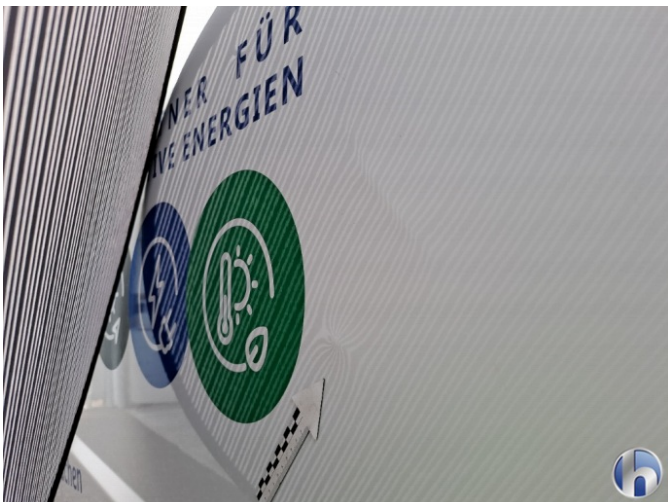
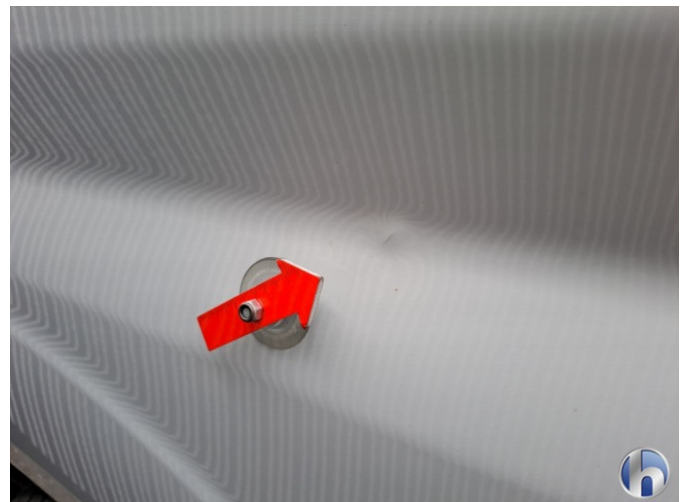
| component | Damage | Rep kind |
|---|---|---|
| 15. Sidewall - Rear - Left | Damaged | Refurbish and paint |

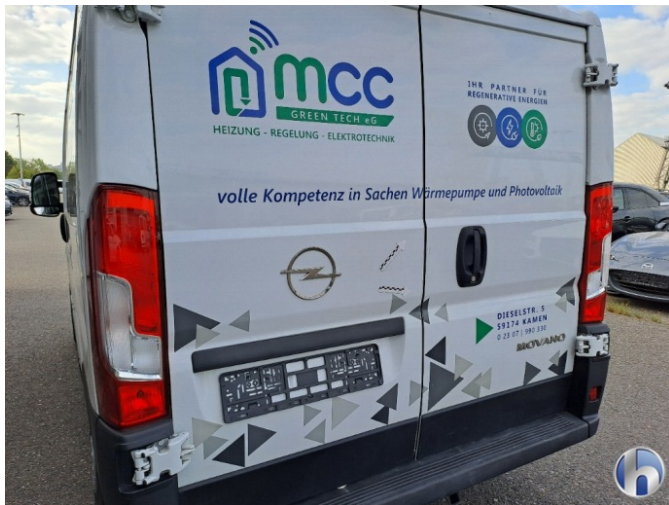
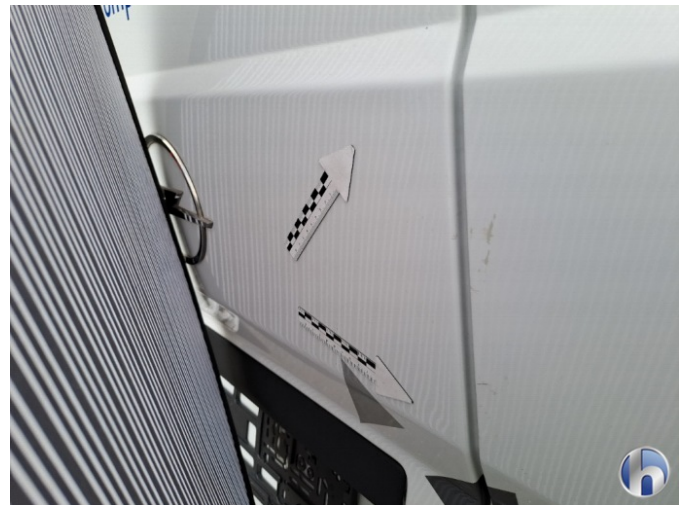
| component | Damage | Rep kind |
|---|---|---|
| 16. Tailgate left | Wear and tear | acceptable |

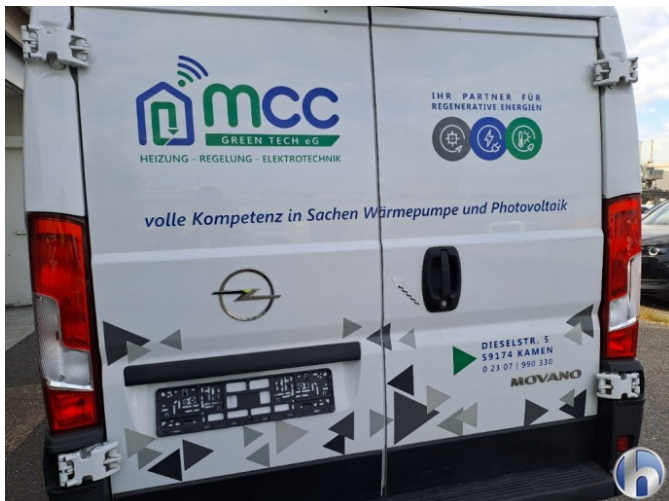
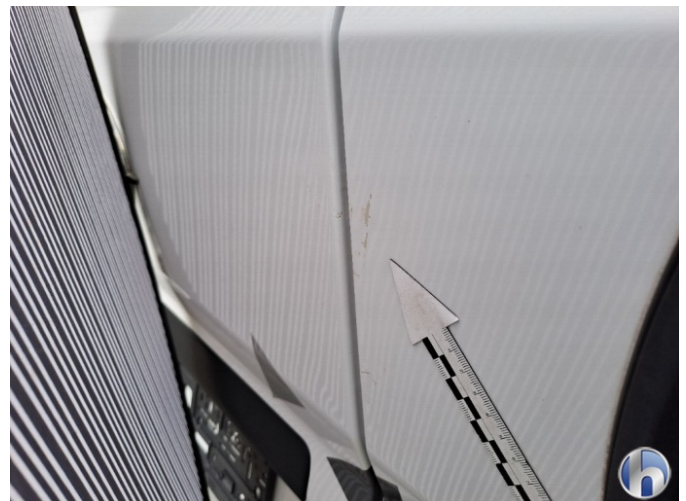
| component | Damage | Rep kind |
|---|---|---|
| 17. Tailgate right | | Refurbish and paint |

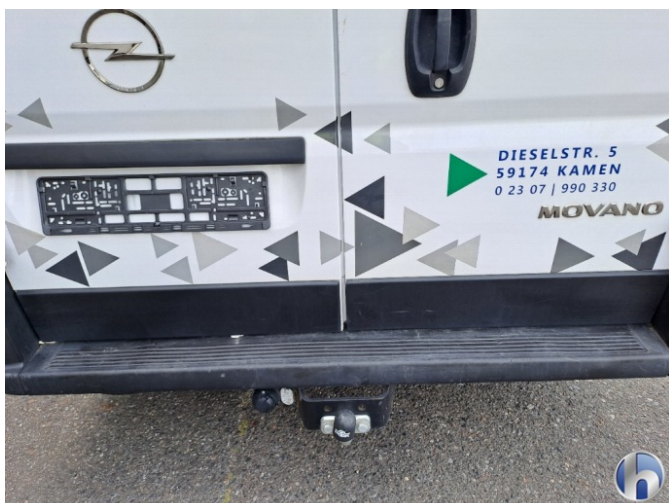
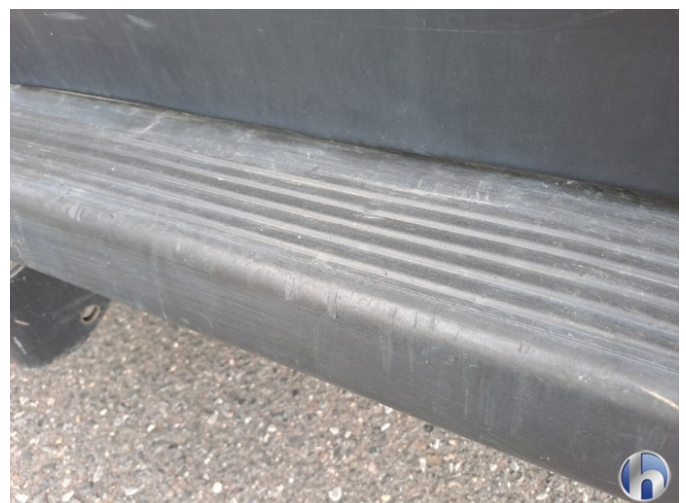
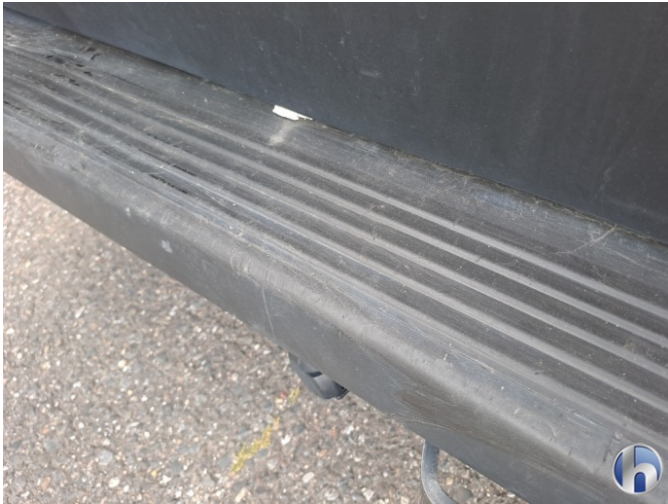
| component | Damage | Rep kind |
|---|---|---|
| 18. Rear bumper | Scrape | Replace |

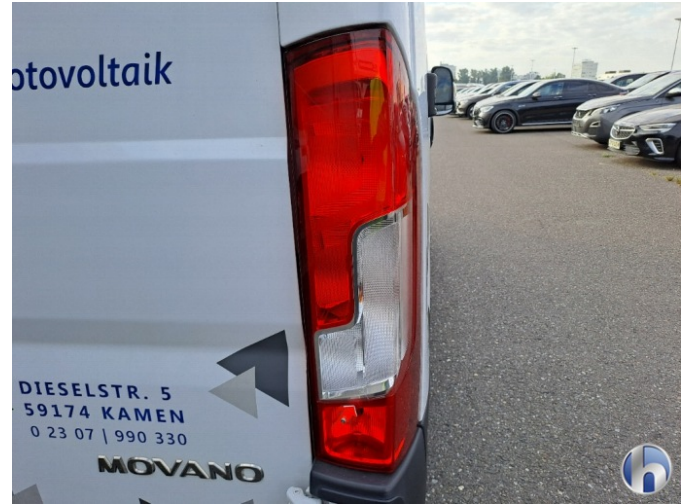
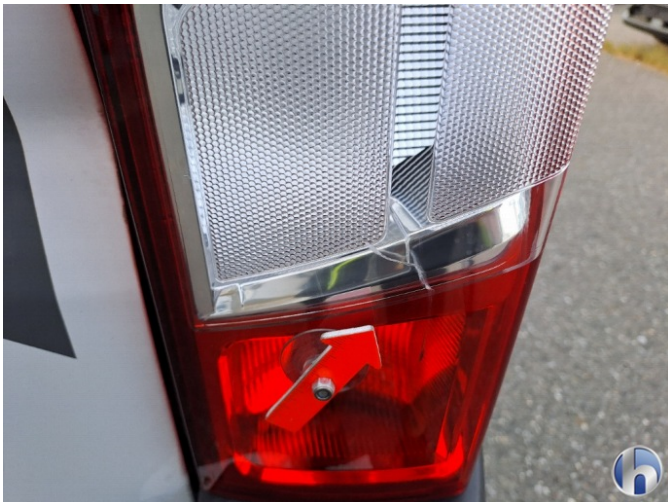
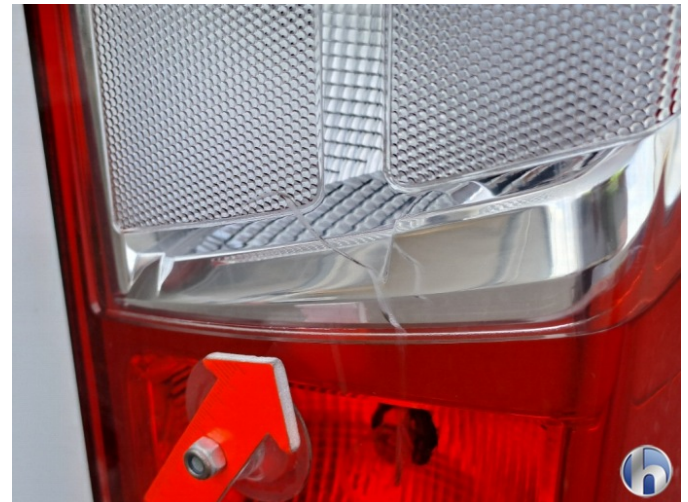
| component | Damage | Rep kind |
|---|---|---|
| 19. Taillight right | Breakage | Replace |

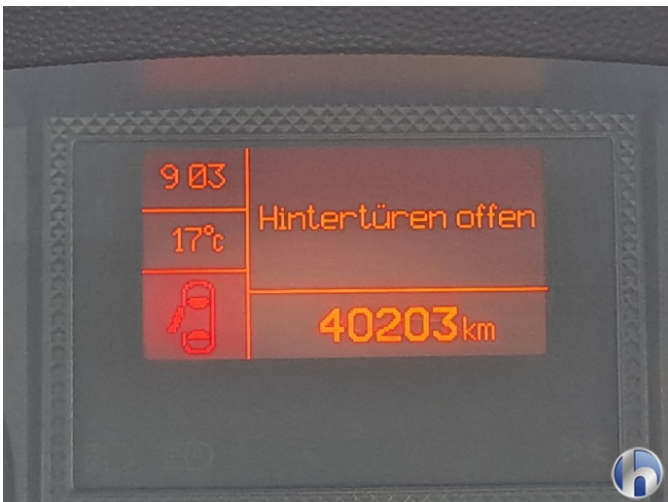
| <b>reference:</b> | *Alters-, Transport- und Laufleistungsbedingte Gebrauchsspuren vorhanden. Obwohl die Hecktüren geschlossen sind, werden diese als geöffnet im Kombiinstrument angezeigt. Es handelt sich um ein Nutzfahrzeug. Dementsprechend sind ggf. Umbauten und stärkere Gebrauchsspuren am und im Fahrzeug vorhanden. Kosten- und Schadenserweiterung möglich. |

| component | Damage | Rep kind |
|---|---|---|
| 20. Tailgate right | Not okay | Carry out a fault diagnosis |

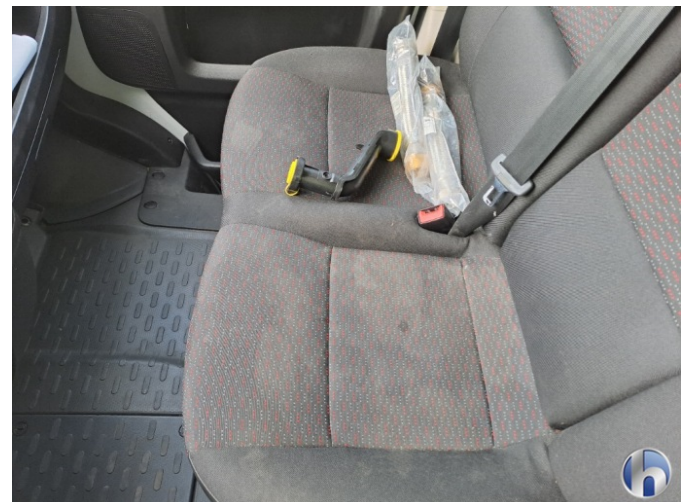
| component | Damage | Rep kind |
|---|---|---|
| 21. | Dirty | |
