OPEL MOVANO (30) MOVANO FGN 3.5T L2H2 140 CH PACK CLIM

VIN NO VXEYCBPFB12U61524
Registration Number GF883TH

Inspection Report Summary

Customer	BCAuto Encheres	Report Number	P20250924113929
Inspection Date / Place	2025-09-24 / BCA GARONS	Cosmetic Grade	5

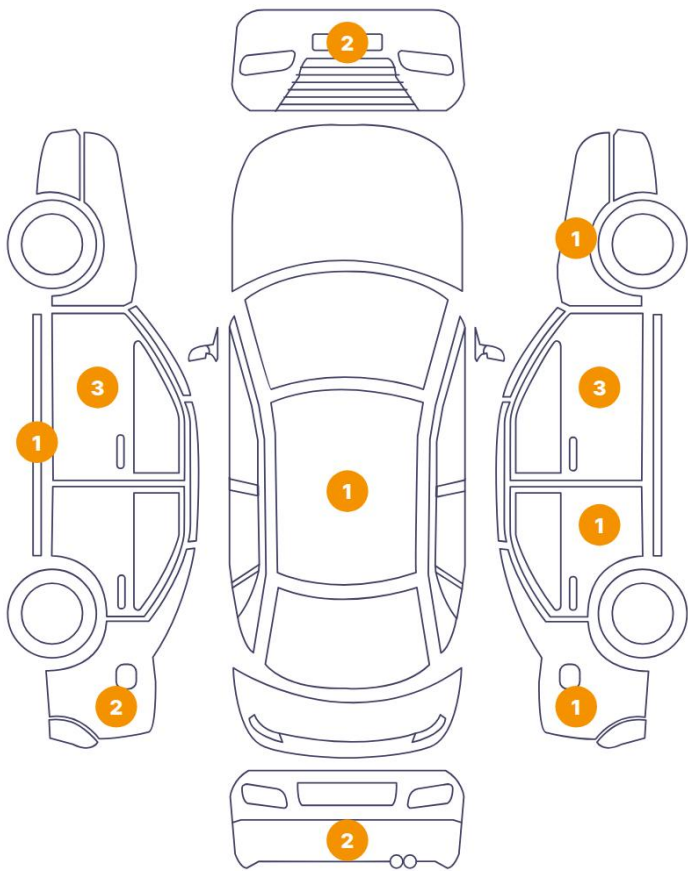
Component		Damage	Comments
1	Fender / Back Right	Bodywork / Dent / Deformation	
2	Shield / Back	Paint / Scratch / Line	
3	Door Side Molding / Back Right	Paint / Scratch / Line	
4	Door Side Molding / Front Right	Bodywork / Breakage / Crack	
5	Door / Front Right	Bodywork / Dent / Deformation	
6	Mirror / Front Right	Paint / Scratch / Line	
7	Fender / Front Right	Bodywork / Dent / Deformation	
8	Shield / Front	Paint / Scratch / Line	
9	Antenna Rod	Missing Part	
10	Shield / Front	Bodywork / Dent / Deformation	
11	Mirror / Front Left	Paint / Scratch / Line	
12	Door / Front Left	Bodywork / Dent / Deformation

13	Door / Front Left	Bodywork / Dent / Deformation
14	Seat Cushion / Front Left	Interior / Dirty
15	Rocker Panel / Center Left	Bodywork / Dent / Deformation
16	Fender / Back Left	Bodywork / Dent / Deformation
17	Fender / Back Left	Bodywork / Dent / Deformation
18	Shield / Back	Bodywork / Breakage

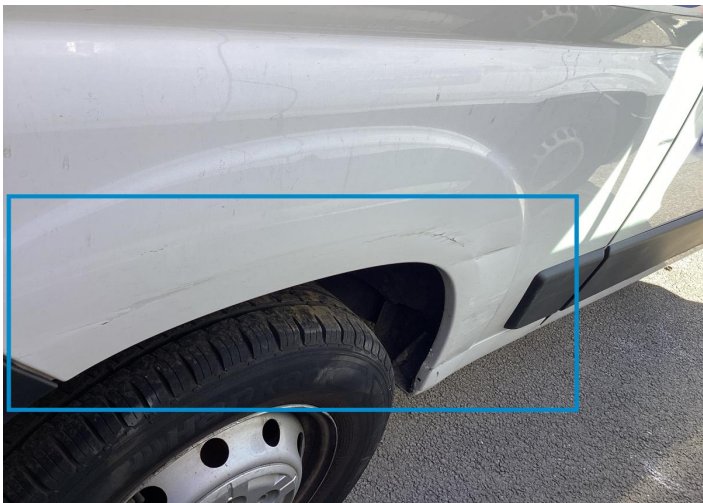
1. Fender / Back Right
Bodywork / Dent / Deformation -

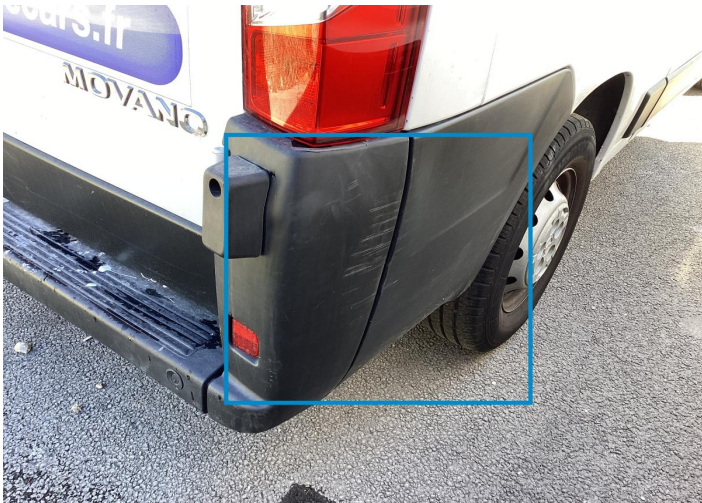
2. Shield / Back
Paint / Scratch / Line -

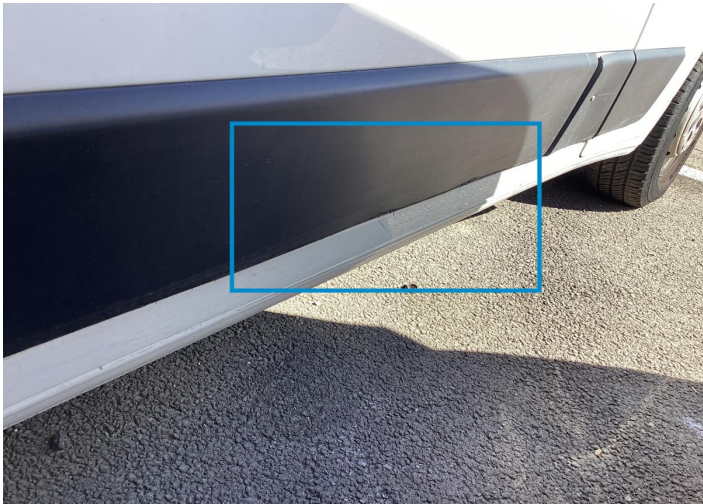
3. Door Side Molding / Back Right
Paint / Scratch / Line -

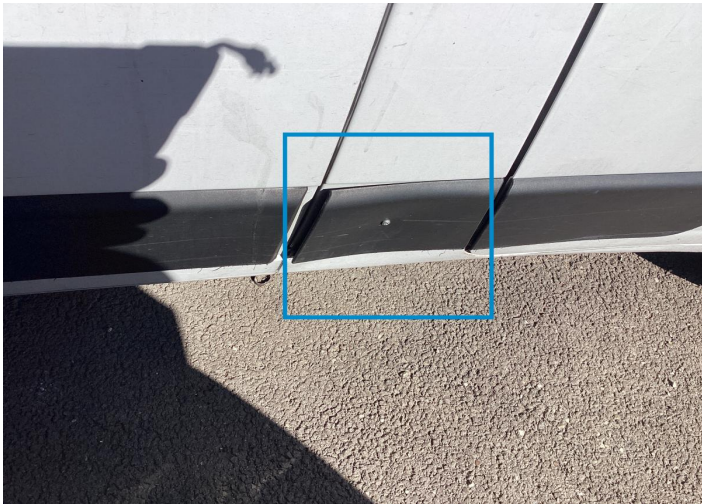
4. Door Side Molding / Front Right
Bodywork / Breakage / Crack -

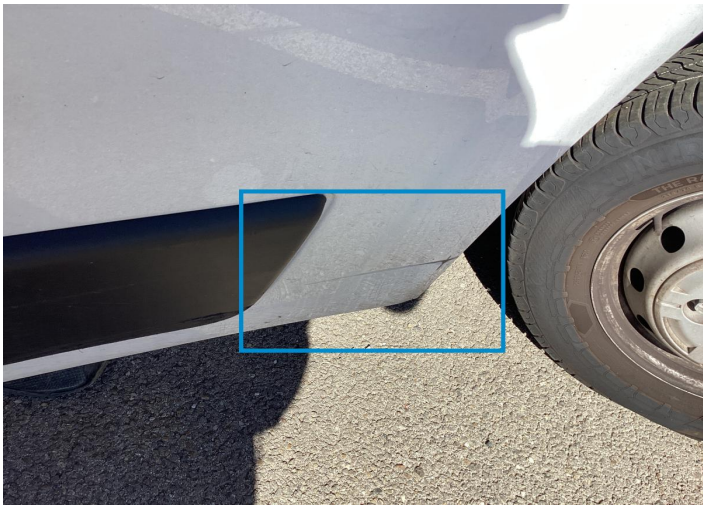
5. Door / Front Right
Bodywork / Dent / Deformation -

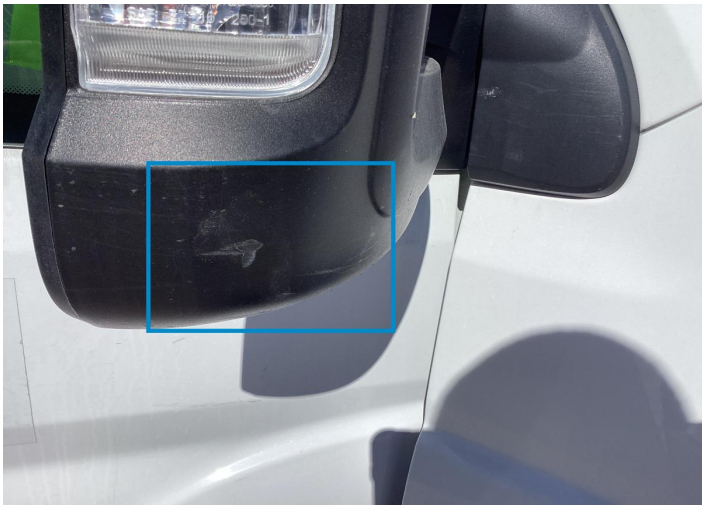
6. Mirror / Front Right
Paint / Scratch / Line -

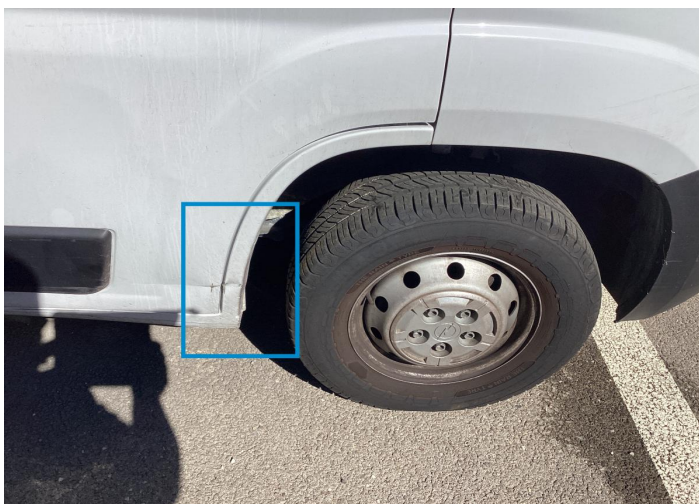
7. Fender / Front Right
Bodywork / Dent / Deformation -

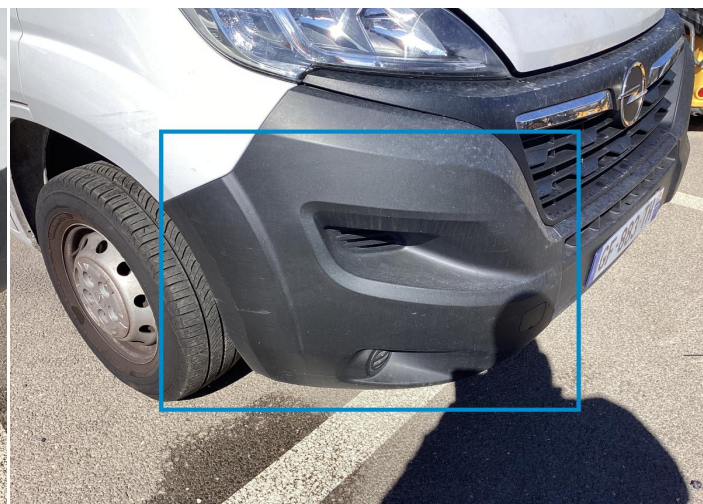
8. Shield / Front
Paint / Scratch / Line -

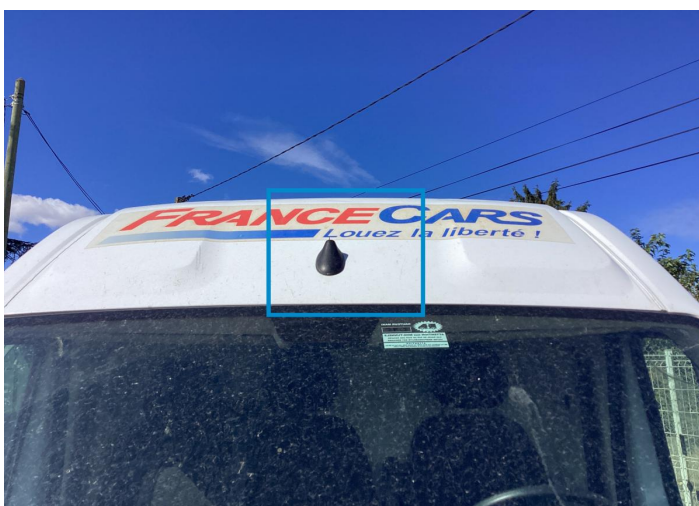
9. Antenna Rod
Missing Part -

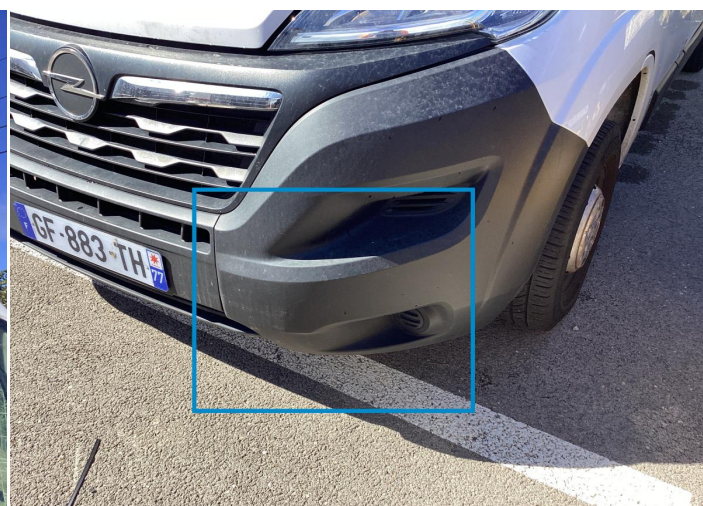
10. Shield / Front
Bodywork / Dent / Deformation -

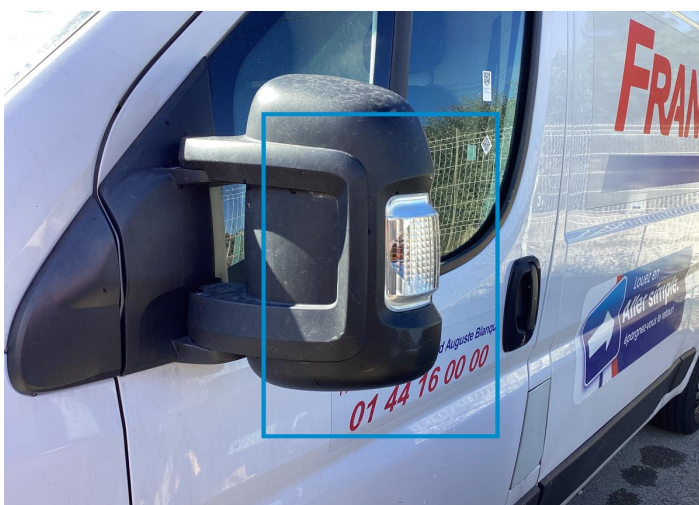
11. Mirror / Front Left
Paint / Scratch / Line -

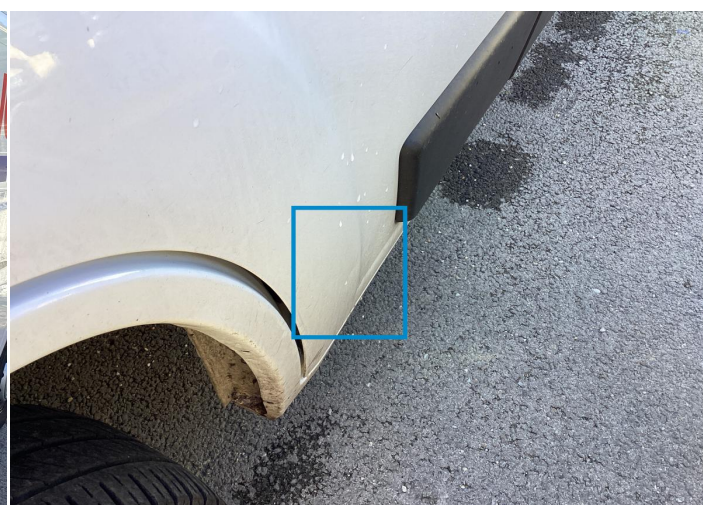
12. Door / Front Left
Bodywork / Dent / Deformation -

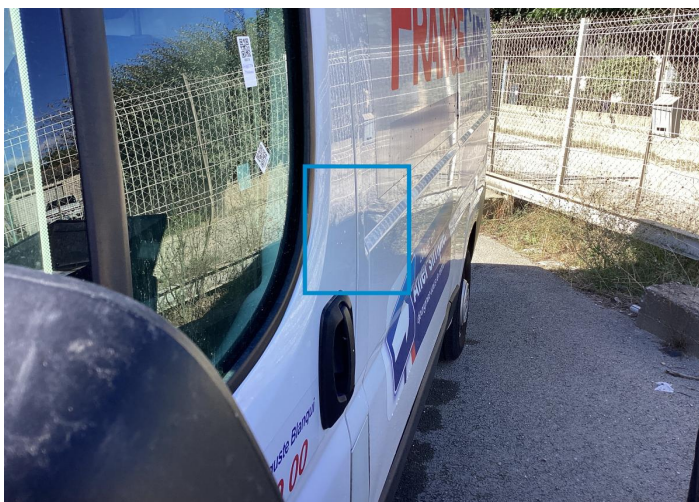
13. Door / Front Left
Bodywork / Dent / Deformation -

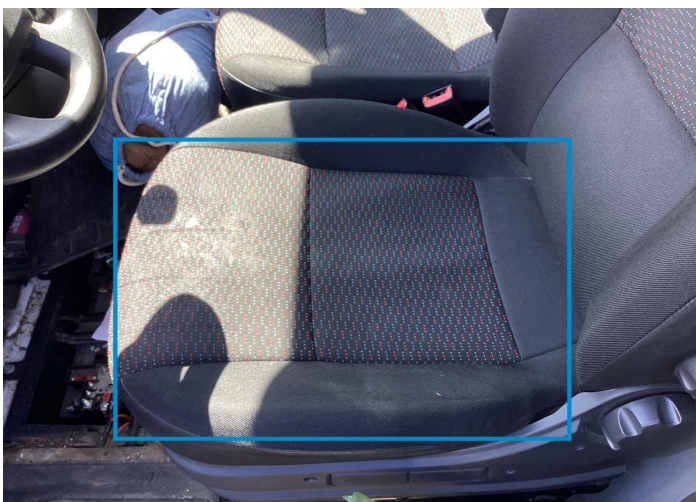
14. Seat Cushion / Front Left
Interior / Dirty -

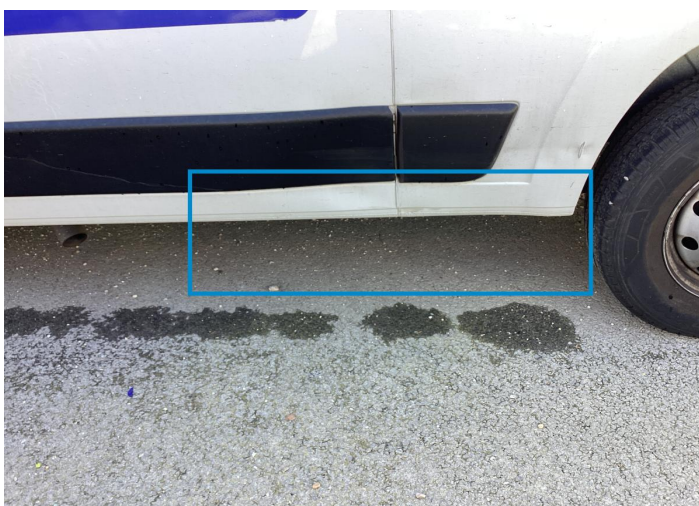
15. Rocker Panel / Center Left
Bodywork / Dent / Deformation -

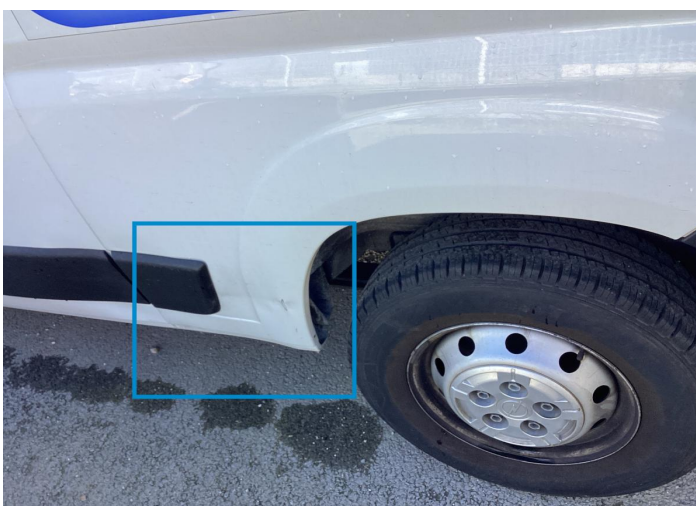
16. Fender / Back Left
Bodywork / Dent / Deformation -

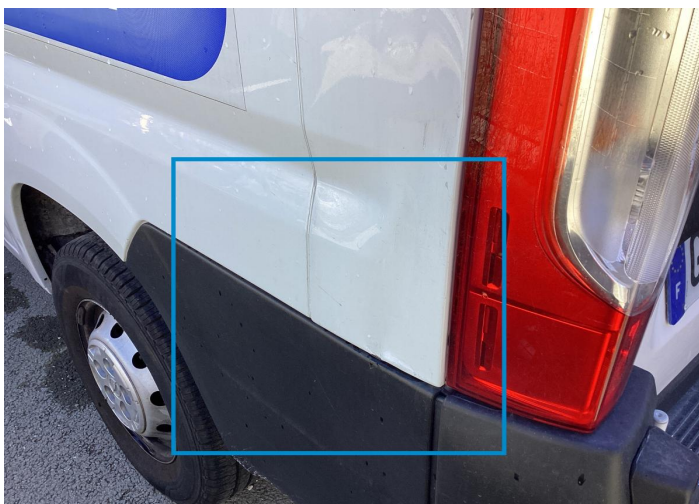
17. Fender / Back Left
Bodywork / Dent / Deformation -

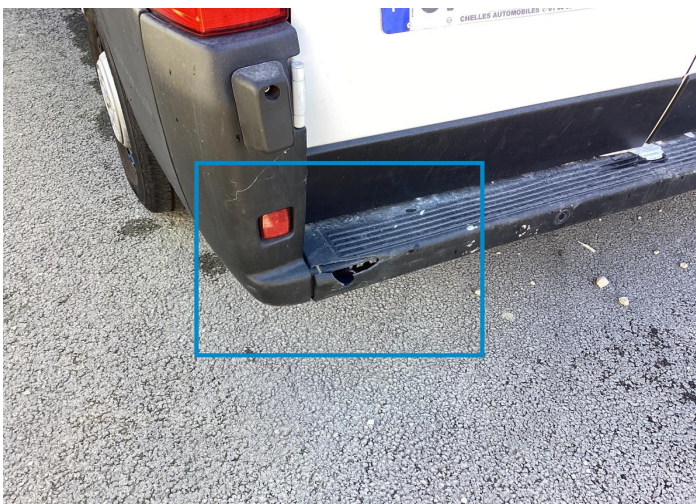
18. Shield / Back
Bodywork / Breakage -
