## status report

vehicle data			
<b>Opel Movano C Kasten HKa L3H2 3,5t Edition</b>			
Vehicle identification number	<b>VXEYCBPFC12V96105</b>	mileage read:	<b>43782 km</b>
..:			
First Registration / construction year:	<b>24.02.2023 / 2022</b>	Visit Date / place of birth:	<b>26.08.2025 Dorfmark</b>
Bodywork:	<b>pickup</b>	Re - import:	<b>no</b>
Body type:	<b>van</b>	KBA no. :	<b>3003//BAM</b>
Fuel / emission class:	<b>diesel / € 6</b>	transmission type:	<b>6 speed manual transmission</b>
Displacement / power:	<b>2179 ccm / 103 kW (140 PS)</b>	Engine:	<b>front-wheel drive</b>
paint:	<b>white</b>	Number of previous owners:	<b>1</b>
Doors / seats:	<b>2 / 3</b>	number keys:	<b>2</b>
Next HU / AU:	<b>- / -</b>	cushion type:	<b>substance</b>
Service book available:	<b>yes</b>	Interior Color:	<b>black</b>
smoking vehicle:	<b>no</b>	Last service km / on the:	<b>- / -</b>
Vehicle roadworthy:	<b>yes</b>	Vehicle roadworthy:	<b>yes</b>

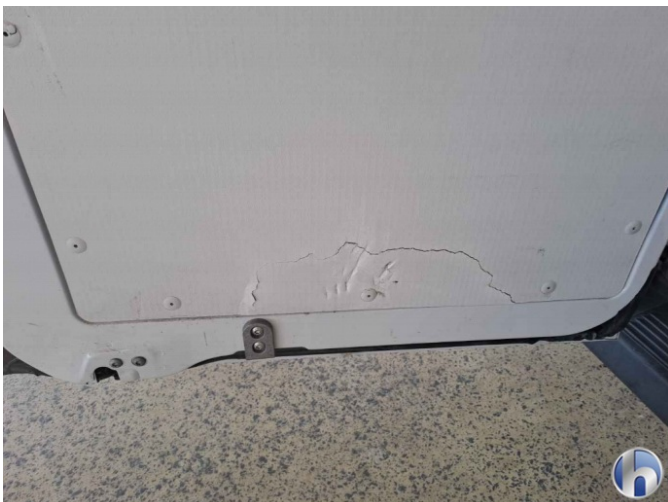
**Damaged**

<b>component</b>	<b>Damage</b>	<b>Rep kind</b>
1.	maintenance	Missing	Replace
2.	exterior body	Wear and tear	acceptable
3.	Verkleidung Tür Hinten Links	Damaged	Replace
4.		Wear and tear	acceptable
5.	Sidewall - Rear - right	Deformed (slightly)	Refurbish and paint

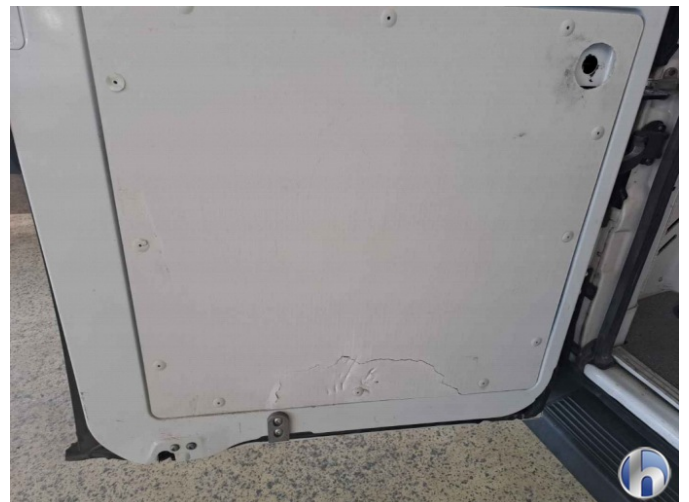
3. Verkleidung Tür Hinten Links

**Damaged**

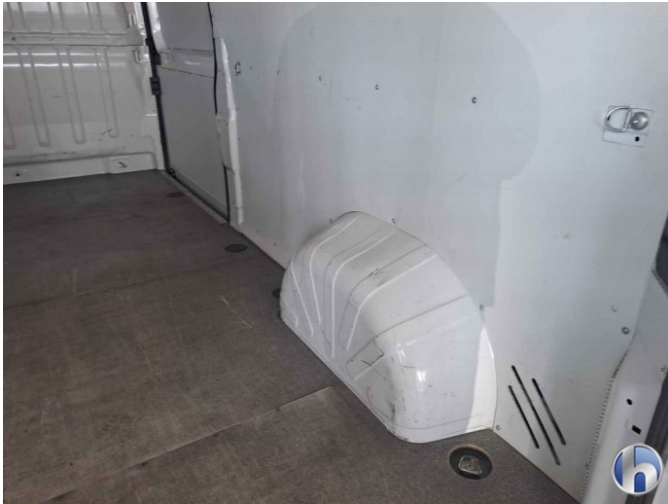
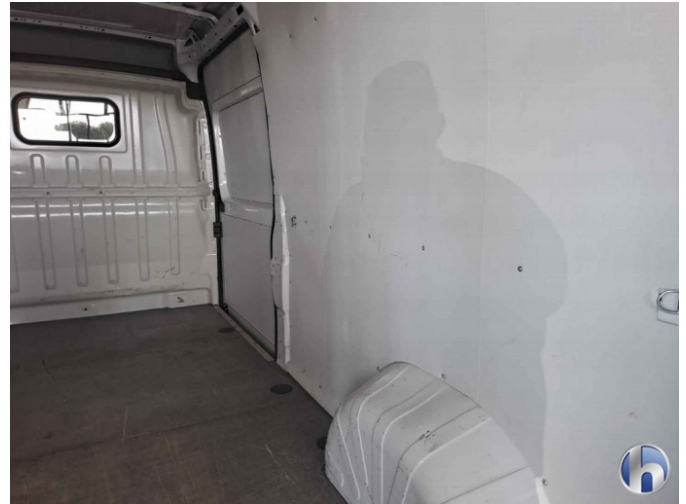
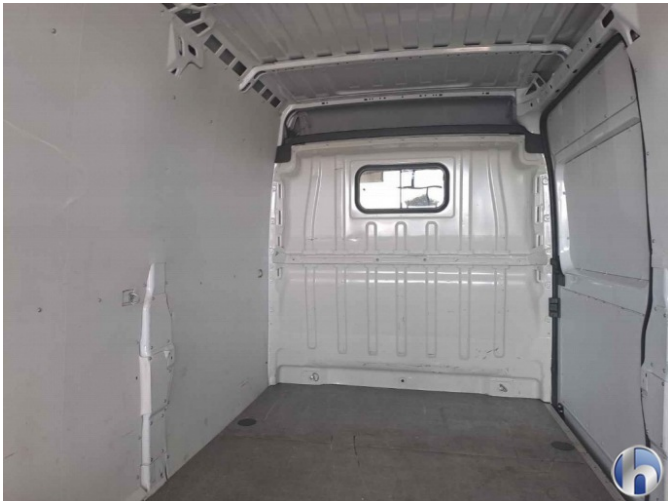
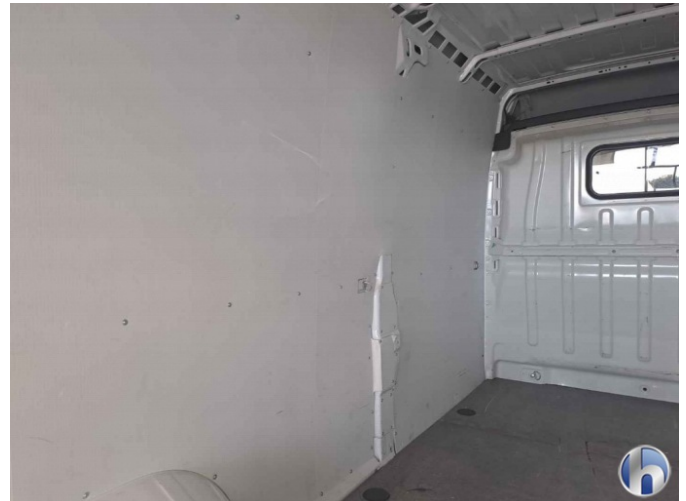
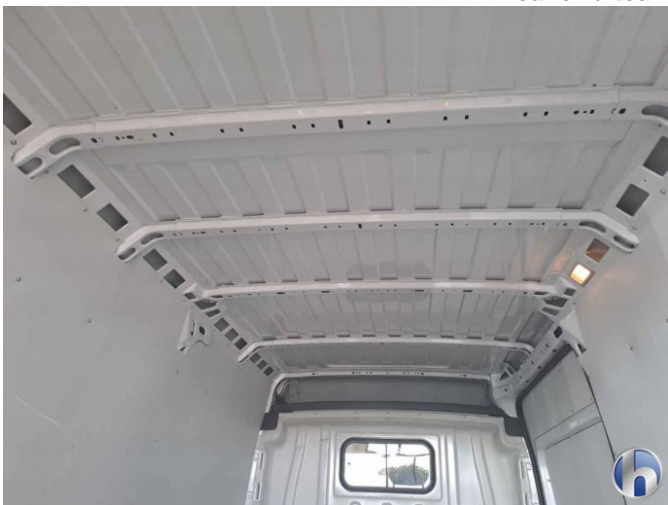
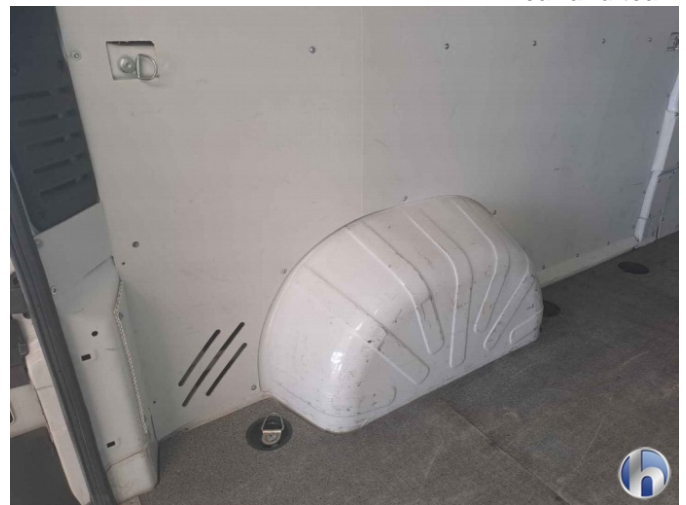
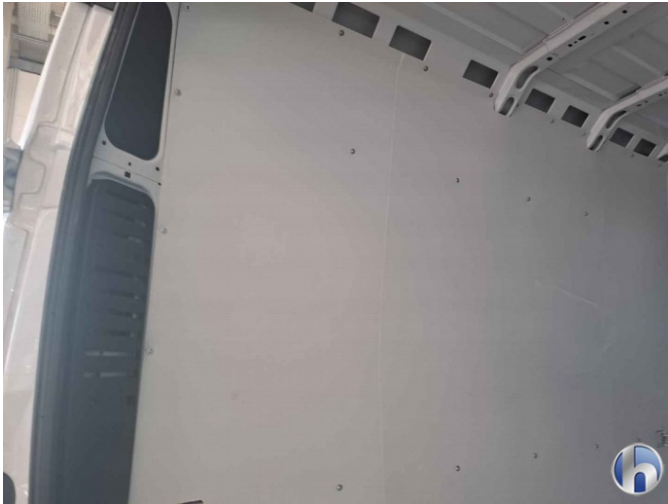
4. **Wear and tear**

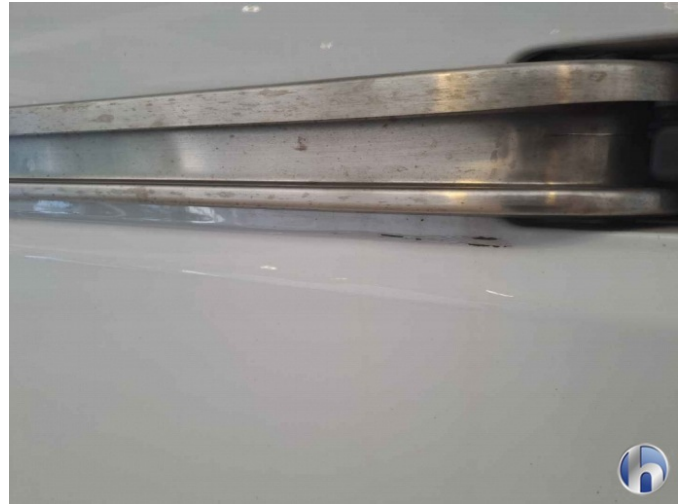
5. Sidewall - Rear - right **Deformed (slightly)**

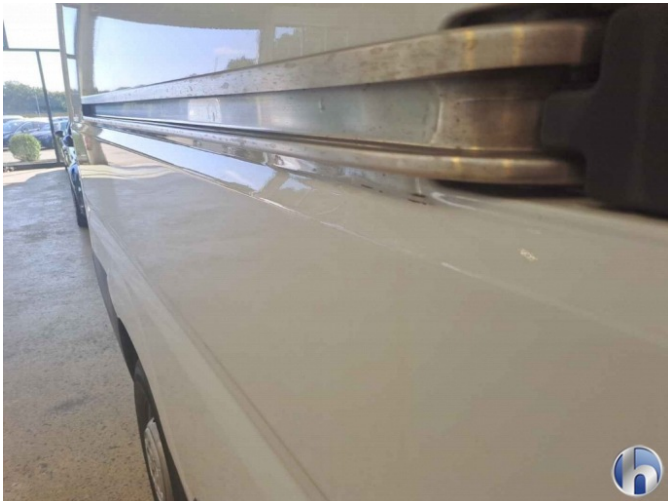
5. Sidewall - Rear - right **Deformed (slightly)**

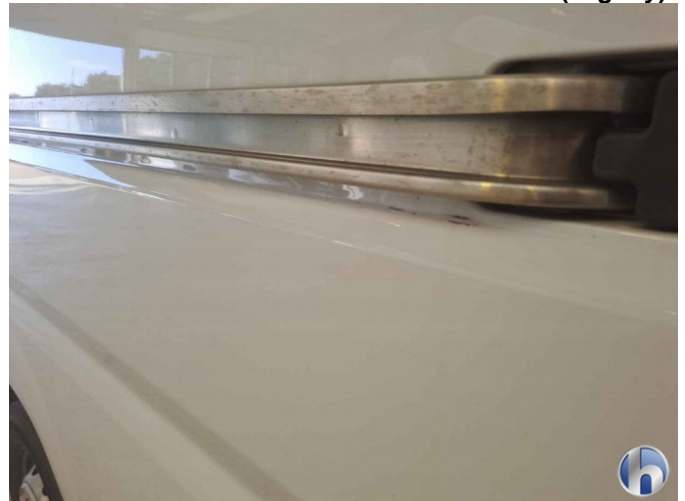
5. Sidewall - Rear - right **Deformed (slightly)**
