## status report

#### Opel Movano C Kasten GKa L4H3 3,5t Edition

| Vehicle identification number | <b>VXEYDCPFCNG008841</b> | mileage read: | <b>87587 km</b> |

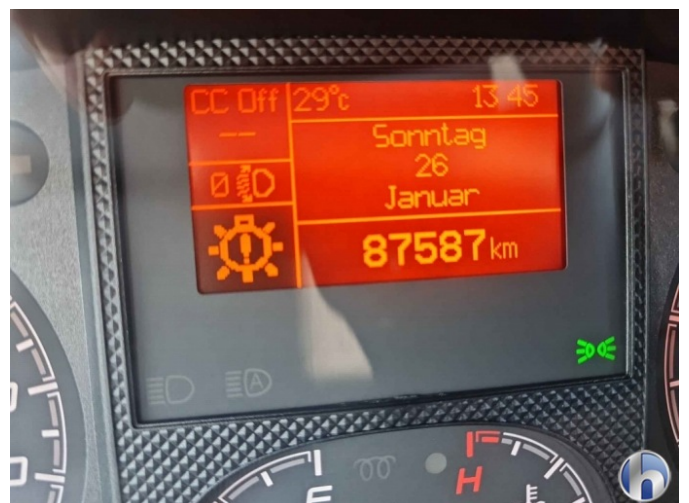
| Performed testing technology | |
|---|---|
| <b>lighting system:</b> | For sightseeing timing defects in the lighting system were noted .<br>*Fehlermeldung |

1. Beleuchtung

Error message

| | component | Damage | Rep kind |
|---|---|---|---|
| 1. | Beleuchtung | Error message | Carry out a fault diagnosis |

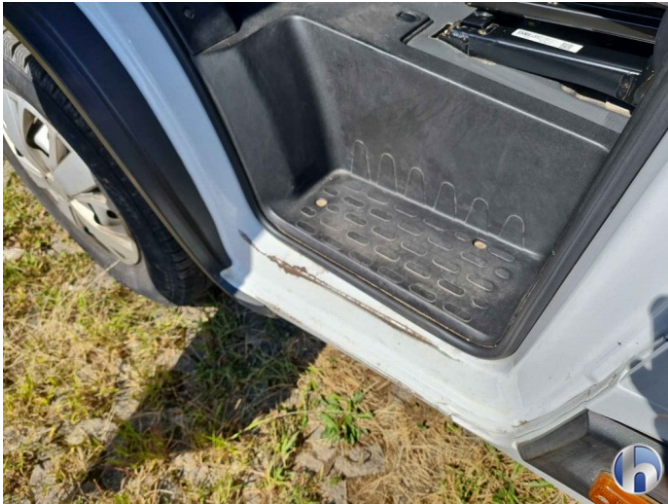
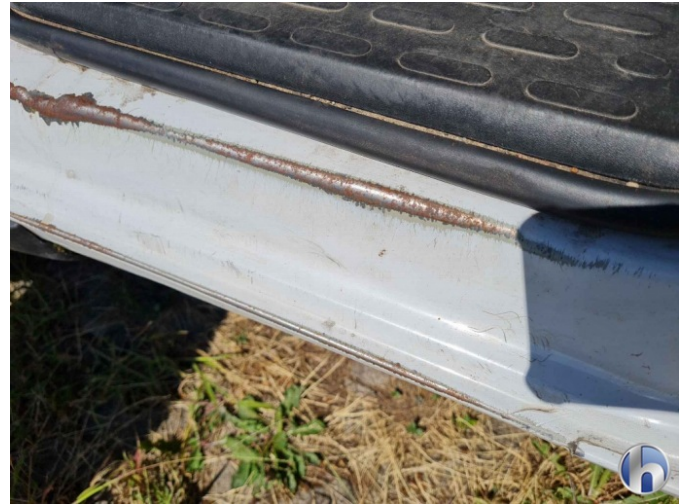
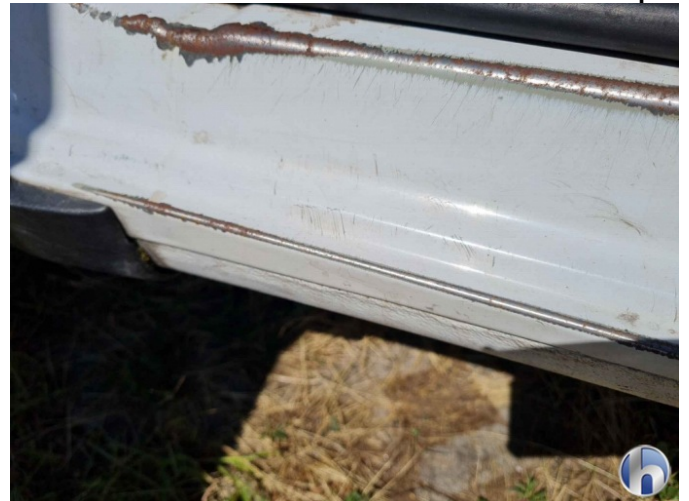
3. Türeinstieg Vorne - Links

**Scrape**

| | component | Damage | Rep kind |
|---|---|---|---|
| 3. | Türeinstieg Vorne - Links | Scrape | Paint |

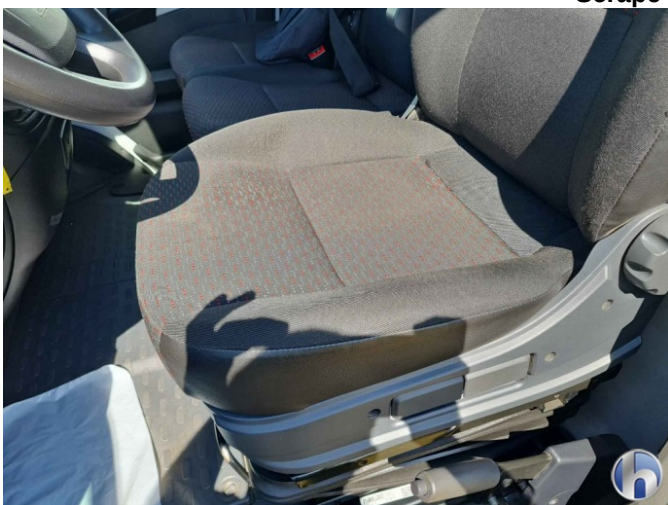
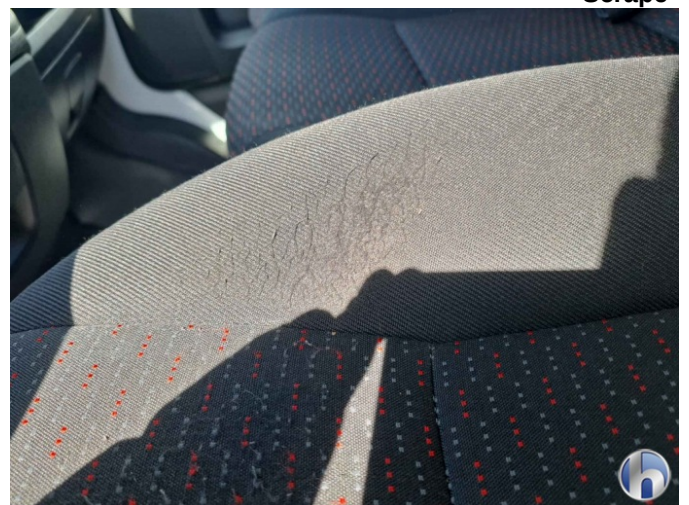
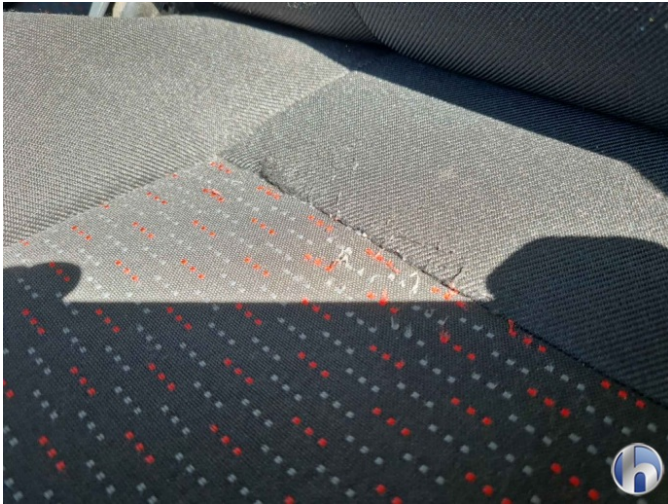
4.

**Material wear**

4. **Material wear**

| | component | Damage | Rep kind |
|---|---|---|---|
| 4. | | Material wear | Replace |

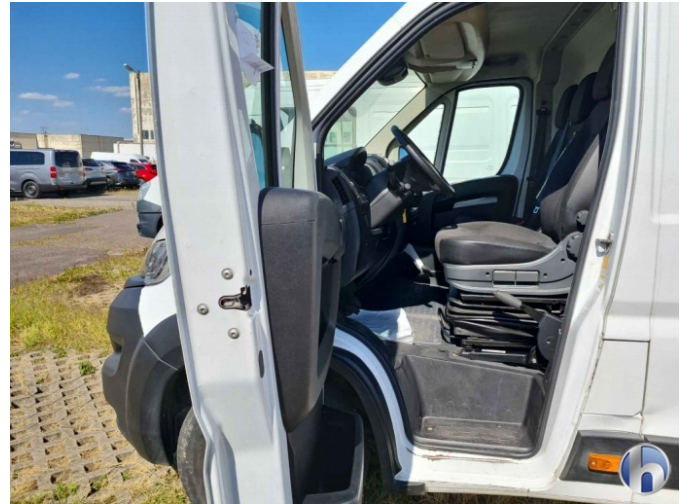
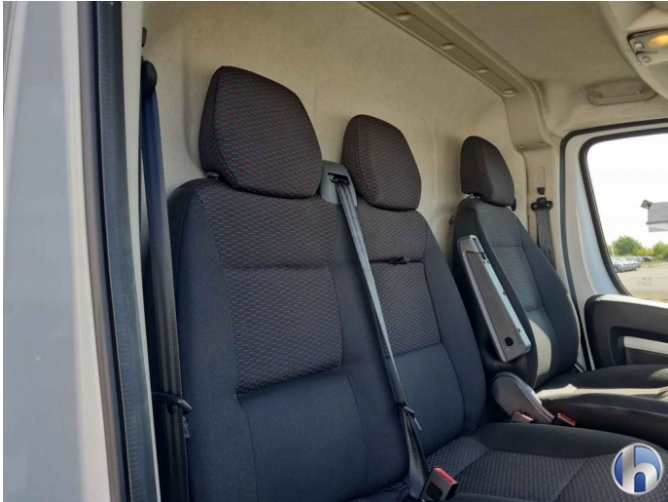
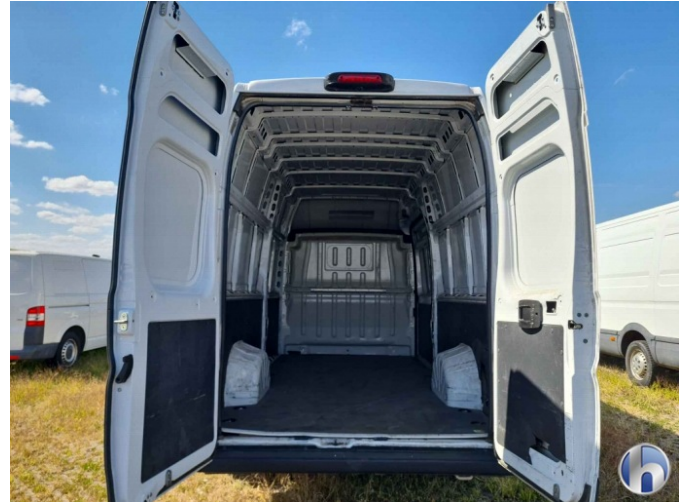
5. Laderaum und Innenraum **Wear and tear**

| | component | Damage | Rep kind |
|---|---|---|---|
| 5. | Laderaum und Innenraum | Wear and tear | acceptable |

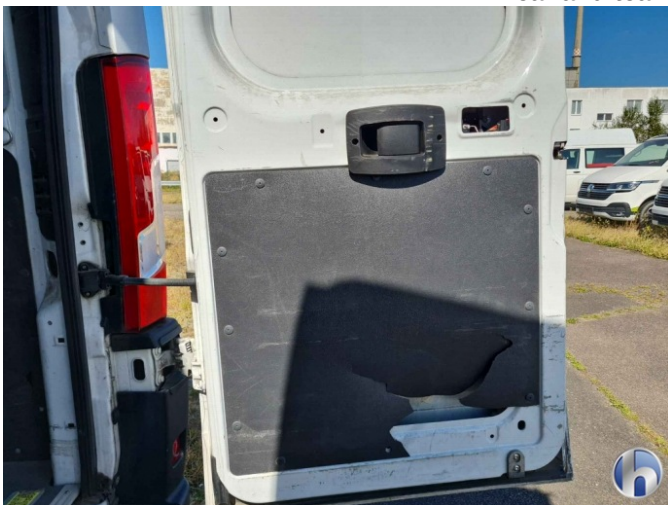
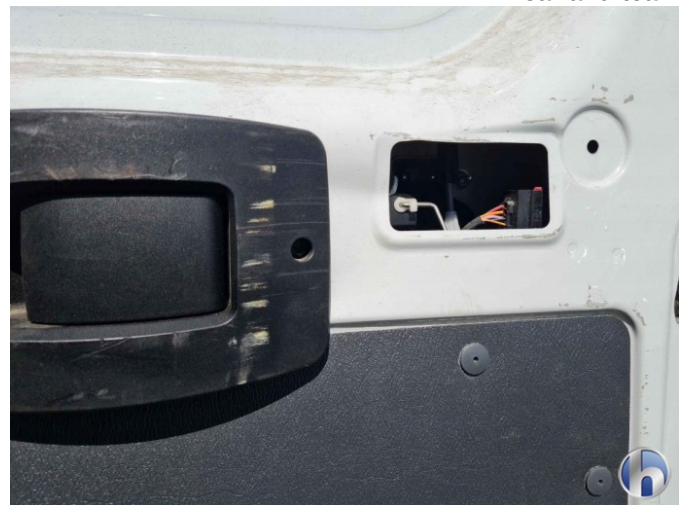
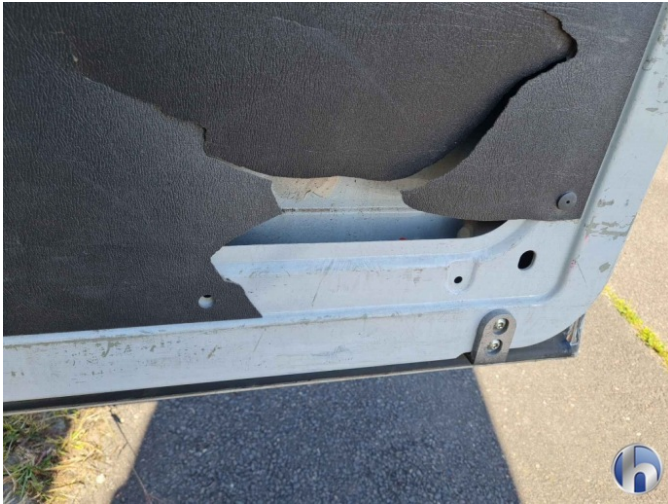
6. Hecktürverkleidung rechts **Damaged**

6. Hecktürverkleidung rechts

**Damaged**

| | component | Damage | Rep kind |
|---|---|---|---|
| 6. | Hecktürverkleidung rechts | Damaged | Replace |

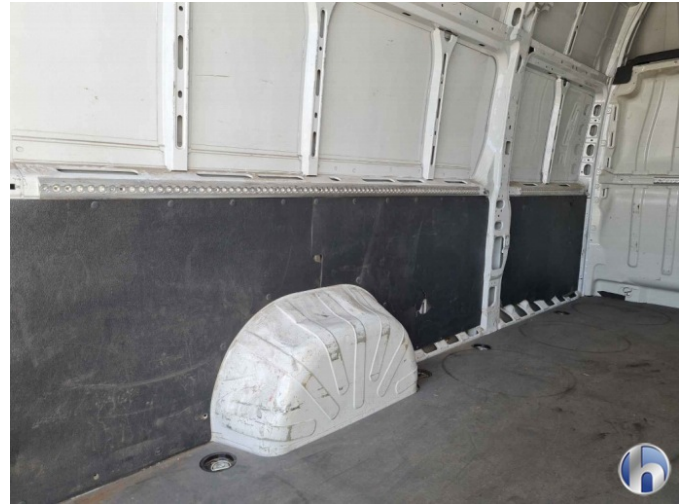
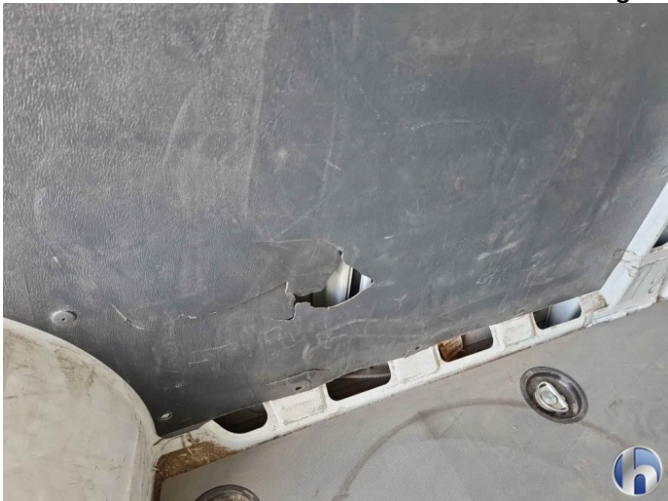
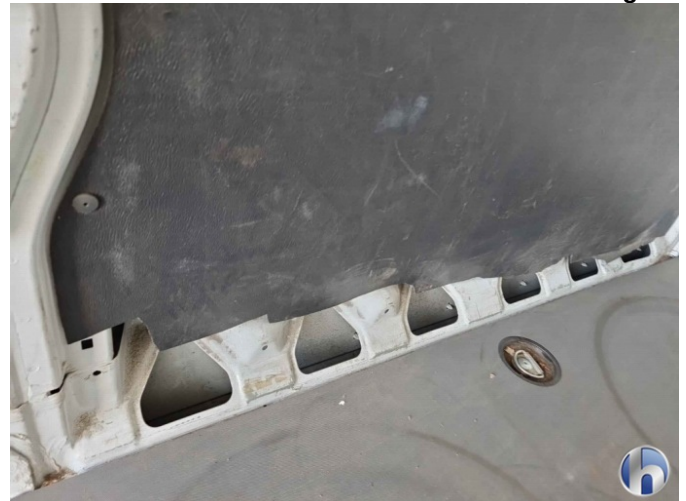
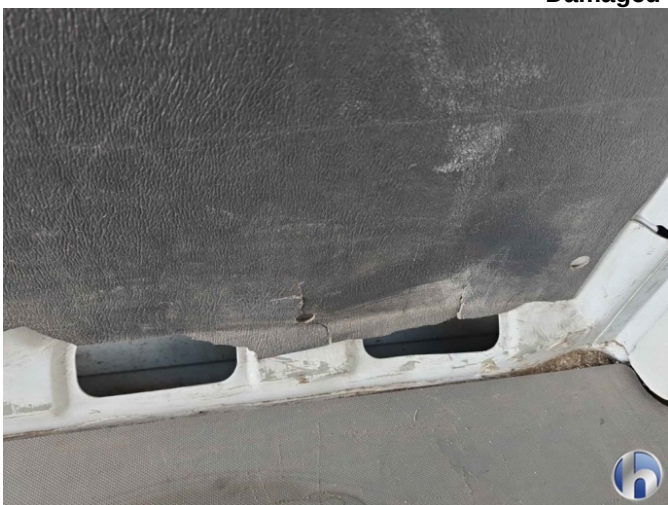
7. Seitenwandverkleidungen links

**Damaged**

| | component | Damage | Rep kind |
|---|---|---|---|
| 7. | Seitenwandverkleidungen links | Damaged | Replace |

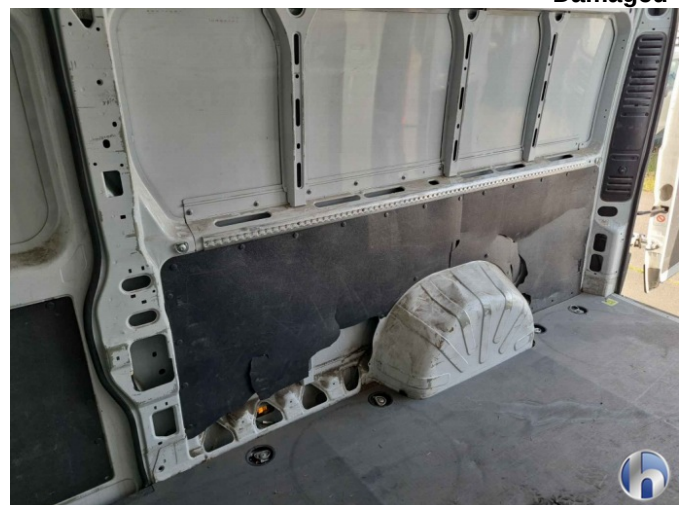
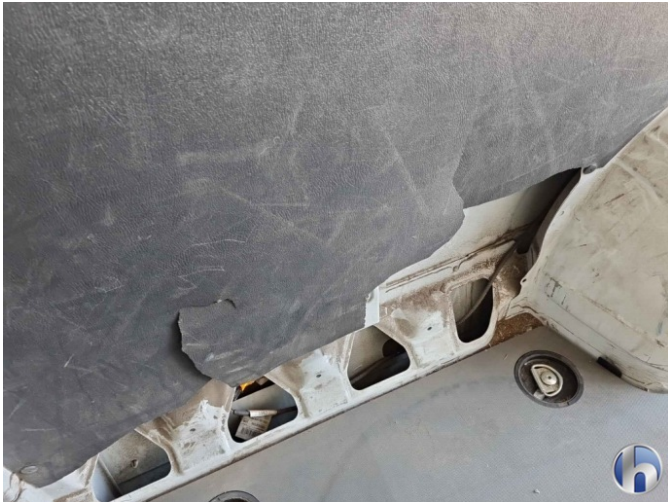
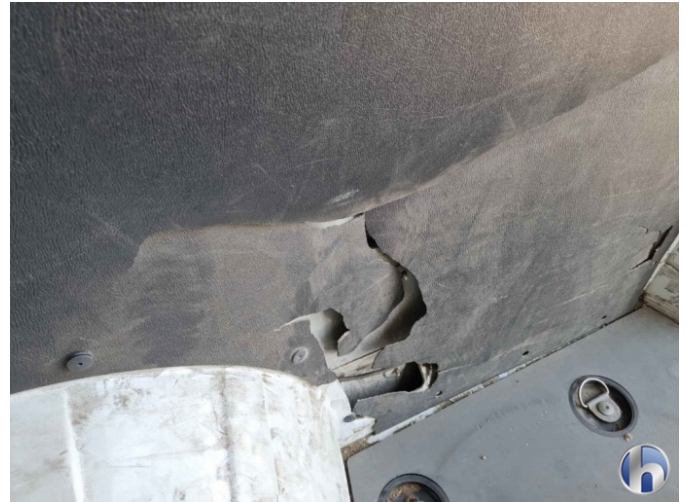
8. Seitenwandverkleidungen rechts

**Damaged**

| | component | Damage | Rep kind |
|---|---|---|---|
| 8. | Seitenwandverkleidungen rechts | Damaged | Replace |

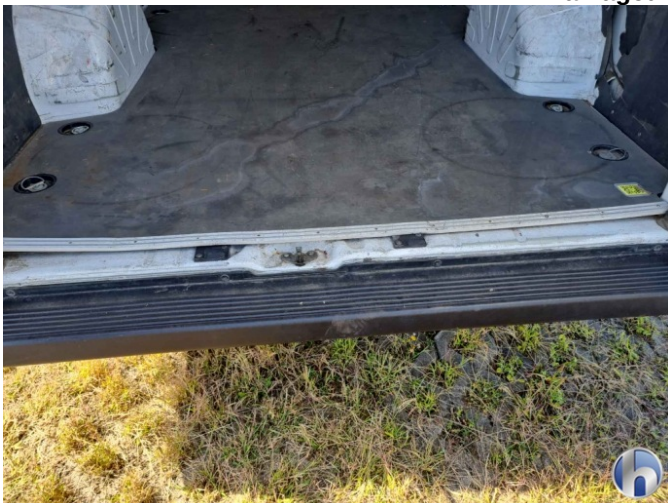
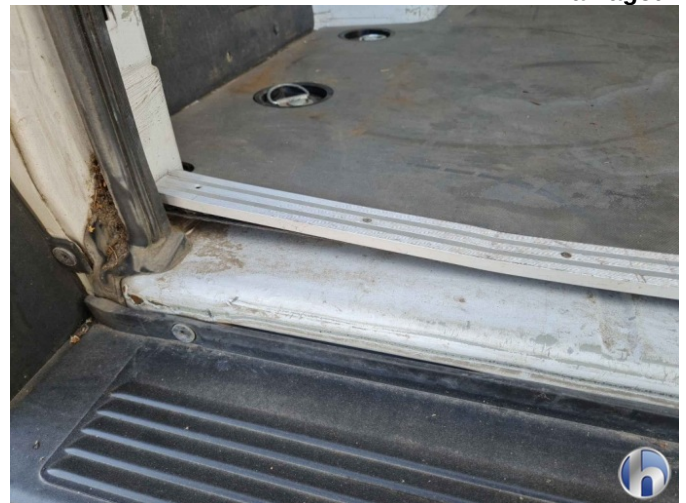
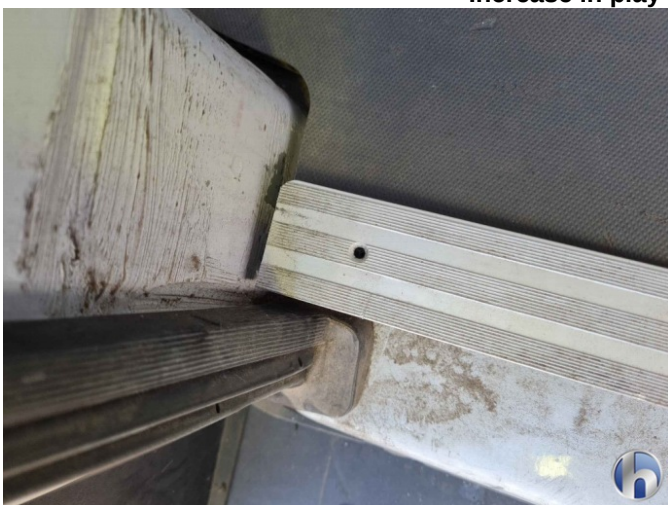
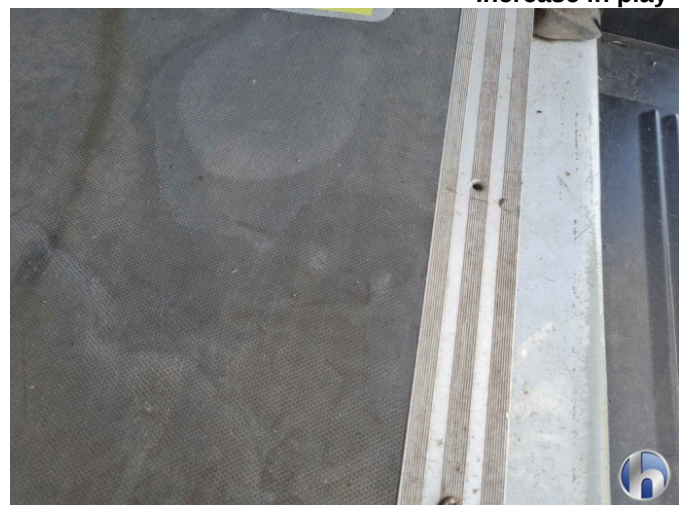
9. Laderaumboden Abschlussleiste

**Increase in play**

| | component | Damage | Rep kind |
|---|---|---|---|
| 9. | Laderaumboden Abschlussleiste | Increase in play | Uninstall/install |

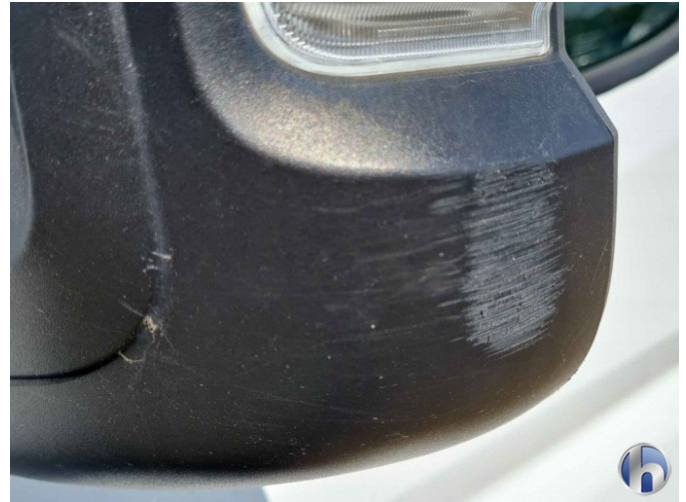
11. Outside mirror - left

**Scrape**

| | component | Damage | Rep kind |
|---|---|---|---|
| 11. | Outside mirror - left | Scrape | Replace |

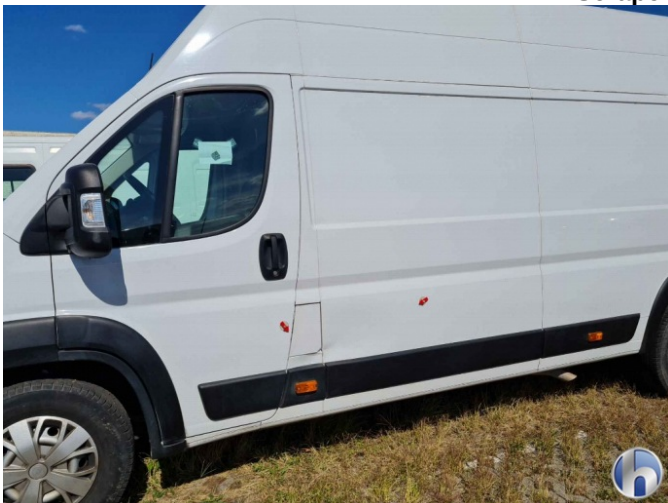
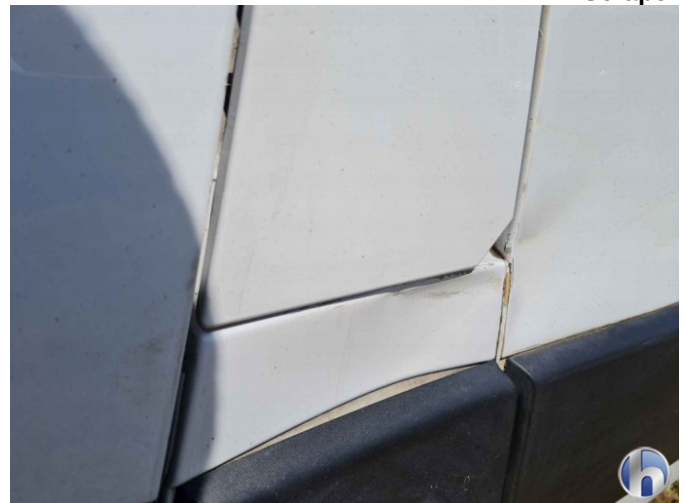
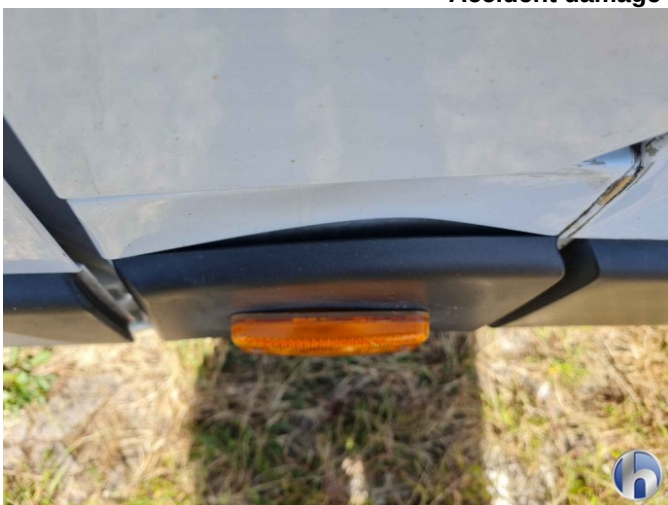
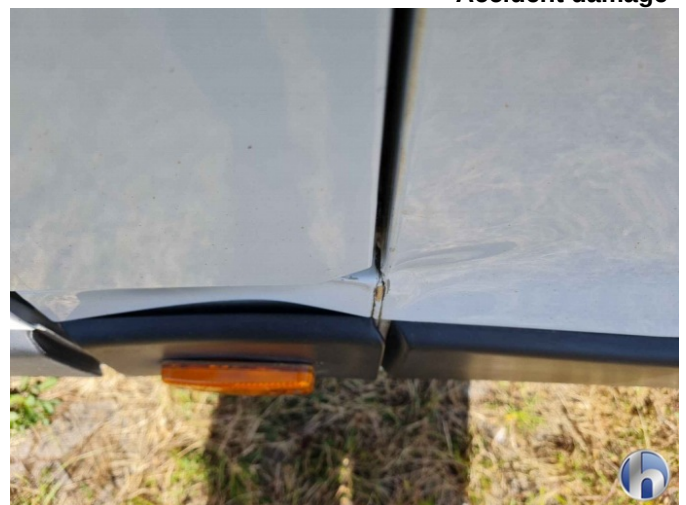
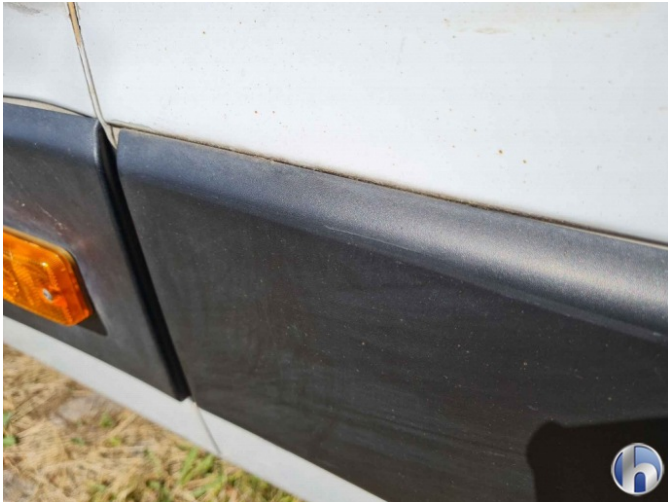
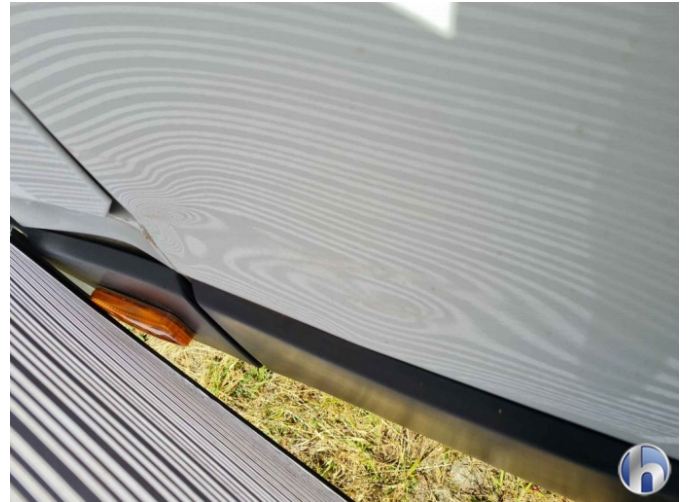
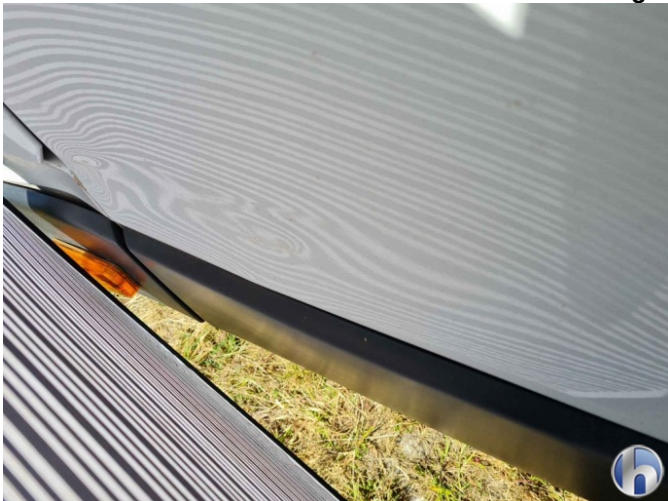
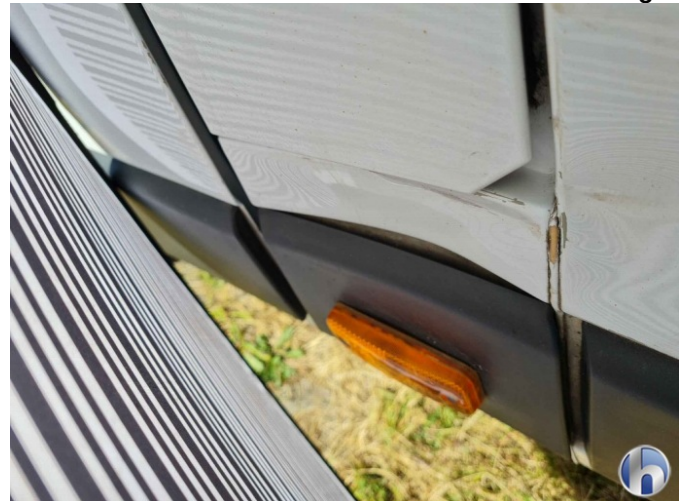
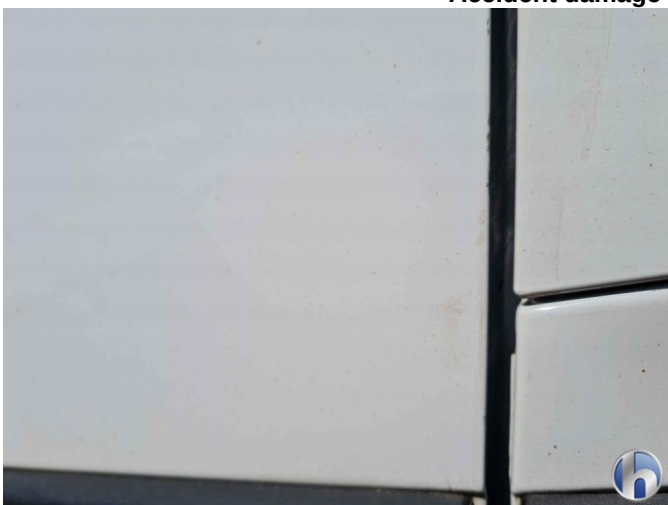
At the unrepaired vehicle accident damage were observed on visual examination on the body skin .

Fahrzeug mit bestehenden Unfallschaden, zur Schadensermittlung wurden keine Demontearbeiten durchgeführt, verborgen gebliebene Schäden können nicht ausgeschlossen werden. Unfallschaden Kosten wurden überschlägig Kalkuliert, Kostenerweiterung möglich.

12. Fahrzeug links

**Accident damage**

| | component | Damage | Rep kind |
|---|---|---|---|
| 12. | Fahrzeug links | Accident damage | Refurbish and paint |

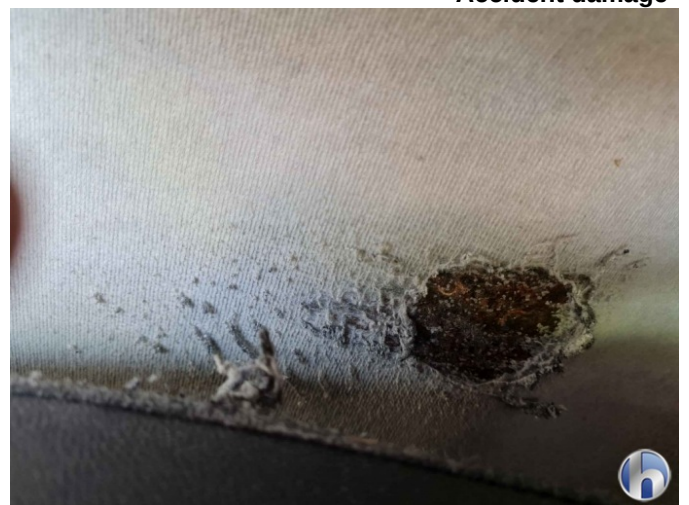
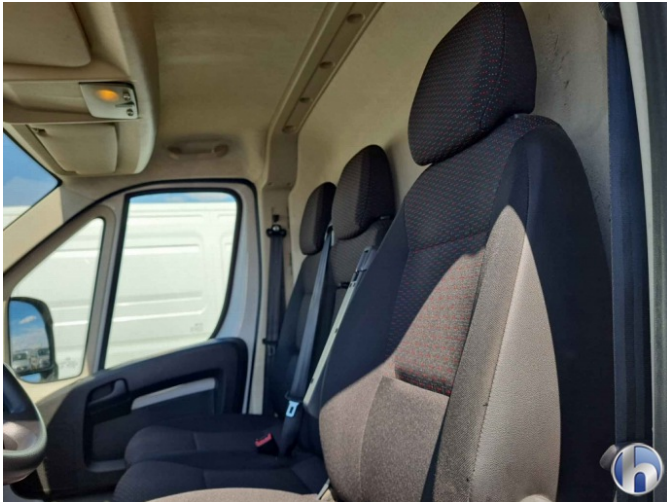
13. Verkleidung Trennwand

**Damaged**

| | component | Damage | Rep kind |
|---|---|---|---|
| 13. | Verkleidung Trennwand | Damaged | Replace |

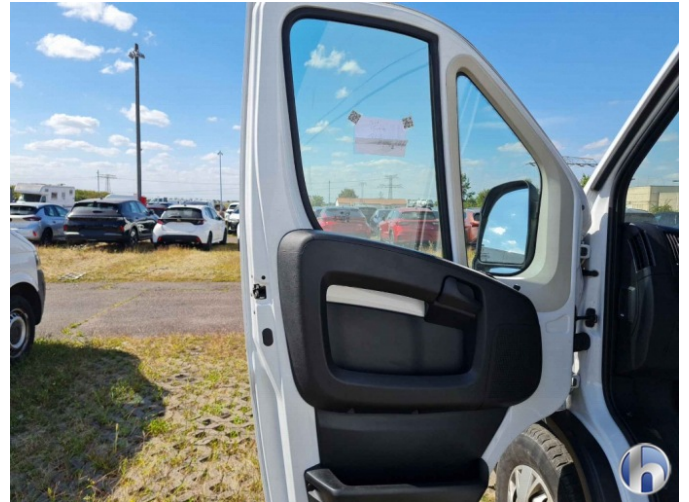
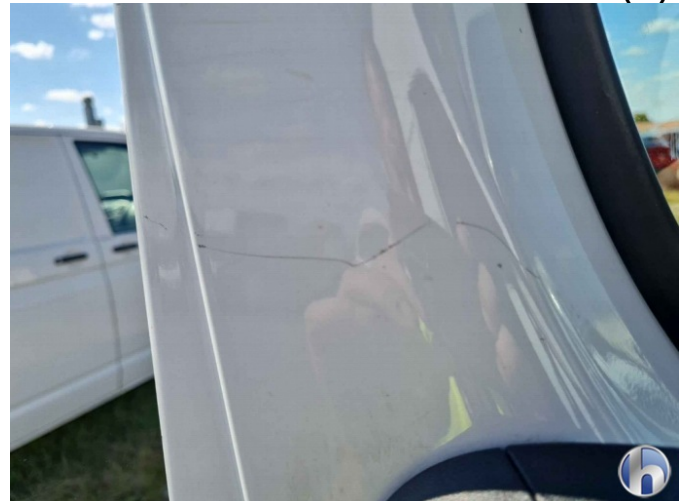
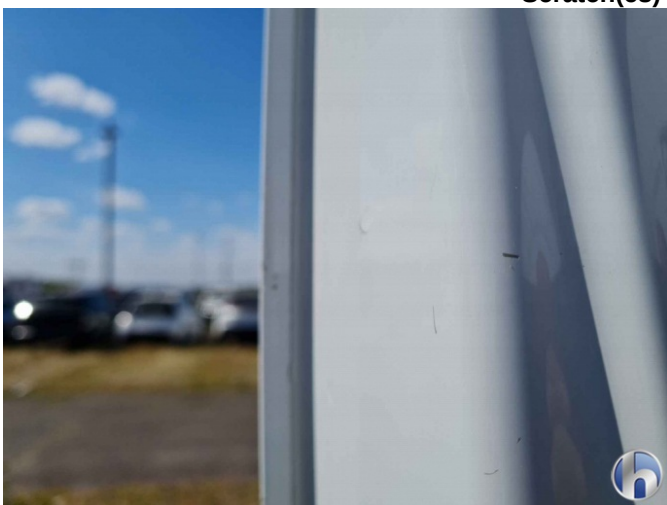
14. Tür Vorne - Links - Innen

**Scratch(es)**

| | component | Damage | Rep kind |
|---|---|---|---|
| 14. | Tür Vorne - Links - Innen | Scratch(es) | Smart repair |

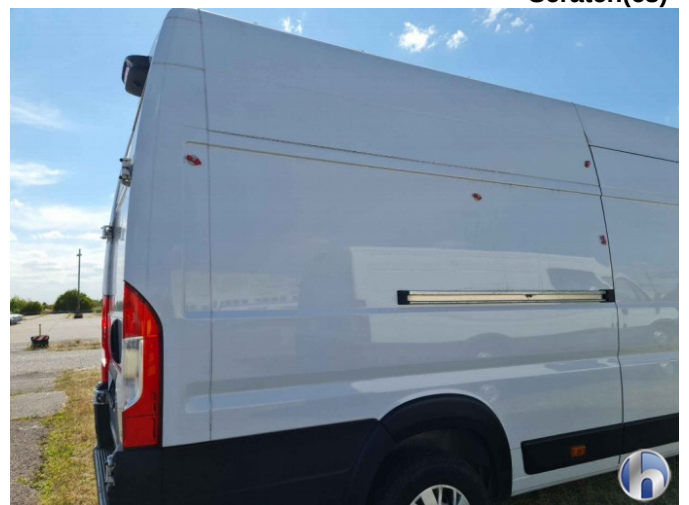
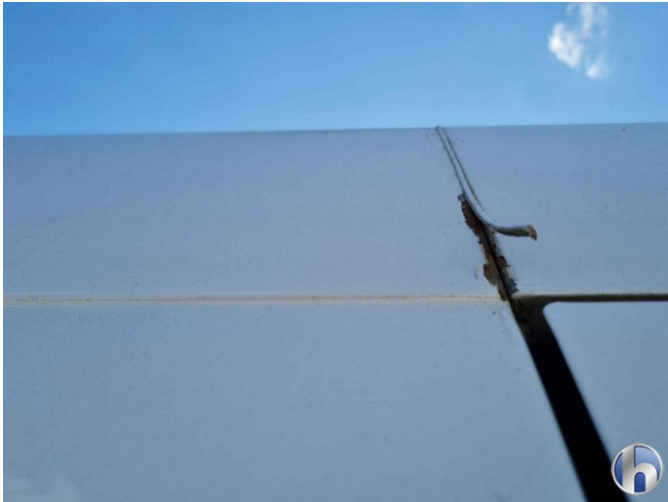
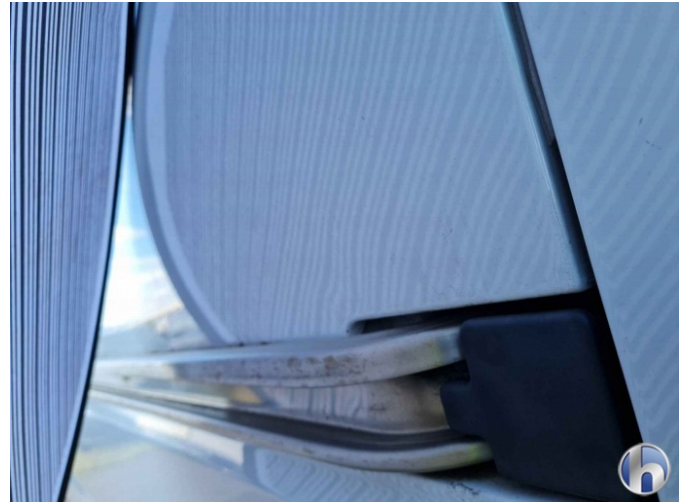
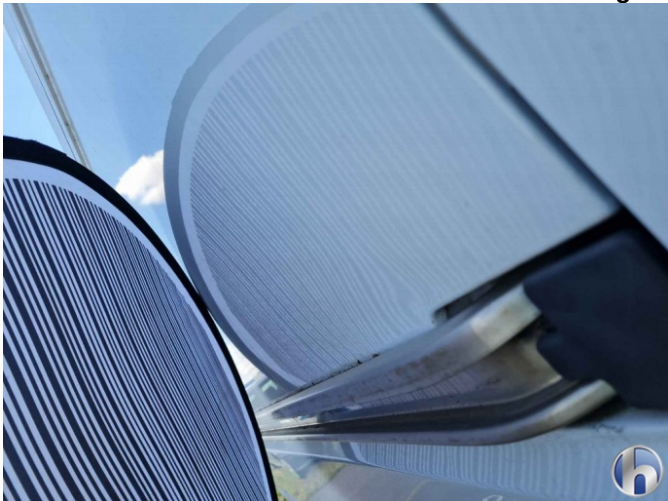
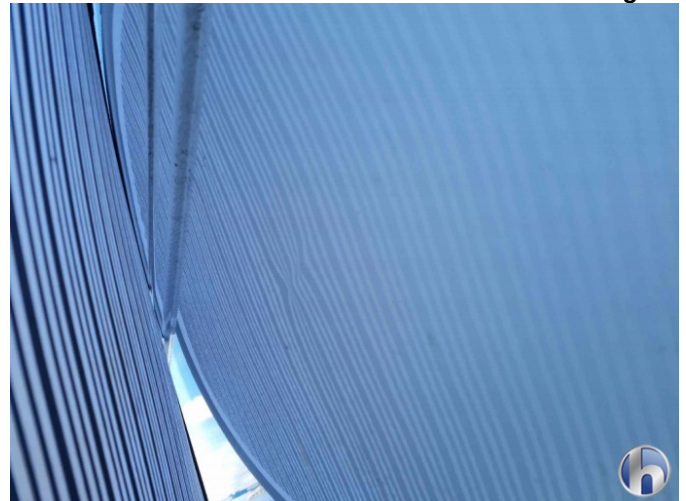
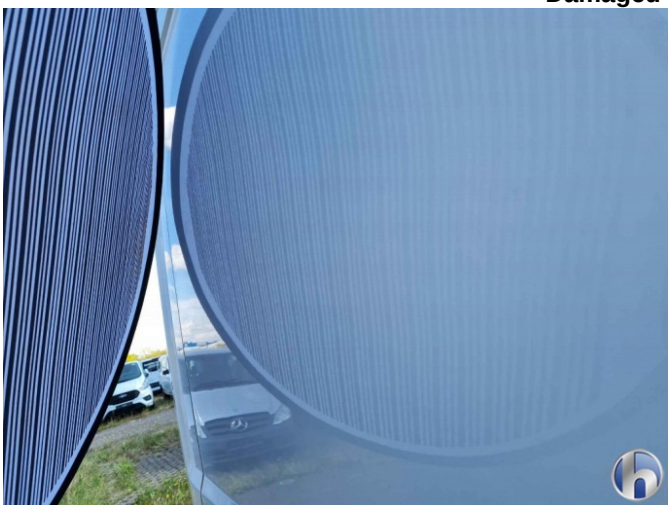
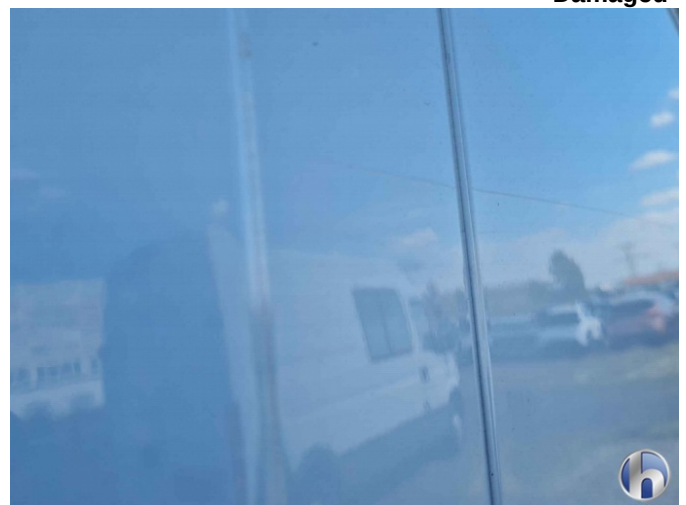
15. Sidewall - Rear - right

**Damaged**

| | component | Damage | Rep kind |
|---|---|---|---|
| 15. | Sidewall - Rear - right | Damaged | Refurbish and paint |

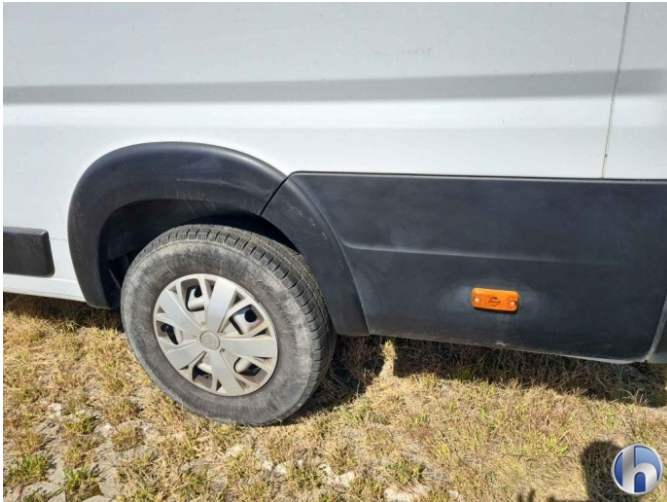
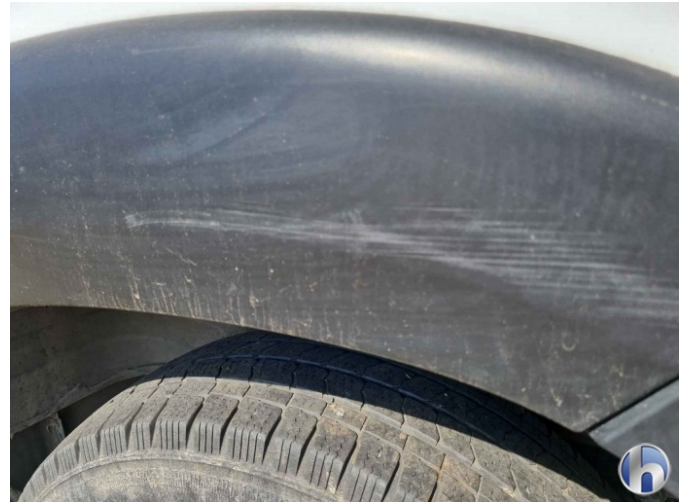
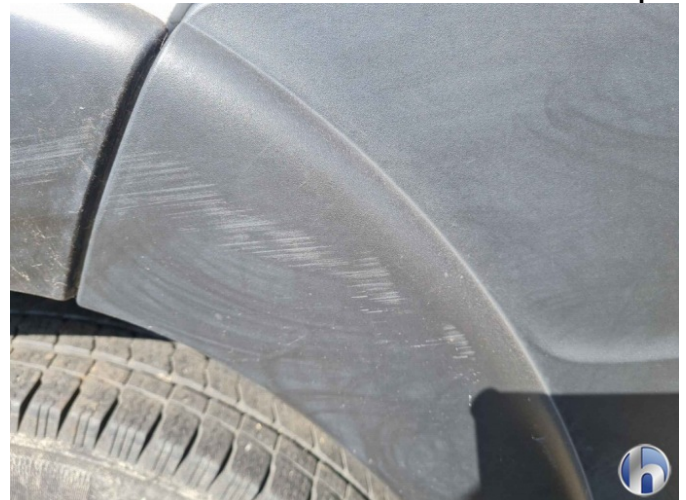
16. Radlaufleiste hinten Seitenwandverkleidung links außen

Scrape

| | component | Damage | Rep kind |
|---|---|---|---|
| 16. | Radlaufleiste hinten<br>Seitenwandverkleidung links außen | Scrape | Replace |

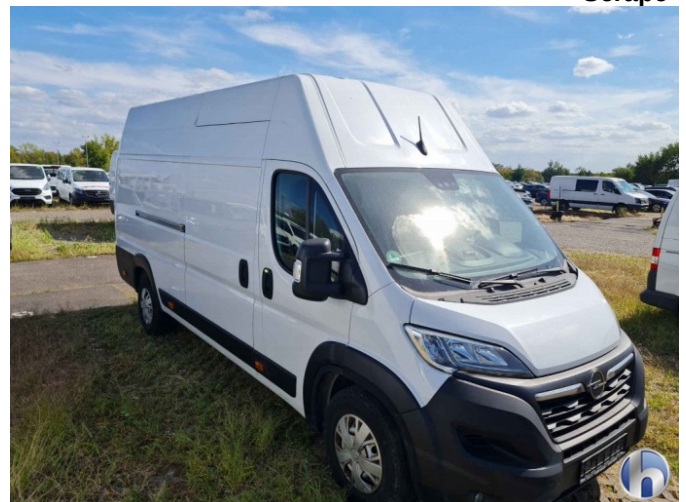
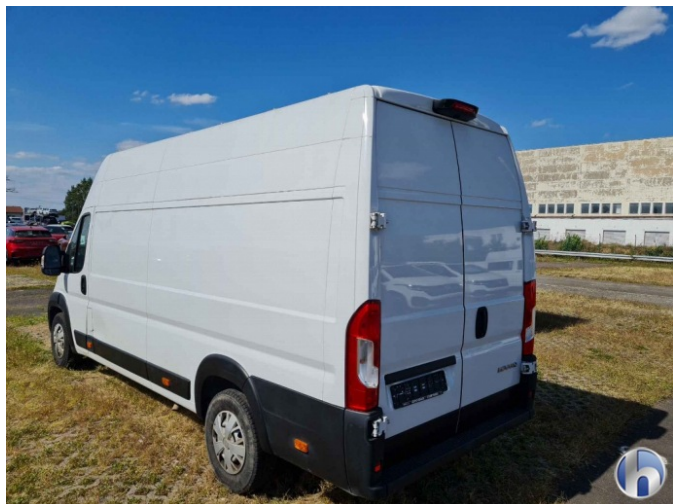
18. Fahrzeug (Kratzer, Harz-/Säureeinwirkung, Flugrost, Verschmutzungen)

18. Fahrzeug (Kratzer, Harz-/Säureeinwirkung, Flugrost, Verschmutzungen)  
**Scratch(es)**

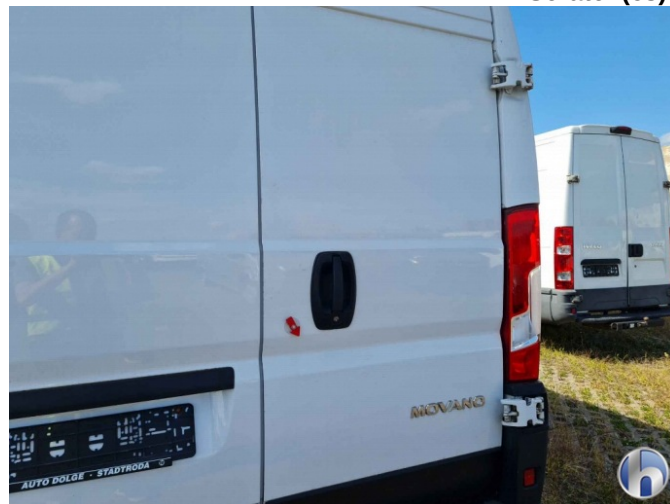
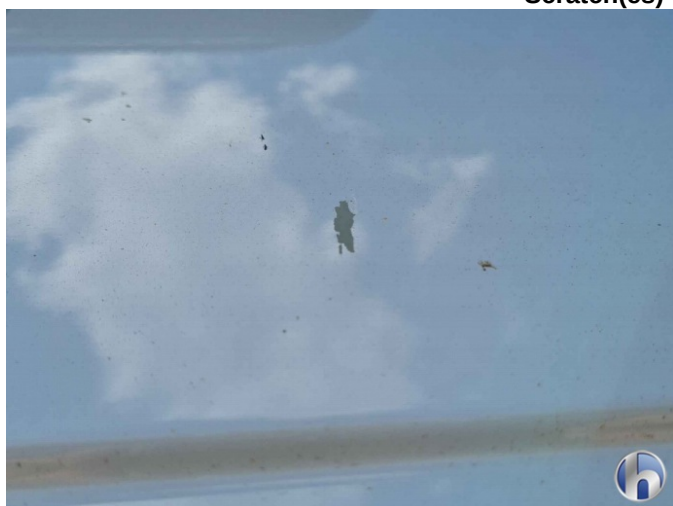
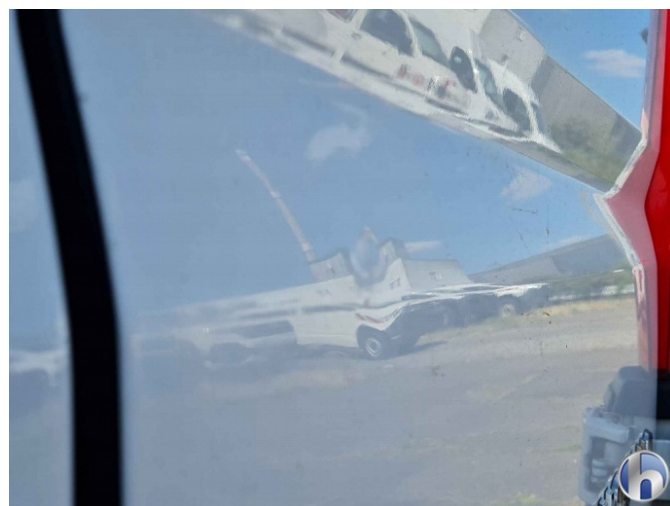
19. Hecktür Rechts  
**Damaged**

| | component | Damage | Rep kind |
|---|---|---|---|
| 19. | Hecktür Rechts | Damaged | Smart repair |

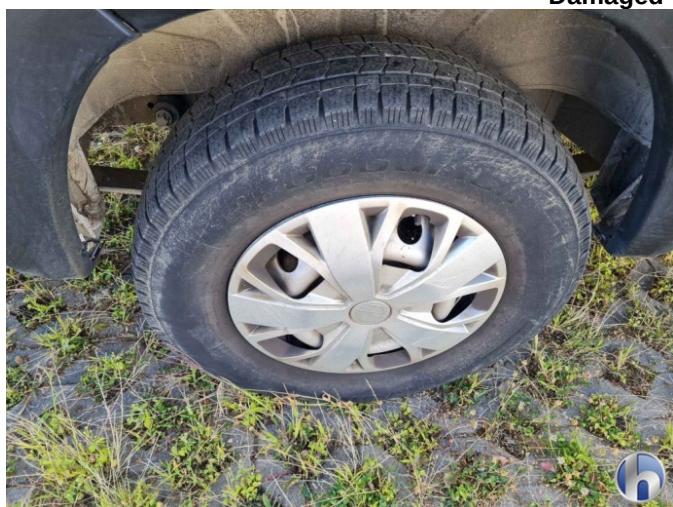
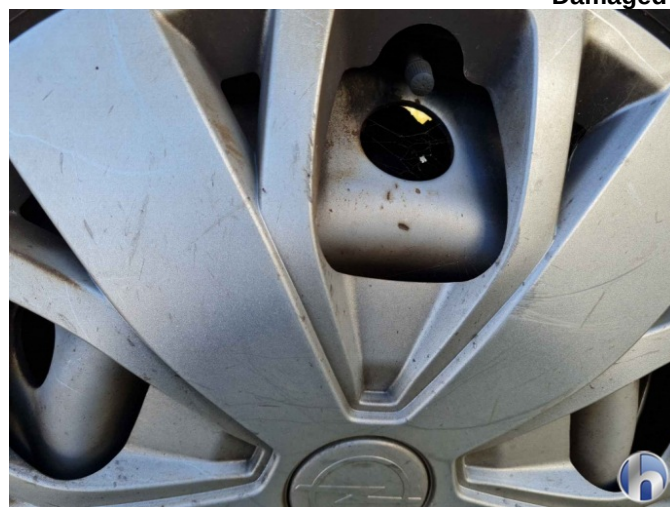
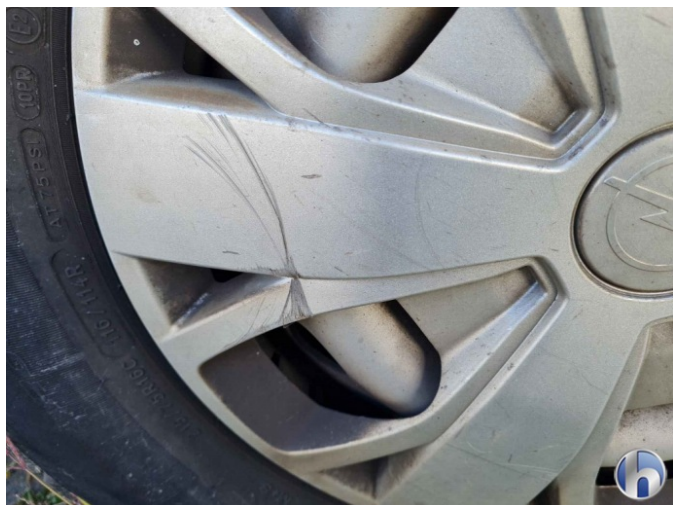
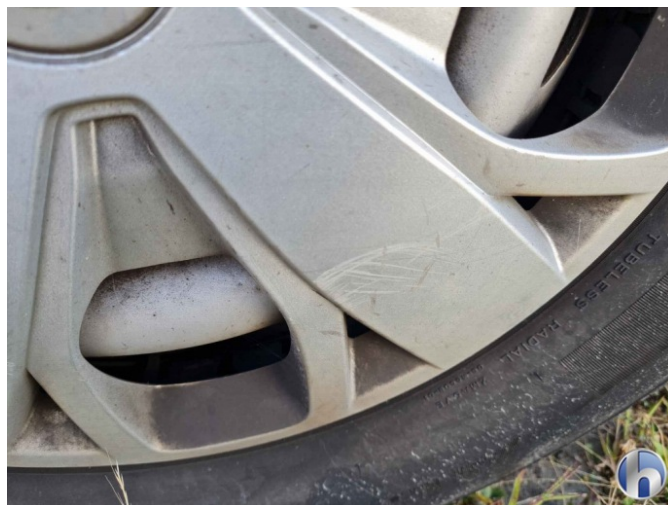
20. Radzierblende hinten rechts  
**Damaged**

20. Radzierblende hinten rechts

**Damaged**

| | component | Damage | Rep kind |
|---|---|---|---|
| 20. | Radzierblende hinten rechts | Damaged | Replace |
