Expertise

Protocol number: 41809762  
Order number / reference: 25256119  
Inspection date: 2 Oct 2025

Manufacturer: Opel

Model: Astra 1.5 D Business Edition

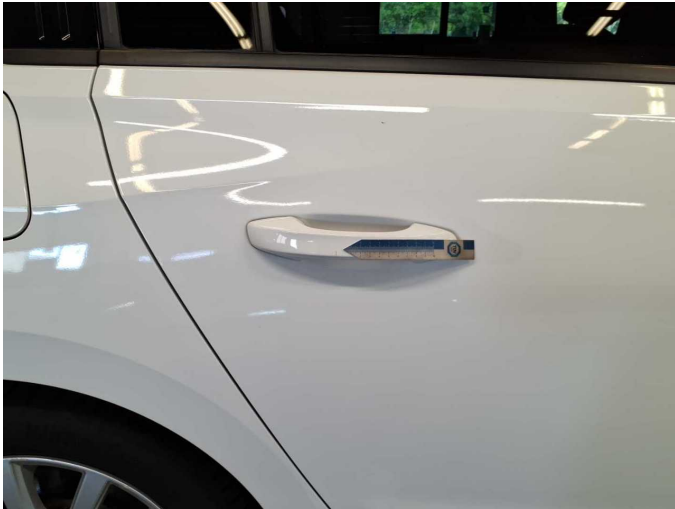
**Damage 1:** Door - rear right side: Door handle - outside - Scratch(es) - Smart repair

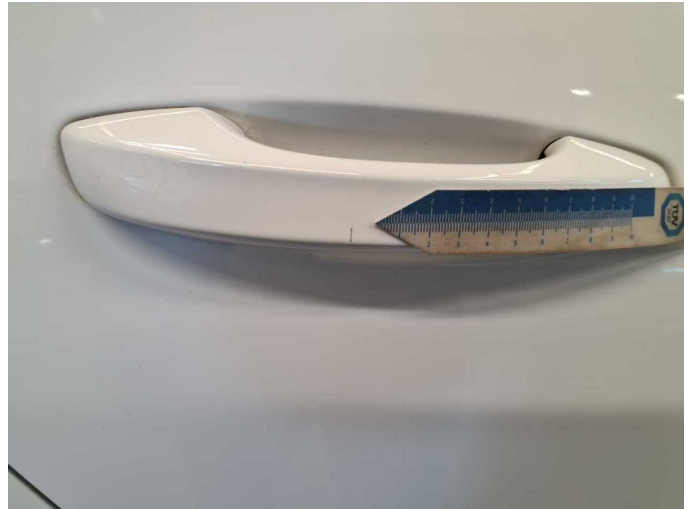
**Damage 1:** Door - rear right side: Door handle - outside - Scratch(es) - Smart repair

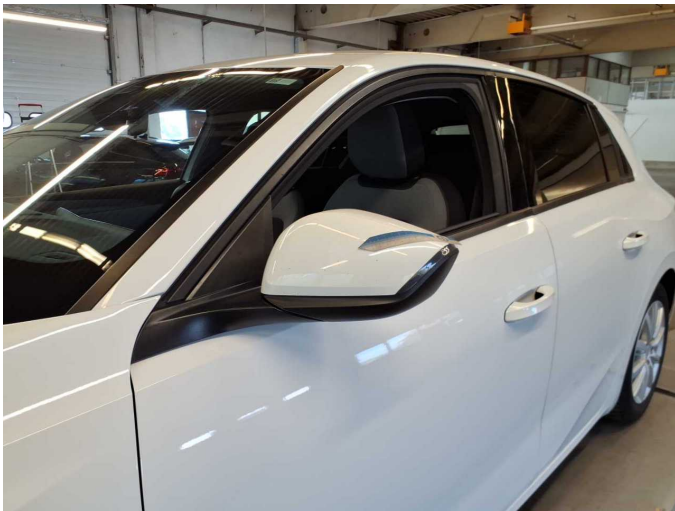
**Damage 2:** Wing mirror - left side: Cap (Klarlackmangel) - Paint defect - Smart repair

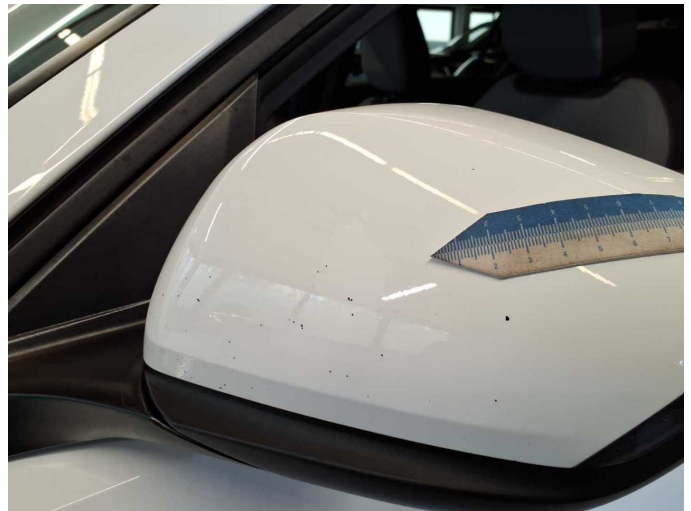
**Damage 2:** Wing mirror - left side: Cap (Klarlackmangel) - Paint defect - Smart repair

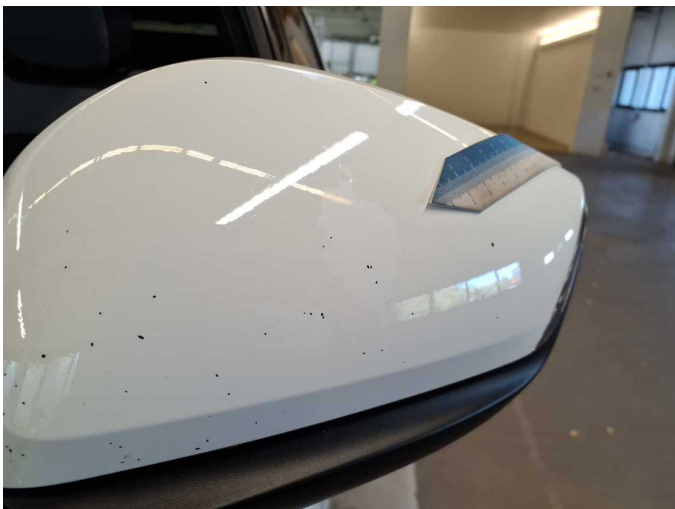
**Damage 2:** Wing mirror - left side: Cap (Klarlackmangel) - Paint defect - Smart repair

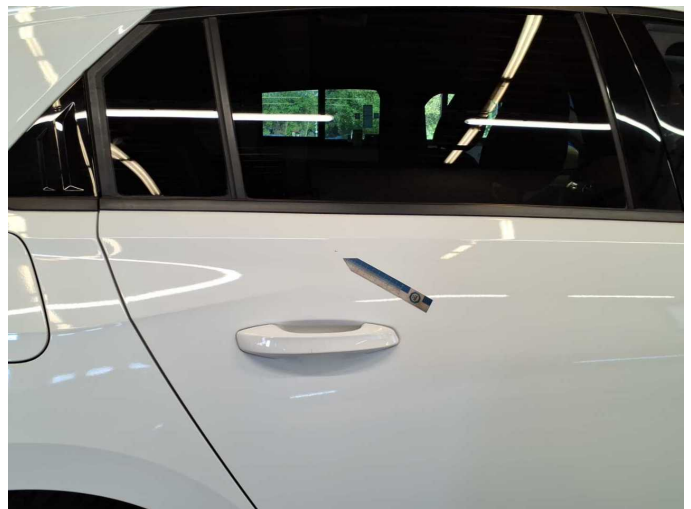
**Damage 3:** Door - rear right side: Door - Stone chips - Smart repair

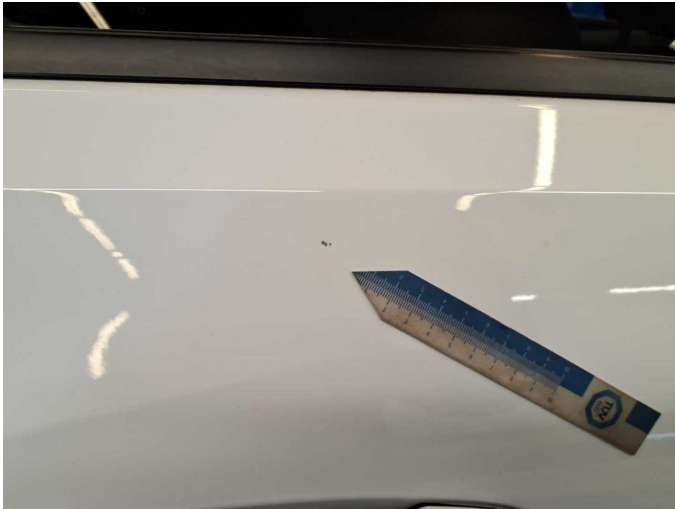
**Damage 3:** Door - rear right side: Door - Stone chips - Smart repair

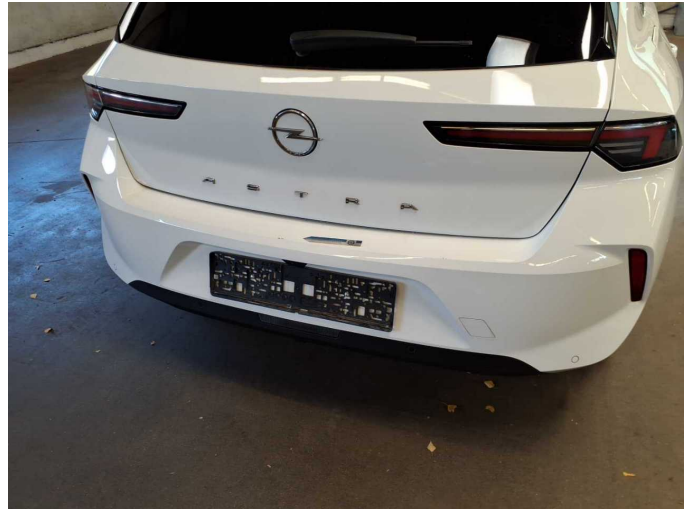
**Damage 4:** Rear bumper: Rear bumper - Scratch(es) - Smart repair

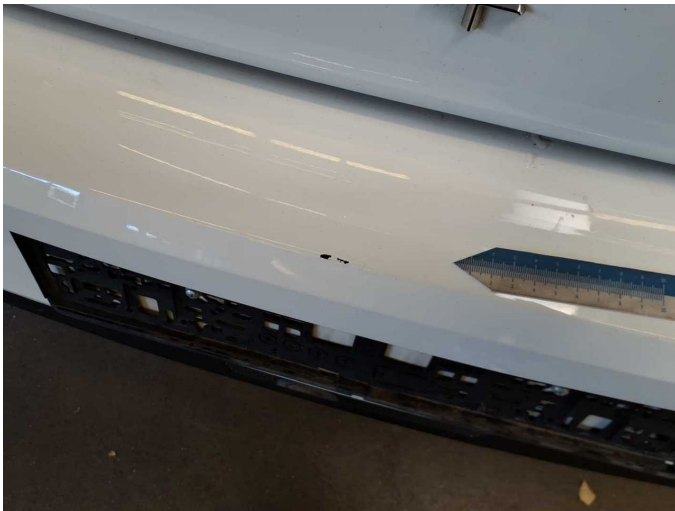
**Damage 4:** Rear bumper: Rear bumper - Scratch(es) - Smart repair

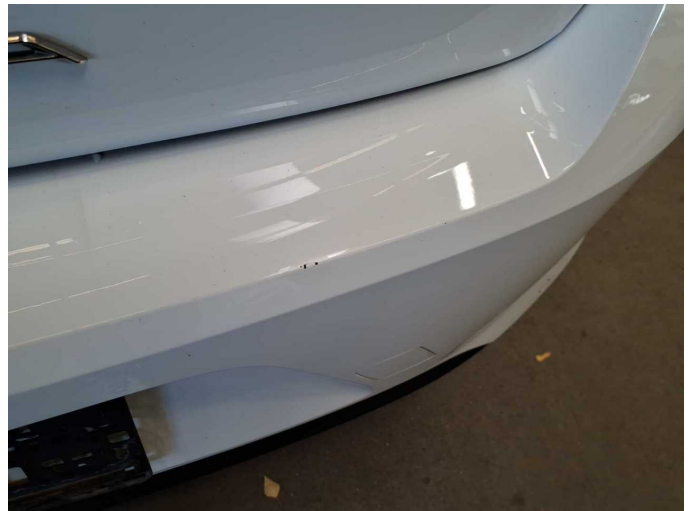
**Damage 4:** Rear bumper: Rear bumper - Scratch(es) - Smart repair

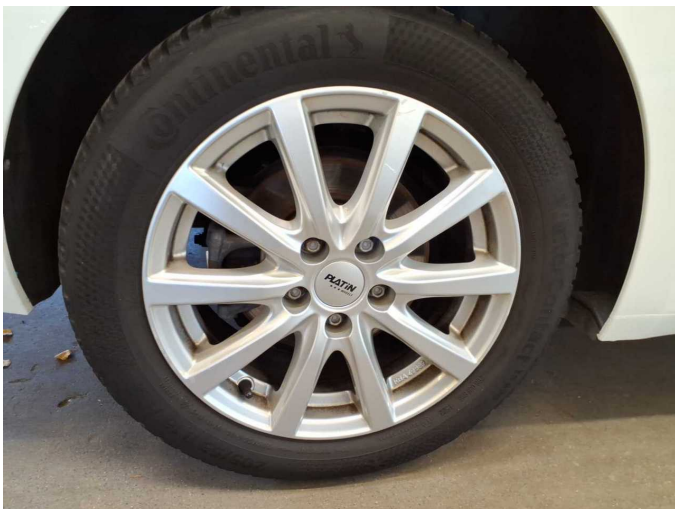
**Damage 5:** Wheel / tyres: Alloy rim - rear right side - Scratch(es) - Loss in value

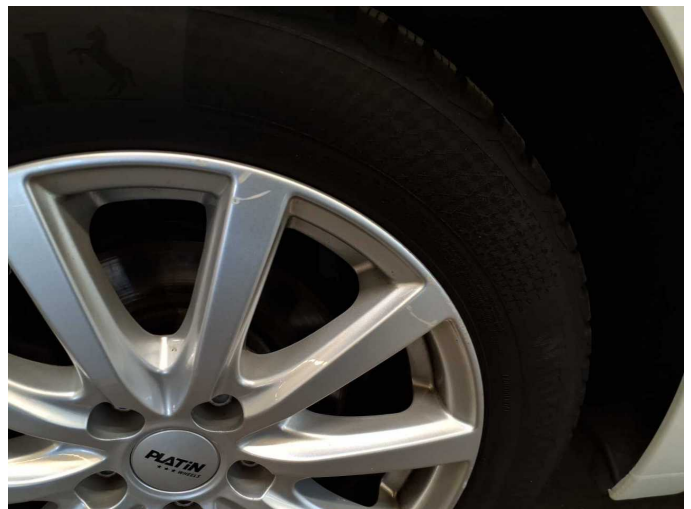
**Damage 5:** Wheel / tyres: Alloy rim - rear right side - Scratch(es) - Loss in value

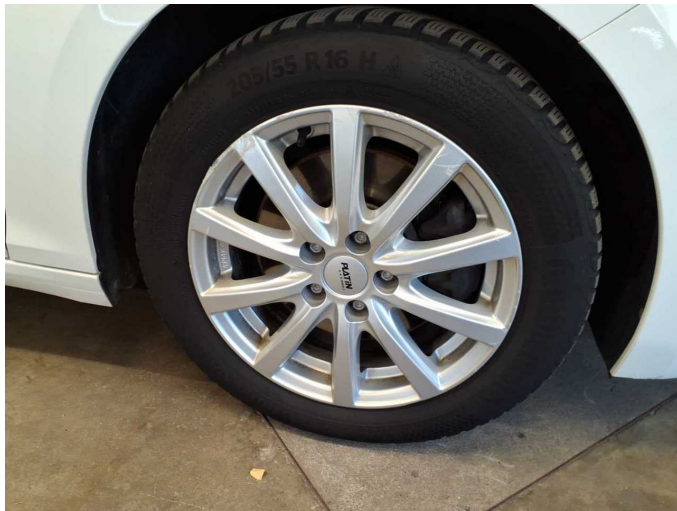
**Damage 7:** Wheel / tyres: Alloy rim - front right side - Scratched - Replace

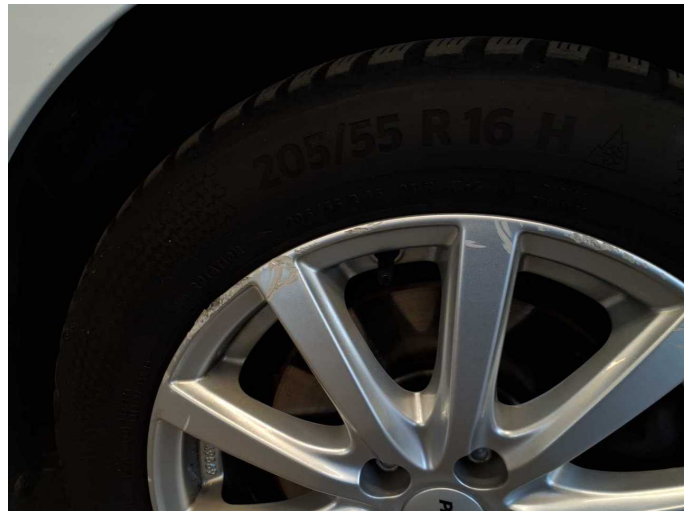
**Damage 7:** Wheel / tyres: Alloy rim - front right side - Scratched - Replace

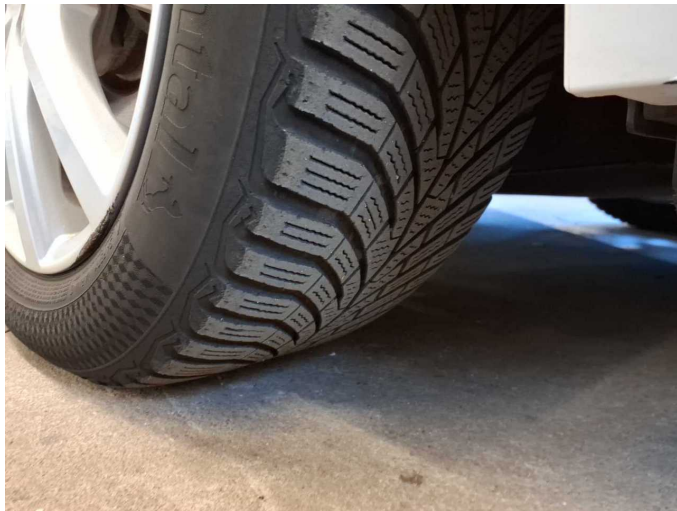
**Damage 8:** Wheel / tyres: Tyres - complete set (4mm) - Does not meet the leasing specifications - Replace

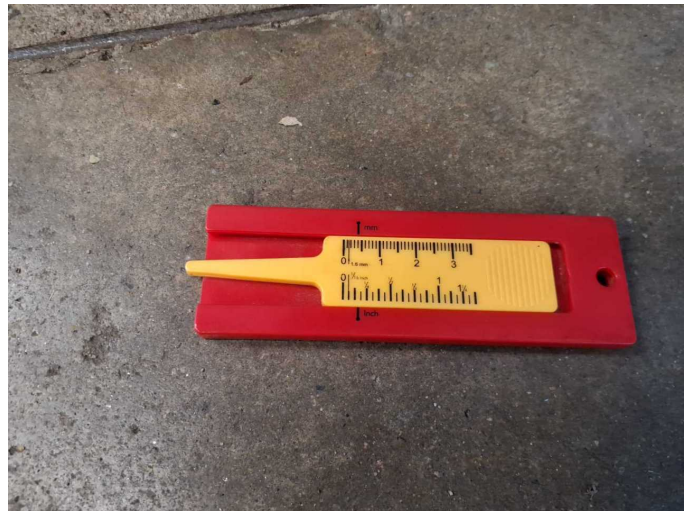
**Damage 8:** Wheel / tyres: Tyres - complete set (4mm) - Does not meet the leasing specifications - Replace

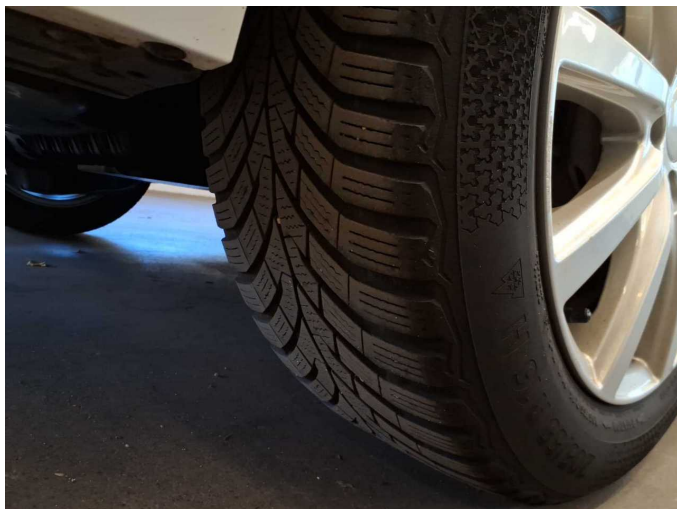
**Damage 8:** Wheel / tyres: Tyres - complete set (4mm) - Does not meet the leasing specifications - Replace

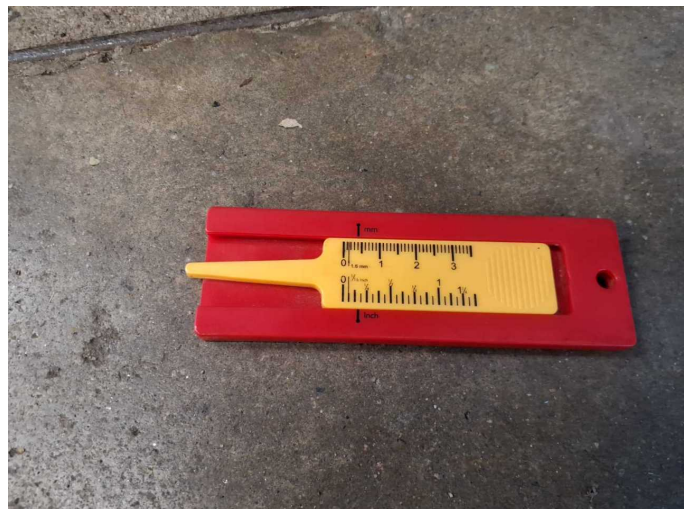
**Damage 8:** Wheel / tyres: Tyres - complete set (4mm) - Does not meet the leasing specifications - Replace

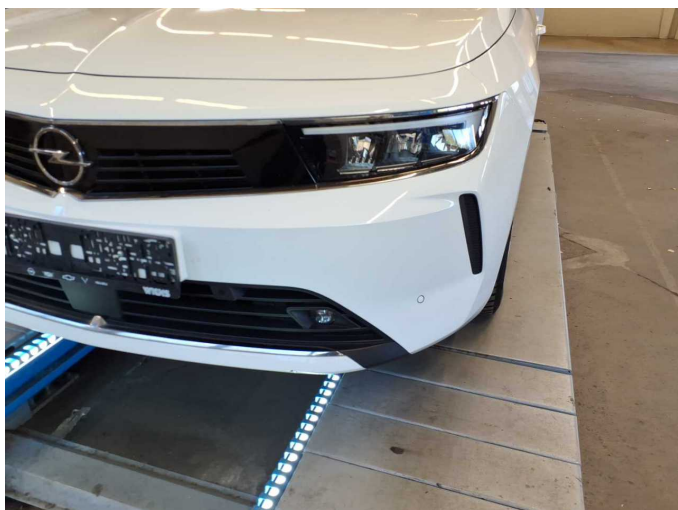
**Damage 9:** Front bumper: Front bumper - Scratch(es) - Paint

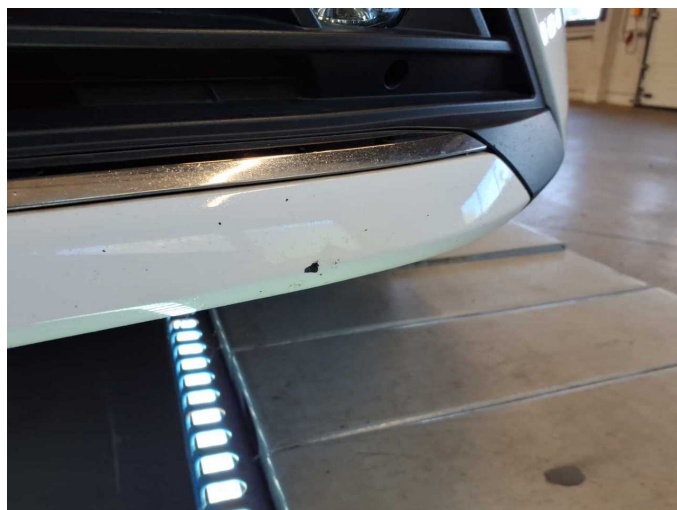
**Damage 9:** Front bumper: Front bumper - Scratch(es) - Paint

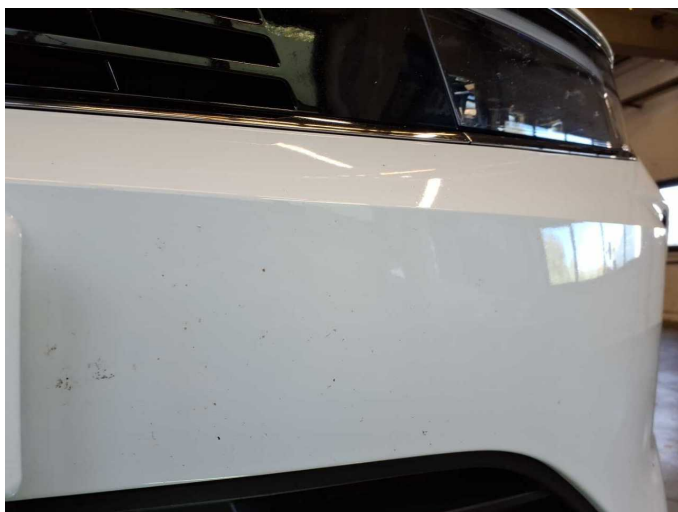
**Damage 9:** Front bumper: Front bumper - Scratch(es) - Paint

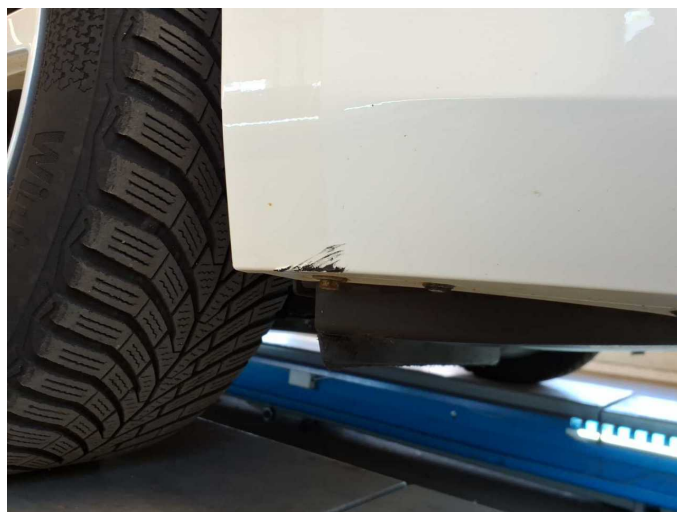
**Damage 9:** Front bumper: Front bumper - Scratch(es) - Paint

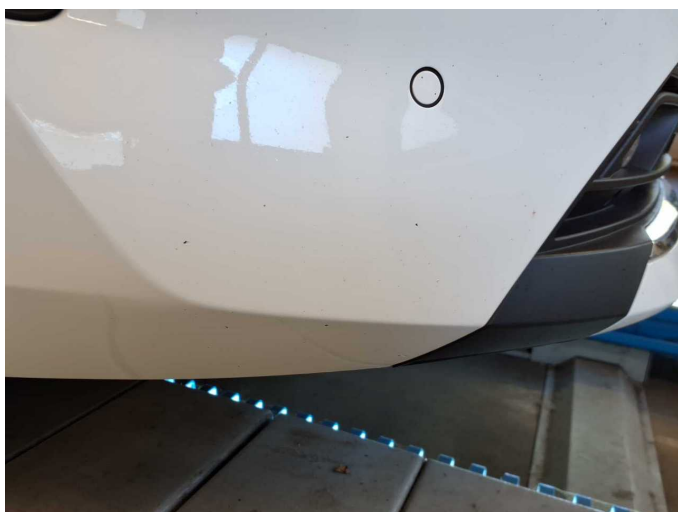
**Damage 9:** Front bumper: Front bumper - Scratch(es) - Paint
