Expertise

Protocol number: 41295093
Order No. / Reference: 25080565
Inspection date: 29 Aug 2025

Manufacturer: Opel

Model: Astra Sports Tourer 1.5 D GS Line

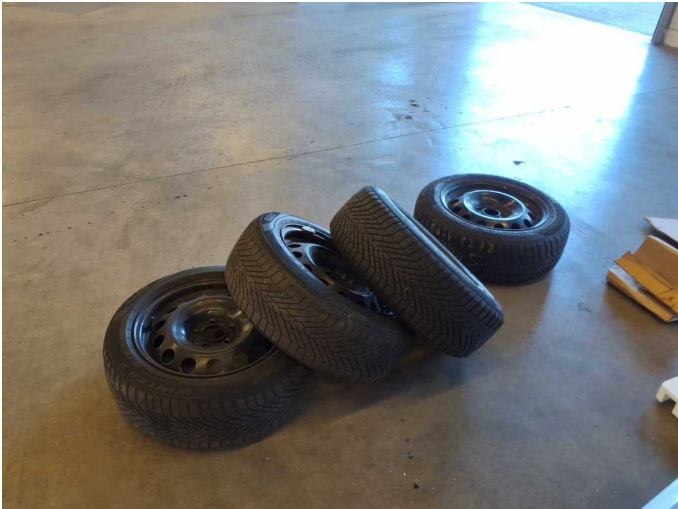
Figure 16: Additional tyres

No.	Component group	Description
1	2nd wheel set	2 tyres (4mm) - Does not meet the leasing specifications - No deduction
2	Body	Body - Scratch(es) - No deduction

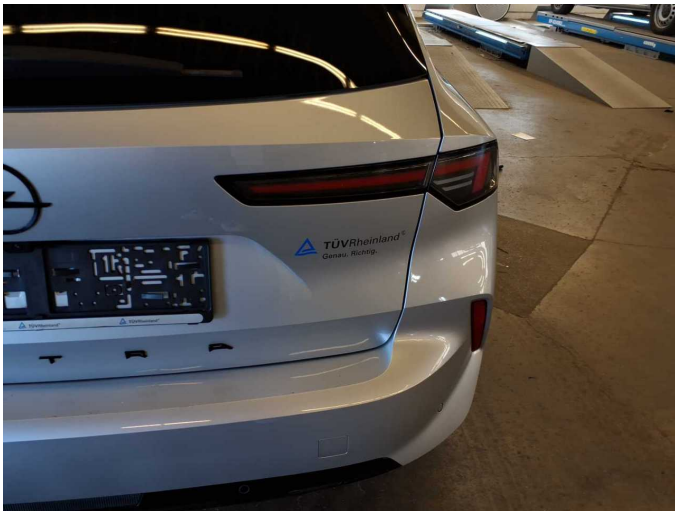
Damage 2: Boot lid / rear door: Boot lid - Glued / labelled - De-glue / neutralise

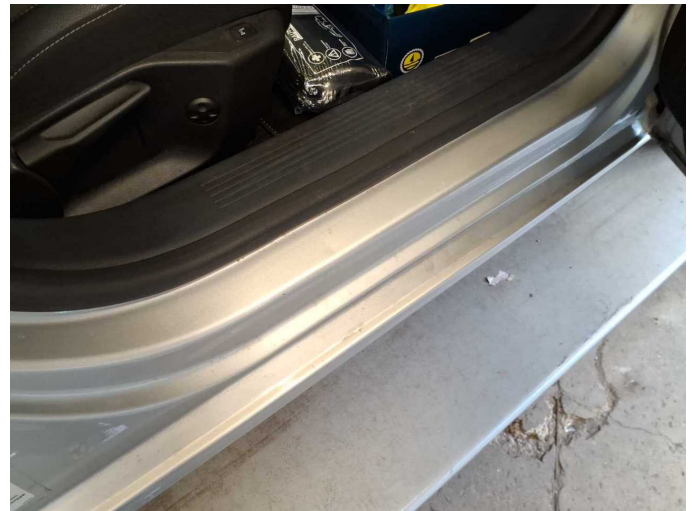
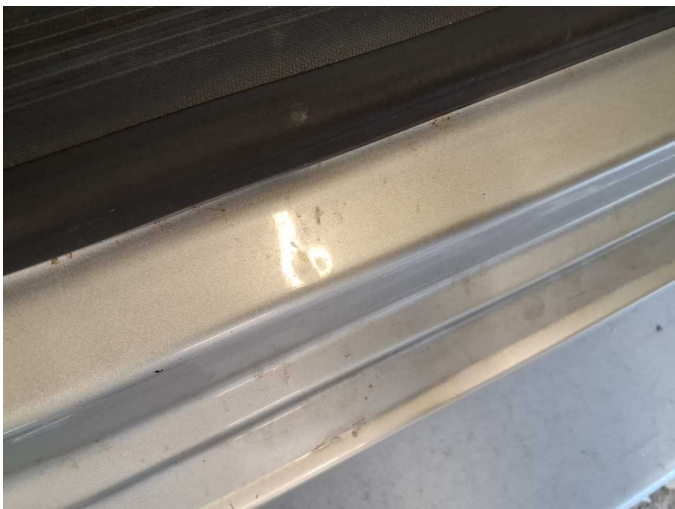
Damage 3: Sill - right side: Sill - dent(s) - Smooth repair work

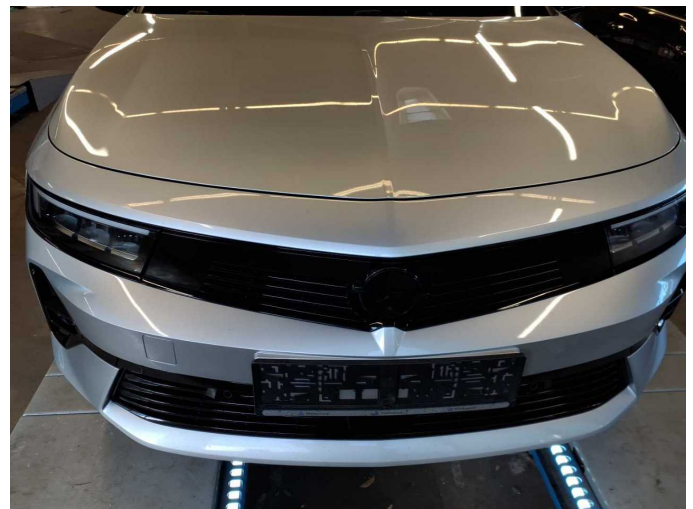
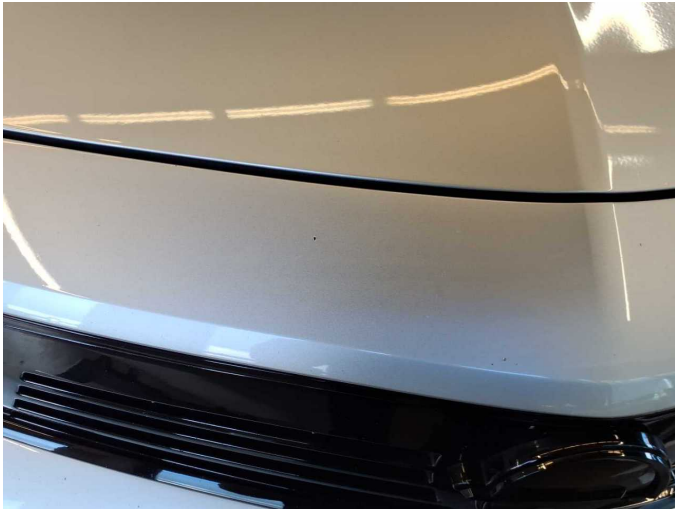
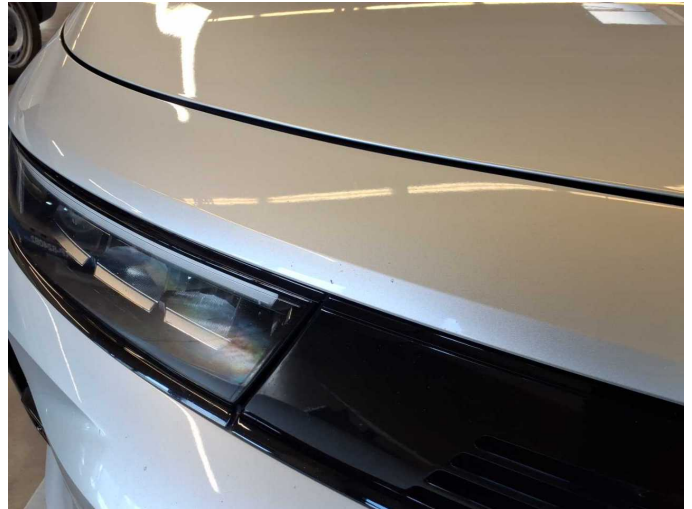
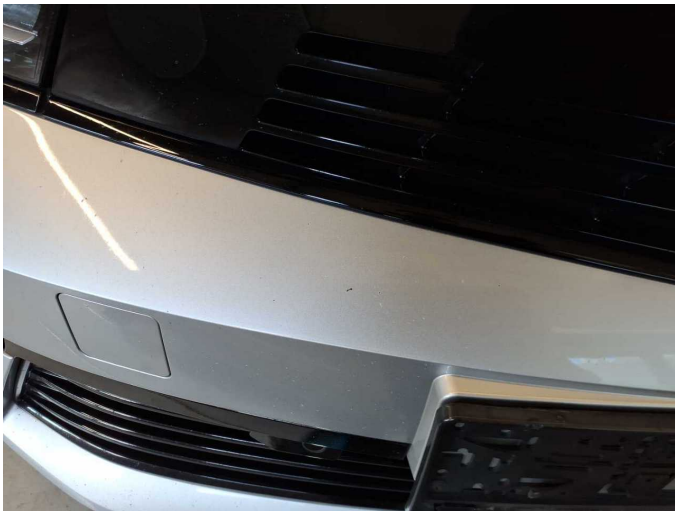
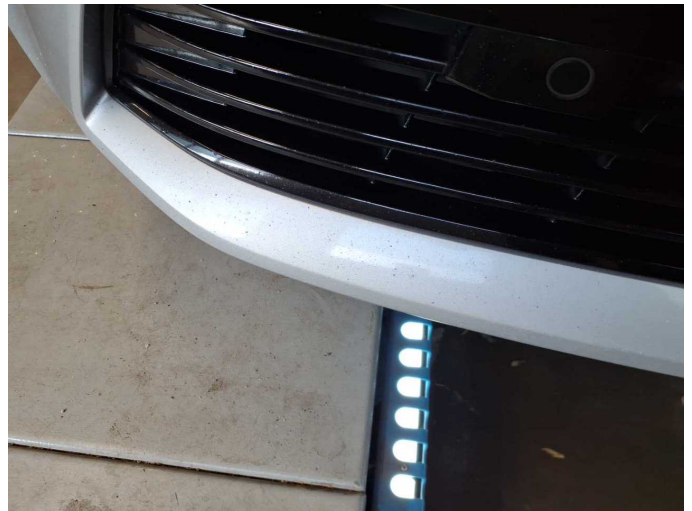
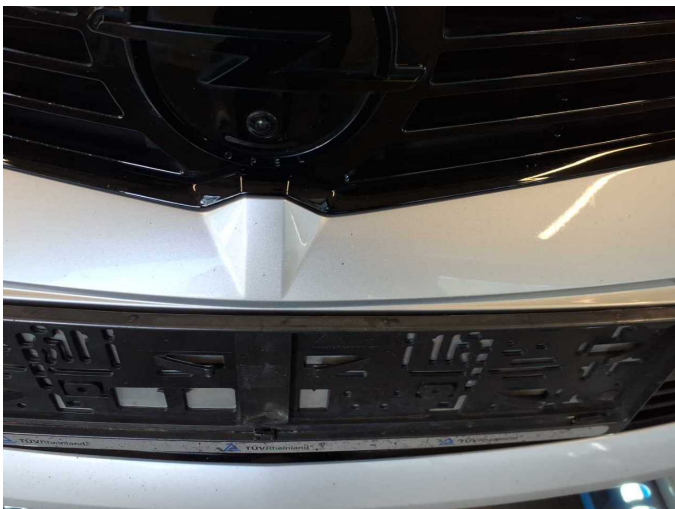
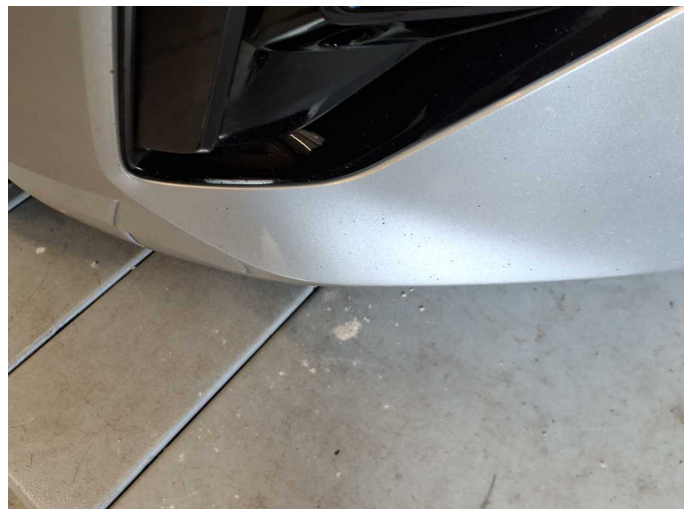
Damage 4: Front bumper: Front bumper - Stone chips - Paint
