## status report

#### Opel Astra L Sports Tourer Business Elegance

| Vehicle identification number | VXKFCYHZLP1047106 | mileage read: | 53095 km |

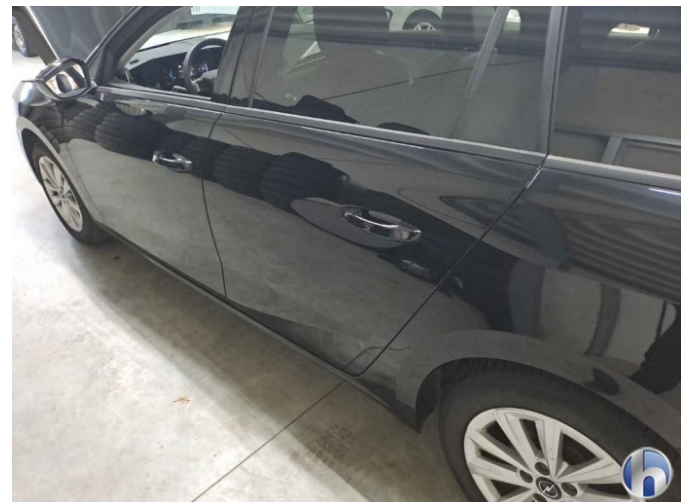
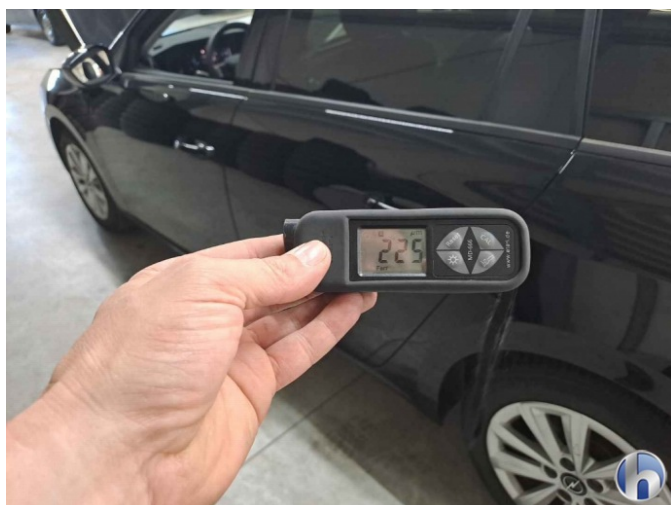
| | component | Damage | Rep kind |
|---|---|---|---|
| 1. | Rear door - left | Subsequently painted | acceptable |

1. Rear door - left

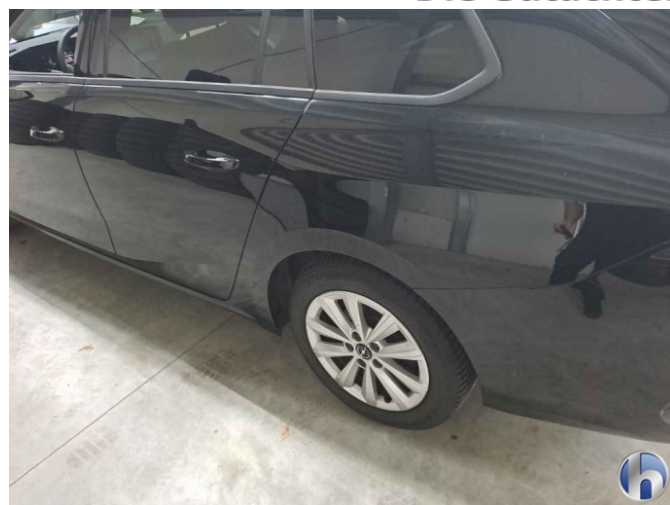
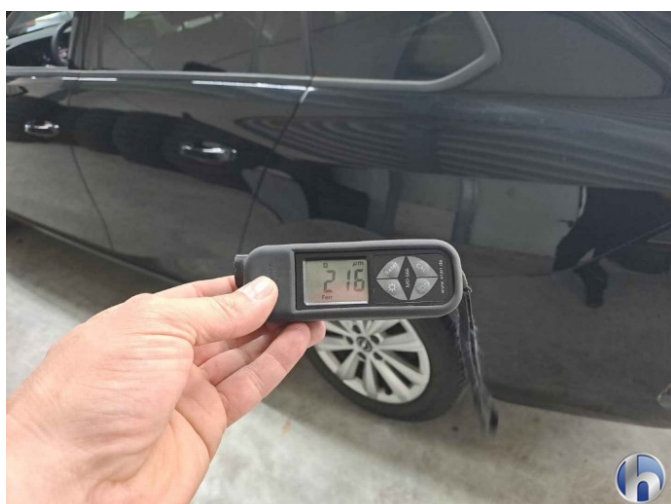
| | component | Damage | Rep kind |
|---|---|---|---|
| 2. | Sidewall - Rear - Left | Subsequently painted | acceptable |

2. Sidewall - Rear - Left

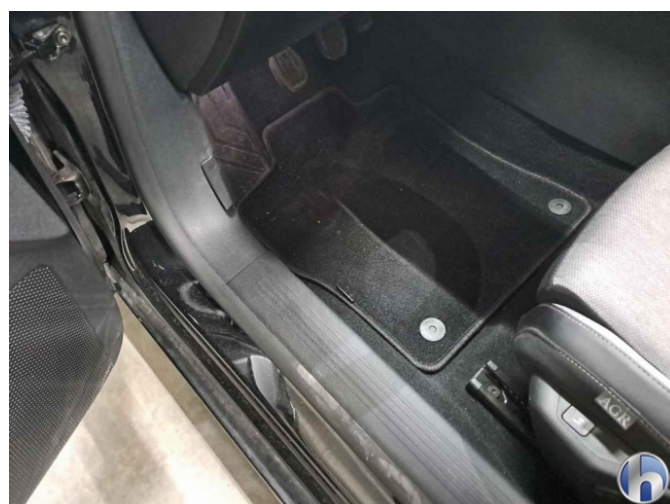
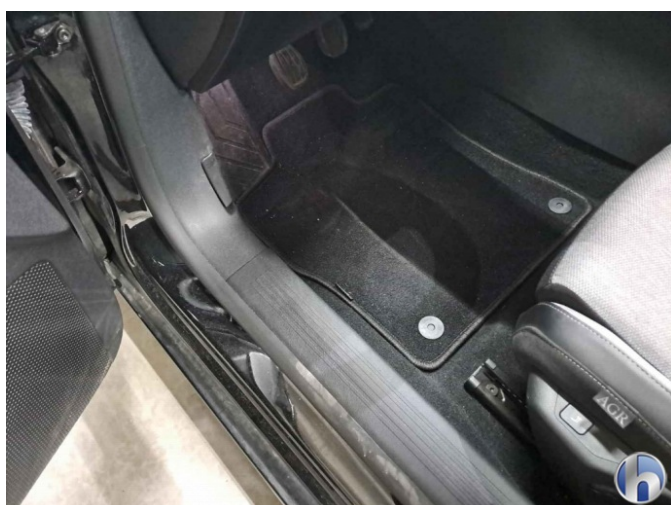
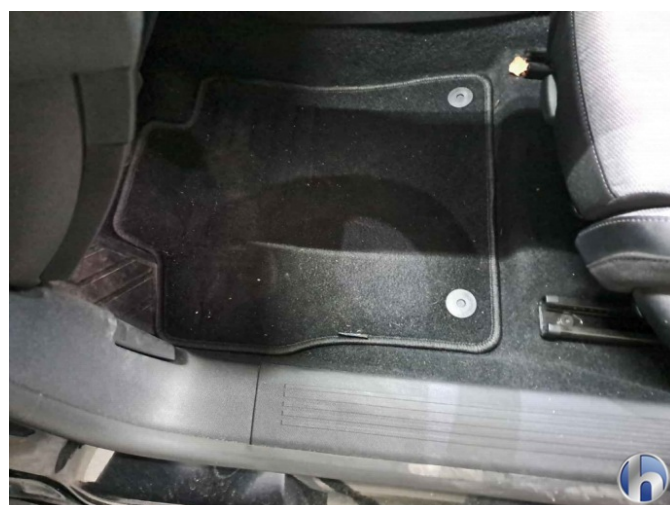
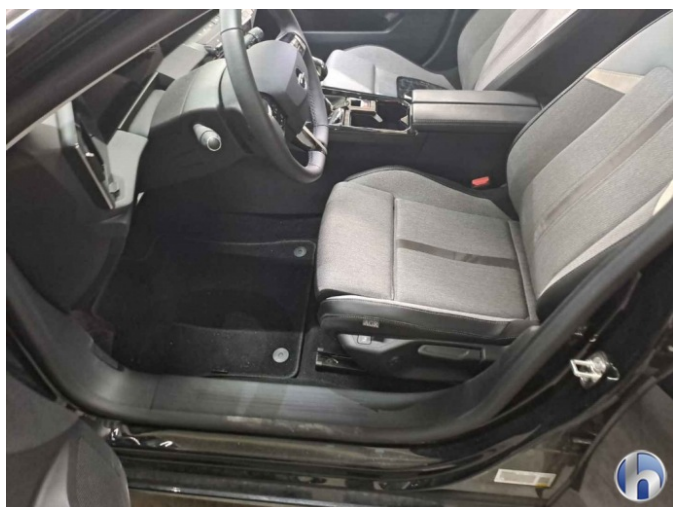
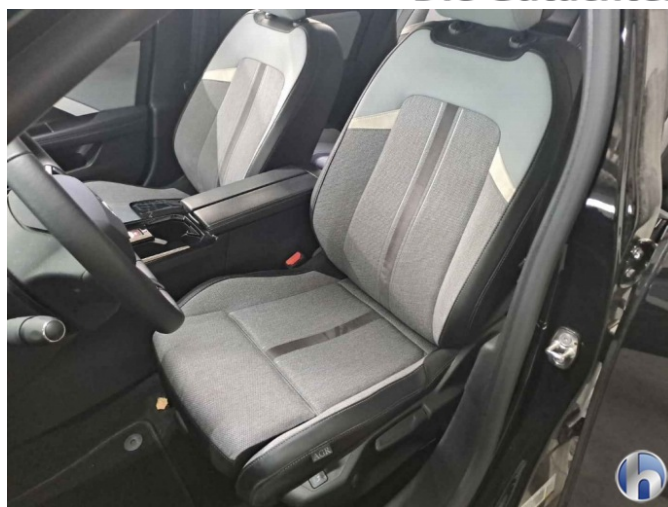
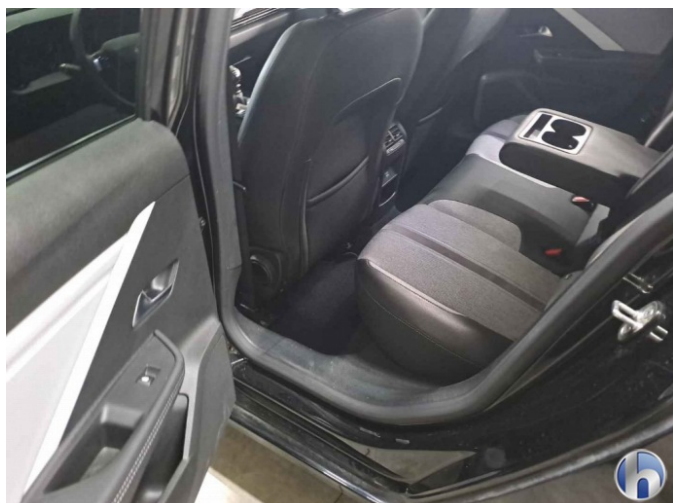
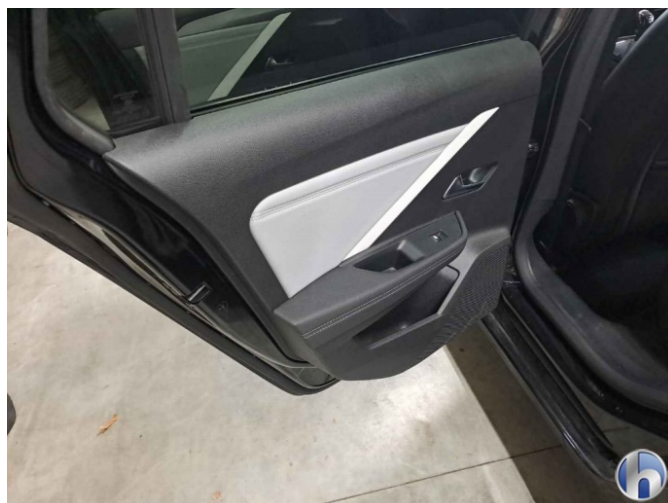
| | component | Damage | Rep kind |
|---|---|---|---|
| 3. | Innenraum | Dirty (slightly) | |

3. Innenraum

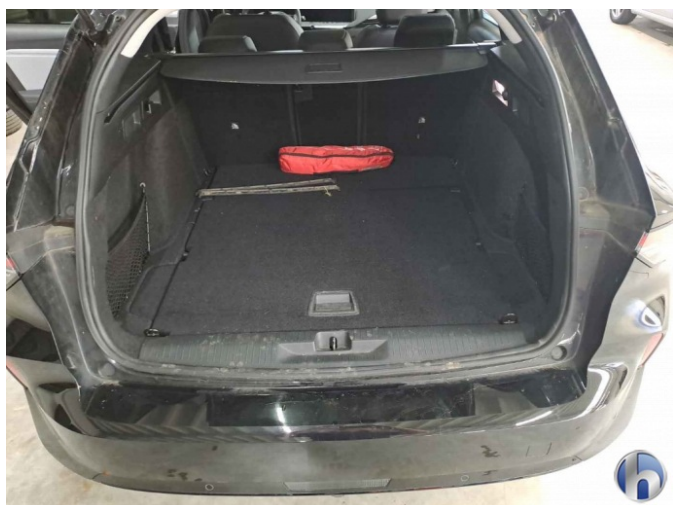
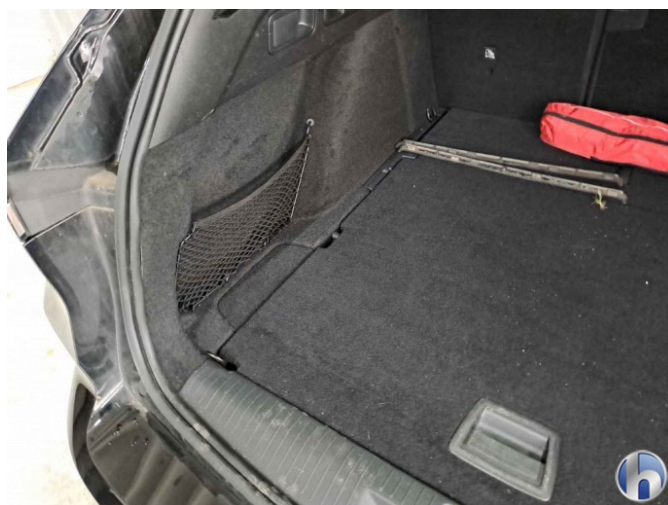
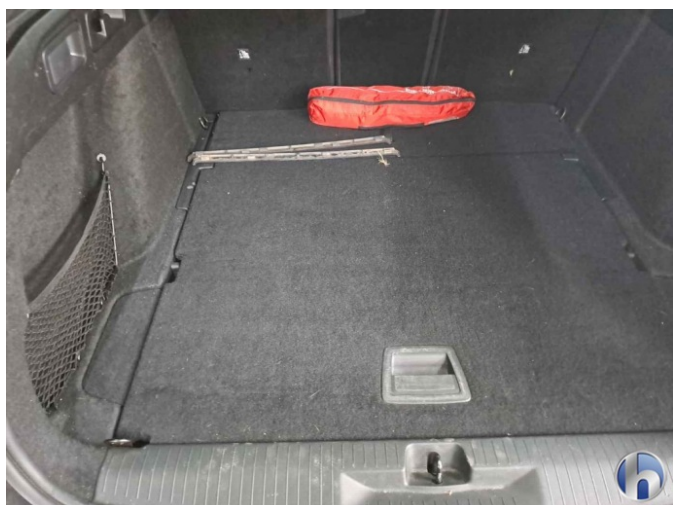
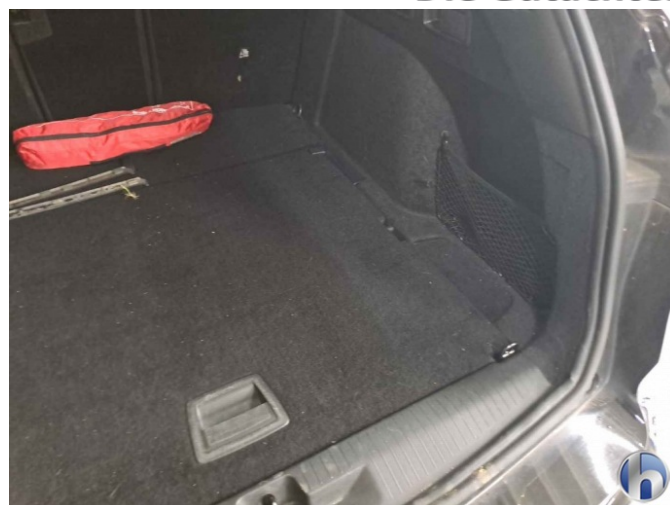
| | component | Damage | Rep kind |
|---|---|---|---|
| 4. | Kofferraumbodenbelag | Dirty | |

4. Kofferraumbodenbelag

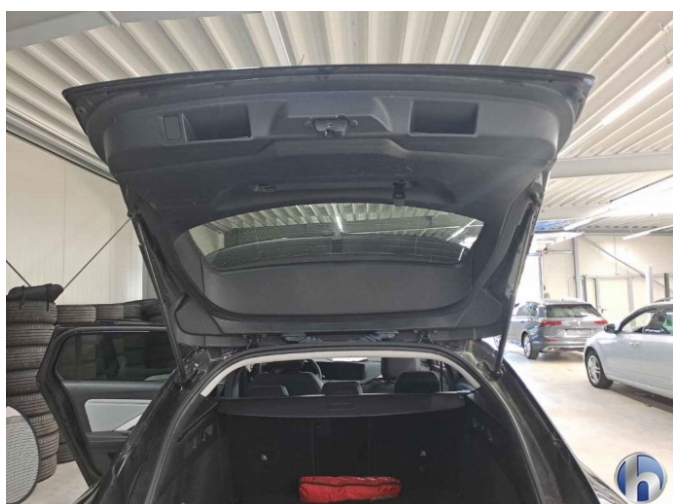
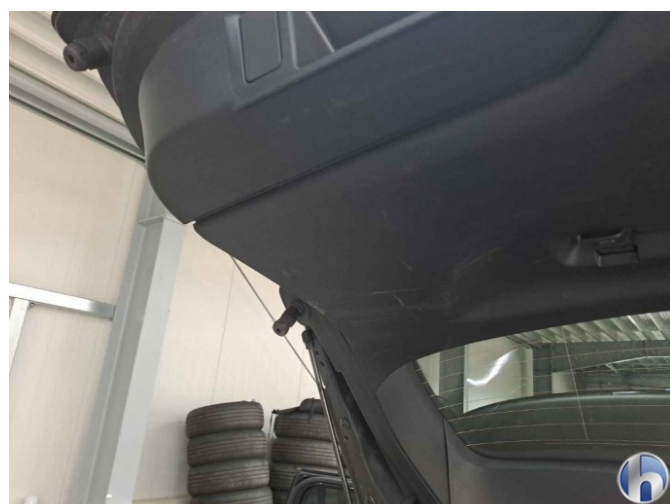
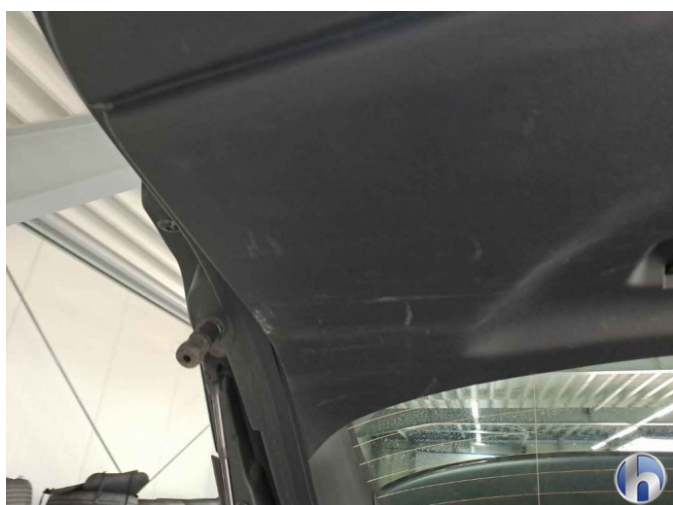
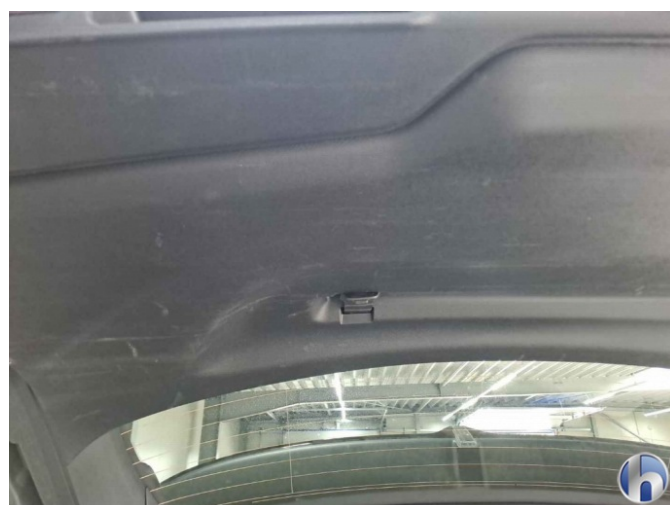
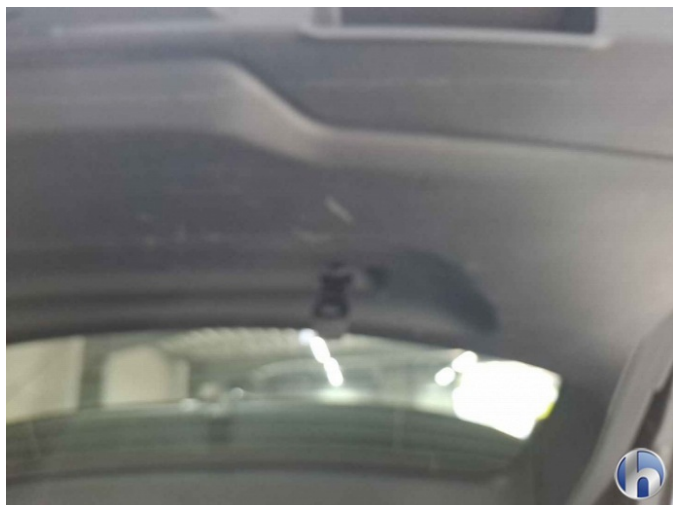
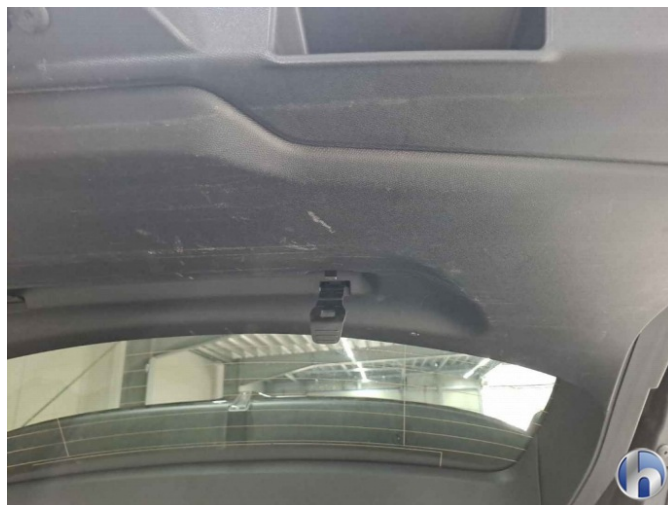
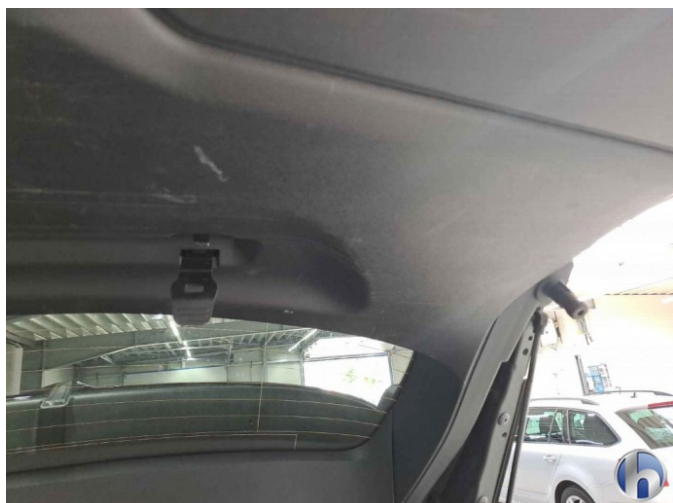
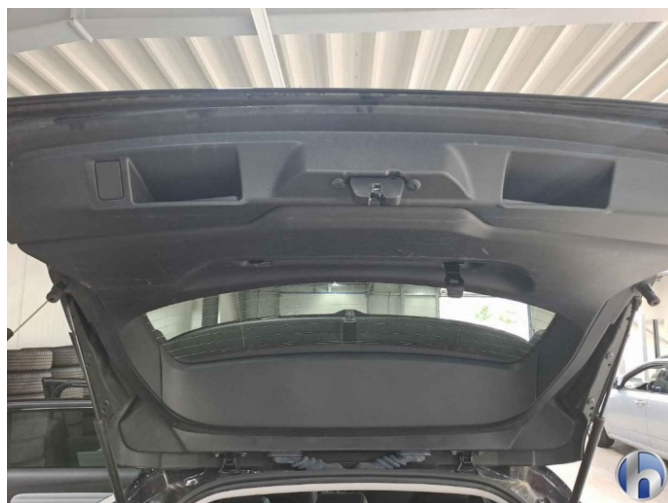
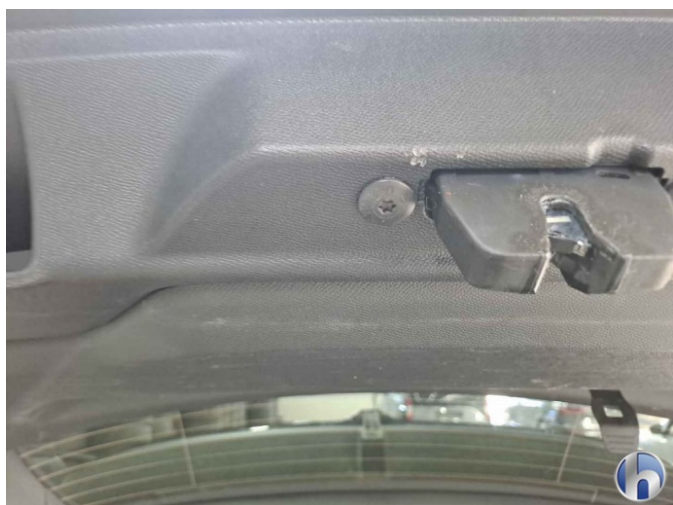
| | component | Damage | Rep kind |
|---|---|---|---|
| 5. | Heckdeckelverkleidung | Damaged | Replace |

5. Heckdeckelverkleidung

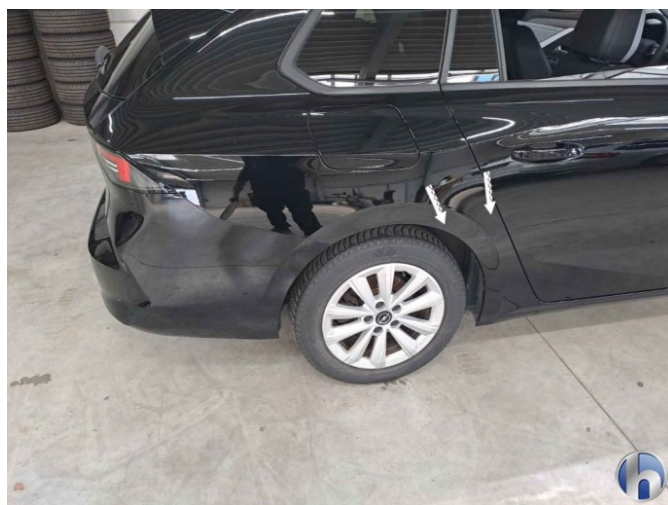
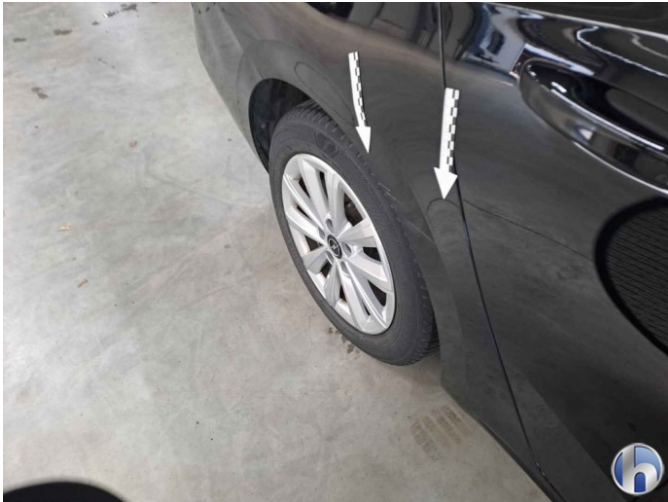
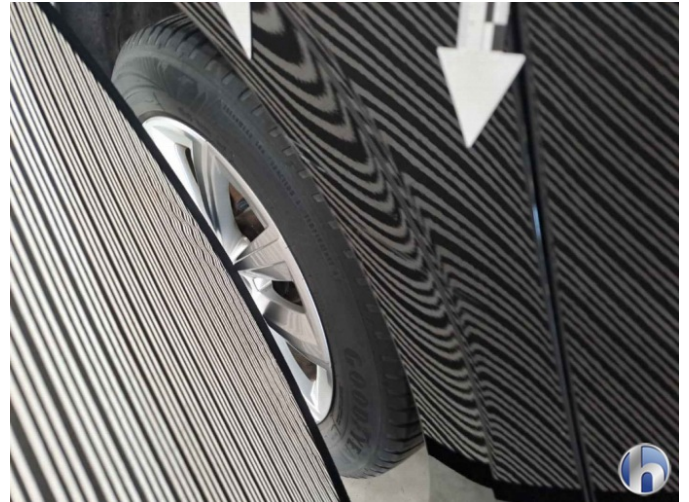
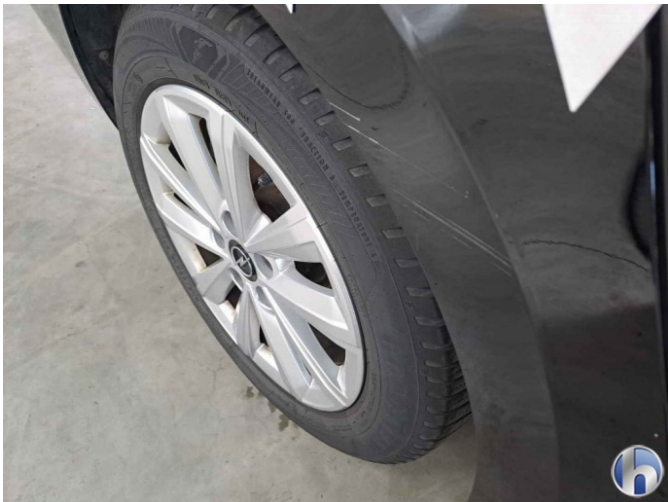
| | component | Damage | Rep kind |
|---|---|---|---|
| 7. | Sidewall - Rear - right | Damaged | Refurbish and paint |

7. Sidewall - Rear - right

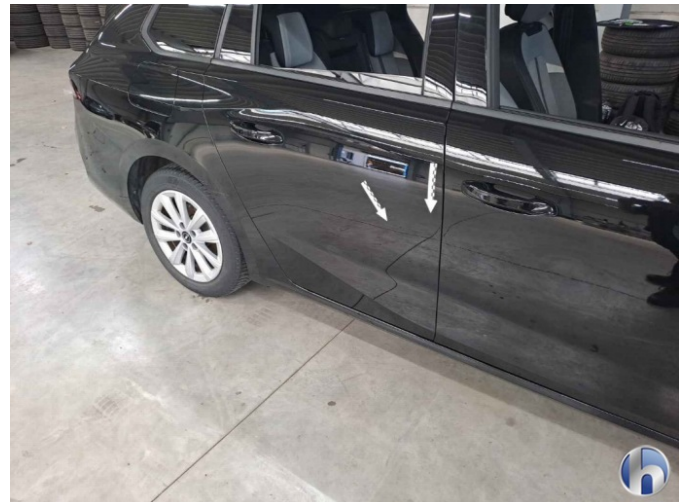
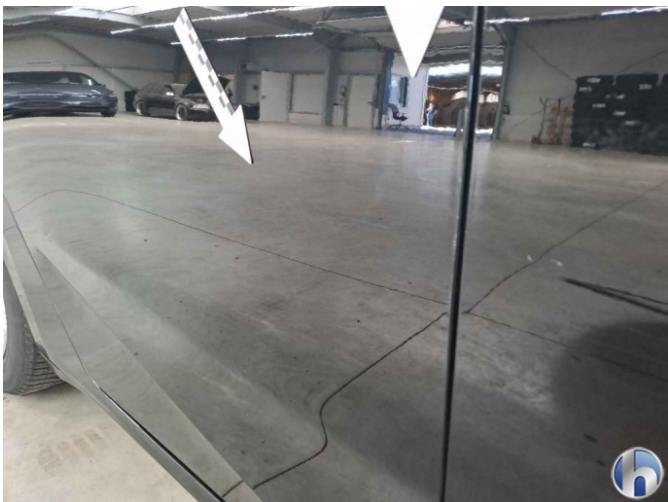
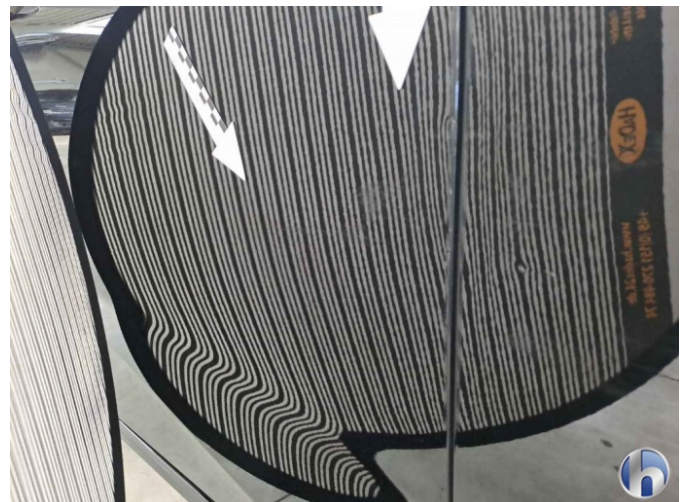
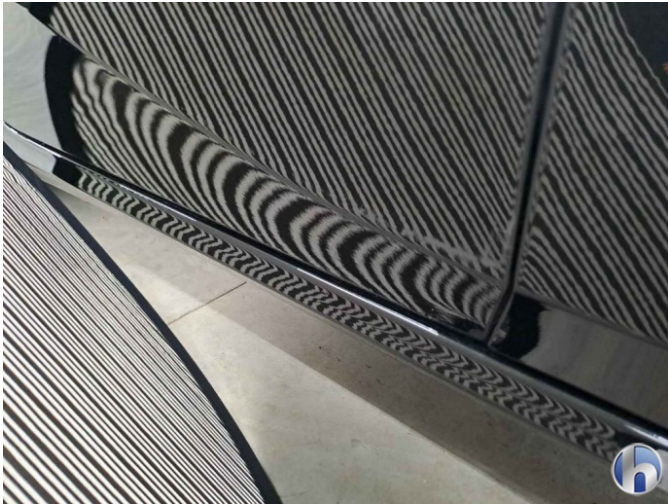
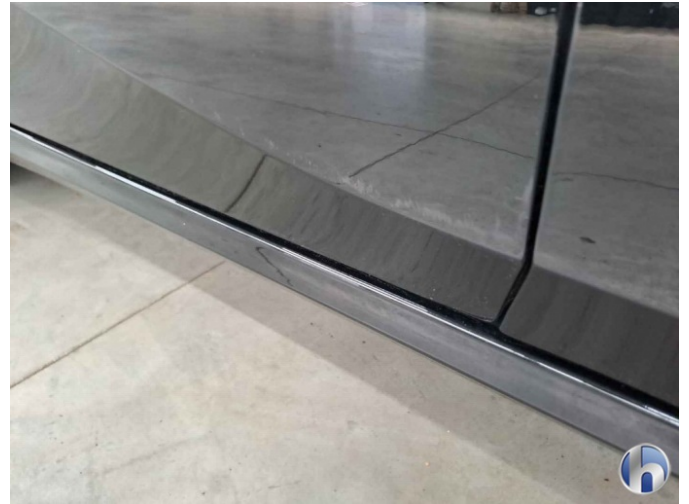
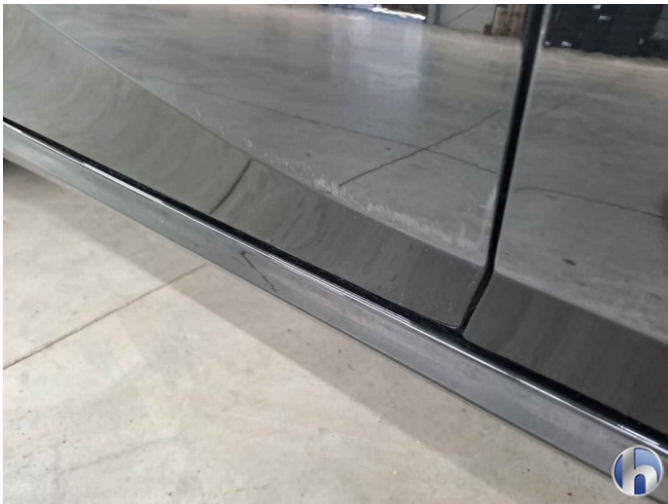
| | component | Damage | Rep kind |
|---|---|---|---|
| 8. | Door Rear - right | Damaged | Refurbish and paint |

8. Door Rear - right

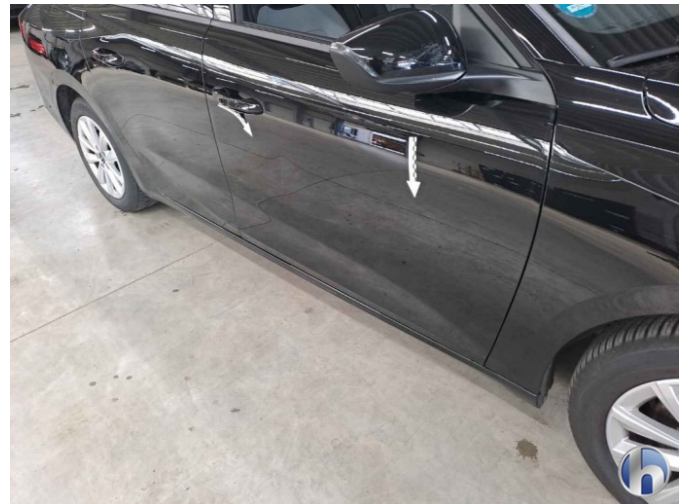
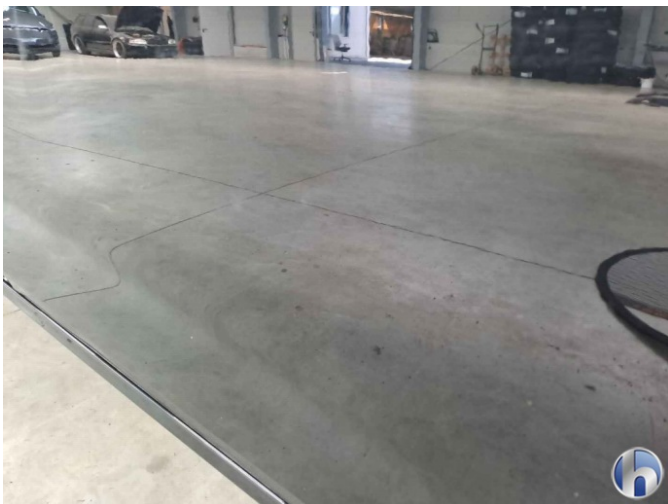
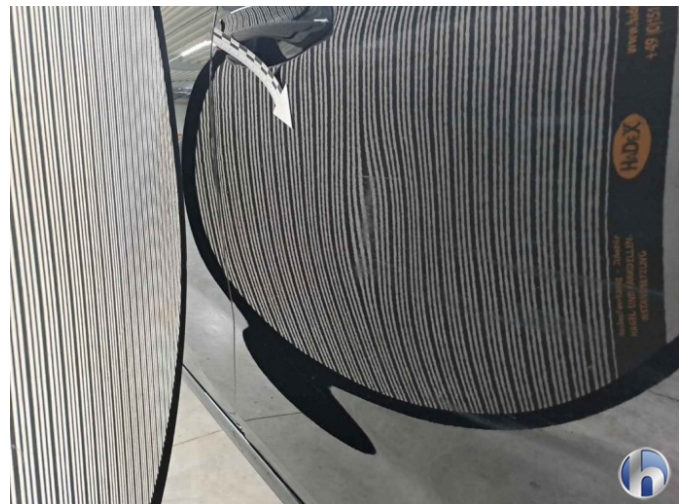
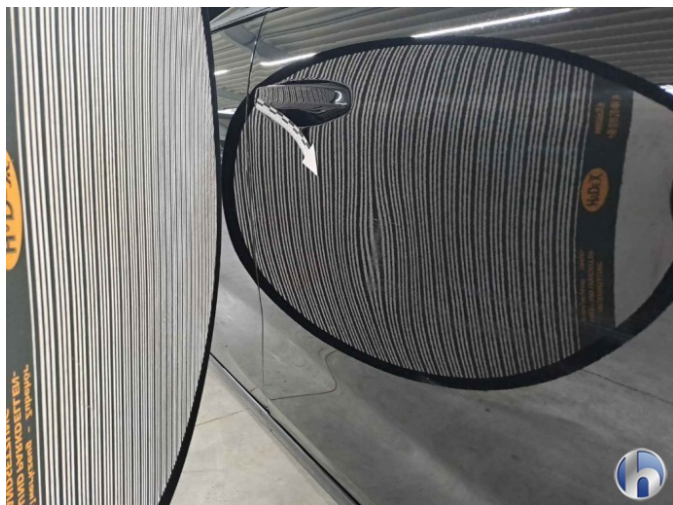
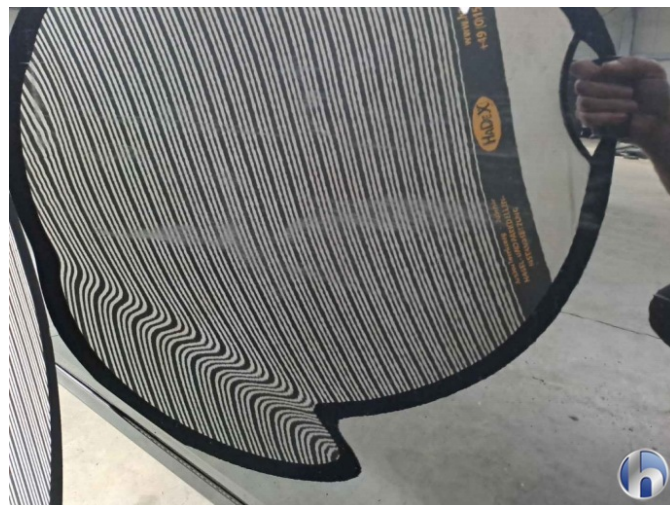
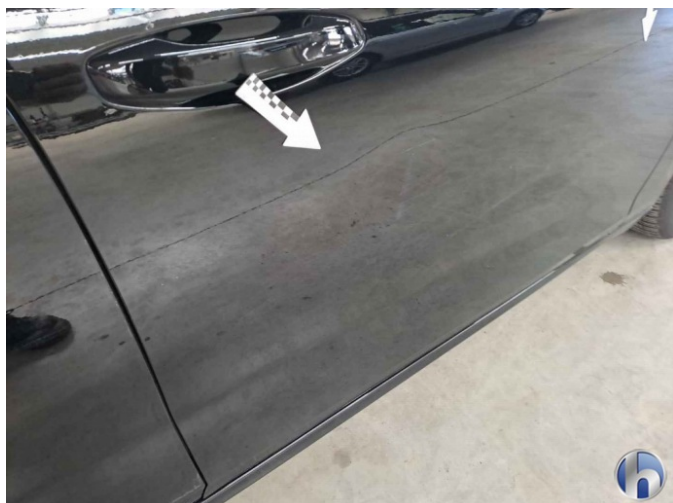
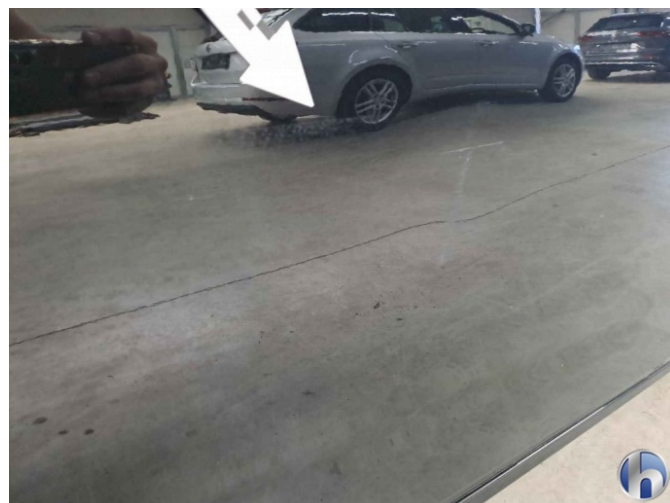
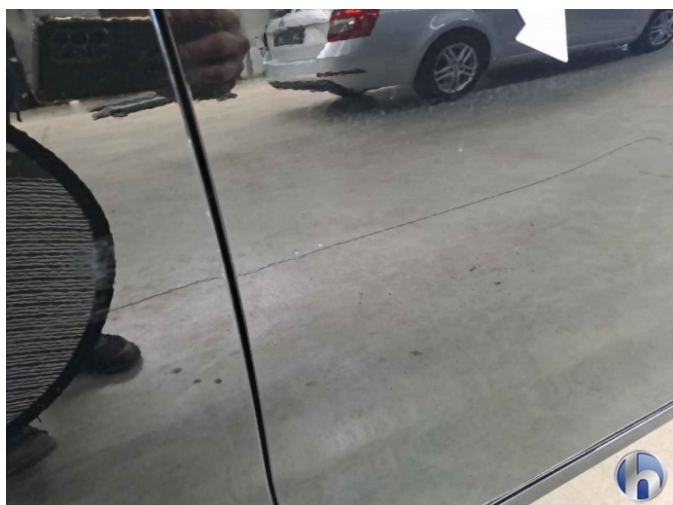
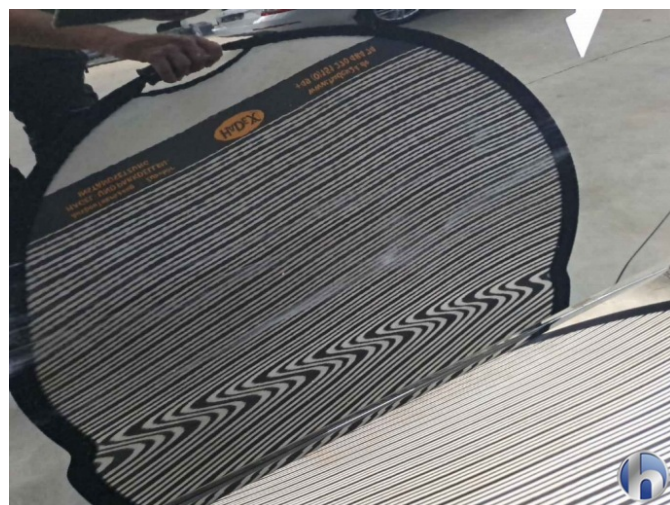
| | component | Damage | Rep kind |
|---|---|---|---|
| 9. | Front door - right | Damaged | Refurbish and paint |

9. Front door - right

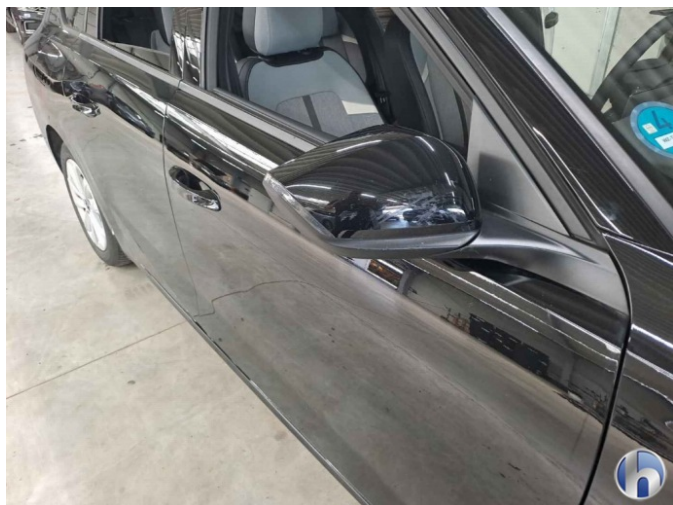
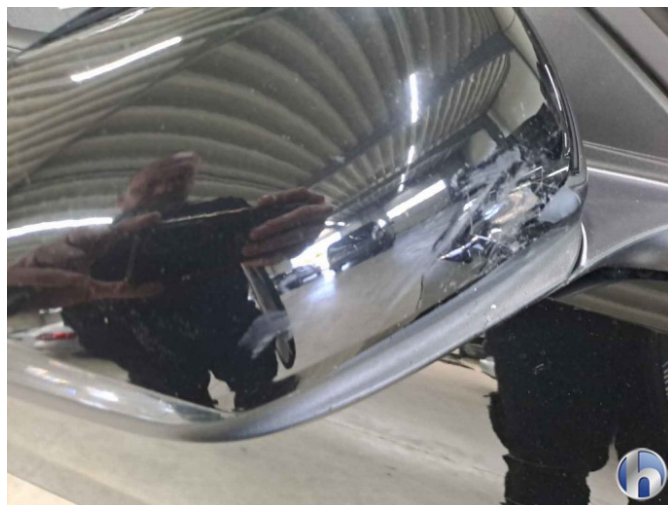
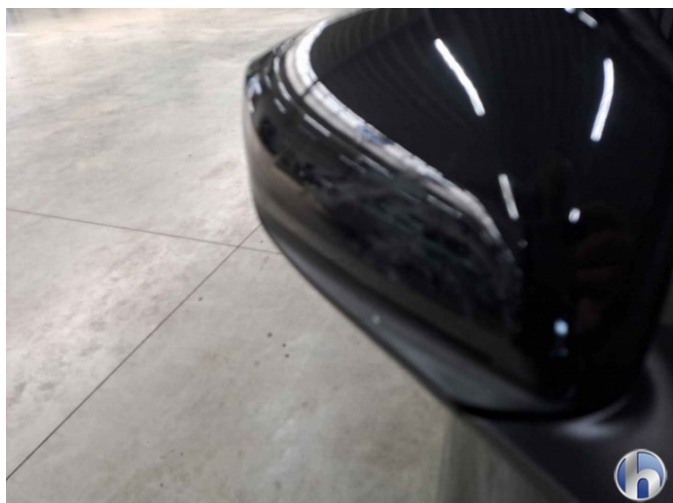
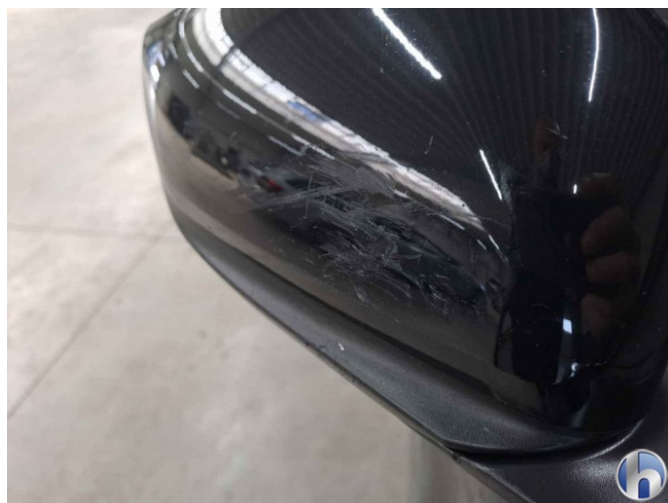
| | component | Damage | Rep kind |
|---|---|---|---|
| 10. | Outside mirror - right | Damaged | Replace |

10. Outside mirror - right
