## status report

#### Opel Astra L Lim. 5-trg. GS Line

| Vehicle identification number | <b>VXKFPHNSLN1024942</b> | mileage read: | <b>15515 km</b> |
| First Registration / construction year: | <b>12.08.2022 / 2022</b> | Visit Date / place of birth: | <b>14.05.2025 Heidenheim</b> |

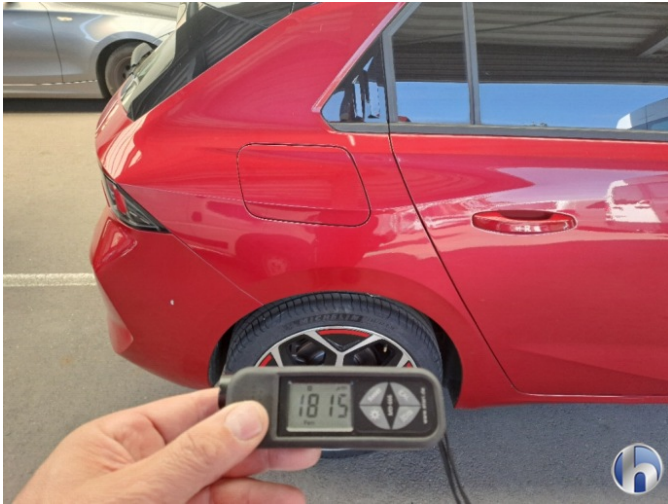
| component | Damage | Rep kind |
|---|---|---|
| 1. Sidewall - Rear - right | Subsequently painted | acceptable |

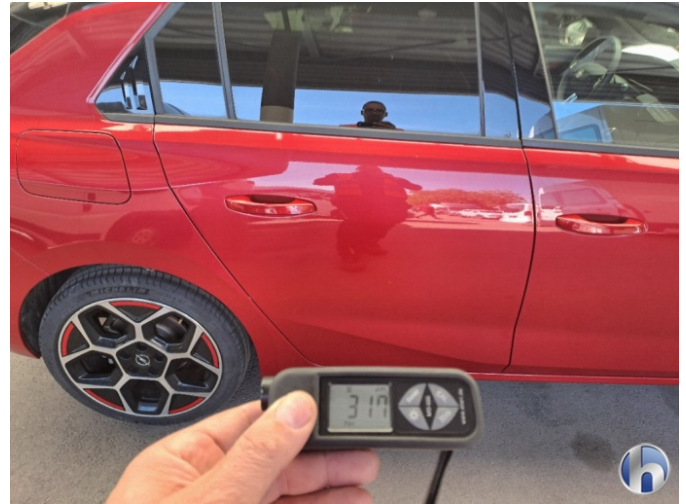
| component | Damage | Rep kind |
|---|---|---|
| 2. Door Rear - right | Subsequently painted | acceptable |

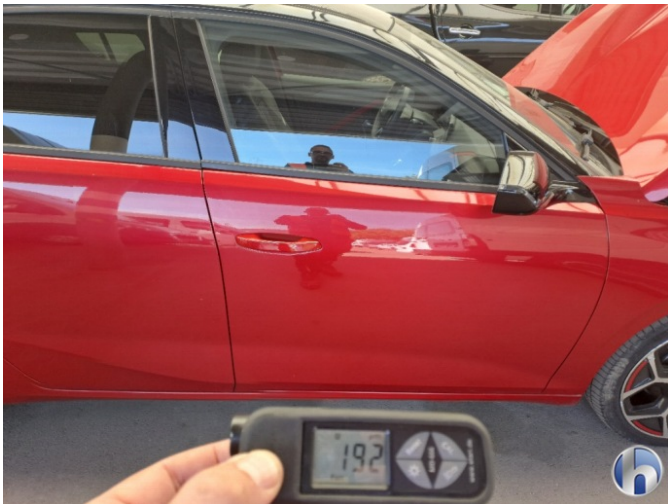
| component | Damage | Rep kind |
|---|---|---|
| 3. Front door - right | Subsequently painted | acceptable |

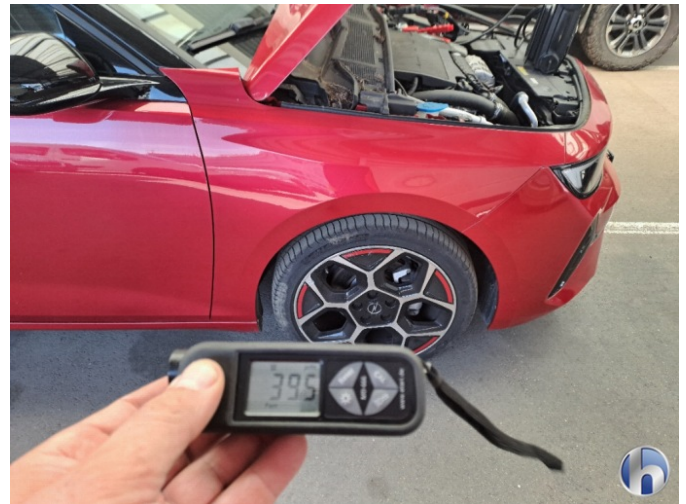
| component | Damage | Rep kind |
|---|---|---|
| 4. Front fender - right | Subsequently painted | acceptable |

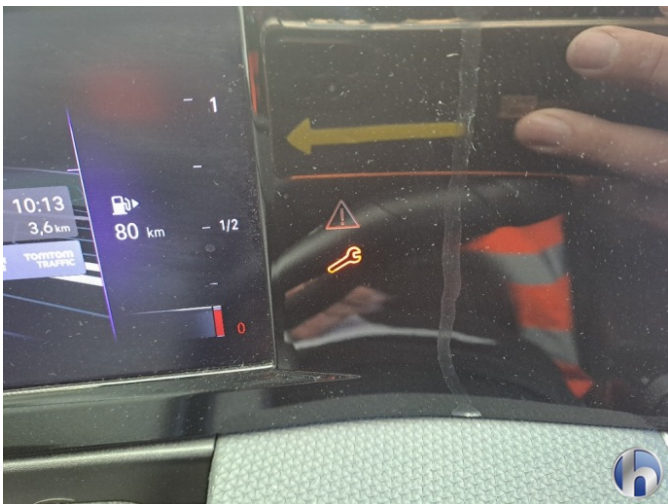
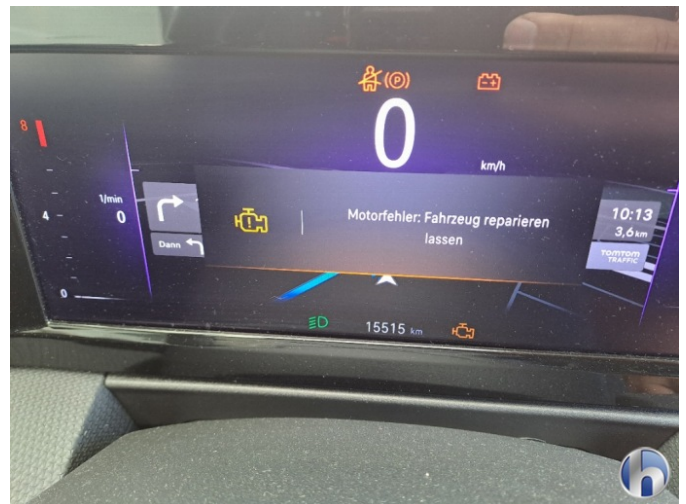
| component | Damage | Rep kind |
|---|---|---|
| 5. Motorkontrolle | Error message | Carry out a fault diagnosis |

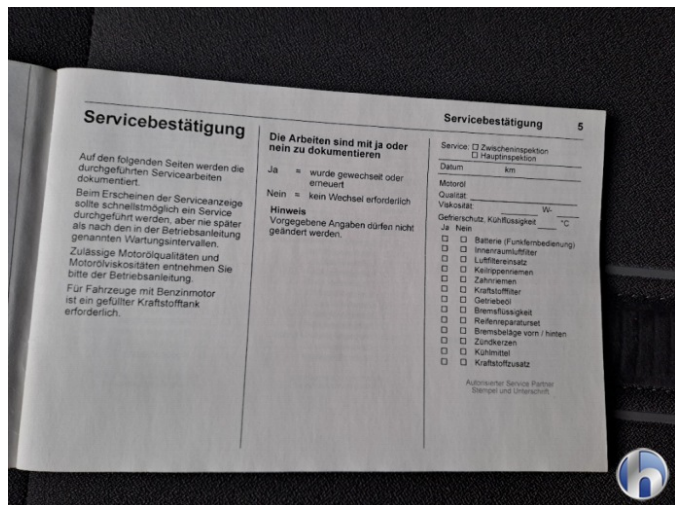
| component | Damage | Rep kind |
|---|---|---|
| 7. Wartung | Due | Replace |

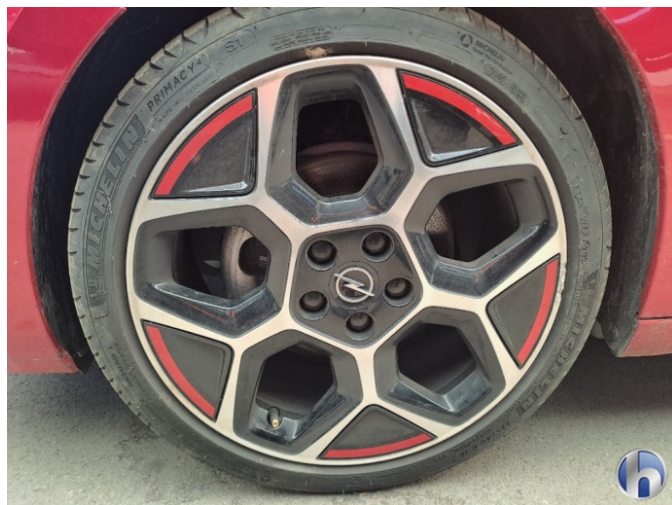
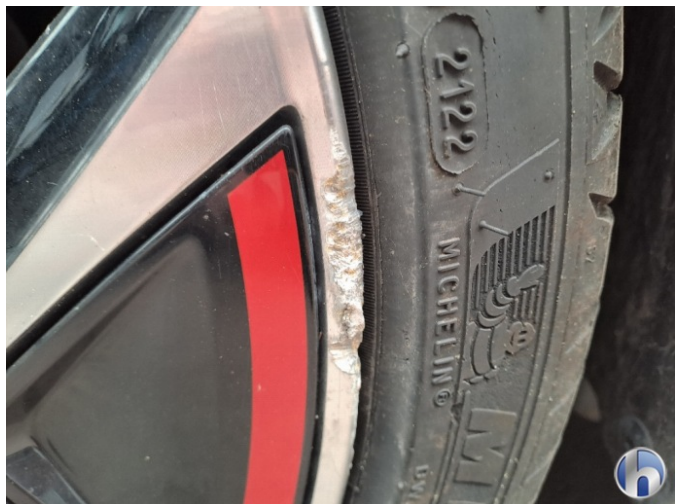
| component | Damage | Rep kind |
|---|---|---|
| 9. Felge vorn links | Scratch(es) | Replace |

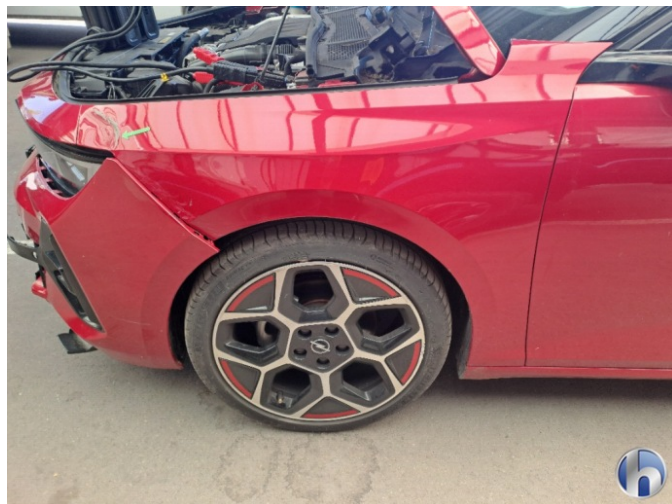
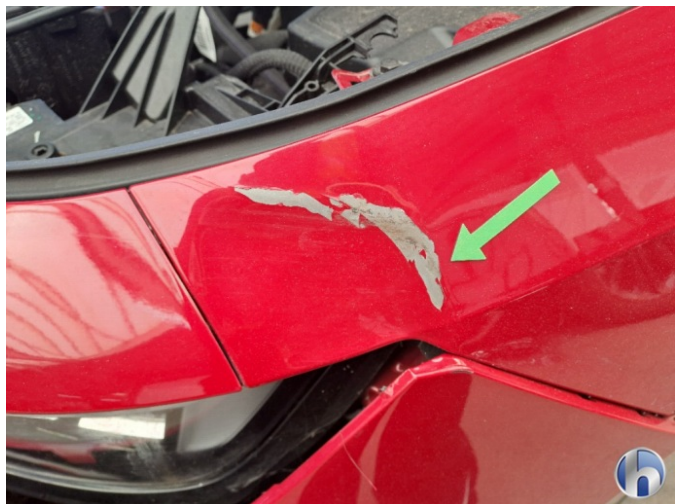
| component | Damage | Rep kind |
|---|---|---|
| 10. Front fender - left | Accident damage | Replace |

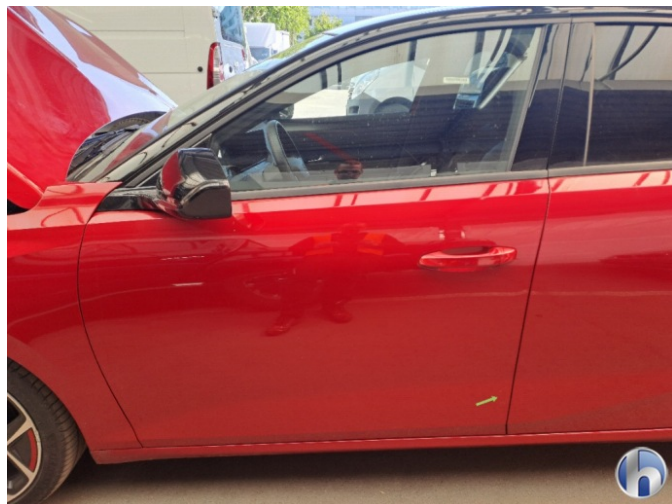
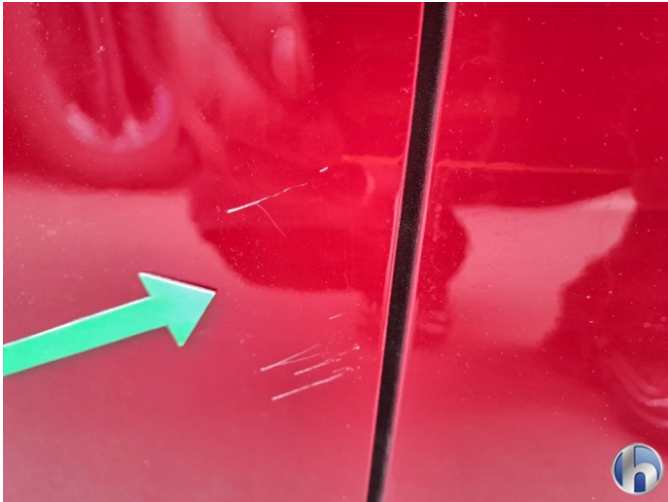
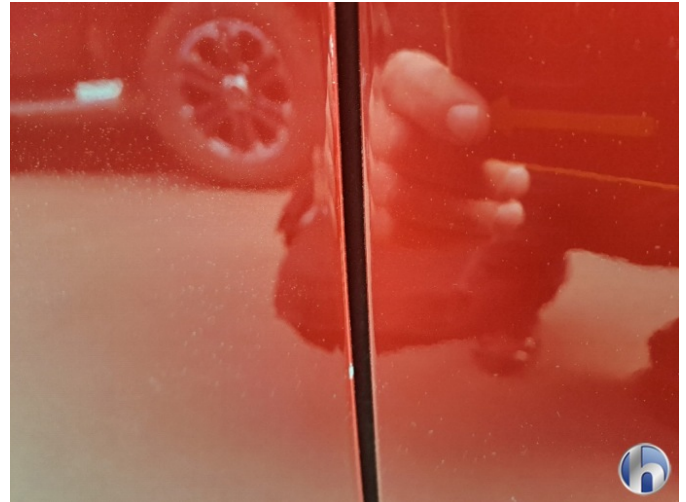
| component | Damage | Rep kind |
|---|---|---|
| 11. Front door - left | Scratch(es) | Paint |

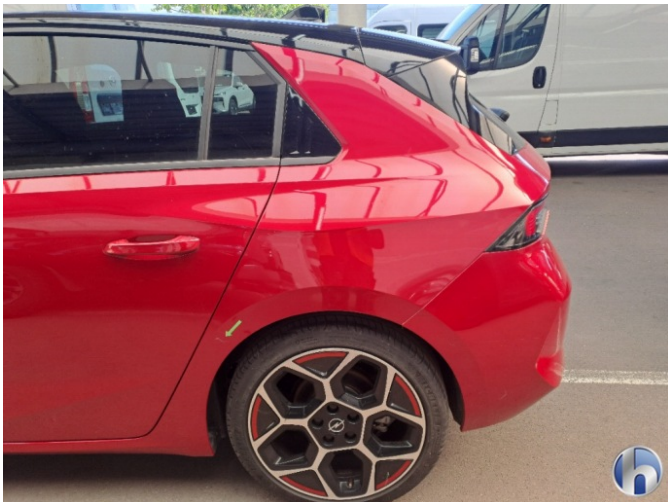
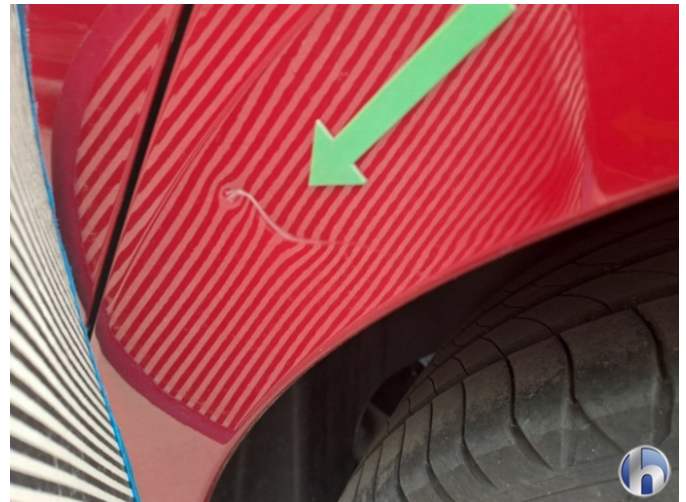
| component | Damage | Rep kind |
|---|---|---|
| 12. Sidewall - Rear - Left | Deformed | Refurbish and paint |

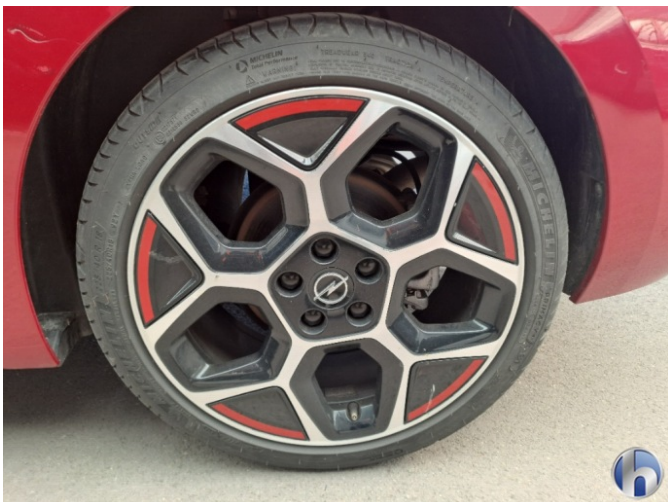
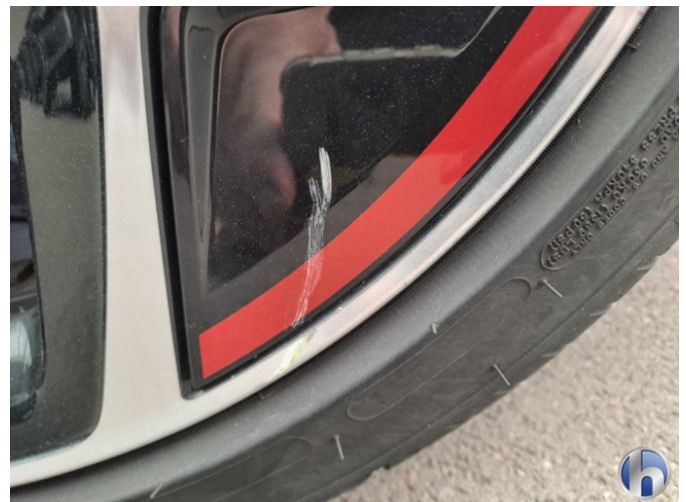
| component | Damage | Rep kind |
|---|---|---|
| 13. Felge Hinten links | Scratch(es) | Replace |

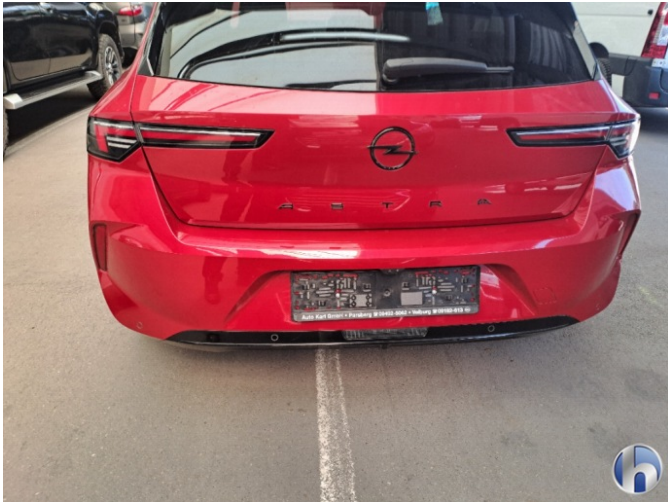
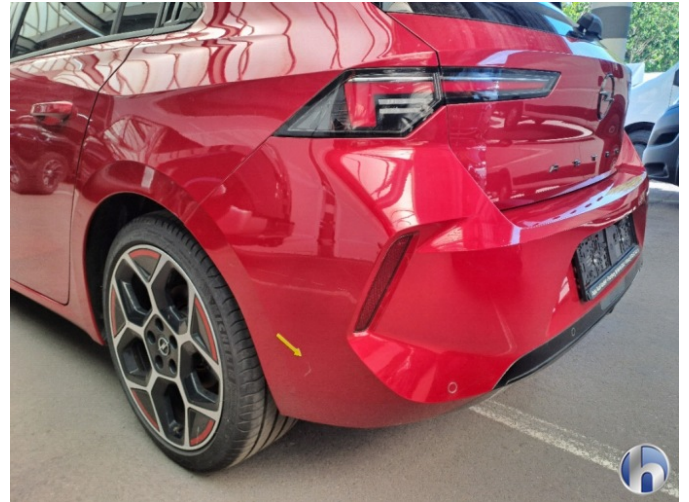
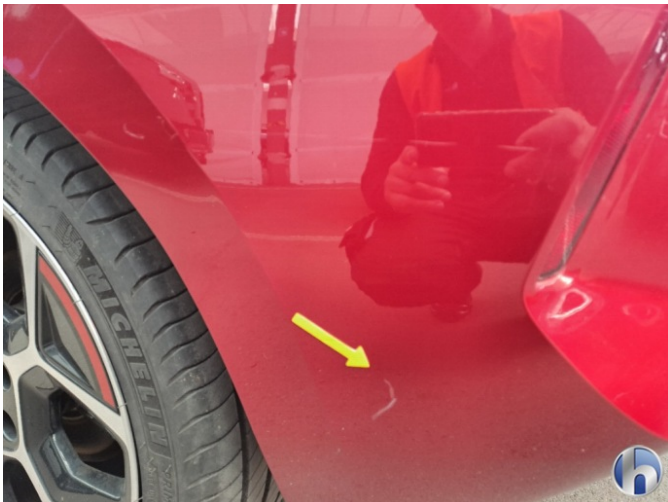
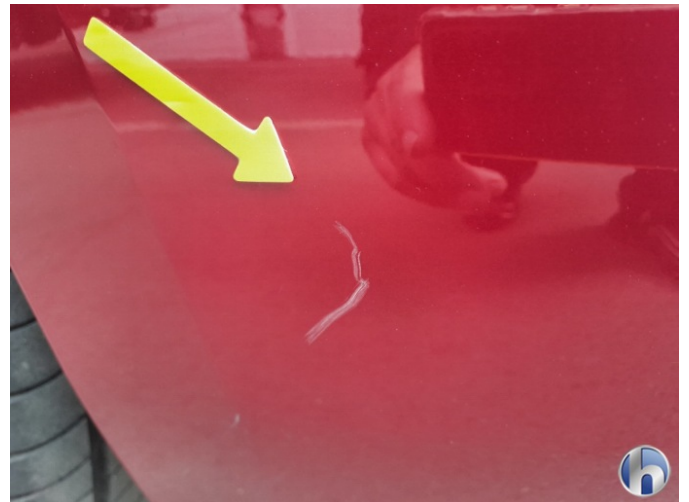
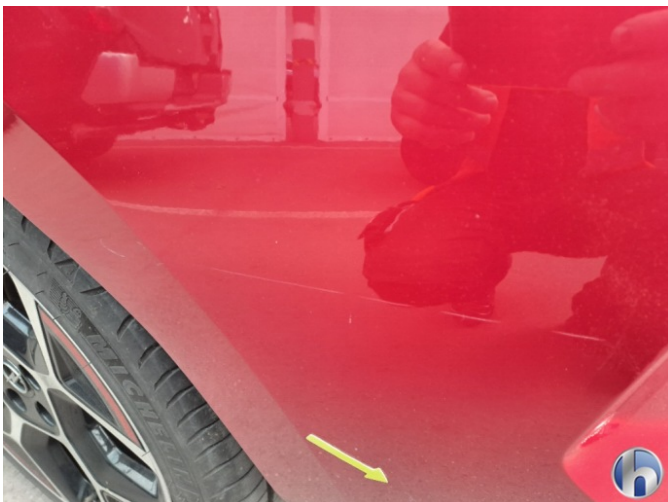
| component | Damage | Rep kind |
|---|---|---|
| 14. Rear bumper | Scratch(es) | Paint |

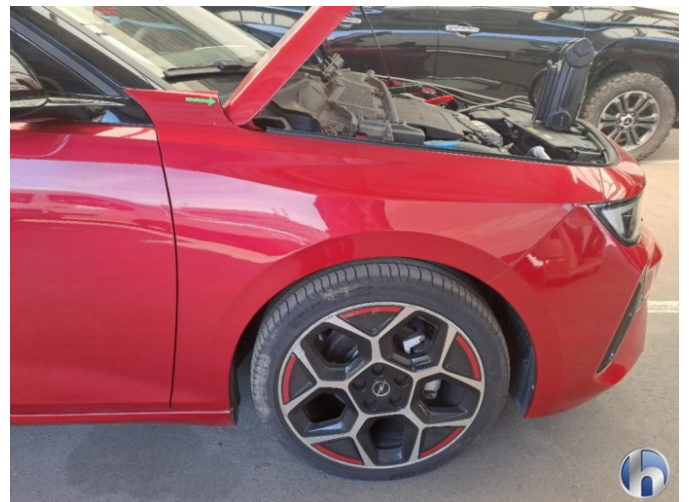
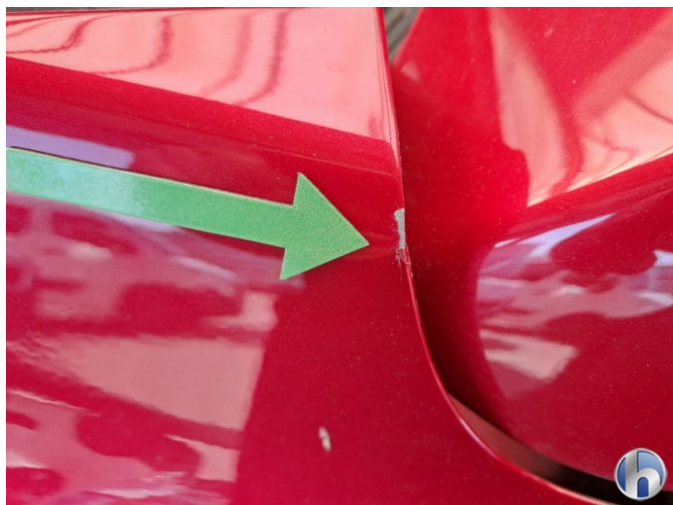
| component | Damage | Rep kind |
|---|---|---|
| 15. Front fender - right | Accident damage | Refurbish and paint |

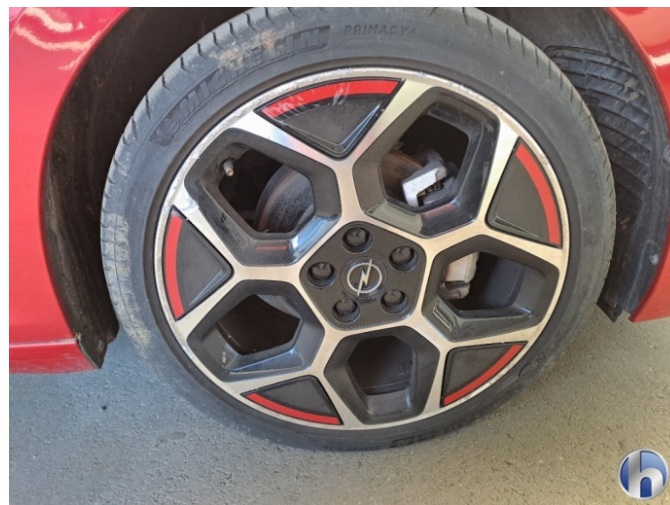
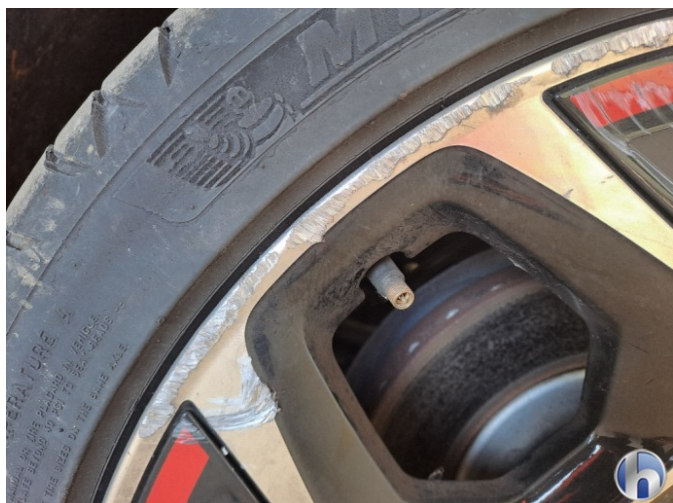
| component | Damage | Rep kind |
|---|---|---|
| 16. Felge vorn rechts | Scratch(es) | Replace |

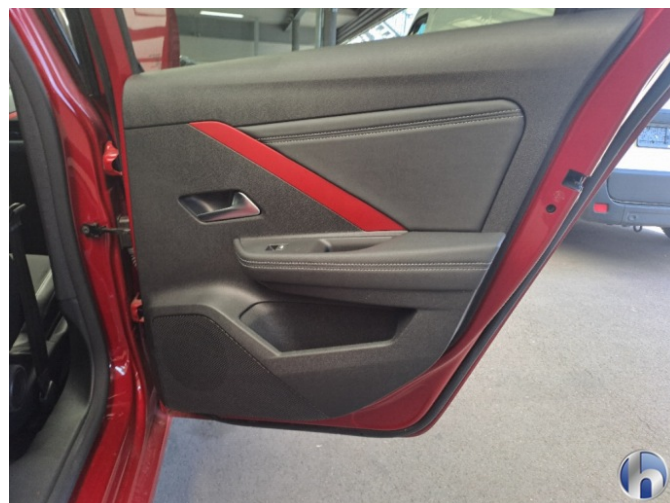
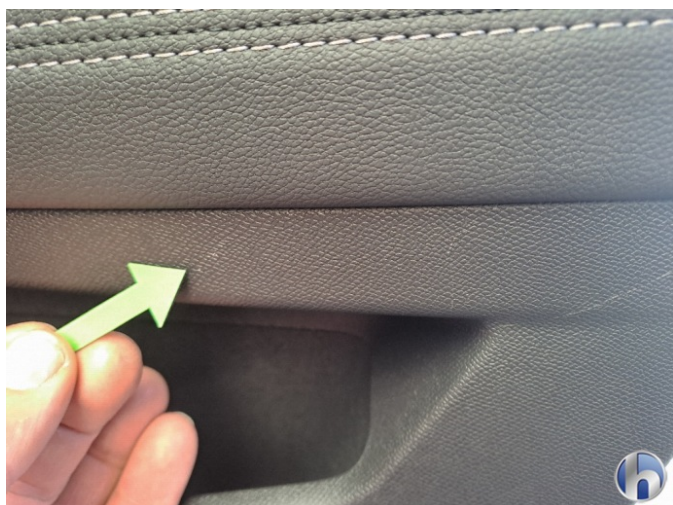
| component | Damage | Rep kind |
|---|---|---|
| 17. Türverkleidung Hinten rechts | Scratch(es) | Smart repair |

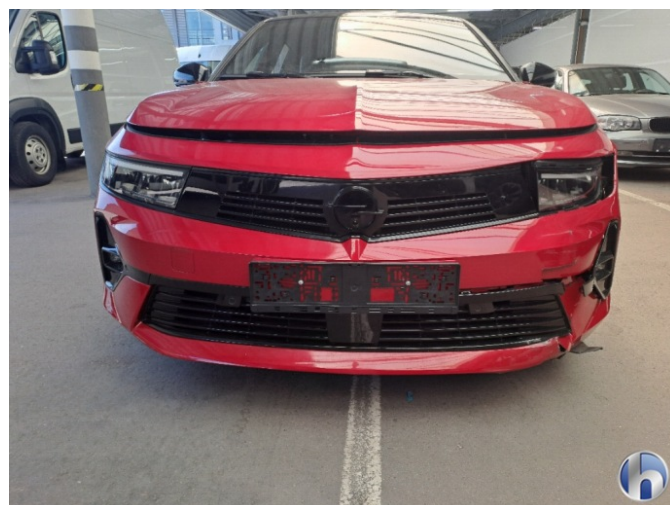
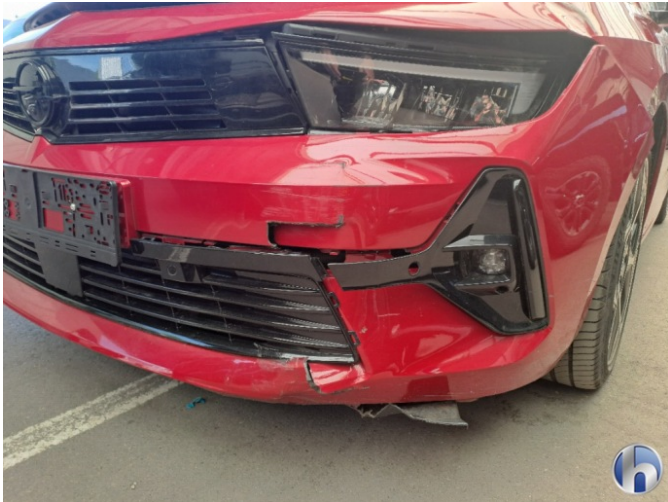
| component | Damage | Rep kind |
|---|---|---|
| 19. Front bumper | Accident damage | Replace |

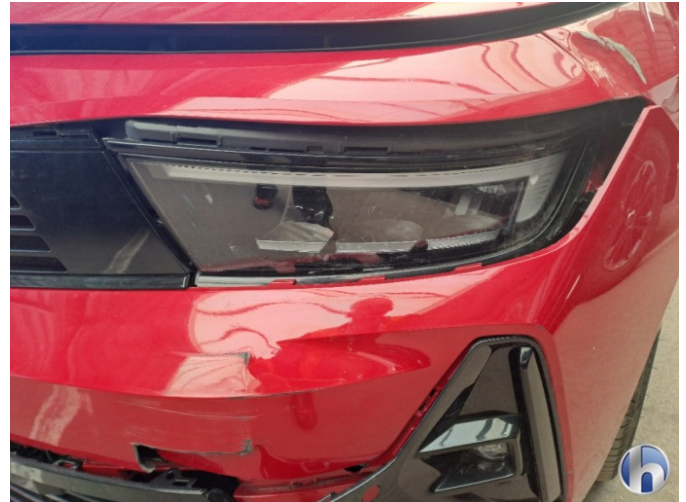
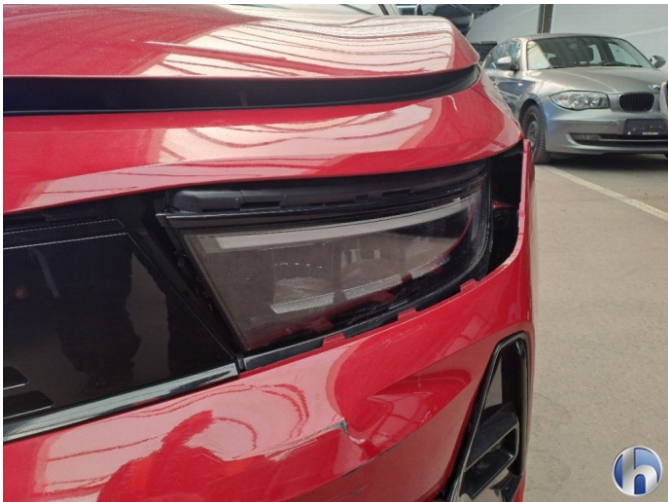
| component | Damage | Rep kind |
|---|---|---|
| 20. Halogen headlights - left | Accident damage | Replace |

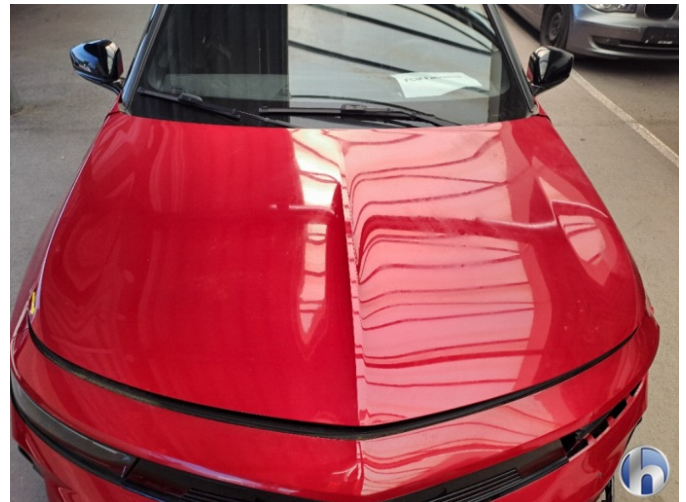
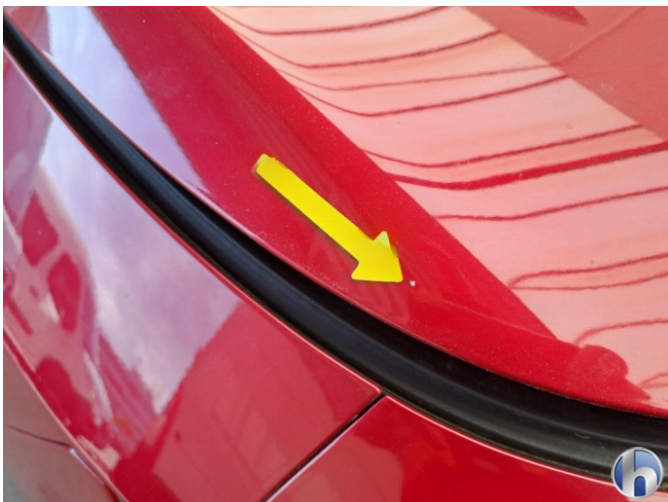
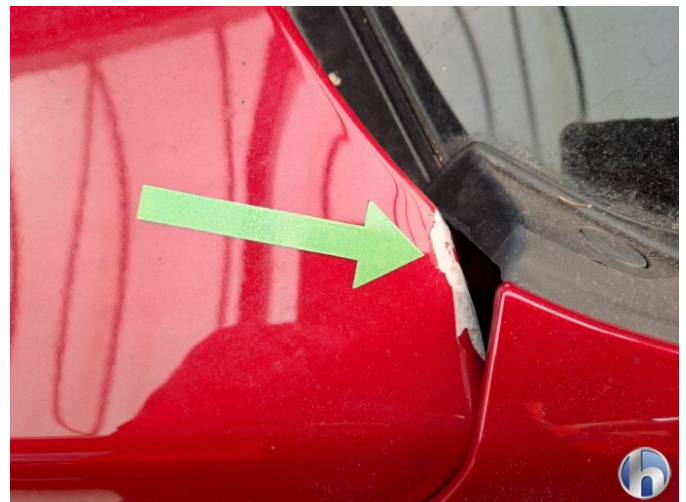
| component | Damage | Rep kind |
|---|---|---|
| 21. hood | Accident damage | Replace |
