## status report

**customer:** Opel Grosskunden/FSL/Free2Move  
**contract number:**  
**reference:**

#### Opel Astra L Lim. 5-trg. Elegance

| Vehicle identification number | VXKFPHNSTN1022513 | mileage read: | 32952 km |

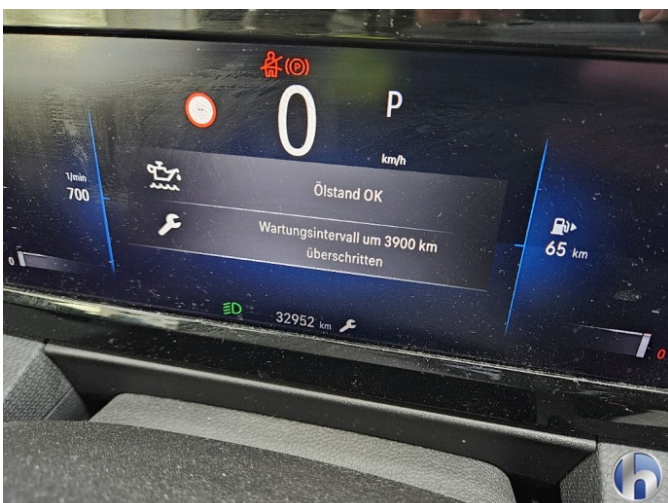
| component | Damage | Rep kind |
|---|---|---|
| 1. maintenance | Due | Replace |

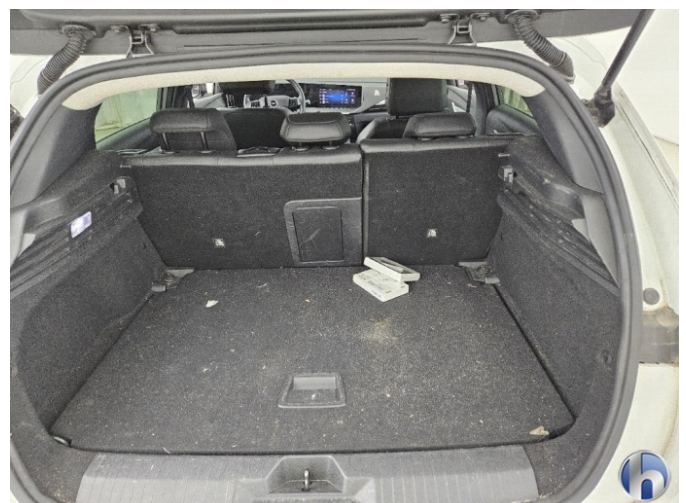
| component | Damage | Rep kind |
|---|---|---|
| 3. Cargo cover | Missing | Replace |

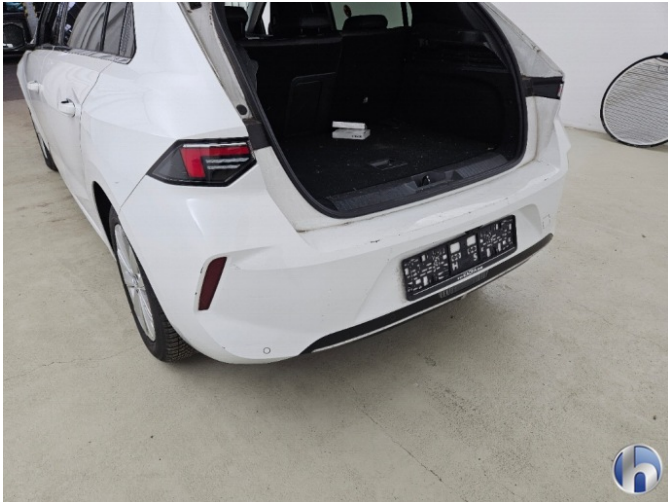
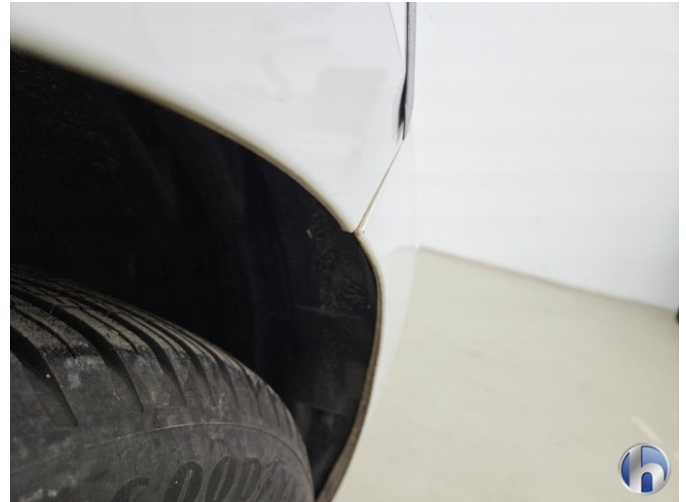
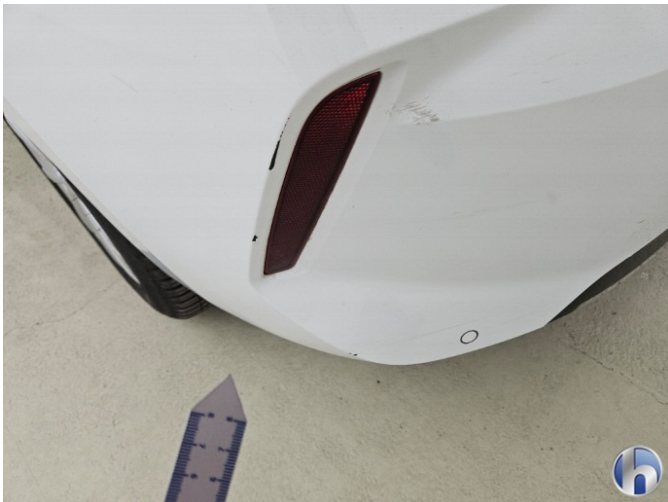
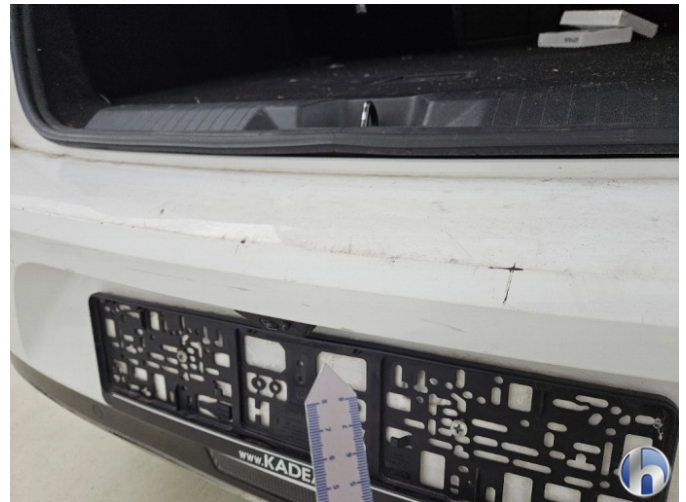
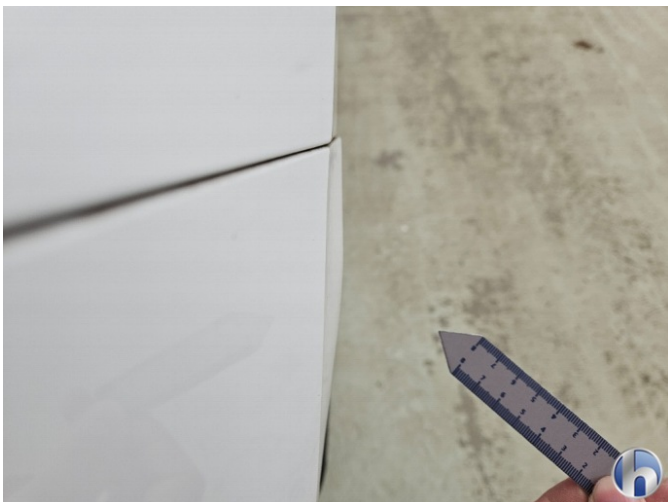
| component | Damage | Rep kind |
|---|---|---|
| 4. Rear bumper | Damaged | Replace |

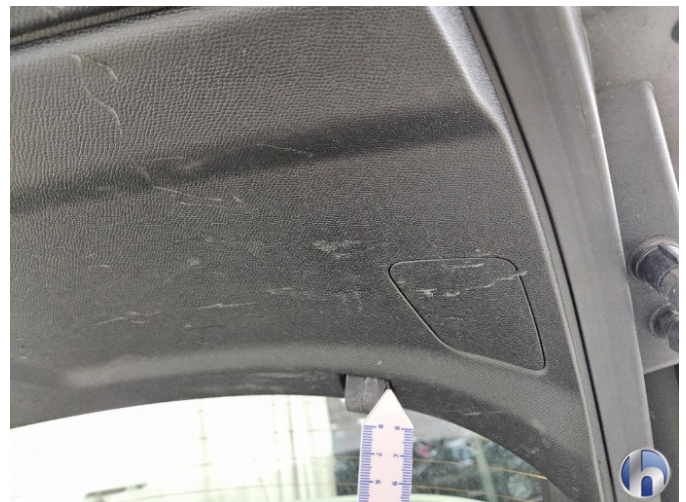
| component | Damage | Rep kind |
|---|---|---|
| 5. tailgate trim | Damaged | Replace |

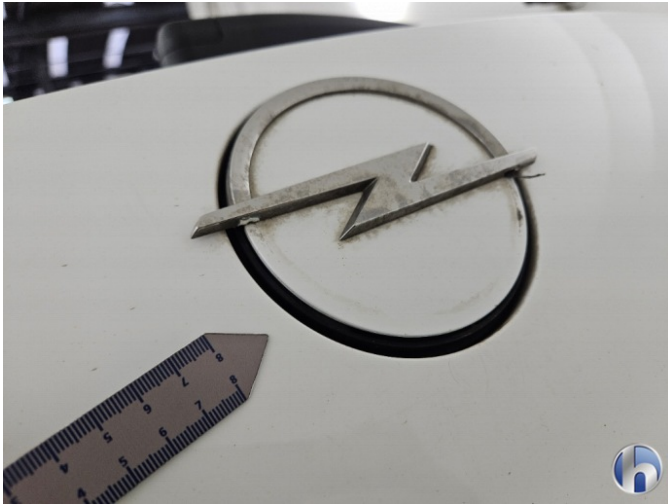
| component | Damage | Rep kind |
|---|---|---|
| 6. | Damaged | Replace |

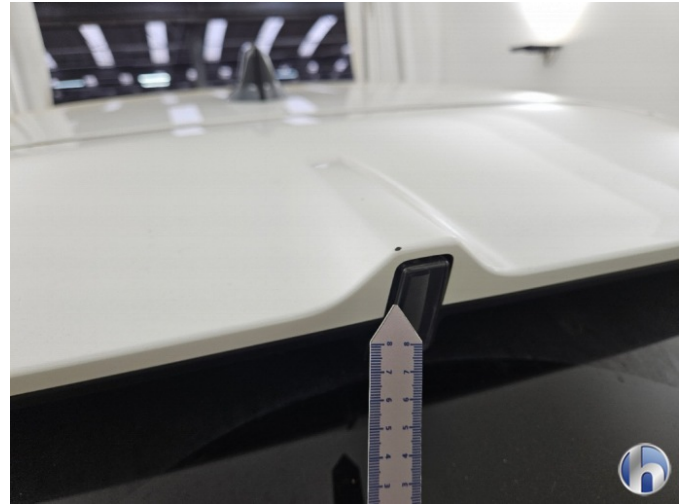
| component | Damage | Rep kind |
|---|---|---|
| 7. tailgate | Wear and tear | acceptable |

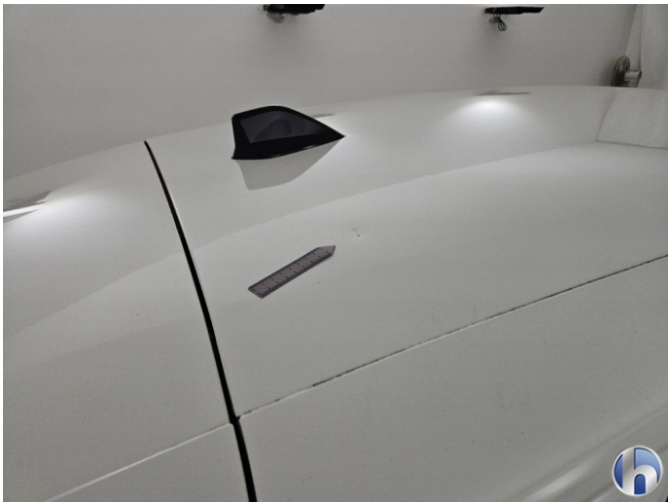
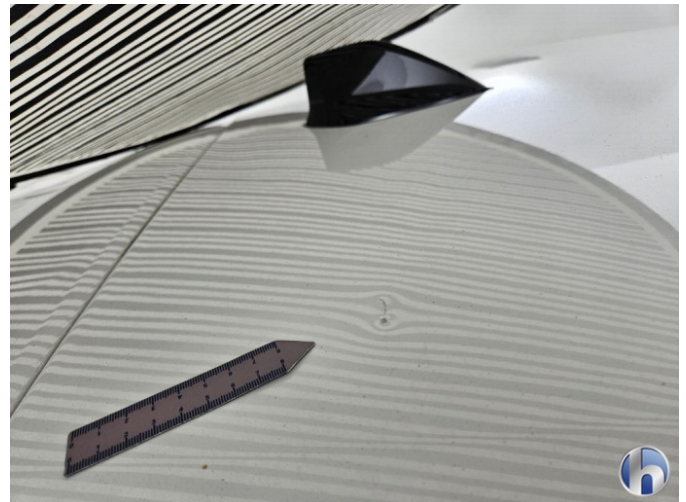
| component | Damage | Rep kind |
|---|---|---|
| 8. roof | Deformed (slightly) | Smart repair |

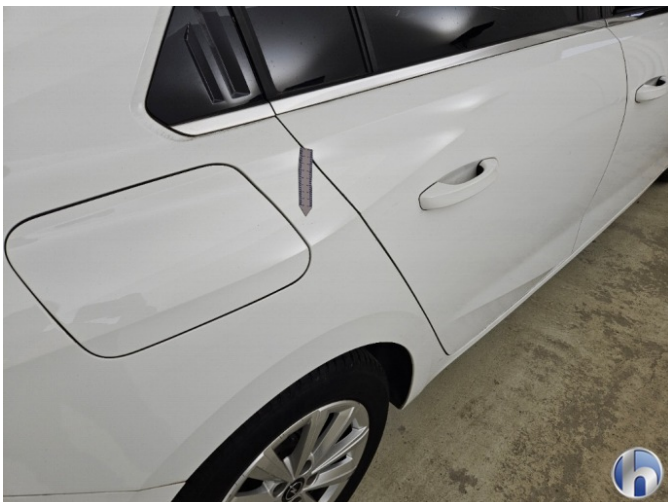
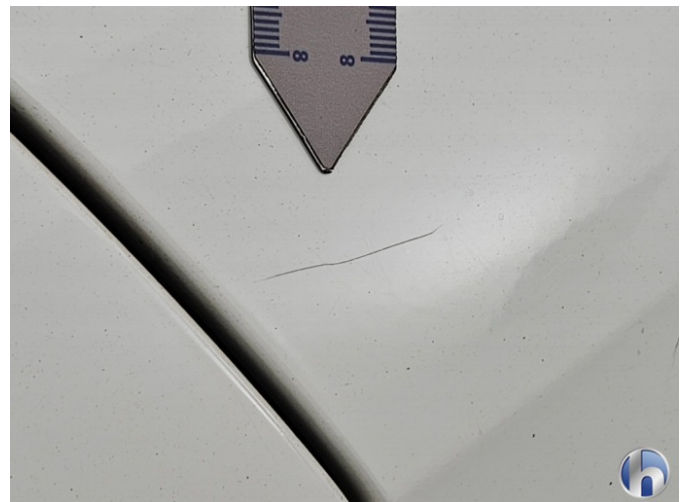
| component | Damage | Rep kind |
|---|---|---|
| 9. Sidewall - Rear - right | Scratch(es) | Paint |

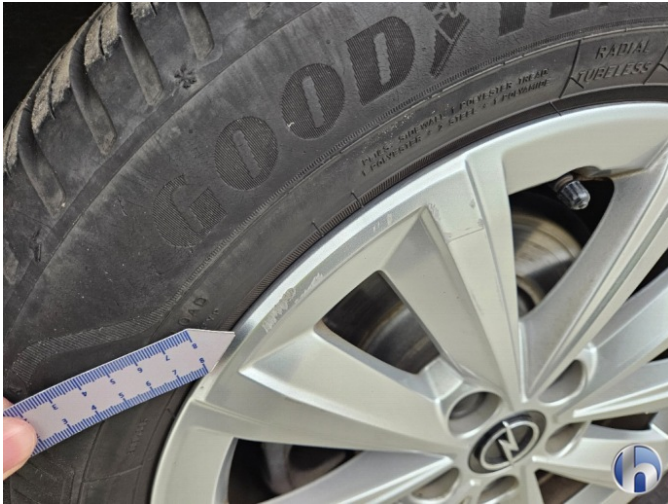
| component | Damage | Rep kind |
|---|---|---|
| 10. | Scratch(es) | Smart repair |

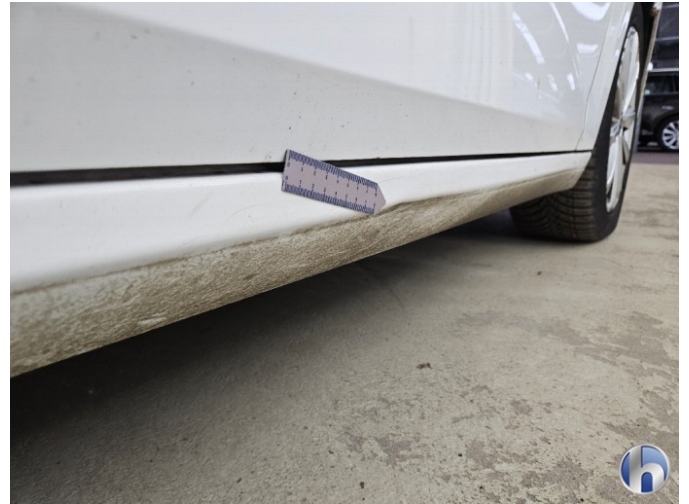
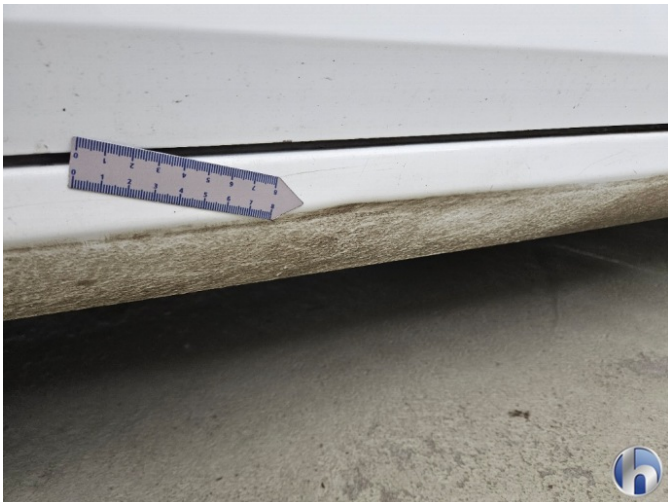
| component | Damage | Rep kind |
|---|---|---|
| 11. side skirt - right | Deformed (slightly) | Refurbish and paint |

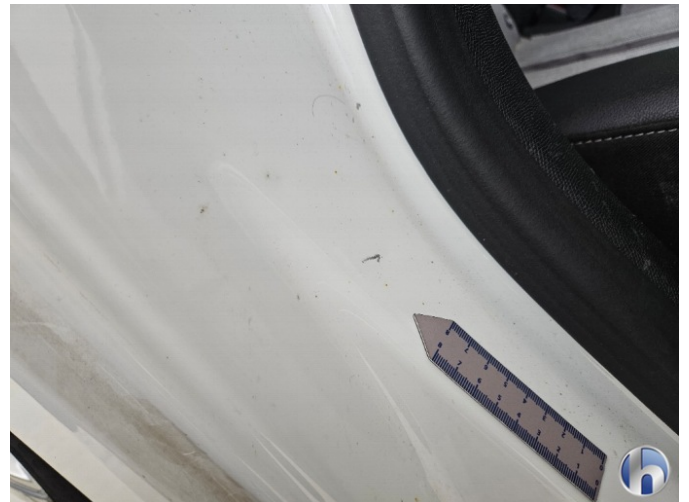
| component | Damage | Rep kind |
|---|---|---|
| 12. Türeinstieg Hinten - Rechts | Scratch(es) | Paint |

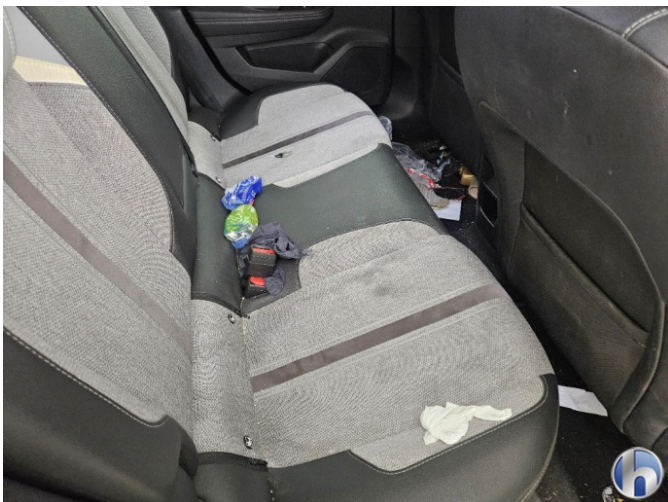
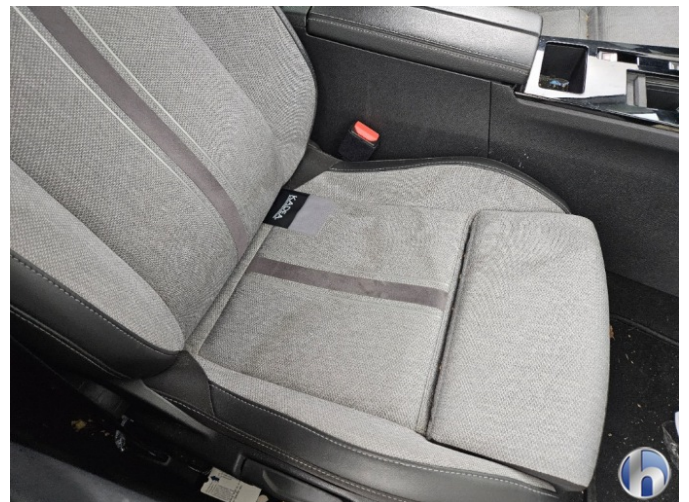
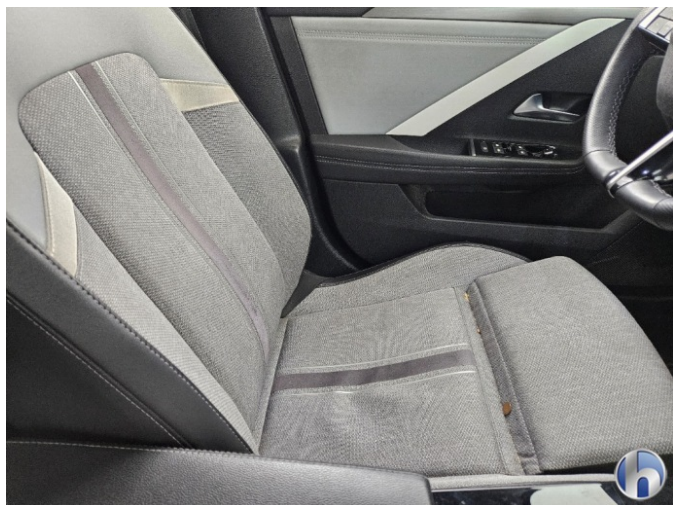
| component | Damage | Rep kind |
|---|---|---|
| 13. | Dirty (strong) | |

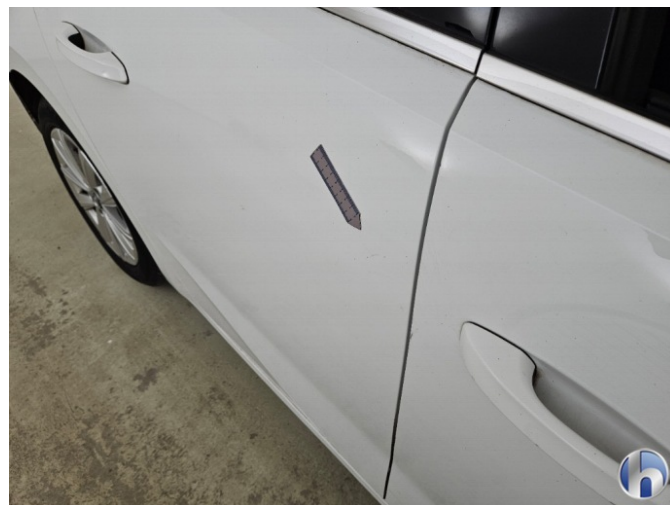
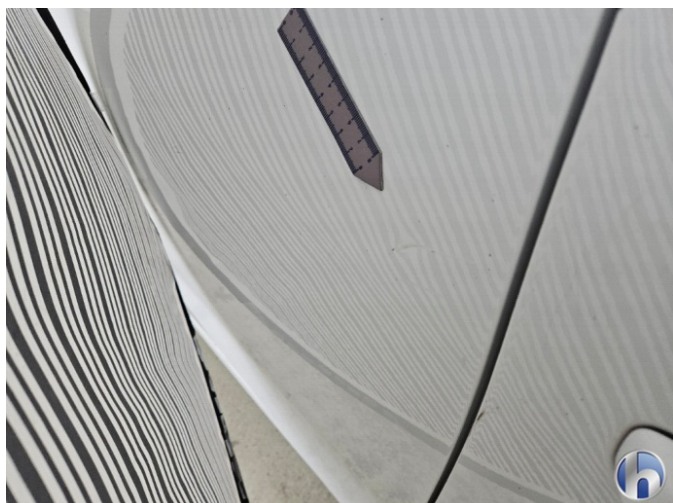
| component | Damage | Rep kind |
|---|---|---|
| 14. Door Rear - right | Damaged | Smart repair |

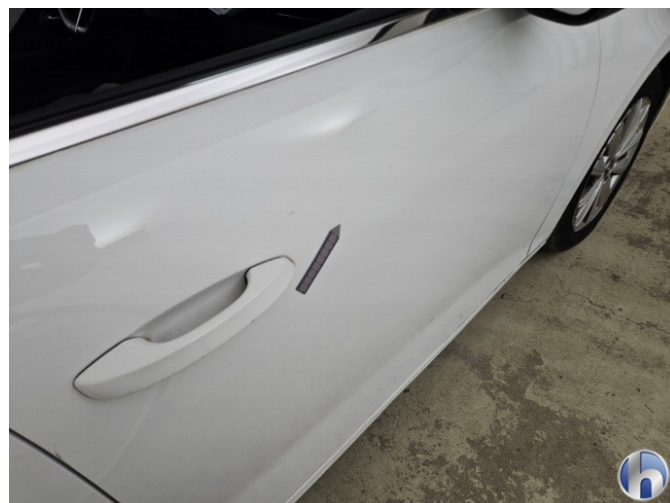
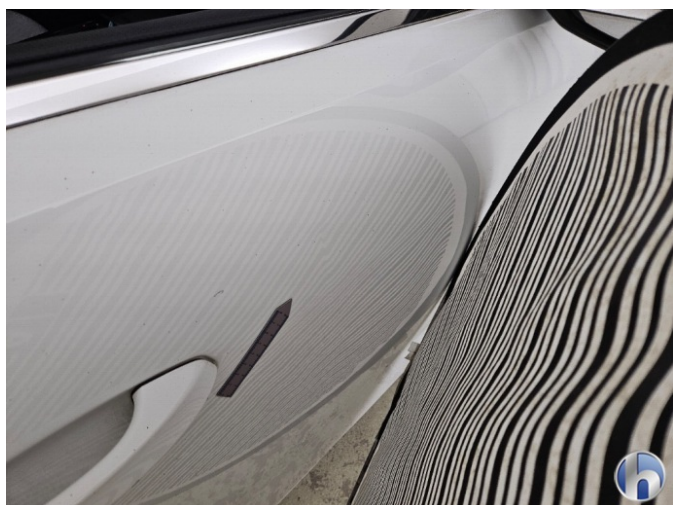
| component | Damage | Rep kind |
|---|---|---|
| 15. Front door - right | Deformed (slightly) | Smart repair |

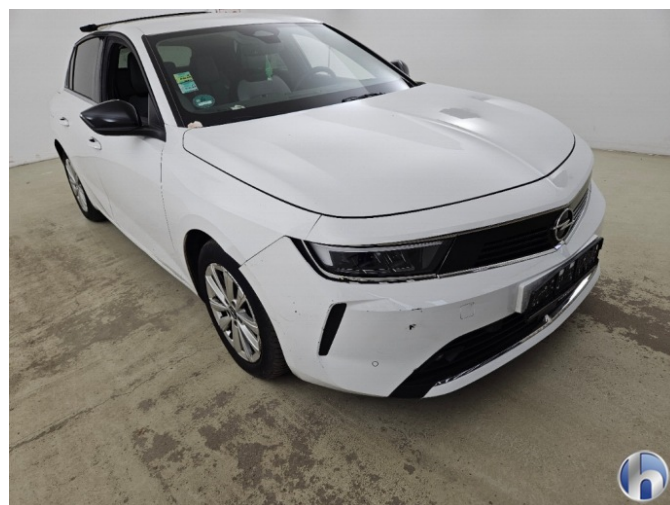
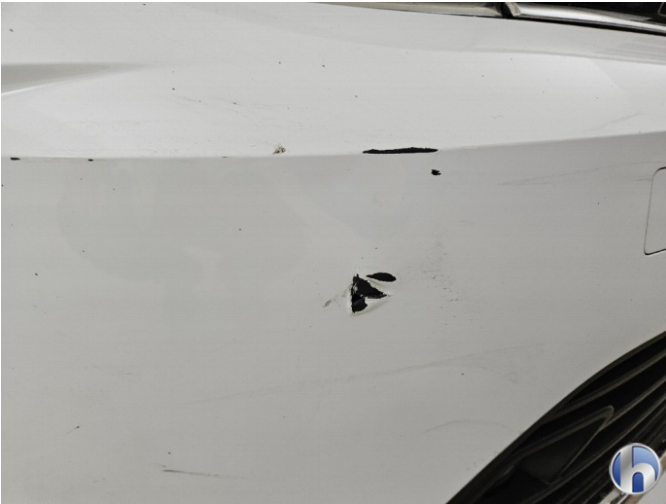
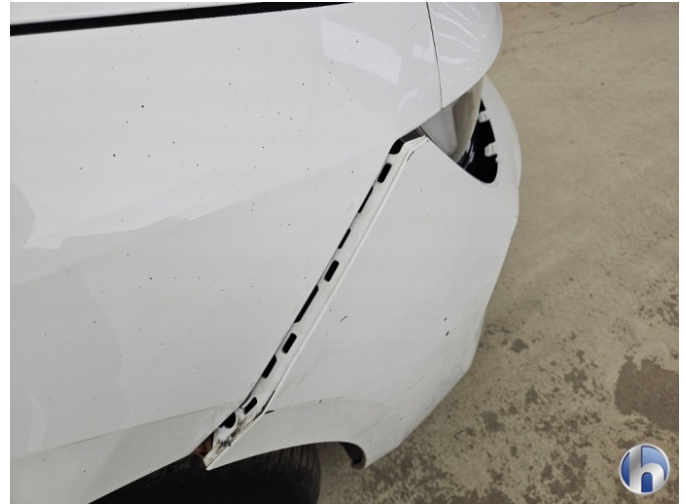
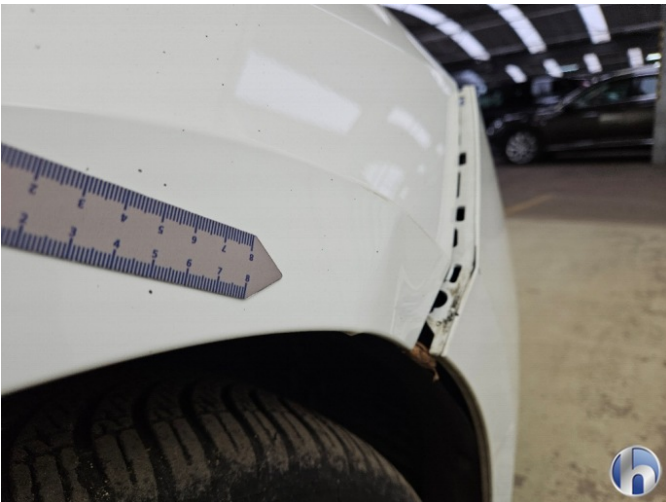
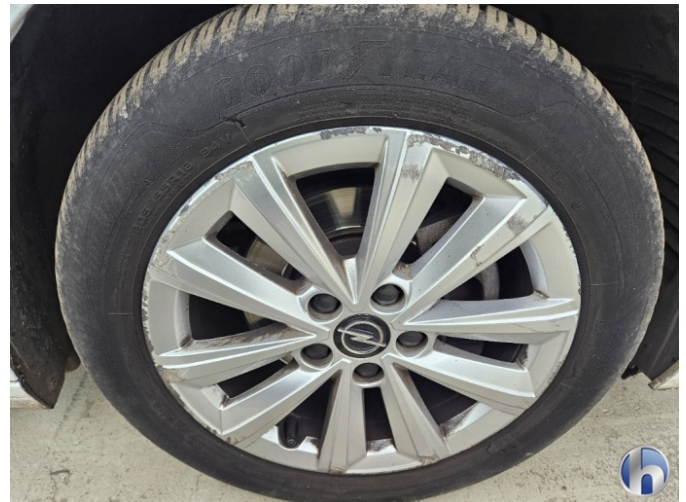
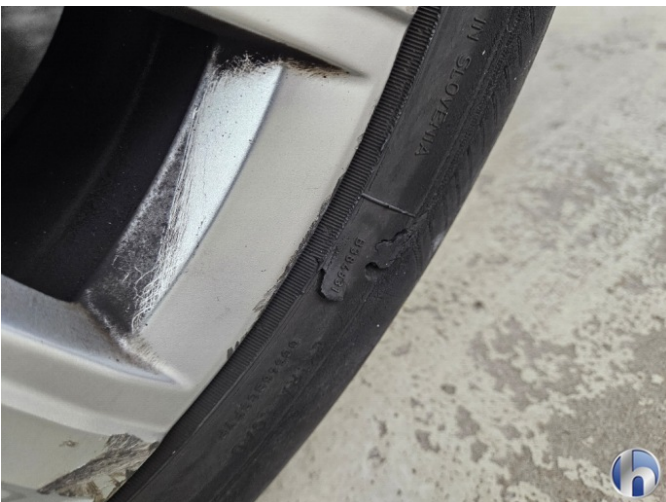
| <b>Existing collision damage:</b> | <b>found</b><br>At the unrepaired vehicle accident damage were observed on visual examination on the body skin . |
| <b>reference:</b> | Fahrzeug mit bestehenden Unfallschaden, zur Schadensermittlung wurden keine Demontagearbeiten durchgeführt, verborgen gebliebene Schäden können nicht ausgeschlossen werden. Unfallschaden Kosten wurden überschlägig Kalkuliert, Kostenerweiterung möglich. |

| component | Damage | Rep kind |
|---|---|---|
| 16. exterior body | Accident damage | Replace |

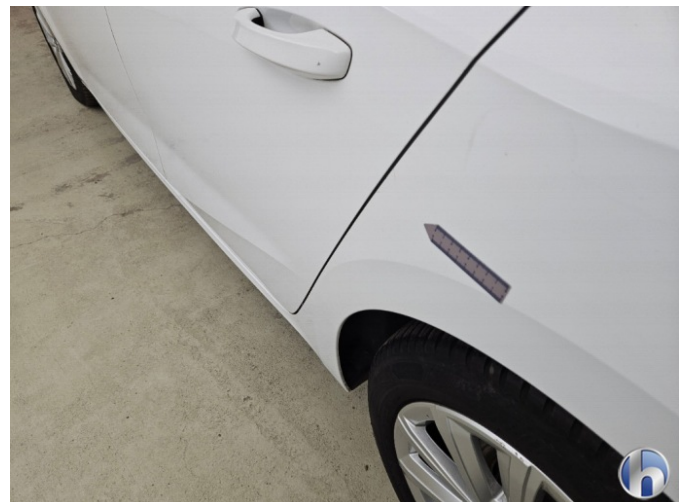
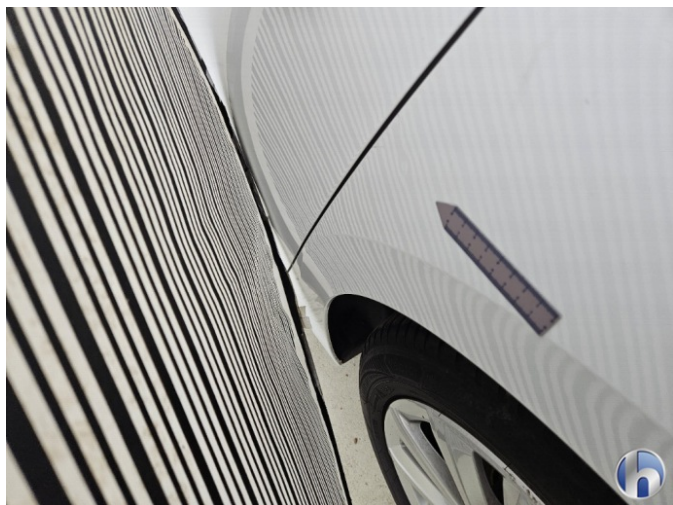
| component | Damage | Rep kind |
|---|---|---|
| 17. Sidewall - Rear - Left | Wear and tear | acceptable |

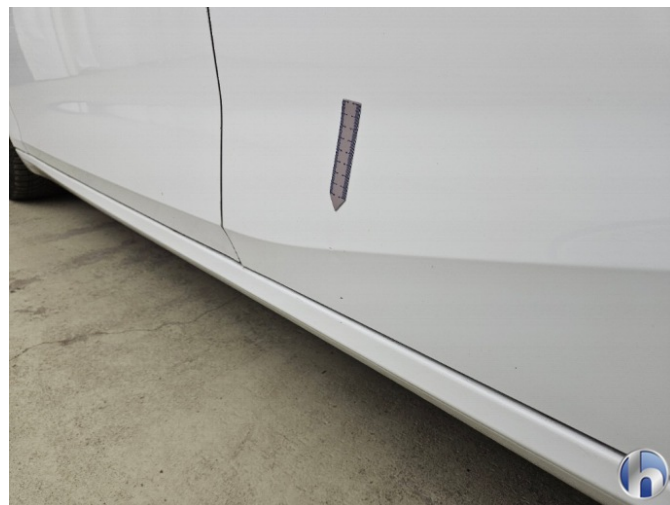
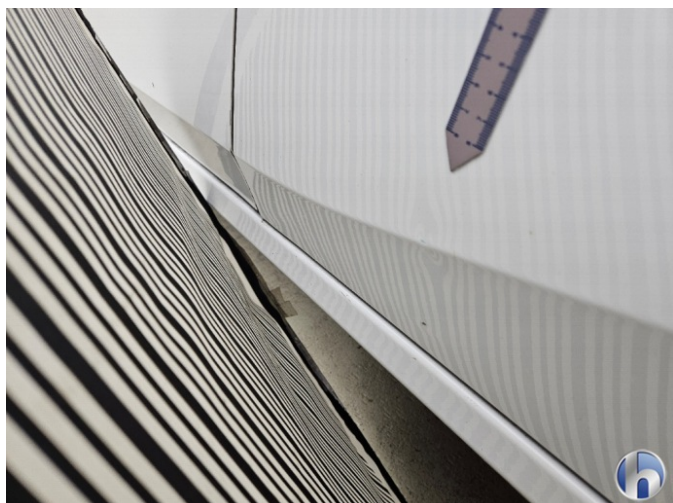
| component | Damage | Rep kind |
|---|---|---|
| 18. Rear door - left | Deformed (slightly) | Smart repair |

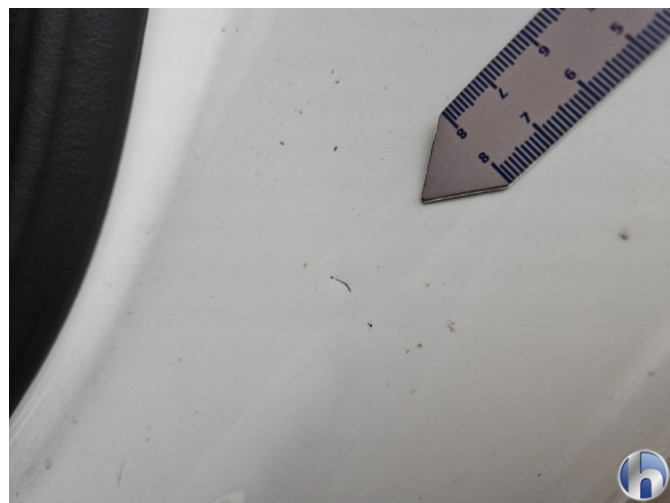
| component | Damage | Rep kind |
|---|---|---|
| 19. Türeinstieg Hinten - Links | Scratch(es) | Paint |

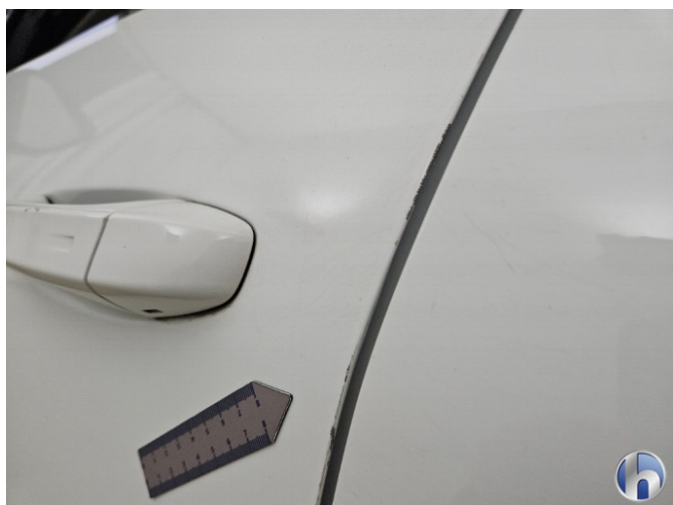
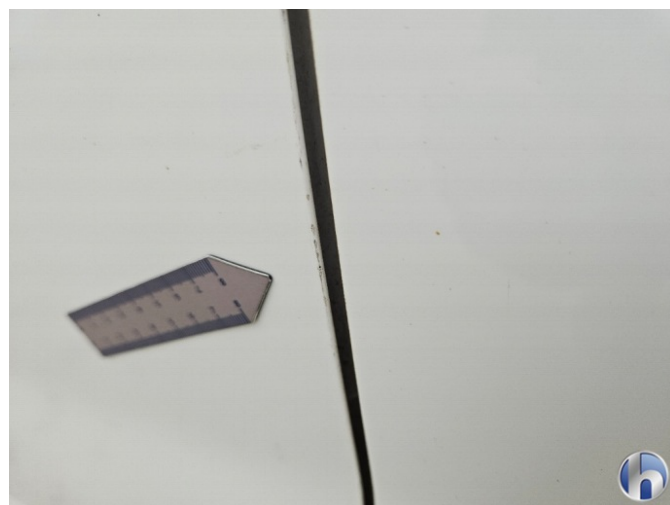
| component | Damage | Rep kind |
|---|---|---|
| 20. Front door - left | Wear and tear | acceptable |

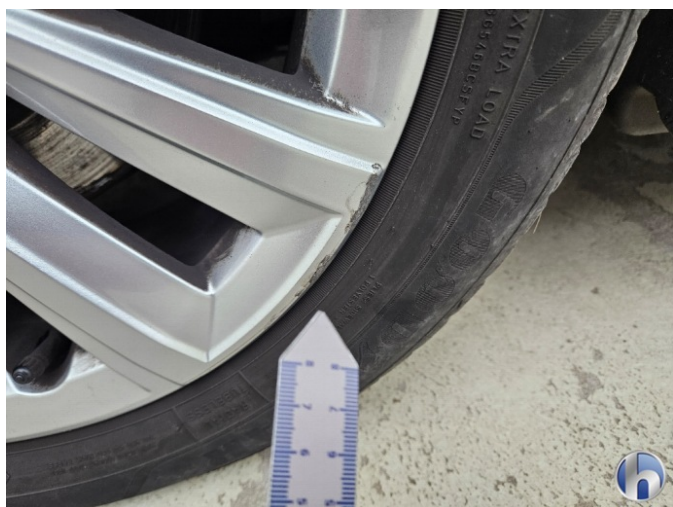
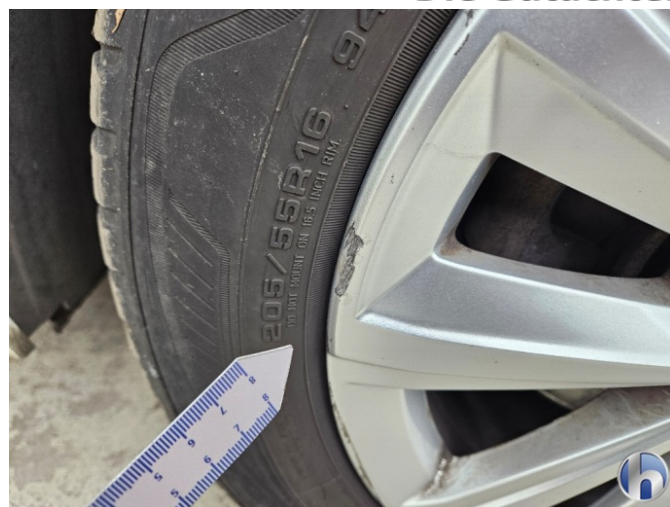
| component | Damage | Rep kind |
|---|---|---|
| 21. | Scratch(es) | Paint |

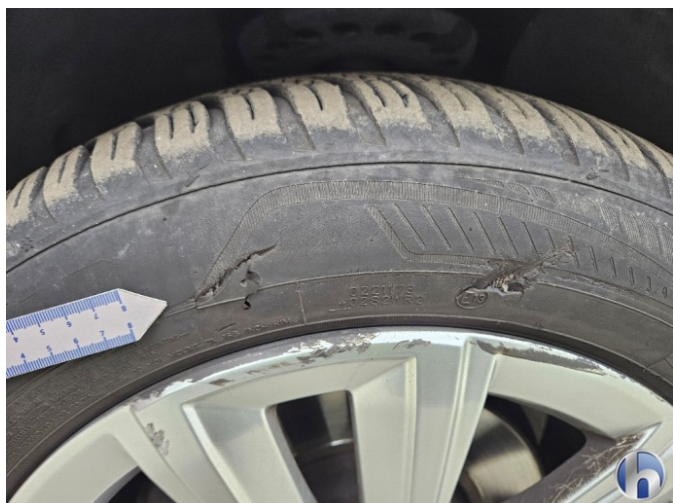
| component | Damage | Rep kind |
|---|---|---|
| 22. | Damaged | Replace |
