## status report

| vehicle data | | | |
|---|---|---|---|
| <b>Opel Astra L Sports Tourer Basis</b> | | | |
| Vehicle identification number | <b>VXKFRHNSTP1042461</b> | mileage read: | <b>45452 km</b> |

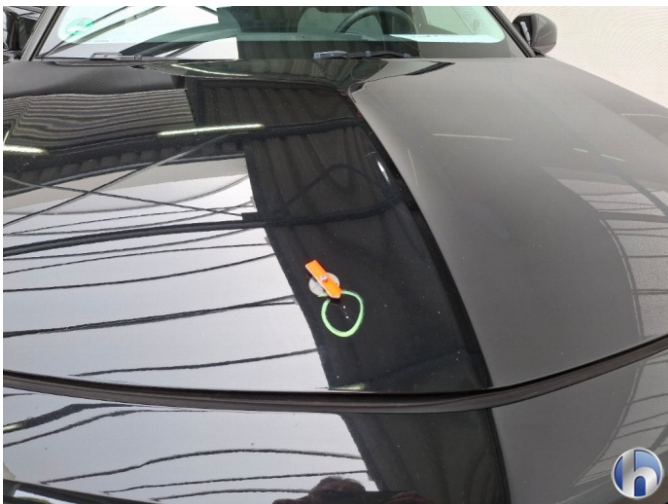
1. hood

Chipping from stones

| | component | Damage | Rep kind |
|---|---|---|---|
| 1. | hood | Chipping from stones | Paint |

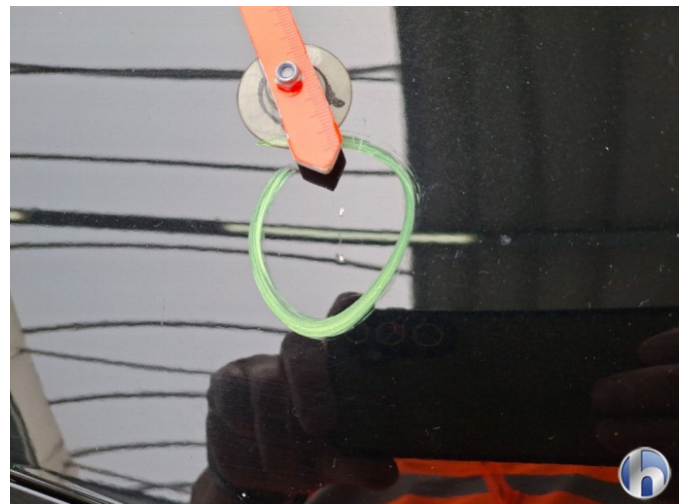
1. hood

Chipping from stones

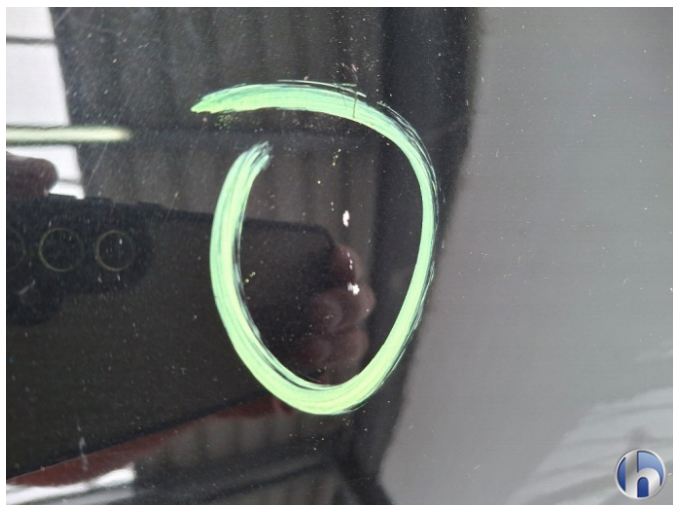
1. hood

**Chipping from stones**

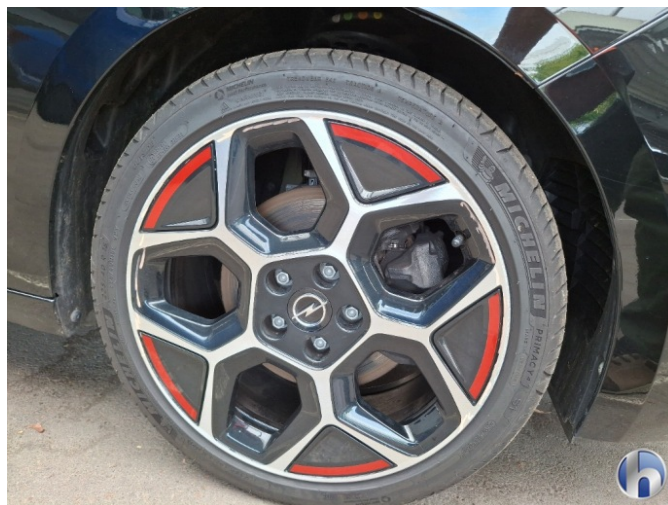
2. Rim front - right

**Damaged**

| | component | Damage | Rep kind |
|---|---|---|---|
| 2. | Rim front - right | Damaged | Replace |

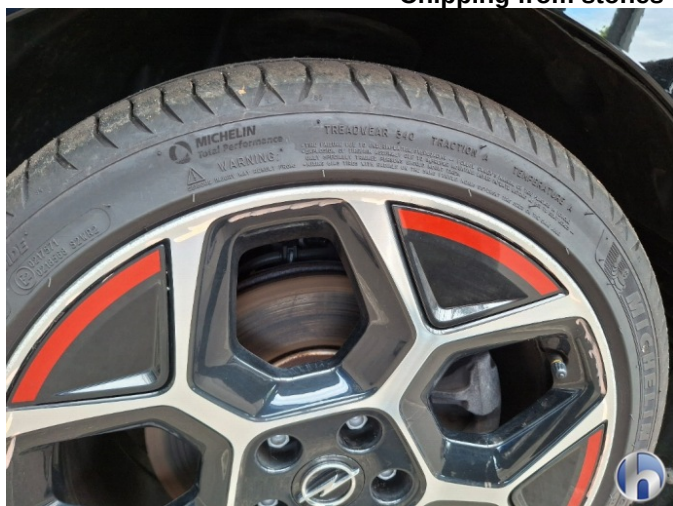
2. Rim front - right

**Damaged**

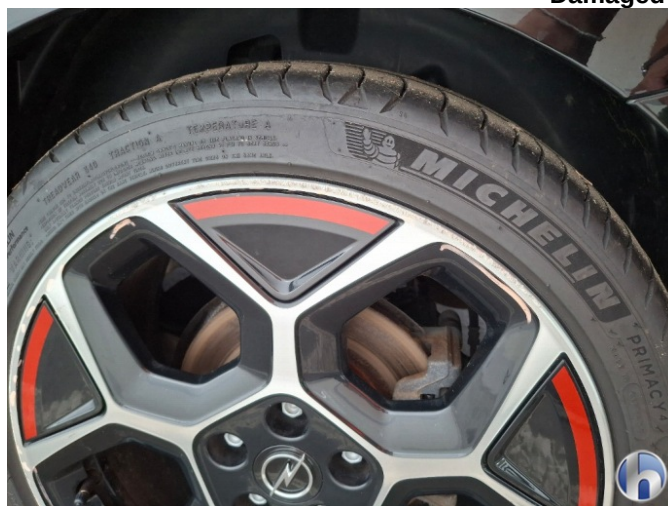
3. Rim front - left

**Damaged**

| | component | Damage | Rep kind |
|---|---|---|---|
| 3. | Rim front - left | Damaged | Replace |

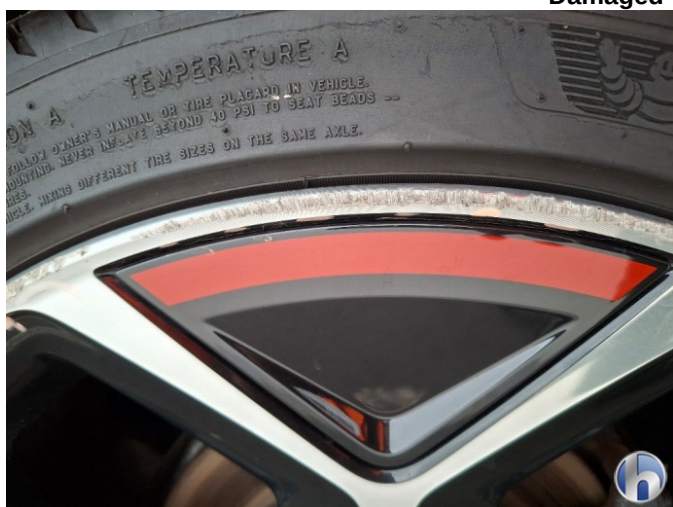
3. Rim front - left

**Damaged**
