Expertise

Protocol number: 41307007  
Order No. / Reference: 25155822  
Inspection date: 29 Aug 2025

Manufacturer: Opel

Model: Corsa-e Edition

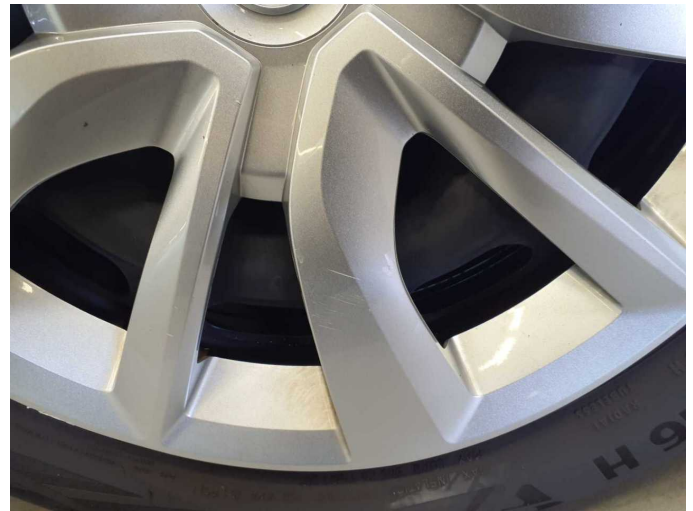
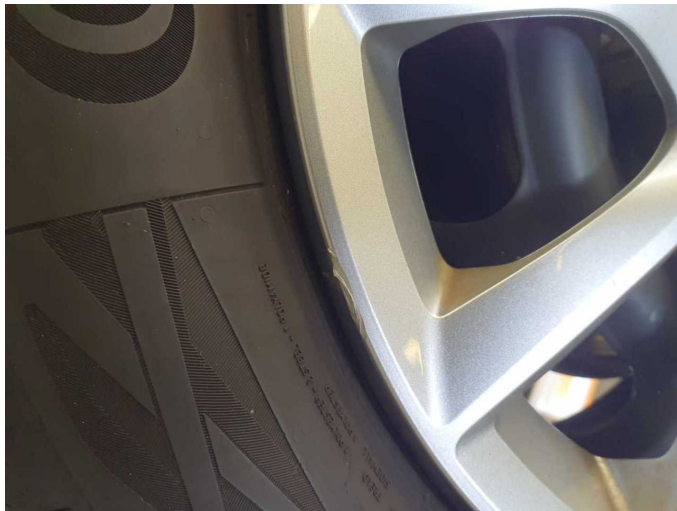
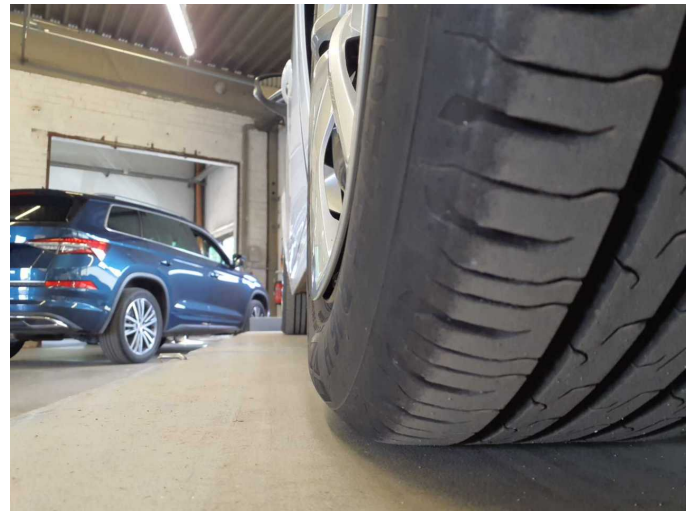
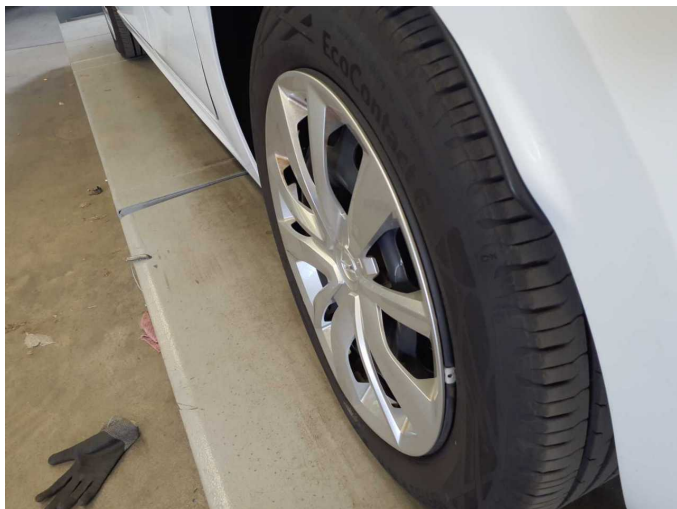
No.	Component group	Description
1	Wheel / tyres	Wheel cover - rear left side (+verformt) - Scratch(es) - Replace
2	Equipment	Tirefit filler - Expired - Replace
3	Door - front left side	Strip - outer - Scratch(es) - Replace
4	Rear bumper	Rear bumper - Scratch(es) - Smart repair

**Damage 1:** Wheel / tyres: Wheel cover - rear left side (+verformt) - Scratch(es) - Replace

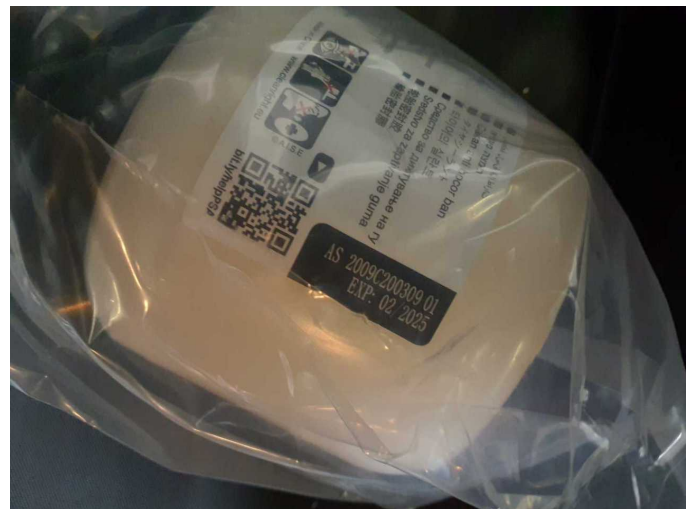
**Damage 2:** Equipment: Tirefit filler - Expired - Replace

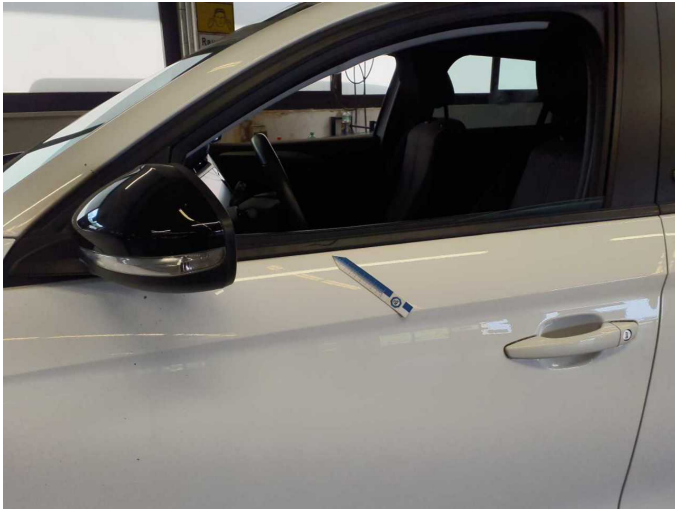
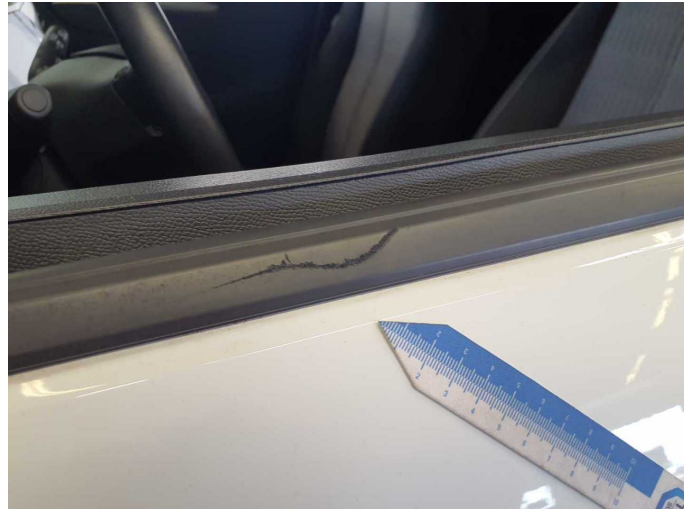
**Damage 3:** Door - front left side: Strip - outer - Scratch(es) - Replace

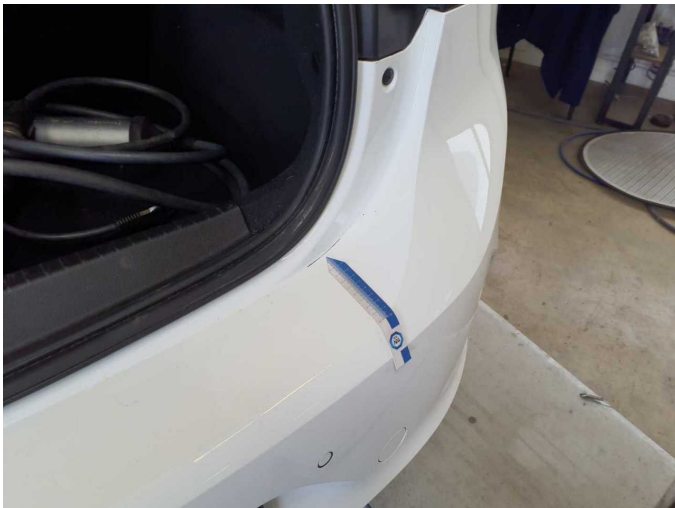
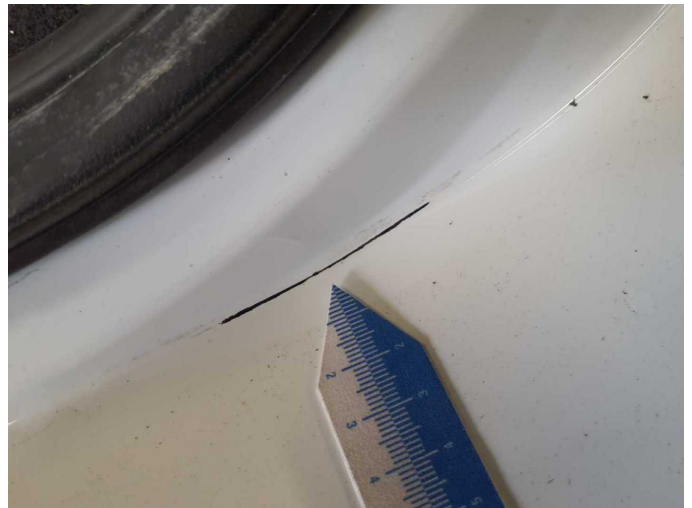
**Damage 4:** Rear bumper: Rear bumper - Scratch(es) - Smart repair

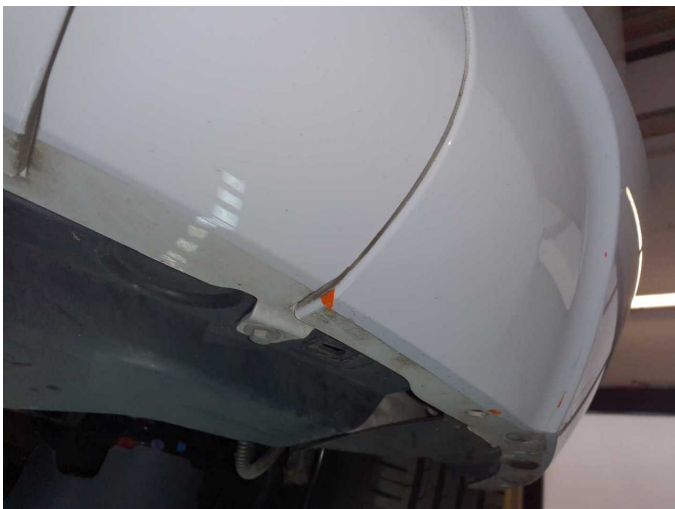
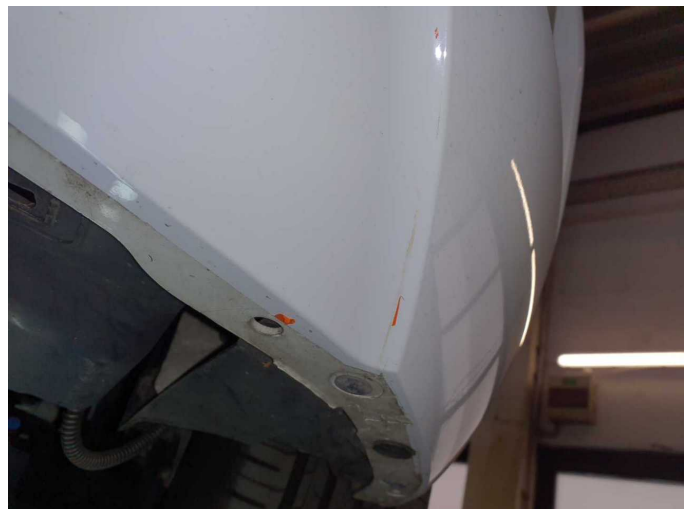
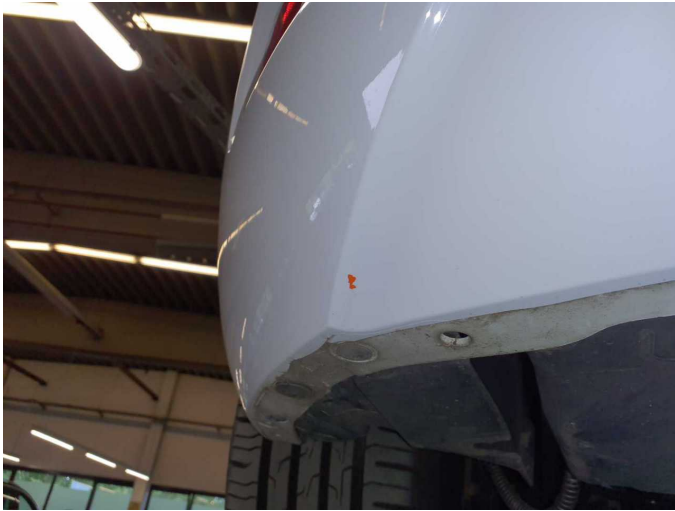
**Wear and tear 3:** Rear bumper: Rear bumper (Kleine klebestreifenreste)  
- Glued / labelled - No deduction
