## status report

#### Opel Corsa F Elegance

| Vehicle identification number | <b>VXKUPHNKKL4023805</b> | mileage read: | <b>122641 km</b> |

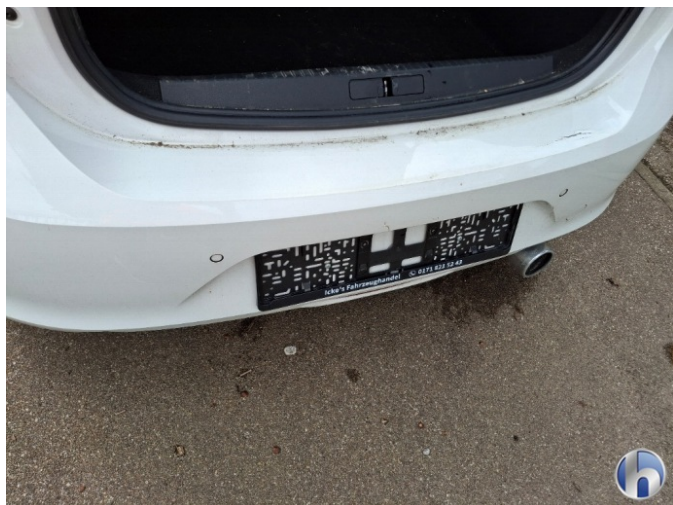
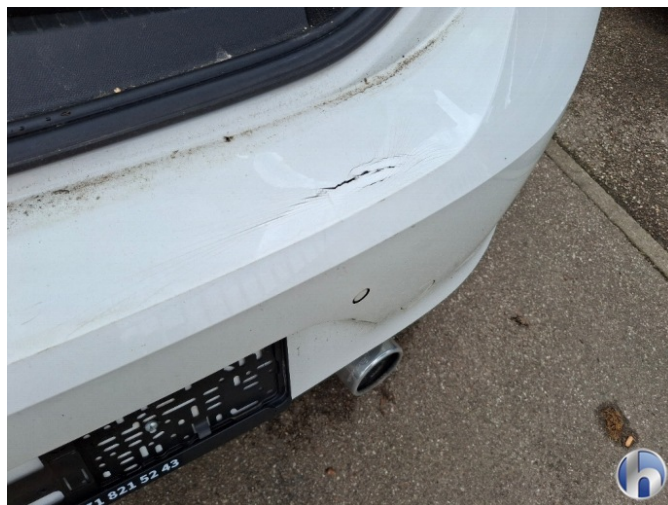
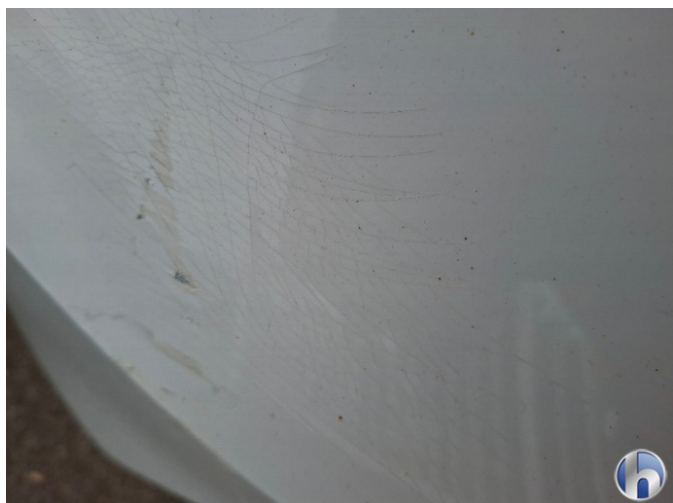
| | <b>component</b> | <b>Damage</b> | <b>Rep kind</b> |
|---|---|---|---|
| 1. | Rear bumper | Breakage | Replace |

1. Rear bumper

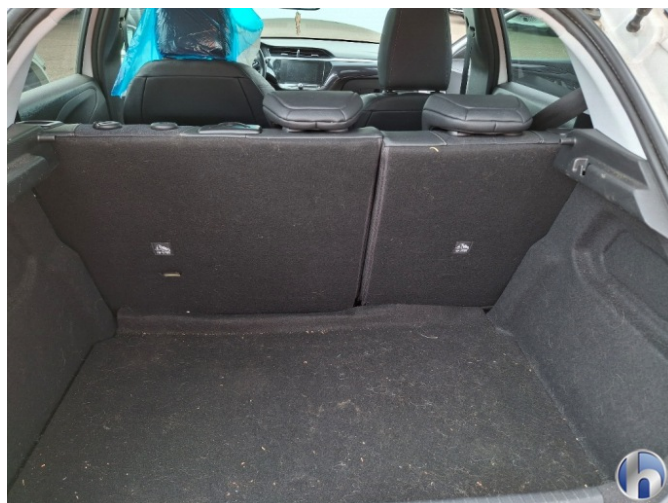
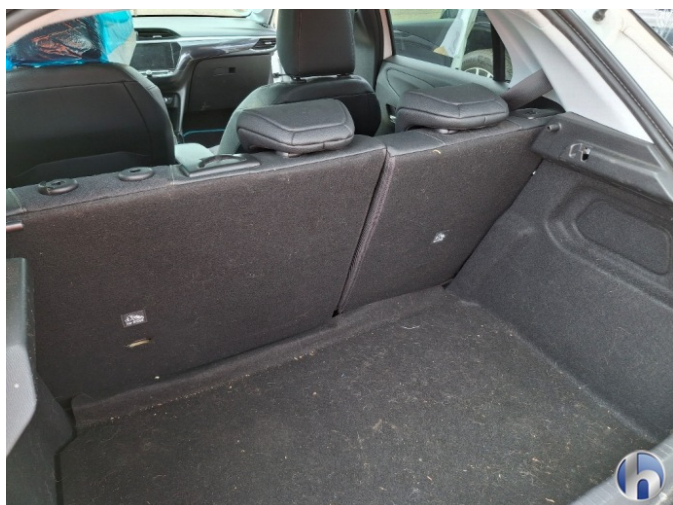
| | <b>component</b> | <b>Damage</b> | <b>Rep kind</b> |
|---|---|---|---|
| 2. | Cargo cover | Missing | Replace |

2. Cargo cover

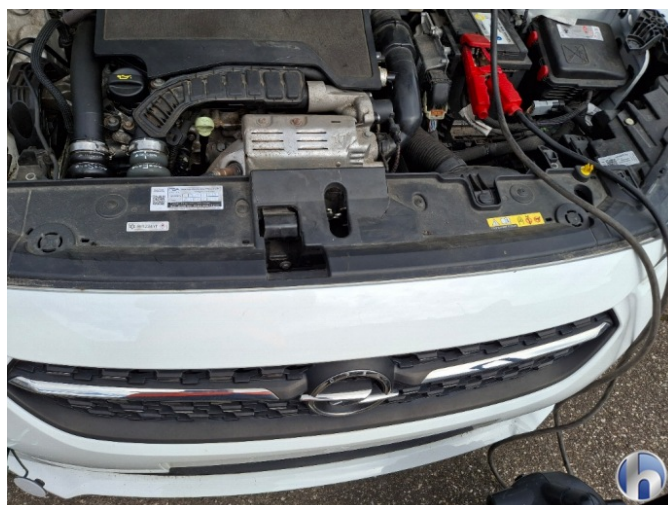
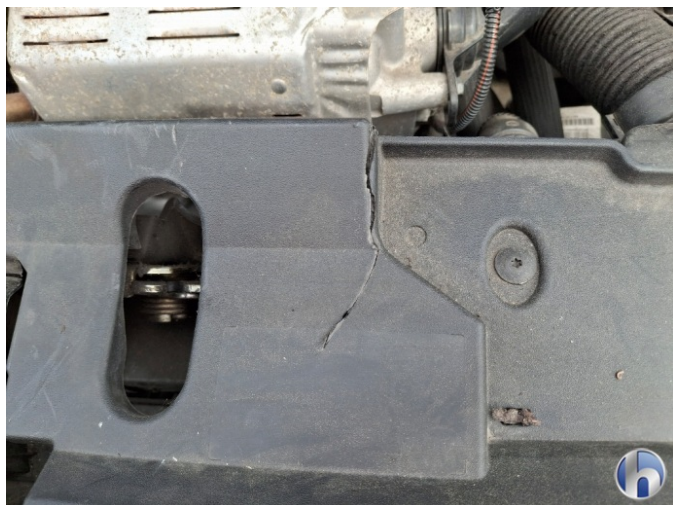
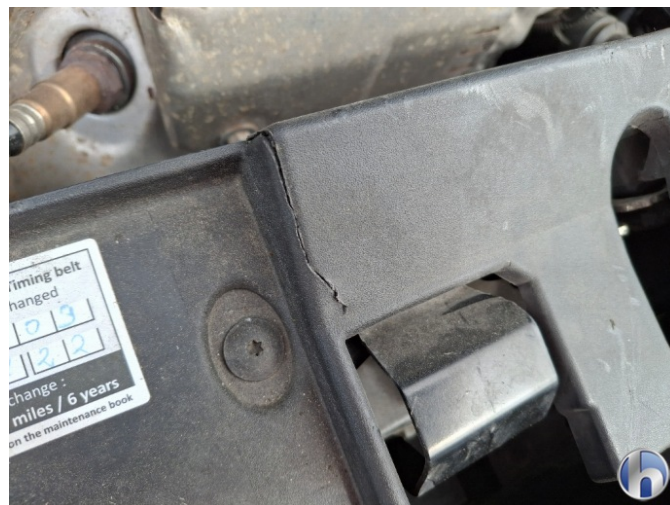
| | <b>component</b> | <b>Damage</b> | <b>Rep kind</b> |
|---|---|---|---|
| 3. | Luftführung | Breakage | Replace |

3. Luftführung

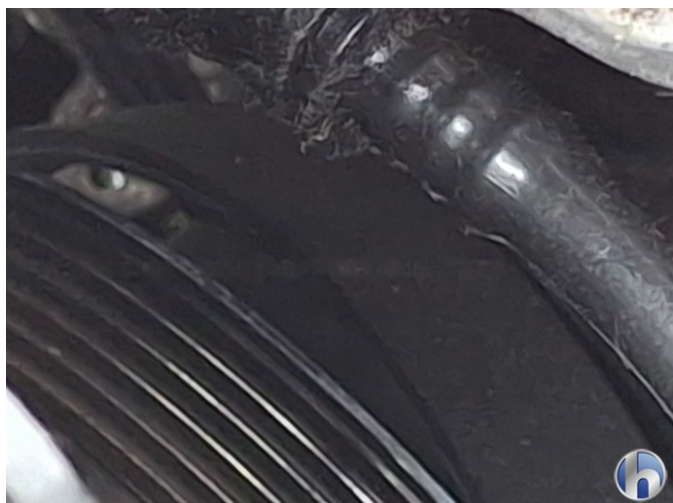
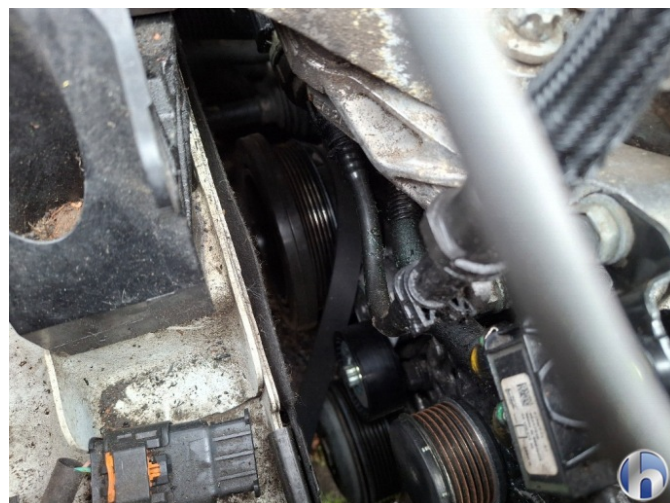
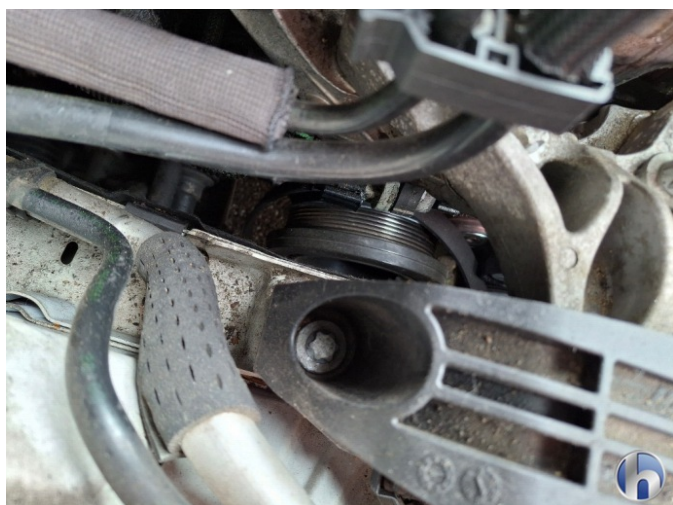
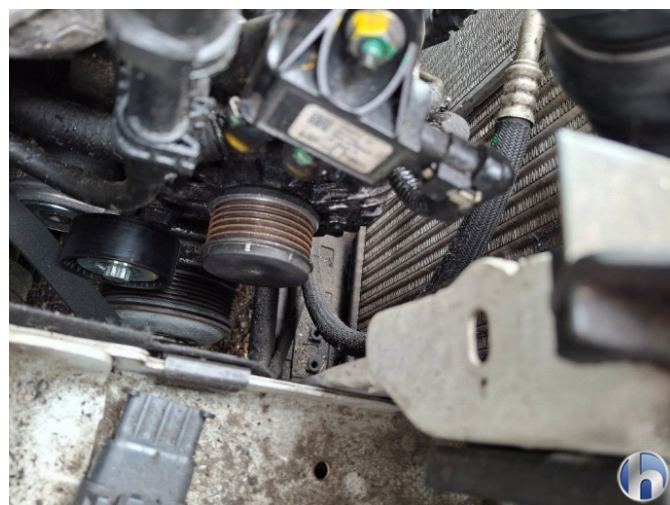
| Performed testing technology | |
|---|---|
| <b>Alternator / Generator:</b> | The function of the alternator (generator) was not tested.<br>*Riemen ist abgesprungen |
| <b>oil loss:</b> | The vehicle was inspected during the visit to an oil leak .<br>*Antriebsriemen für Lichtmaschine abgesprungen<br>**motor. |

| | <b>component</b> | <b>Damage</b> | <b>Rep kind</b> |
|---|---|---|---|
| 4. | Rillenriemen Lichtmaschine | Not okay | Carry out a fault diagnosis |

4. Rillenriemen Lichtmaschine

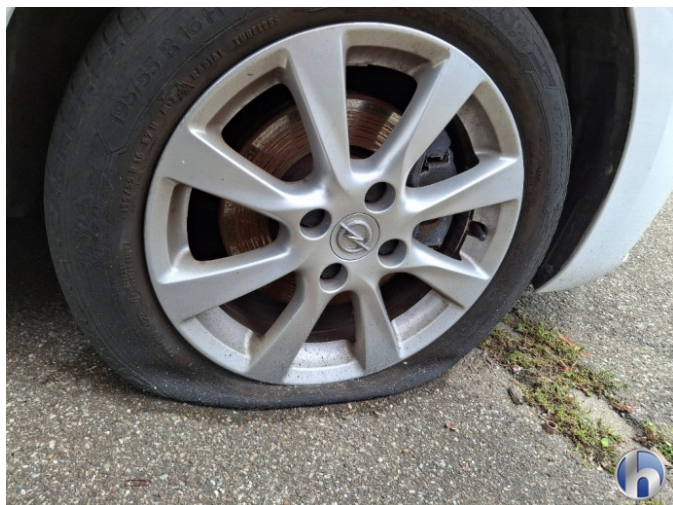
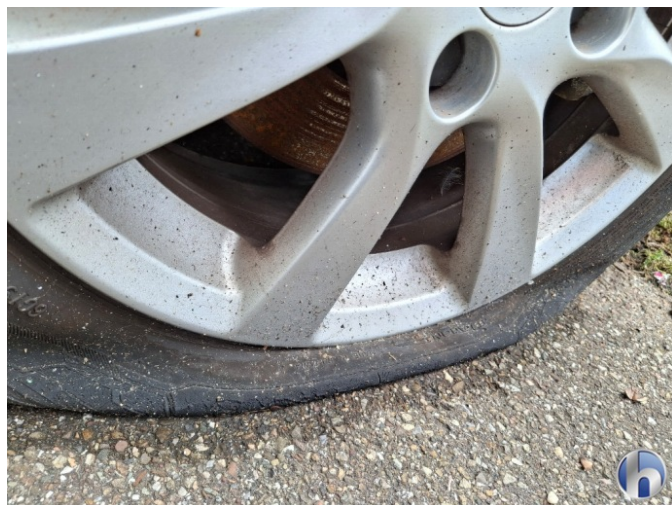
| | <b>component</b> | <b>Damage</b> | <b>Rep kind</b> |
|---|---|---|---|
| 5. | tire front - right | Damaged | Replace |

5. tire front - right
