OPEL Astra Astra 1.7 CDTI Caravan DPF

VIN NO W0L0AHL3592054104 Registration Number 3592054104

Inspection Report Summary

Customer	BCA Online	Report Number	P20250922104042
Inspection Date / Place	2025-09-22 / Dello Lübeck	Cosmetic Grade	4

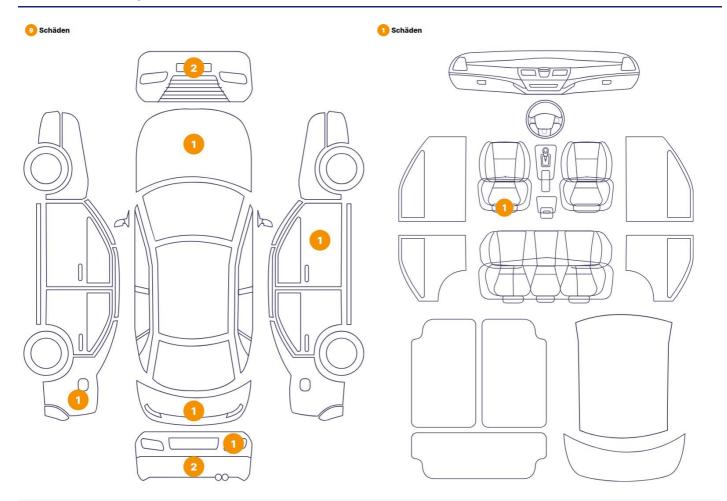
Component	Damage	Comments
1	Seat / Front Left	Interior / Holed	
2	Hood	Bodywork / Dent / Deformation	
3	Mirror / Front Right	Paint / Scratch / Scuff	
4	Bumper / Front	Paint / Scratch / Scuff	
5	Bumper / Front	Missing Part	
6	Fender / Back Left	Bodywork / Dent / Deformation	
7	Bumper / Back	Paint / Scratch / Scuff	
8	Tailgate	Paint / Corrosion	
9	Bumper / Back	Paint / Scratch / Scuff	
10	Back Light / Right	Paint / Chemical Damage

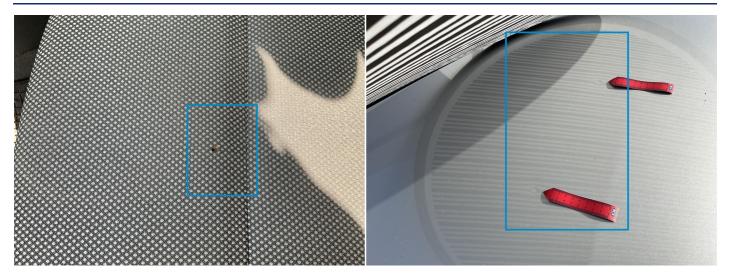
1. Seat / Front Left Interior / Holed -

2. Hood Bodywork / Dent / Deformation -

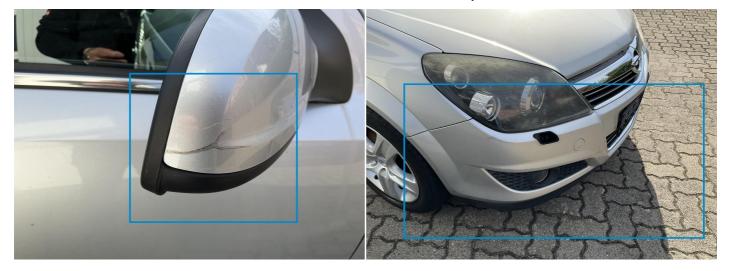
3. Mirror / Front Right Paint / Scratch / Scuff -

4. Bumper / Front Paint / Scratch / Scuff -

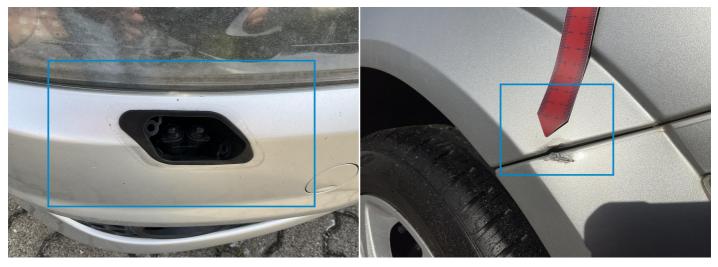
5. Bumper / Front Missing Part -

6. Fender / Back Left Bodywork / Dent / Deformation -

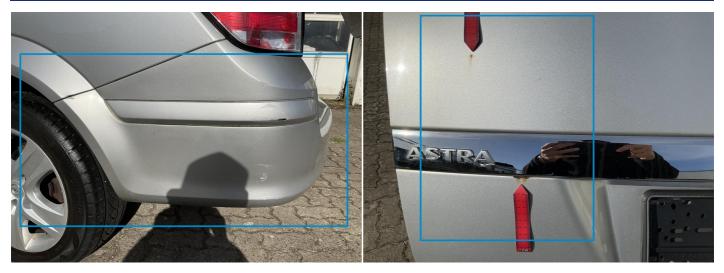
7. Bumper / Back Paint / Scratch / Scuff -

8. Tailgate Paint / Corrosion -

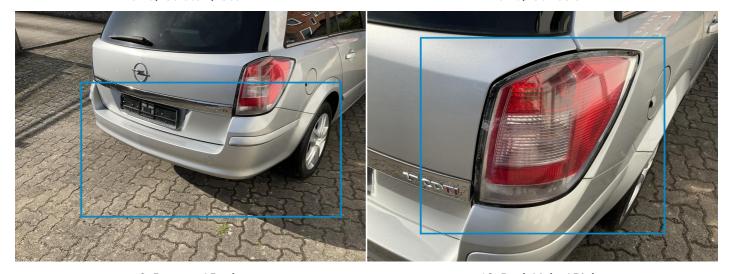
9. Bumper / Back Paint / Scratch / Scuff -

10. Back Light / Right Paint / Chemical Damage -
