OPEL Corsa Corsa 1.2 16V

VIN NO W0L0SDL68A4014342

Inspection Report Summary

Customer	BCA Online	Report Number	P20250926104449
Inspection Date / Place	2025-09-26 / BCA Neuss	Cosmetic Grade	4

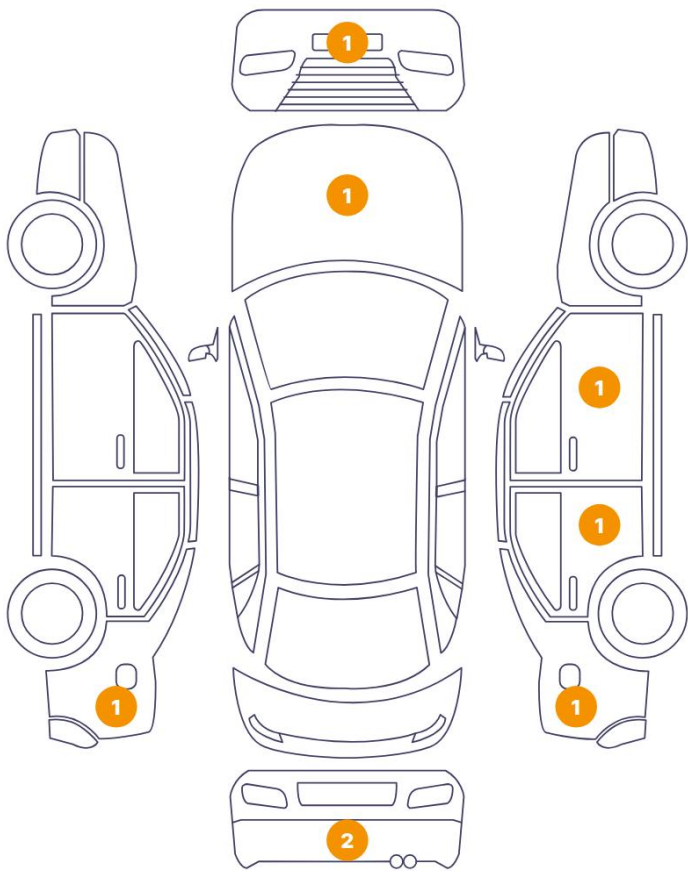
8 Schäden

Component	Damage	Comments
1 Fender / Back Right	Paint / Poor Previous Repair	
2 Door / Back Right	Paint / Poor Previous Repair	
3 Hood	Bodywork / Dent / Dent	
4 Fender / Back Left	Bodywork / Dent / Dent	
5 Bumper / Back	Paint / Scratch / Scuff	
6 Bumper / Back	Bodywork / Breakage / Hole	
7 Door / Front Right	Bodywork / Dent / Dent	
8 Bumper / Front	Paint / Scratch / Scuff	
9 Gear Knob	Interior / Broken

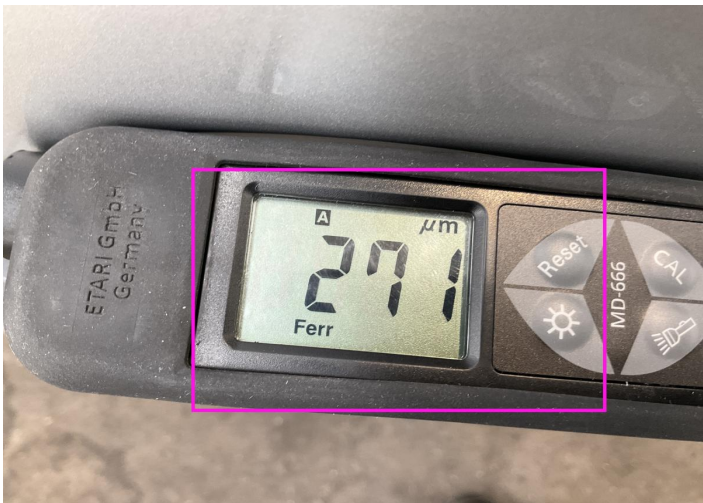
1. Fender / Back Right
Paint / Poor Previous Repair -

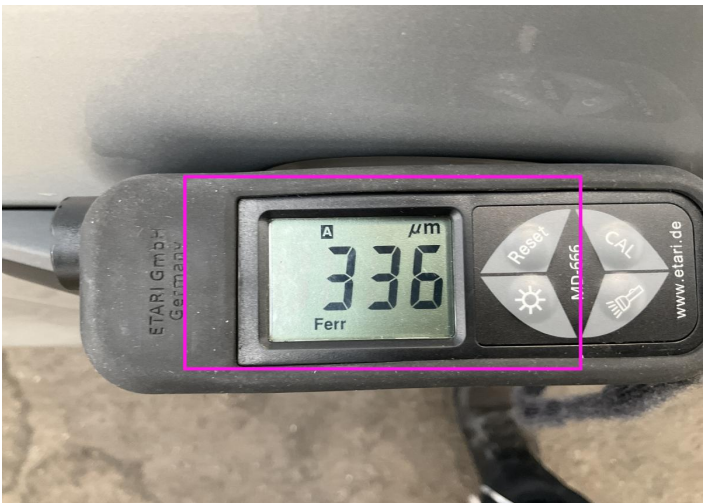
2. Door / Back Right
Paint / Poor Previous Repair -

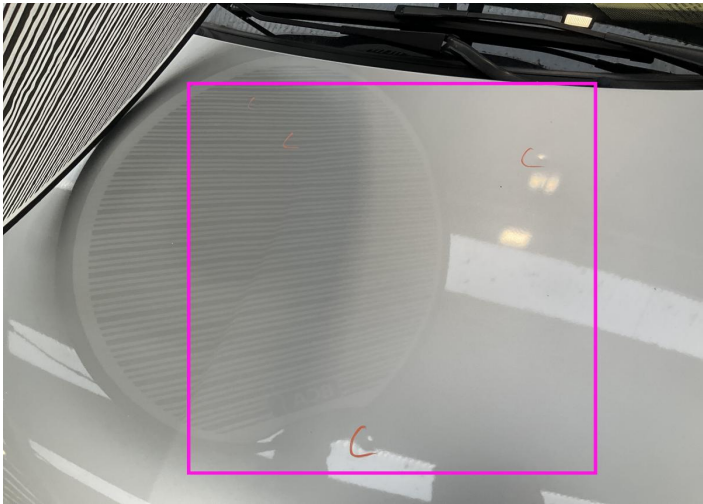
3. Hood
Bodywork / Dent / Dent -

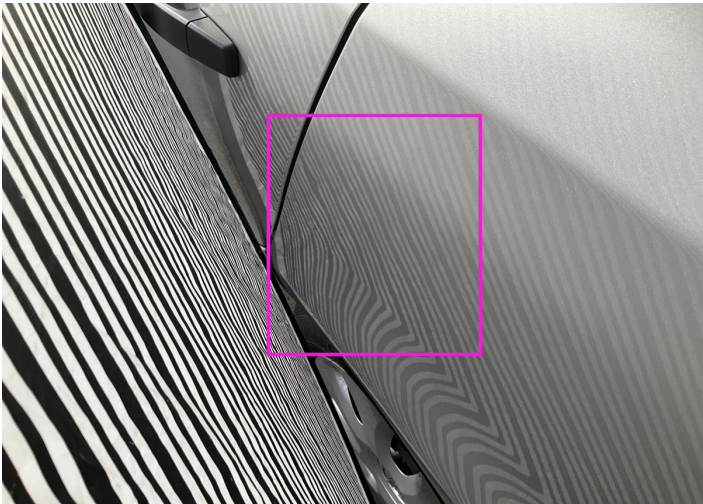
4. Fender / Back Left
Bodywork / Dent / Dent -

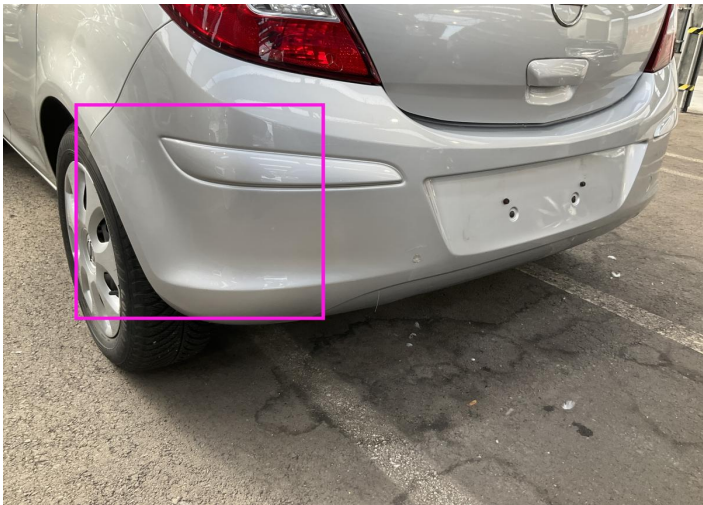
5. Bumper / Back
Paint / Scratch / Scuff -

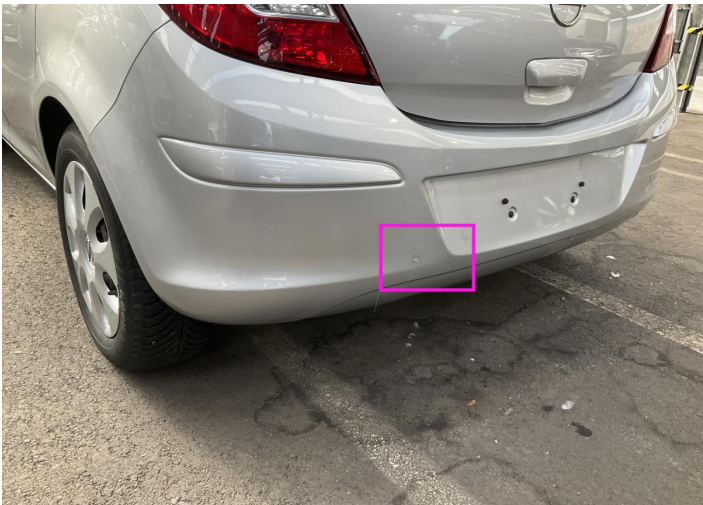
6. Bumper / Back
Bodywork / Breakage / Hole -

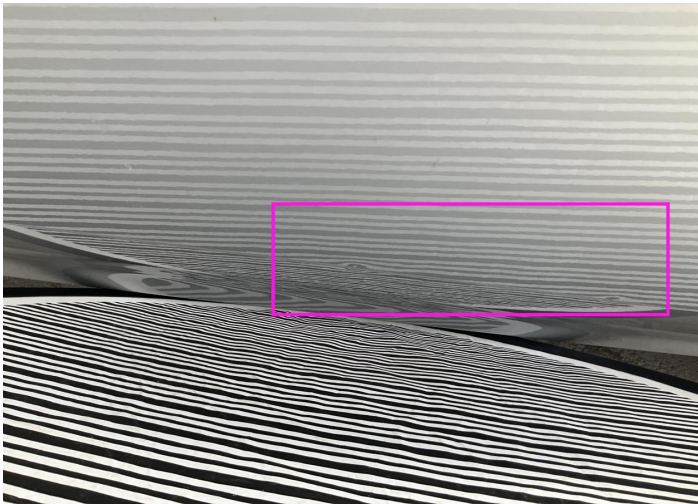
7. Door / Front Right
Bodywork / Dent / Dent -

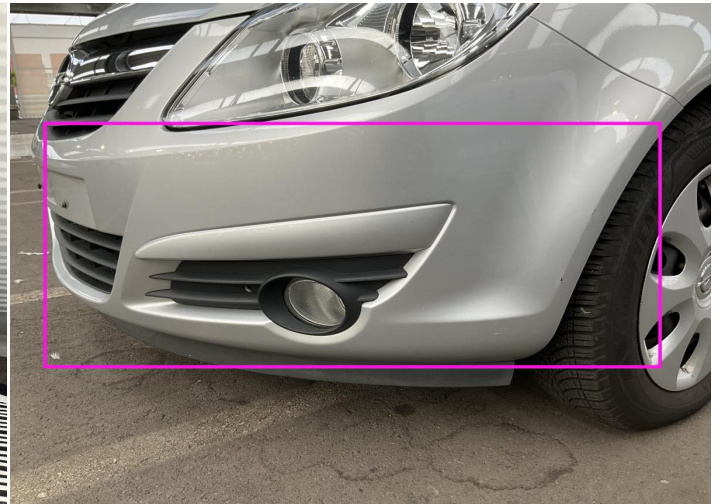
8. Bumper / Front
Paint / Scratch / Scuff -

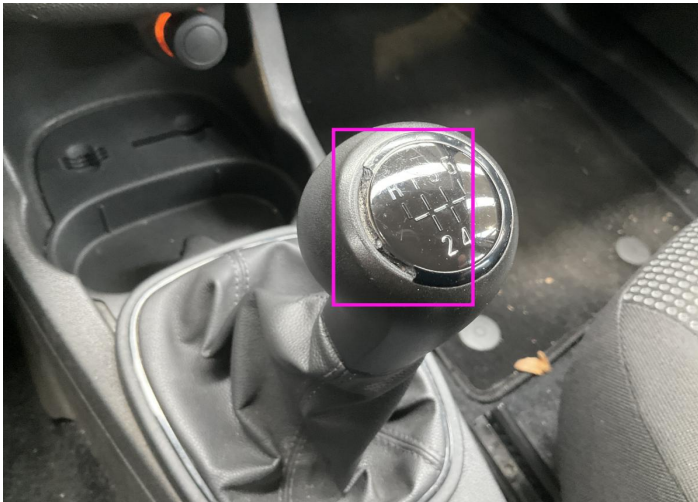
9. Gear Knob
Interior / Broken -
