OPEL Corsa Corsa 1.3 CDTI DPF ecoFLEX Start-Stop

VIN NO W0L0SDL68D4039889 Registration Number 68D4039889

Inspection Report Summary

Customer	BCA Online	Report Number	P20250919105938
Inspection Date / Place	2025-09-19 / ARS Altmann AG Riedstadt	Cosmetic Grade	4

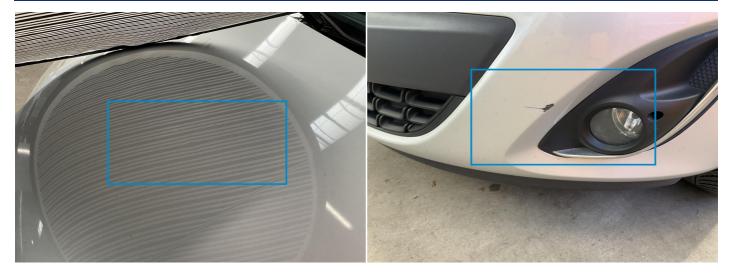
1. Hood Bodywork / Dent / Dent -

2. Bumper / Front Paint / Scratch / Scuff -

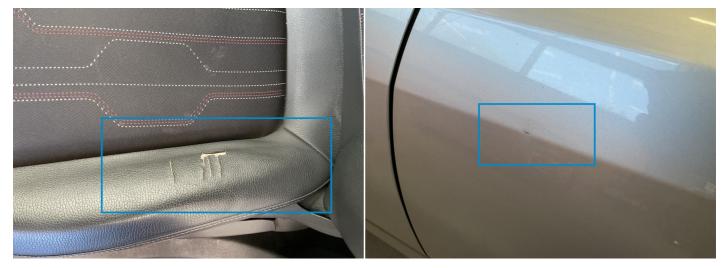
3. Seat / Front Left Interior / Ripped -

4. Door / Back Left Paint / Scratch / Scuff -

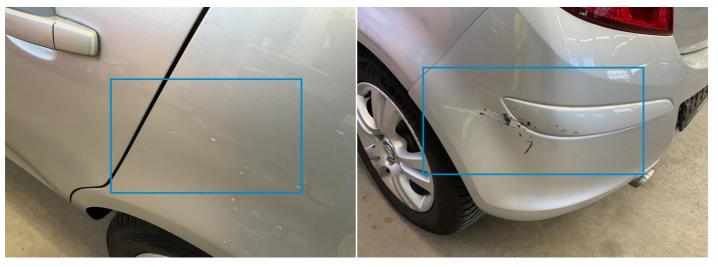
5. Side Panel / Back Left Paint / Scratch / Scuff -

6. Bumper / Back Paint / Scratch / Scuff -

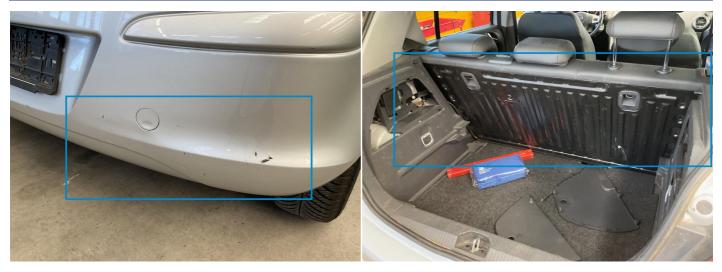
7. Bumper / Back Paint / Scratch / Scuff -

8. Luggage Space Cover / Back Interior / Missing -

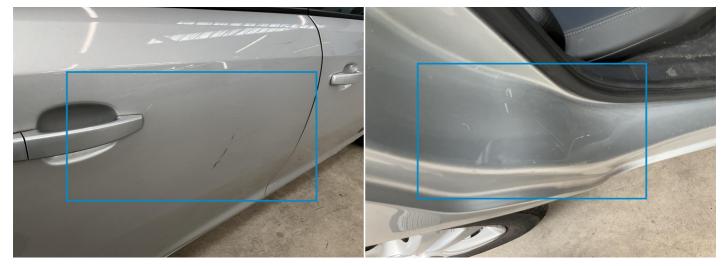
9. Door / Back Right Paint / Scratch / Scuff -

10. Pillar / Back Right Paint / Scratch / Scuff -

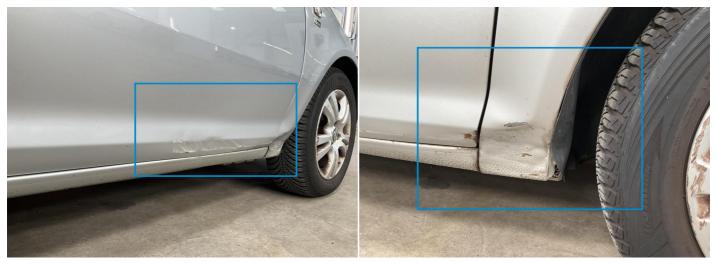
11. Door / Front Right Bodywork / Dent / Deformation -

12. Fender / Front Right Bodywork / Dent / Deformation -

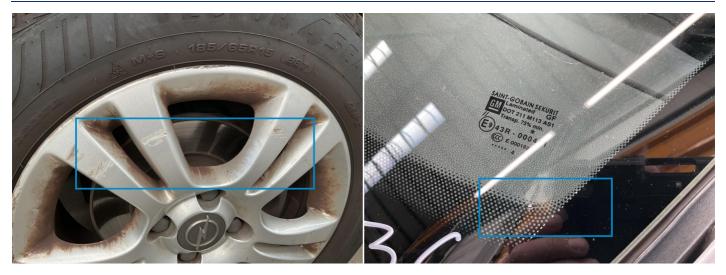
13. Rim / Front Right Out of Bodywork / Scratch -

14. Windshield / Front Glass Break / Impact -
