OPEL Astra

Astra 1.6 Caravan

VIN NO W0L0TGF3542221871
Registration Number 3542221871

Inspection Report Summary

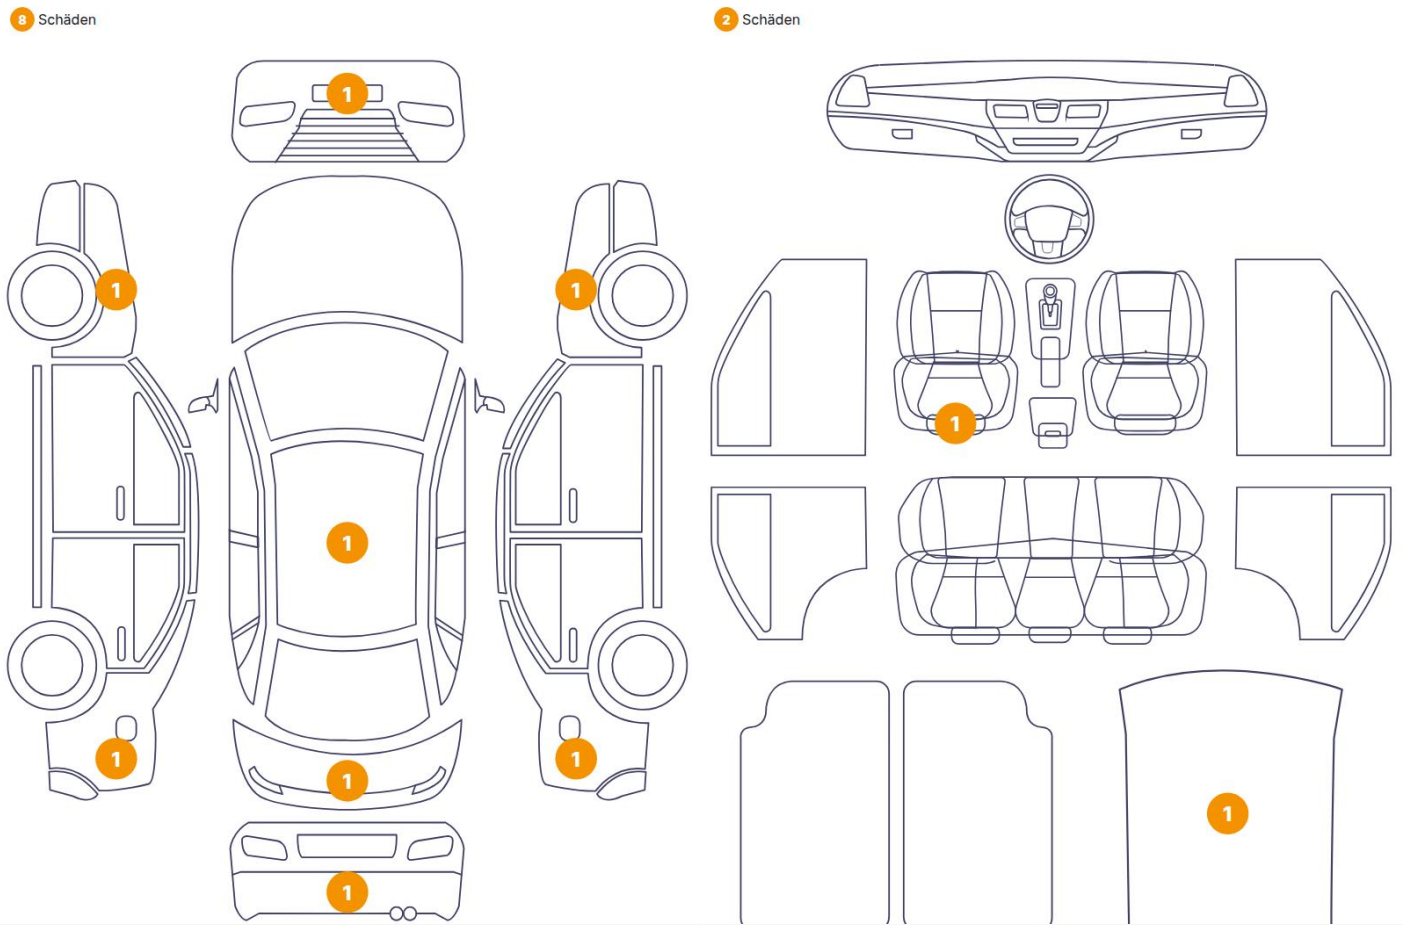
Cosmetic Damage

Component		Damage	Comments
1	Bumper / Front	Paint / Scratch / Scuff	
2	Fender / Front Left	Paint / Corrosion	
3	Roof	Paint / Scratch / Scuff	
4	Side Panel / Back Left	Paint / Corrosion	
5	Seat / Front Left	Interior / Ripped	
6	Bumper / Back	Bodywork / Dent / Dent	
7	Tailgate	Paint / Corrosion	
8	Side Panel / Back Right	Paint / Corrosion	
9	Fender / Front Right	Paint / Scratch / Line	
10	Roof Upholstery	Interior / Loose

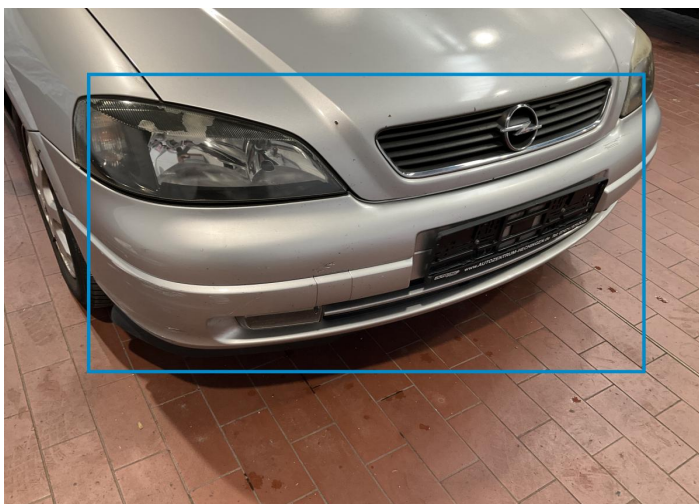
1. Bumper / Front
Paint / Scratch / Scuff -

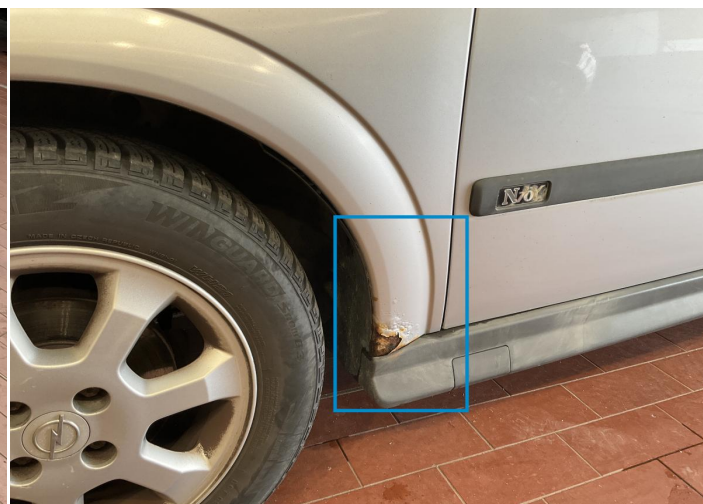
2. Fender / Front Left
Paint / Corrosion -

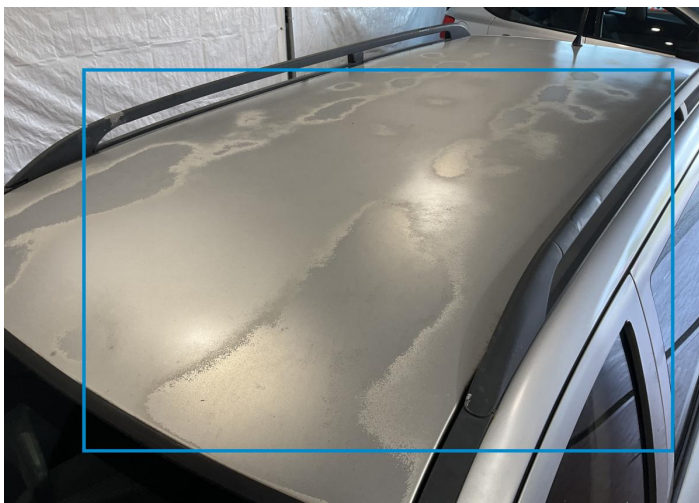
3. Roof
Paint / Scratch / Scuff -

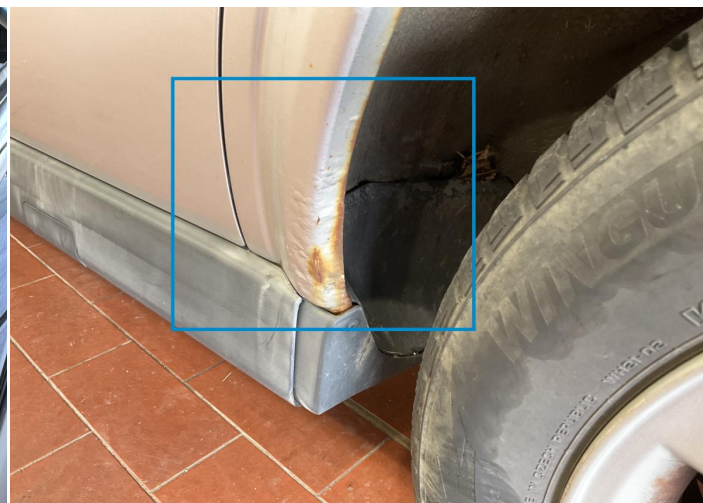
4. Side Panel / Back Left
Paint / Corrosion -

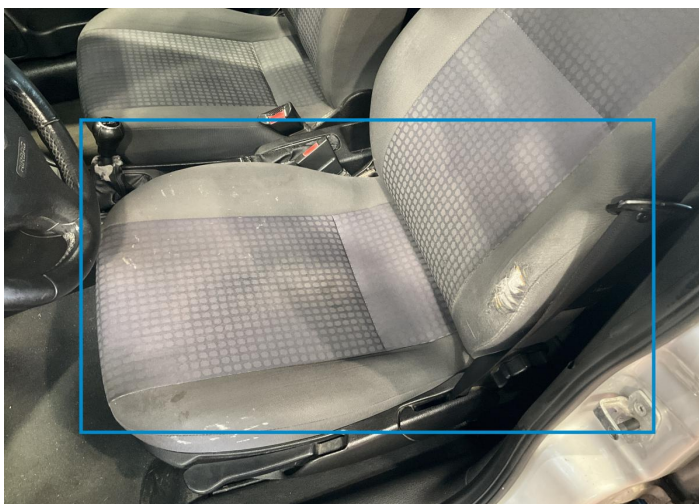
5. Seat / Front Left
Interior / Ripped -

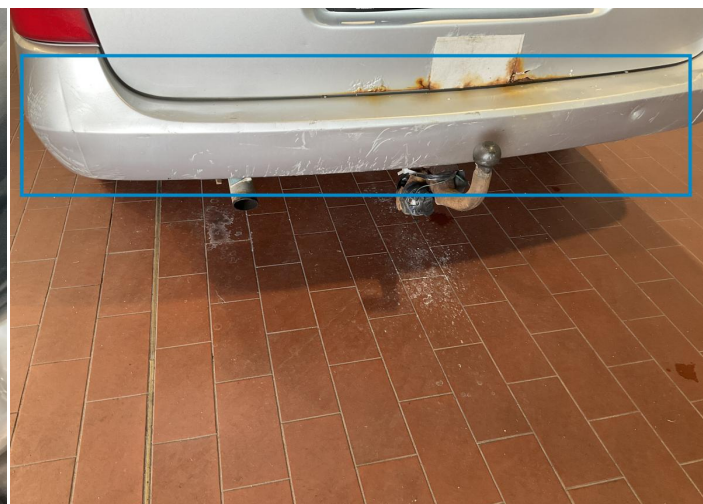
6. Bumper / Back
Bodywork / Dent / Dent -

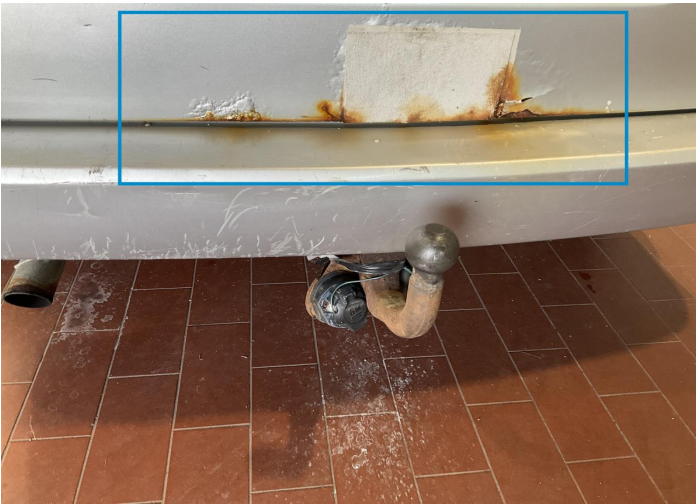
7. Tailgate
Paint / Corrosion -

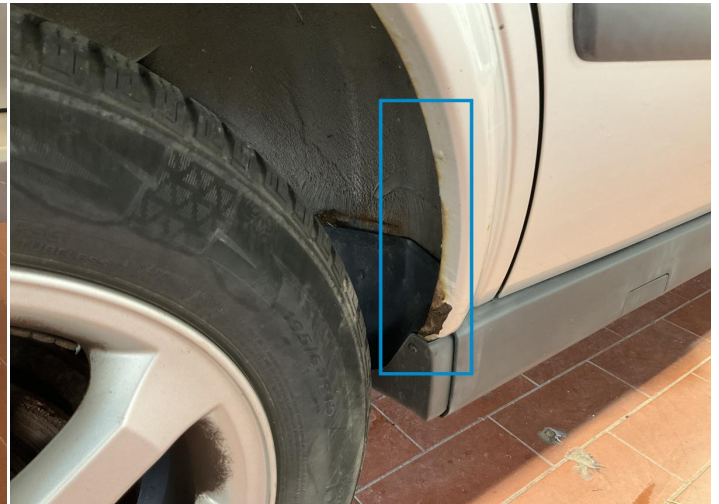
8. Side Panel / Back Right
Paint / Corrosion -

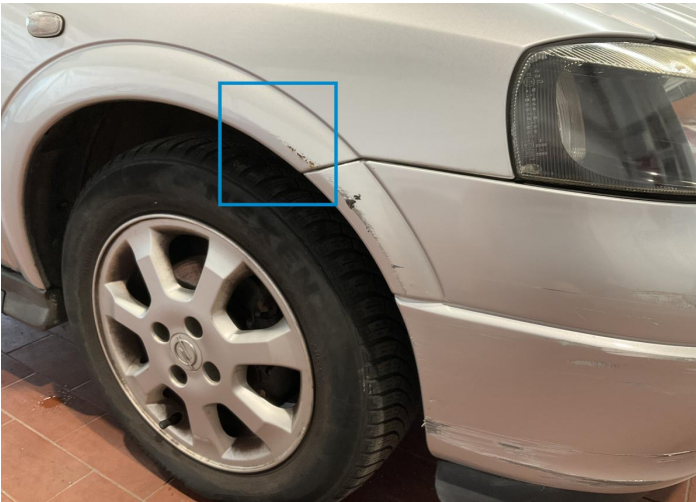
9. Fender / Front Right
Paint / Scratch / Line -

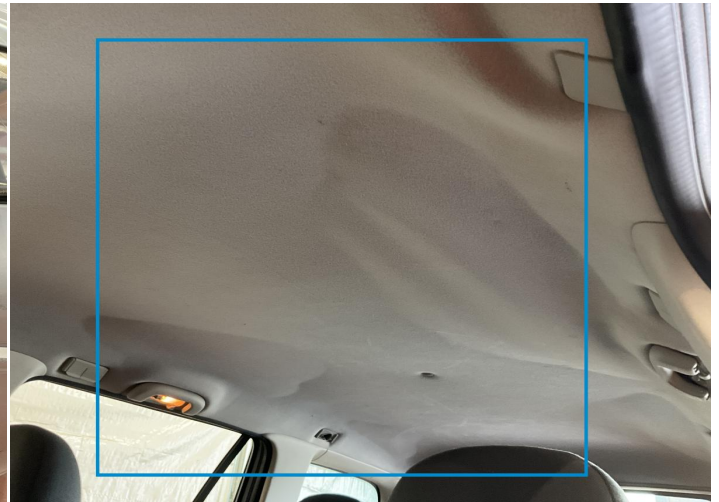
10. Roof Upholstery
Interior / Loose -
