## OPEL Astra

### Astra 1.6 Caravan

### Inspection Report Summary

| Customer | BCA Online | Report Number | P20250716122707 |

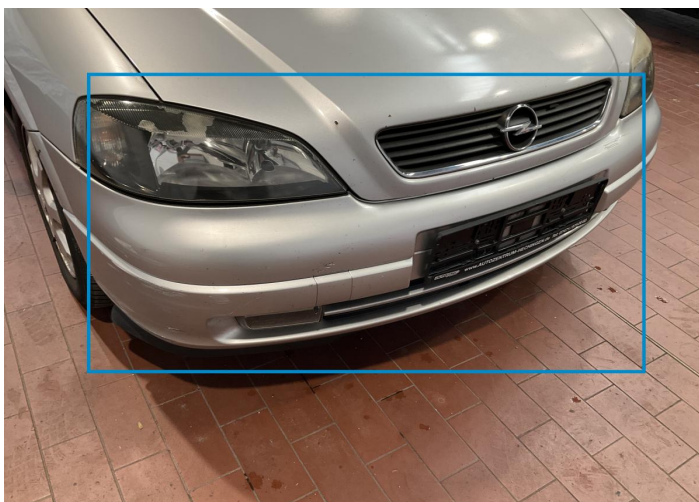
| Component | | Damage | Comments |
|---|---|---|---|
| 1 | Bumper / Front | Paint / Scratch / Scuff | |

1. Bumper / Front  
Paint / Scratch / Scuff -

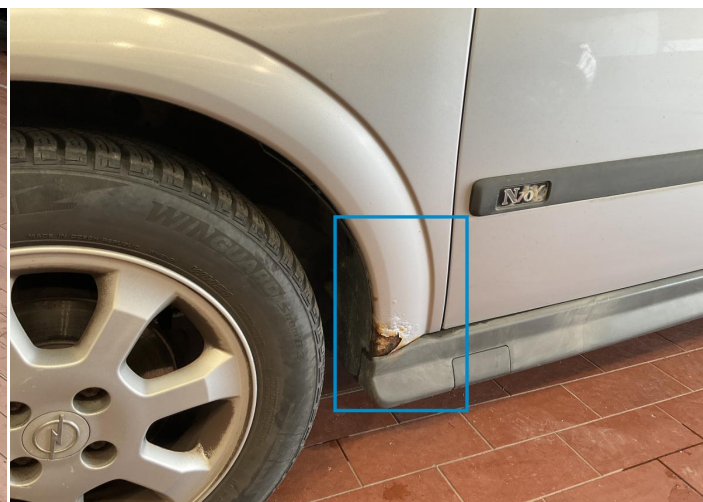
| Component | | Damage | Comments |
|---|---|---|---|
| 2 | Fender / Front Left | Paint / Corrosion | |

2. Fender / Front Left  
Paint / Corrosion -

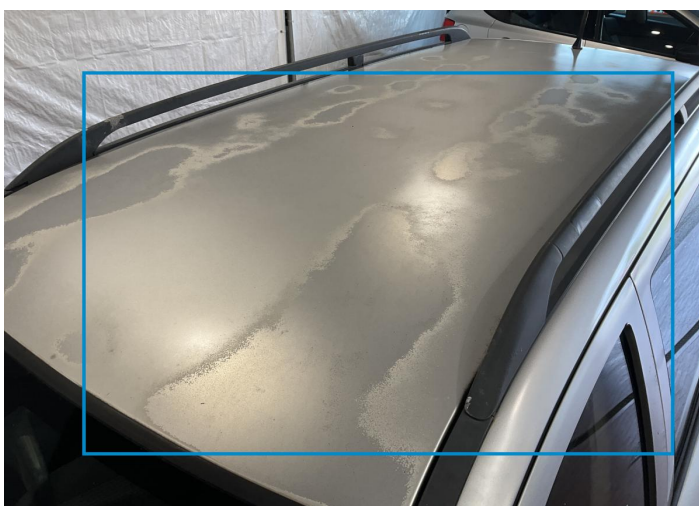
| Component | | Damage | Comments |
|---|---|---|---|
| 3 | Roof | Paint / Scratch / Scuff | |

3. Roof  
Paint / Scratch / Scuff -

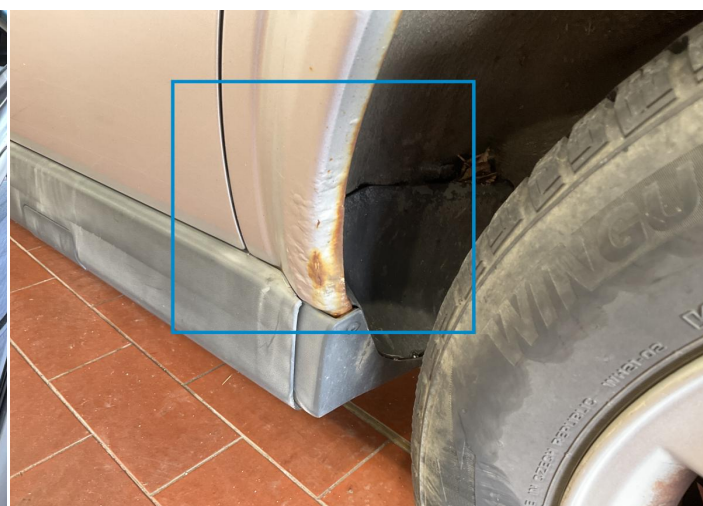
| Component | | Damage | Comments |
|---|---|---|---|
| 4 | Side Panel / Back Left | Paint / Corrosion | |

4. Side Panel / Back Left  
Paint / Corrosion -

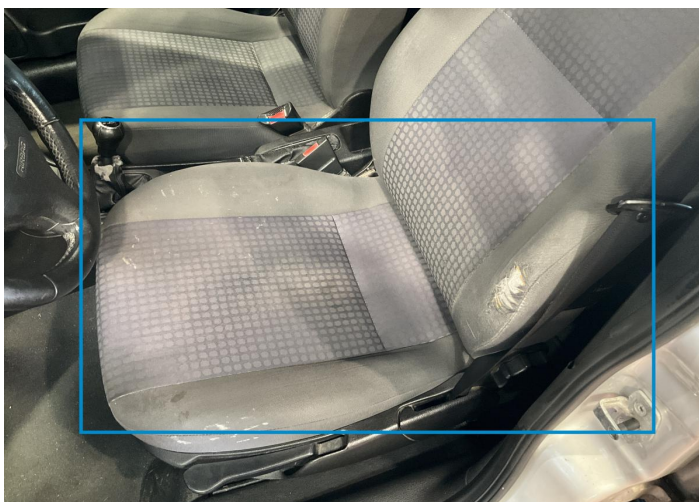
| Component | | Damage | Comments |
|---|---|---|---|
| 5 | Seat / Front Left | Interior / Ripped | |

5. Seat / Front Left  
Interior / Ripped -

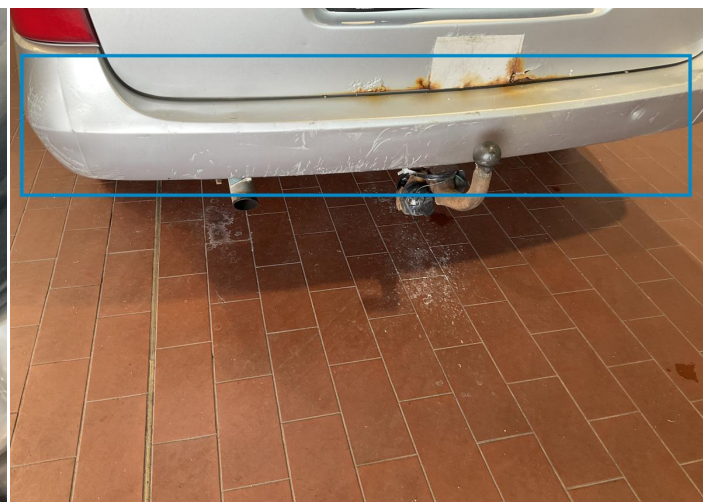
| Component | | Damage | Comments |
|---|---|---|---|
| 6 | Bumper / Back | Bodywork / Dent / Dent | |

6. Bumper / Back  
Bodywork / Dent / Dent -

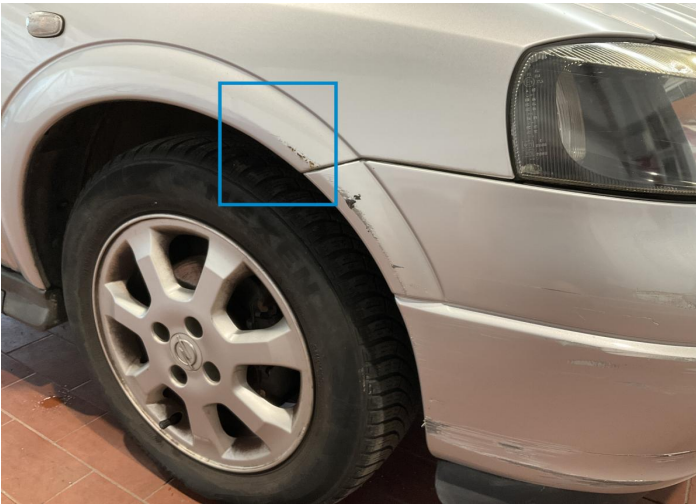
| Component | | Damage | Comments |
|---|---|---|---|
| 9 | Fender / Front Right | Paint / Scratch / Line | |

9. Fender / Front Right  
Paint / Scratch / Line -

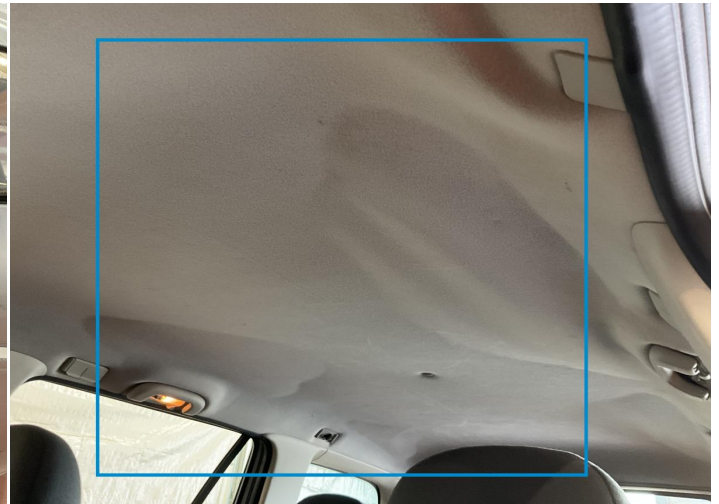
| Component | | Damage | Comments |
|---|---|---|---|
| 10 | Roof Upholstery | Interior / Loose | |

10. Roof Upholstery  
Interior / Loose -
