OPEL CORSA

Corsa 1.3 CDTI Cosmo

VIN NO W0L0XCF6844286320
Registration Number DA385XT

Customer	BCAuto Encheres	Report Number	P20250811100343
Inspection Date / Place	2025-08-11 / BCA GARONS	Cosmetic Grade	5

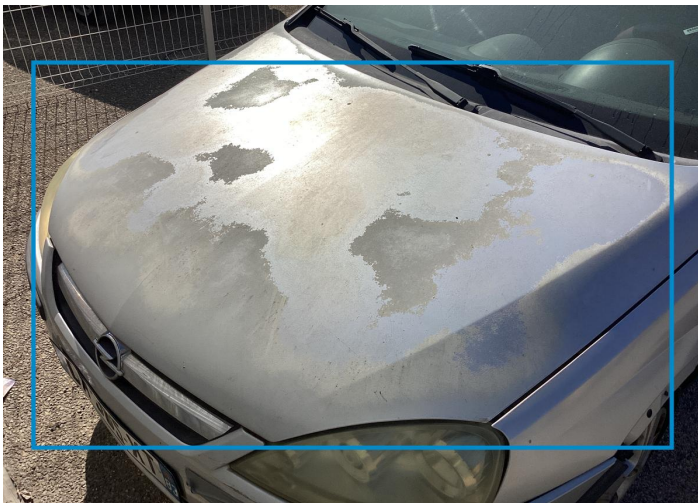
1. Hood
Paint / Poor Previous Repair -

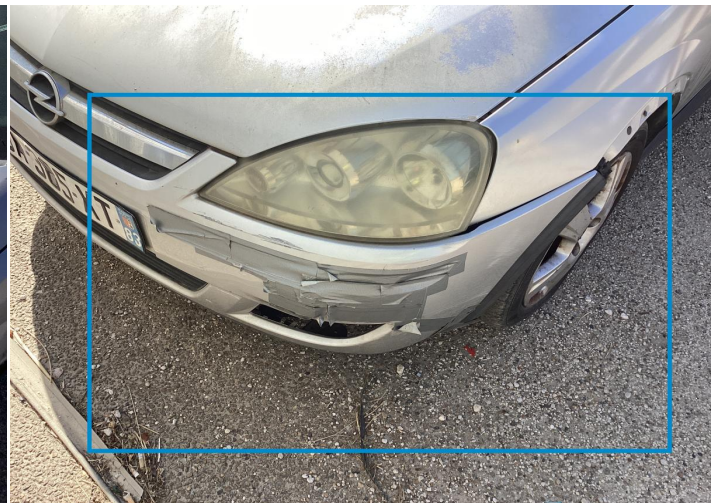
2. Bumper / Front
Bodywork / Breakage / Crack -

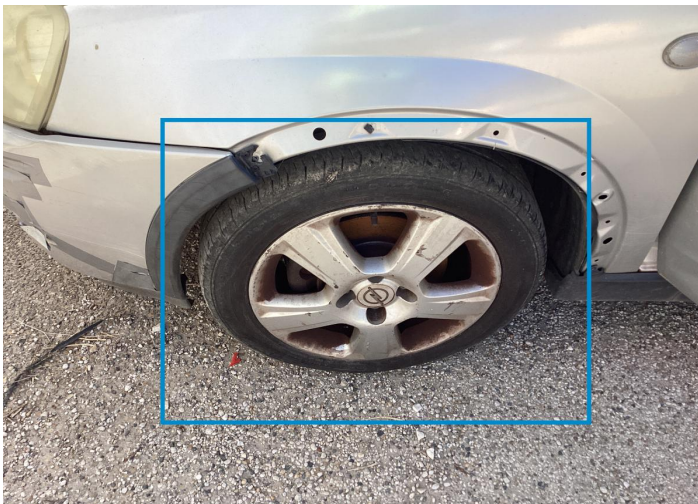
3. Rim / Front Left
Out of Bodywork / Scratch -

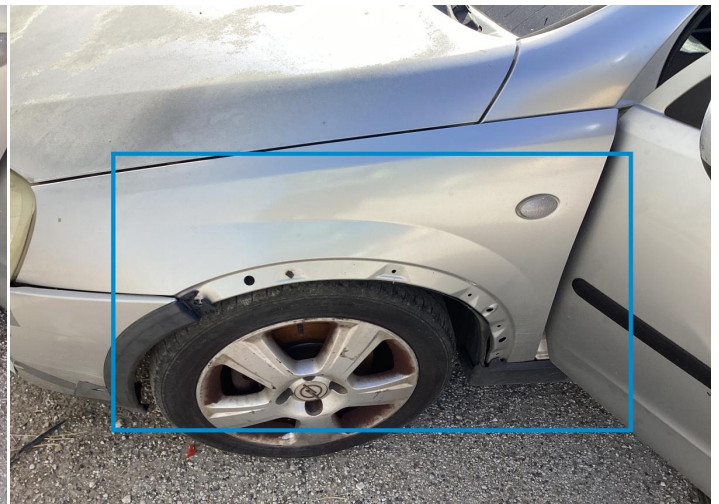
4. Wing Stick / Front Left
Missing Part -

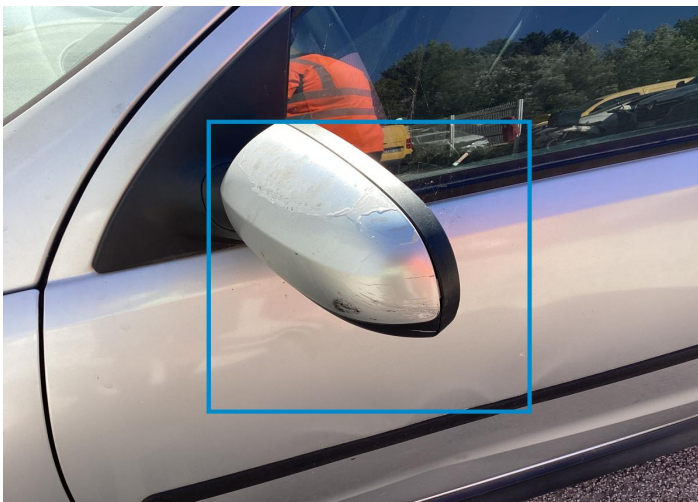
5. Mirror / Front Left
Paint / Scratch / Line -

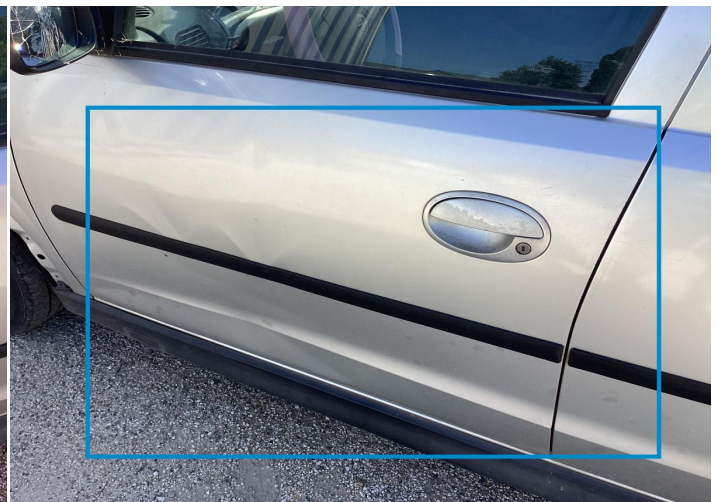
6. Door / Front Left
Bodywork / Dent / Deformation -

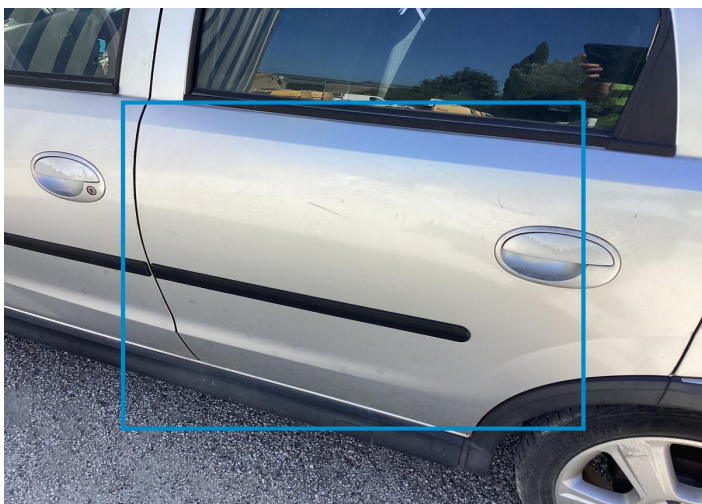
7. Door / Back Left
Bodywork / Dent / Deformation -

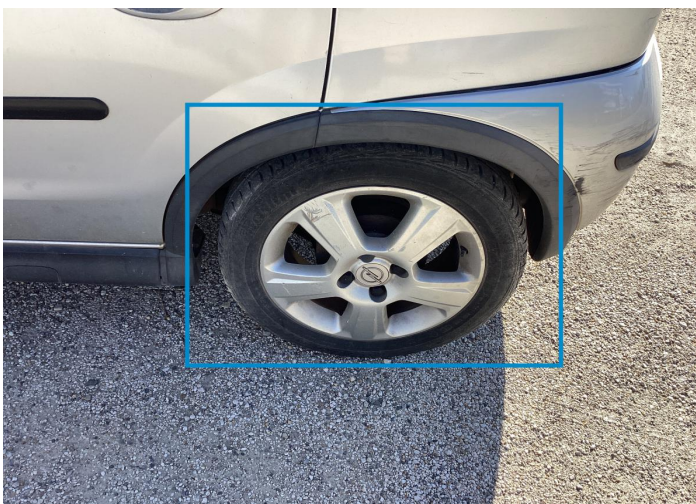
8. Rim / Back Left
Out of Bodywork / Scratch -

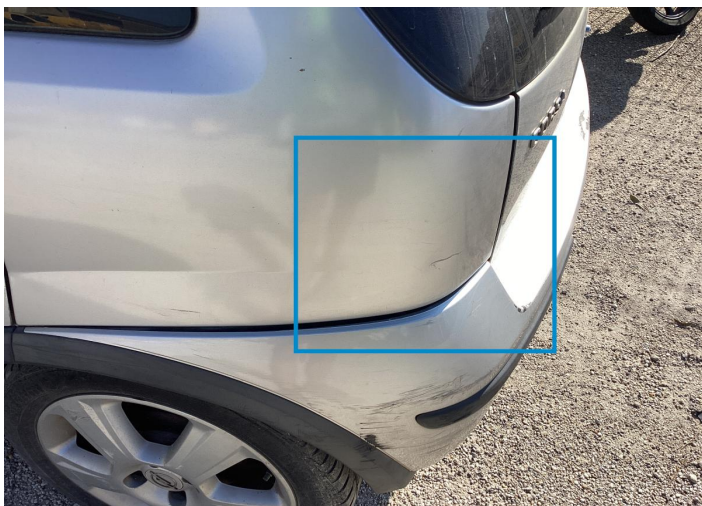
9. Fender / Back Left
Bodywork / Dent / Deformation -

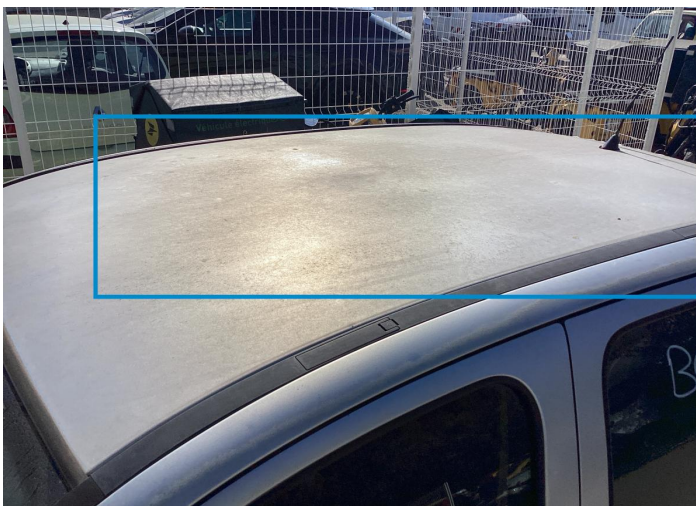
10. Roof
Paint / Poor Previous Repair -

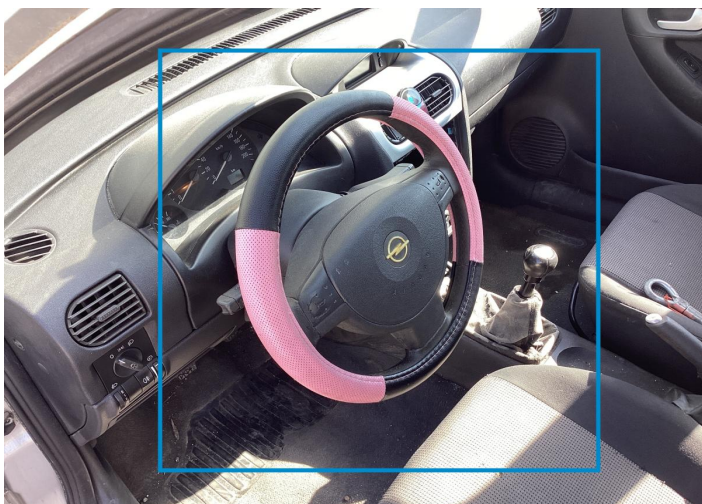
11. Steering Wheel / Front
Interior / Worn - out -

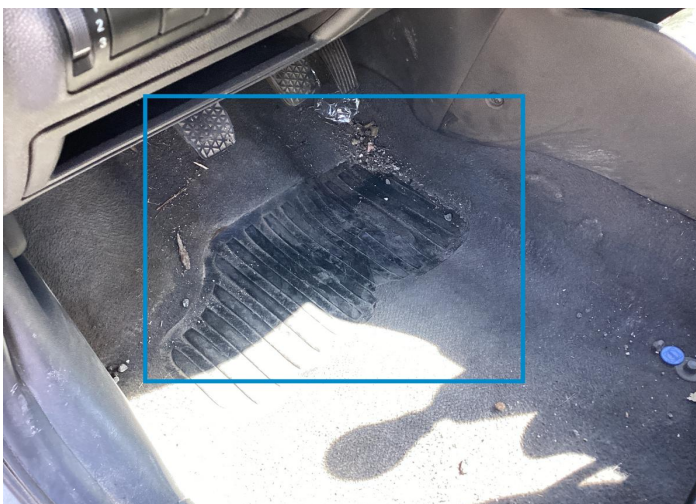
12. Floor Carpet
Interior / Ripped -

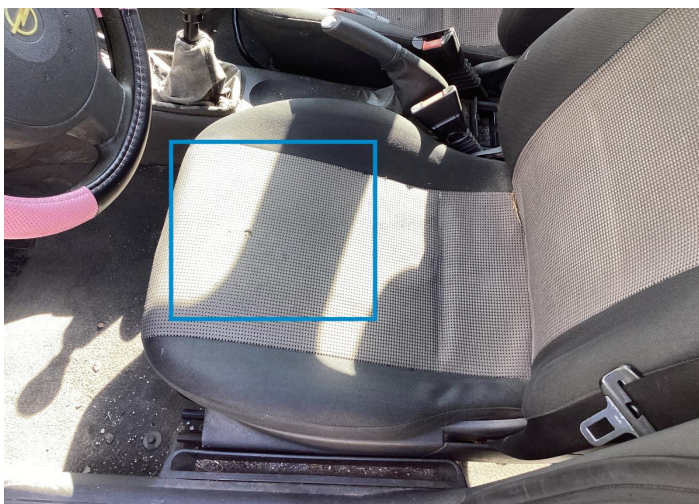
13. Seat / Front Left
Interior / Burn -

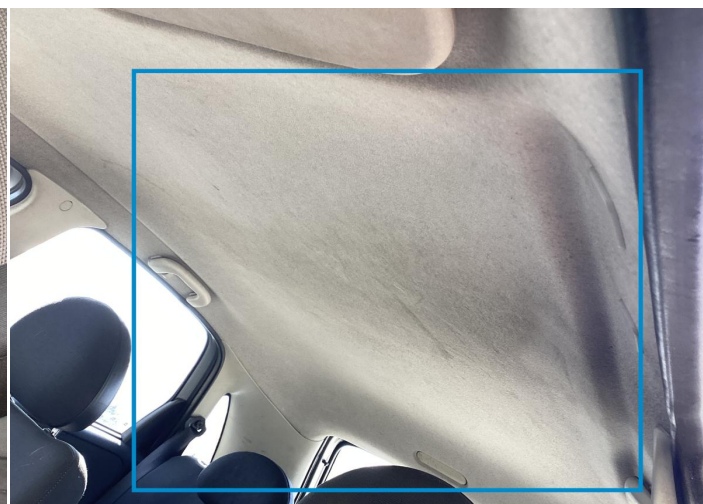
14. Roof Upholstery
Interior / Stained -

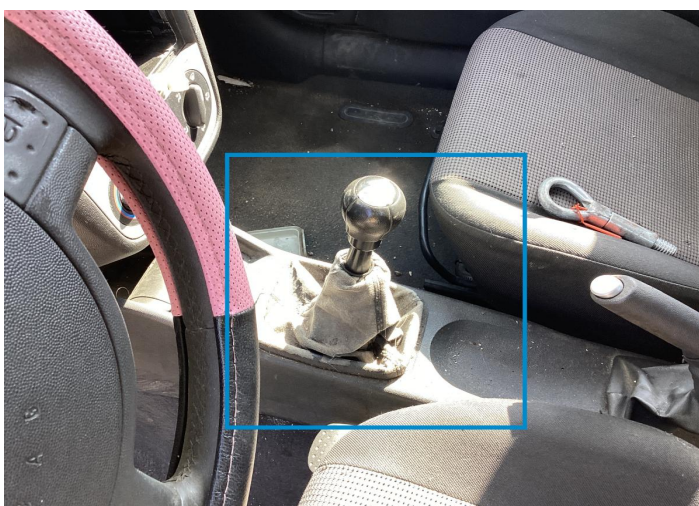
15. Gear Knob
Interior / Ripped -

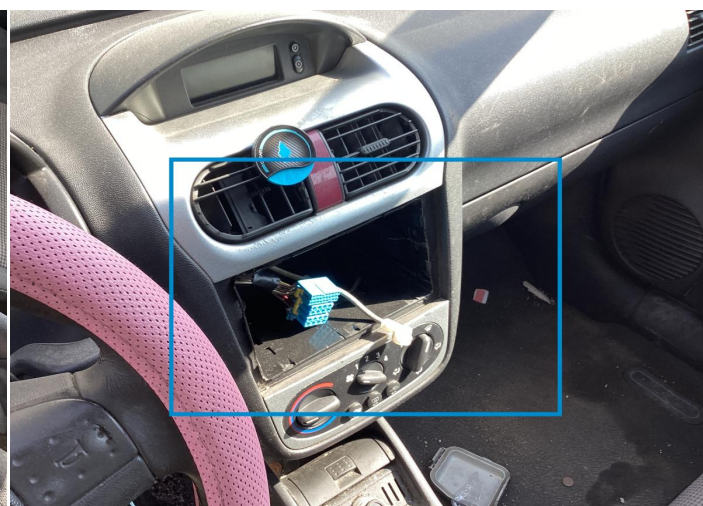
16. TV DVD Screen / Front
Interior / Missing -

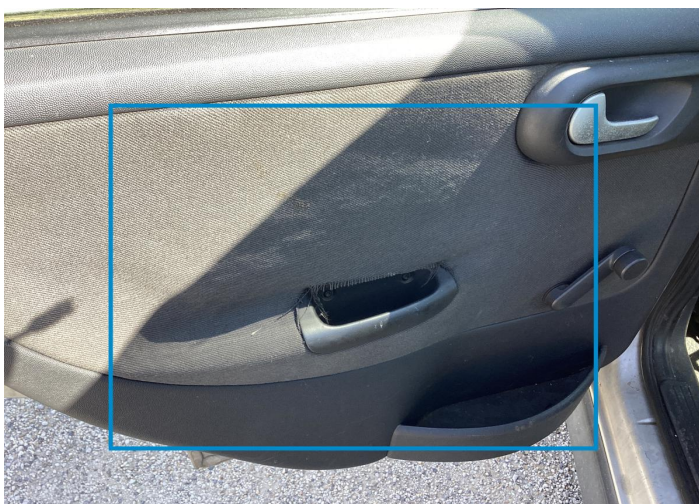
17. Panel Filling / Back Left
Interior / Broken -

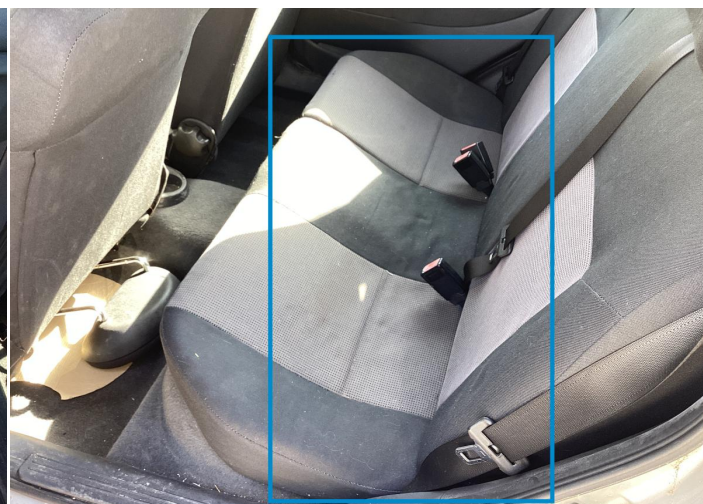
18. Seat / Back Center
Interior / Stained -

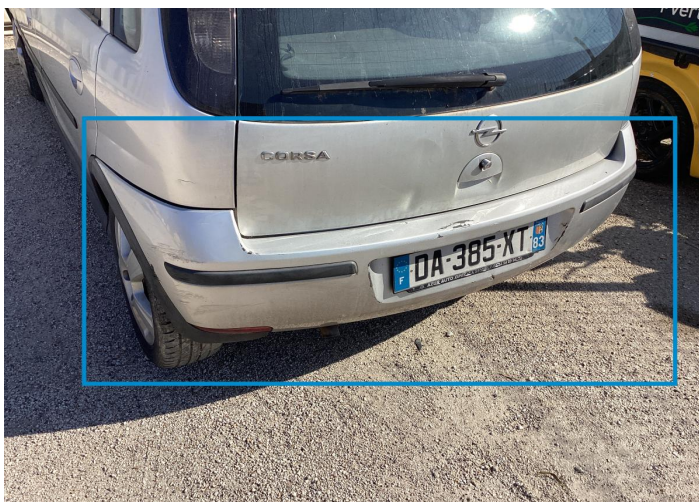
19. Bumper / Back
Bodywork / Dent / Deformation -

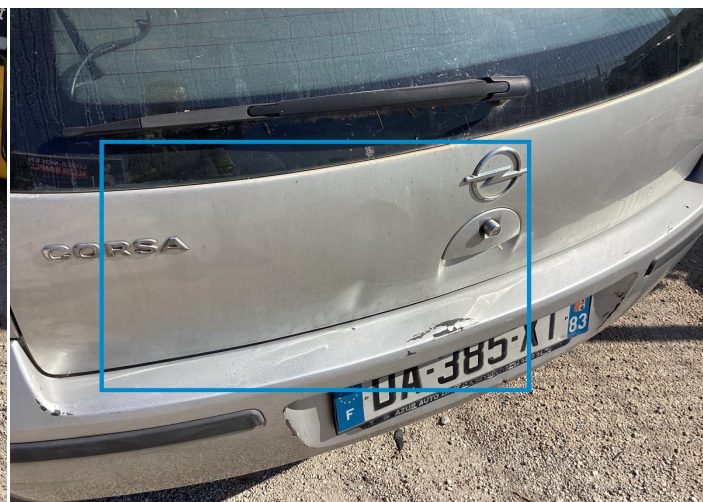
20. Tailgate
Bodywork / Dent / Deformation -

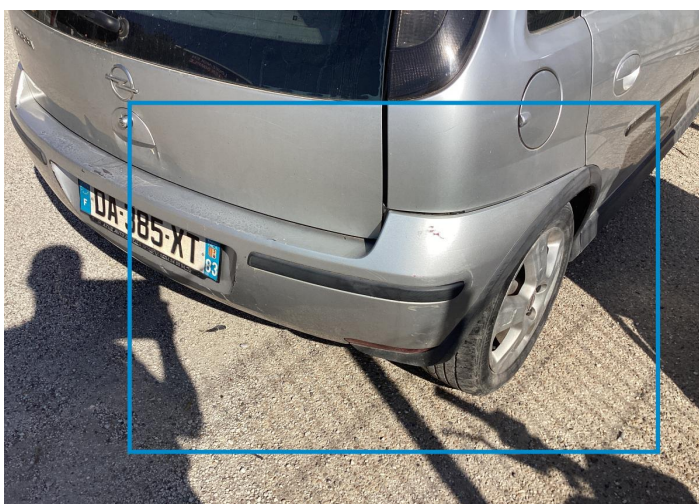
21. Bumper / Back
Bodywork / Dent / Deformation -

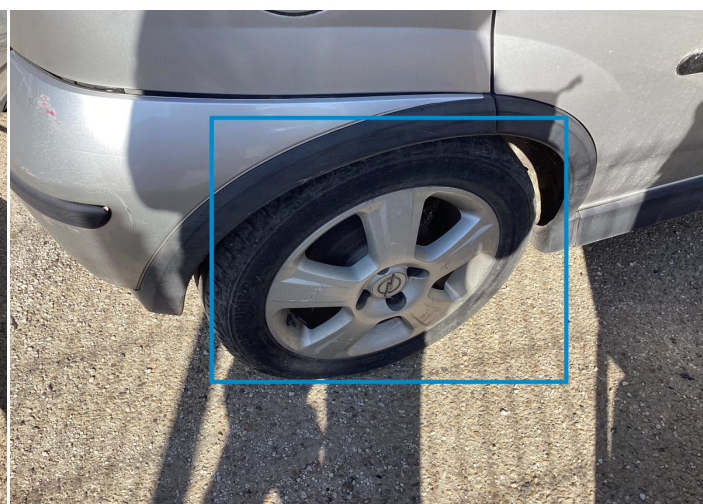
22. Rim / Back Right
Out of Bodywork / Scratch -

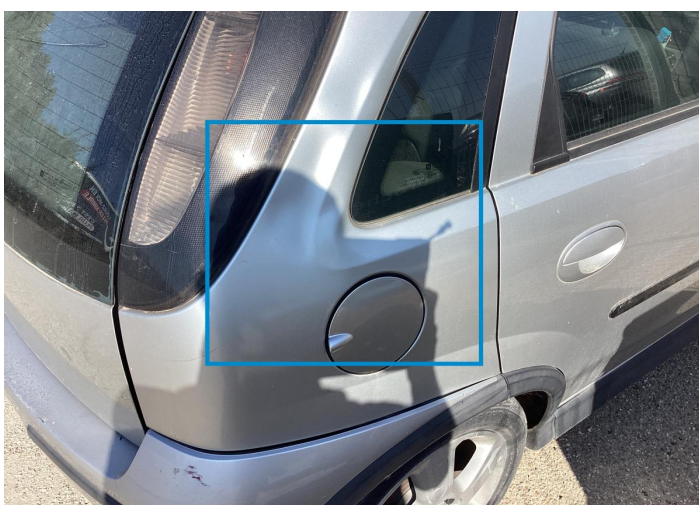
23. Fender / Back Right
Bodywork / Dent / Deformation -

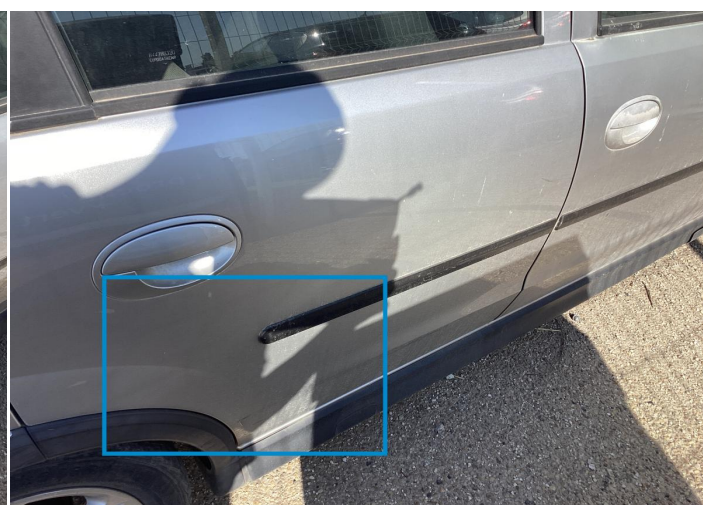
24. Door / Back Right
Bodywork / Dent / Deformation -

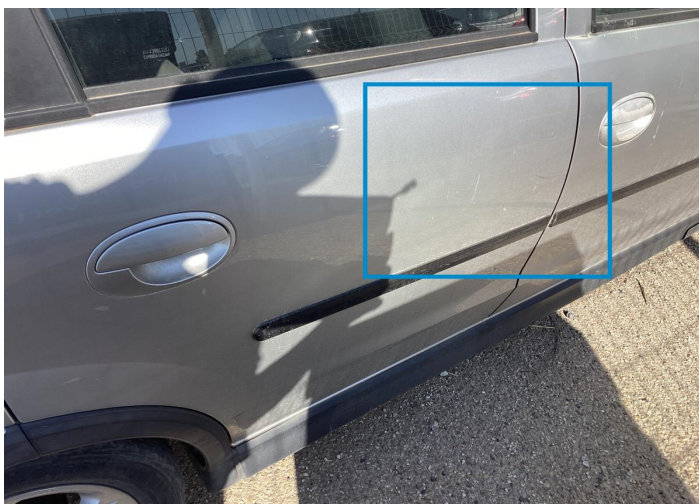
25. Door / Back Right
Paint / Scratch / Line -

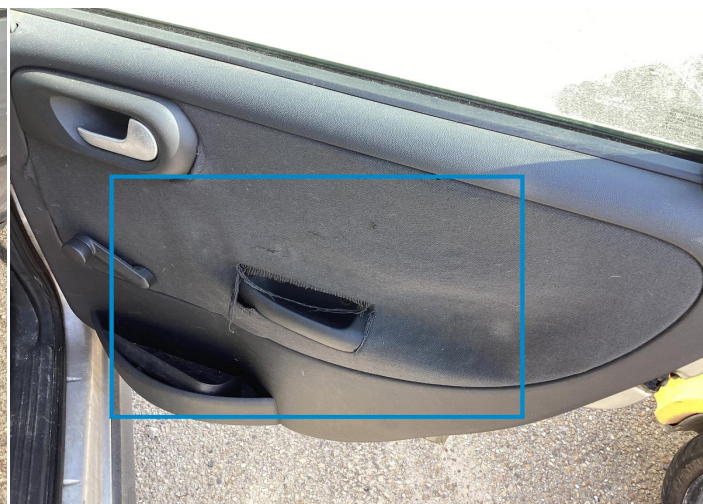
26. Panel Filling / Back Right
Interior / Broken -

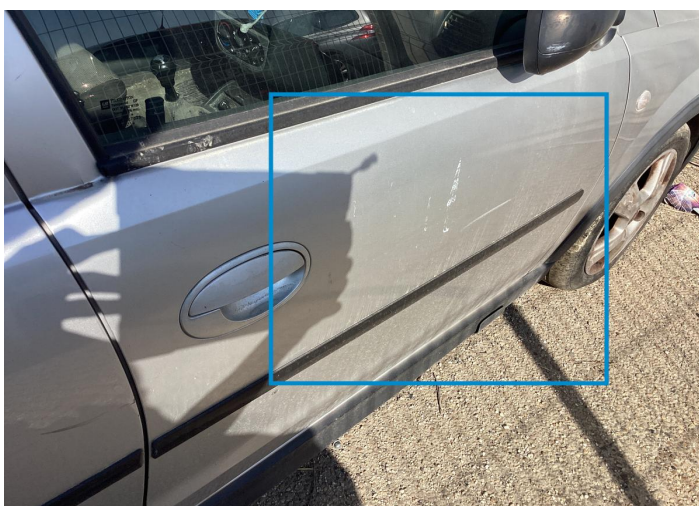
27. Door / Front Right
Bodywork / Dent / Deformation -

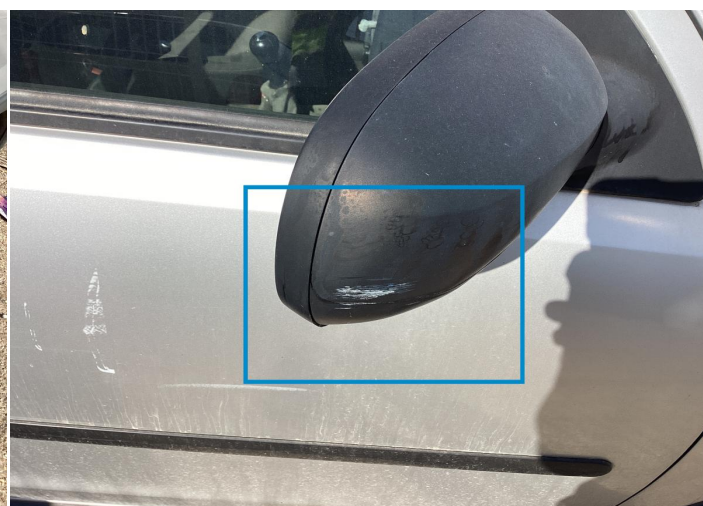
28. Mirror / Front Right
Paint / Scratch / Line -

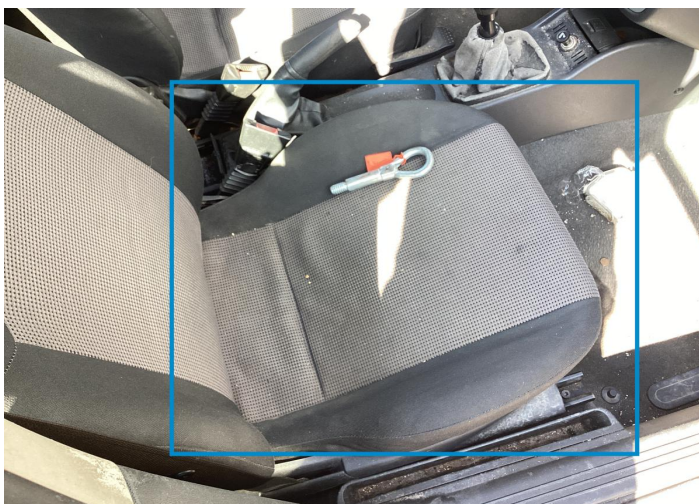
29. Seat / Front Right
Interior / Stained -

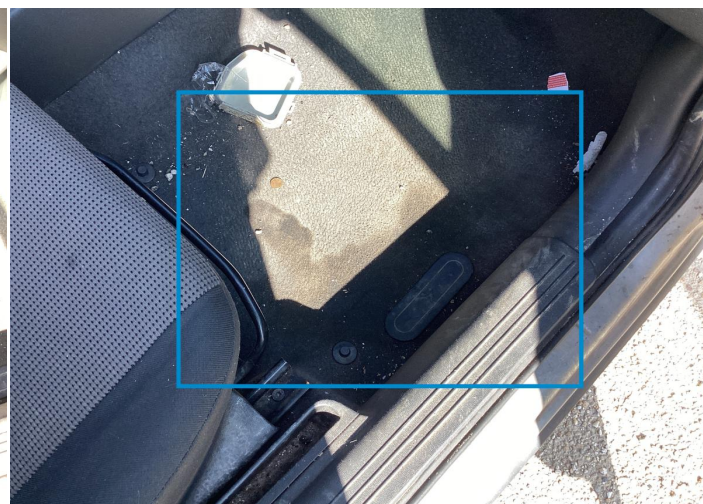
30. Floor Carpet
Interior / Stained -

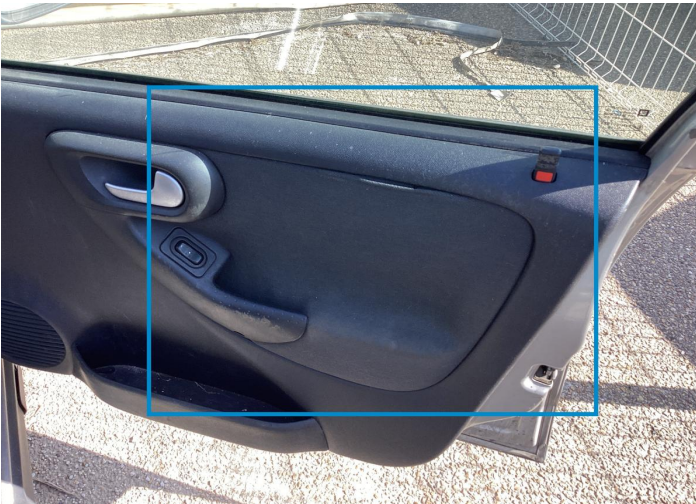
31. Panel Filling / Front Right
Interior / Broken -

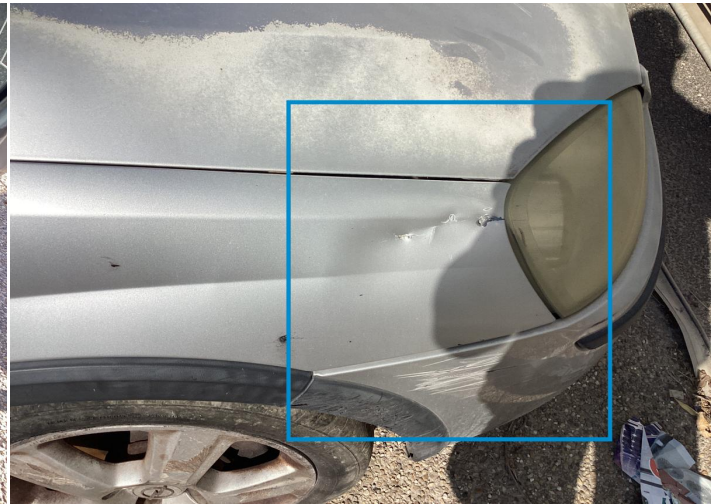
32. Fender / Front Right
Bodywork / Dent / Deformation -

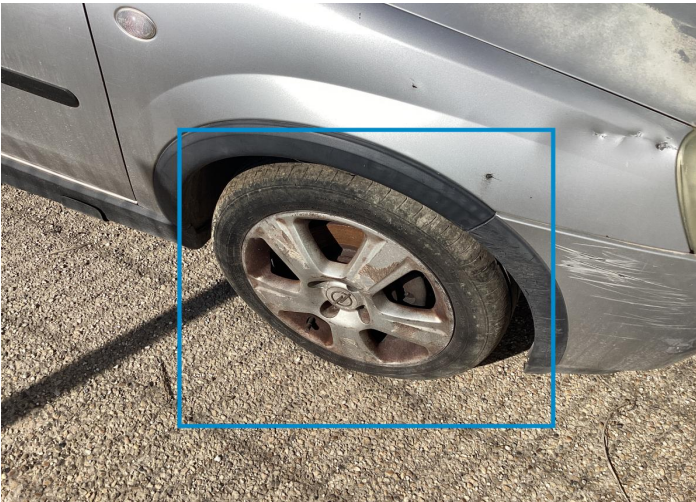
33. Rim / Front Right
Out of Bodywork / Scratch -

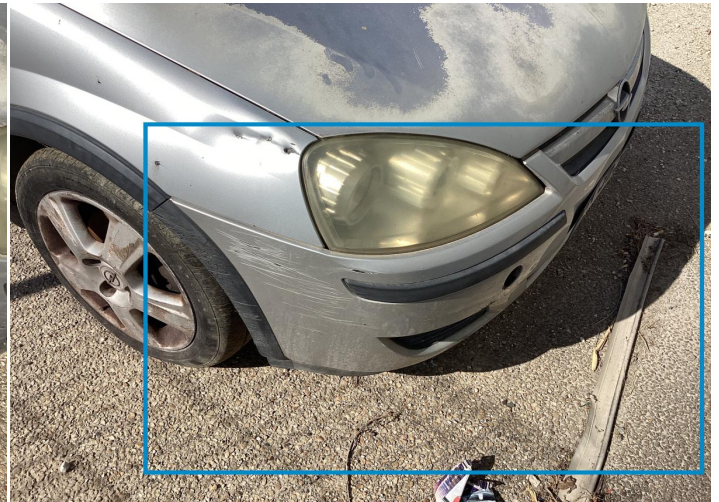
34. Bumper / Front
Paint / Scratch / Line -
