OPEL Corsa Corsa 1.4 Turbo (ecoFLEX) Start/Stop

VIN NO W0L0XEP08F6019893

Inspection Report Summary

Customer	BCA Online	Report Number	P20250903133143
Inspection Date / Place	2025-09-03 / Dello Billstedt/ Hamburg	Cosmetic Grade	3

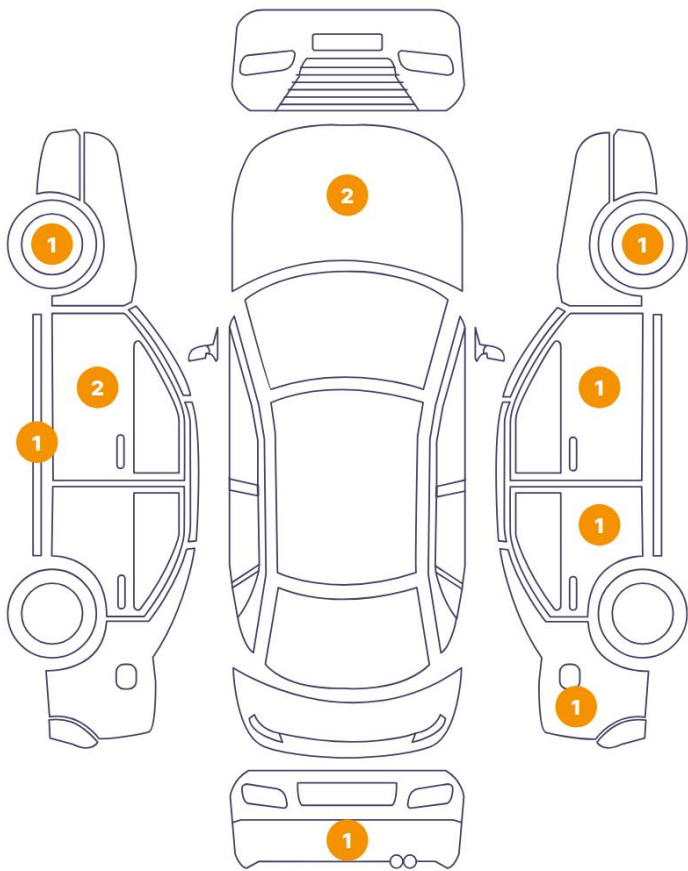
11 Schäden

Component		Damage	Comments
1	Rocker Panel / Center Left	Bodywork / Dent / Dent	
2	Door / Front Left	Bodywork / Dent / Dent	
3	Mirror / Front Left	Paint / Scratch / Scuff	
4	Rim / Front Left	Out of Bodywork / Scratch	
5	Hood	Paint / Stone Chip	
6	Hood	Paint / Stone Chip	
7	Mirror / Front Right	Paint / Scratch / Scuff	
8	Rim / Front Right	Out of Bodywork / Scratch	
9	Window Cover / Back Right	Paint / Scratch / Scuff	
10	Fender / Back Right	Paint / Scratch / Scuff	
11	Bumper / Back	Paint / Scratch / Scuff	
12	Seat / Front Left	Interior / Ripped

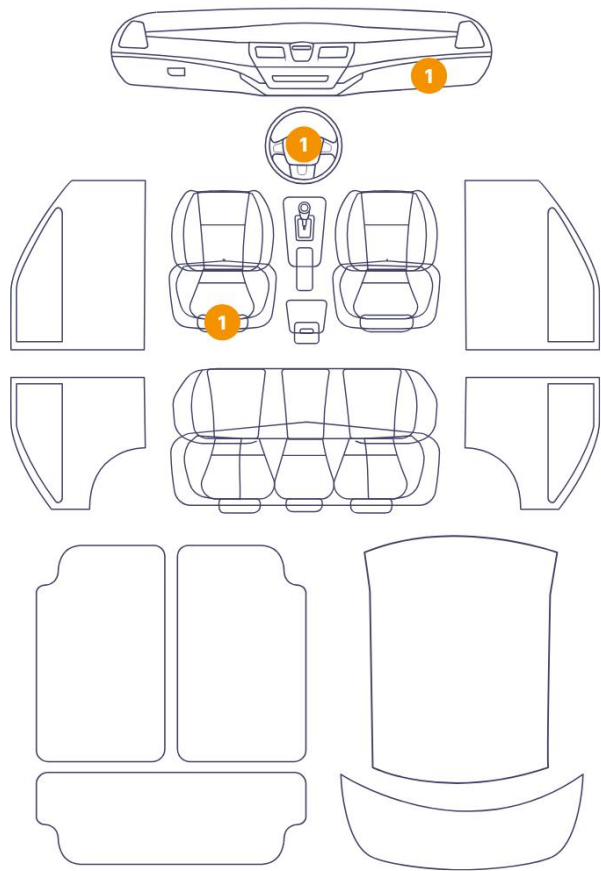
3 Schäden

13	Steering Wheel / Front	Interior / Scraped
----	------------------------	--------------------

14	Center Console	Interior / Worn - out
----	----------------	-----------------------

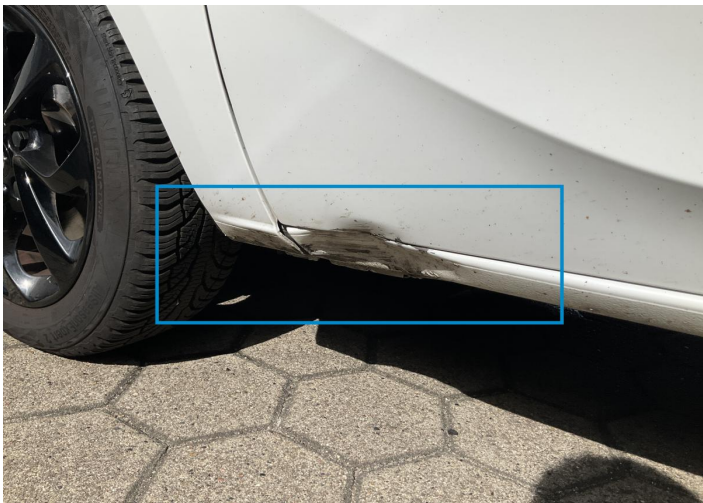
1. Rocker Panel / Center Left
Bodywork / Dent / Dent -

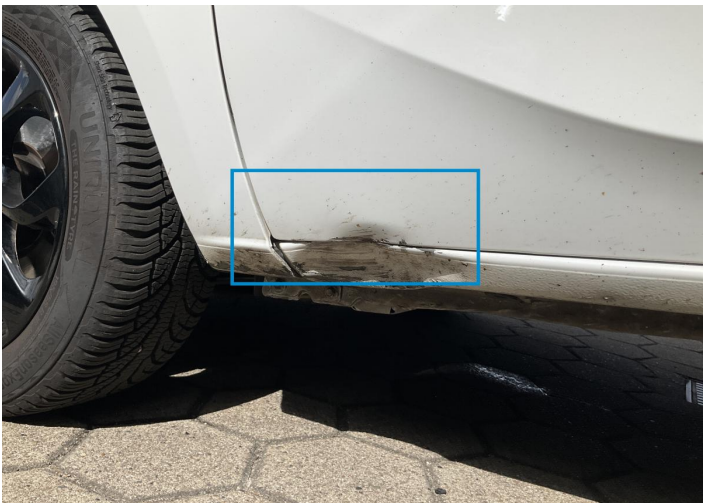
2. Door / Front Left
Bodywork / Dent / Dent -

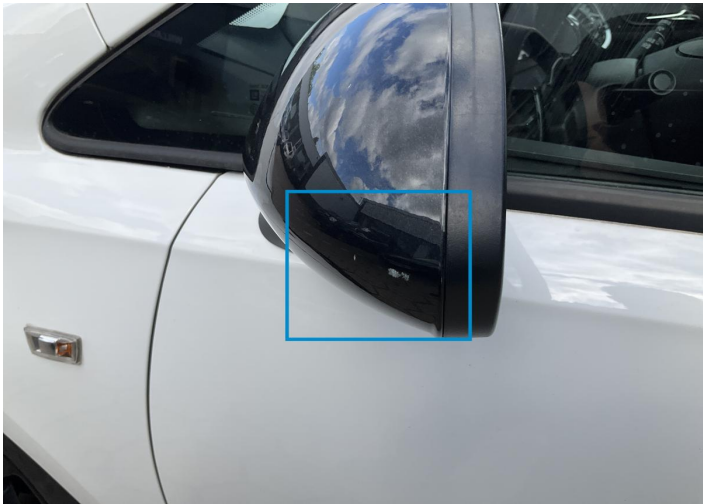
3. Mirror / Front Left
Paint / Scratch / Scuff -

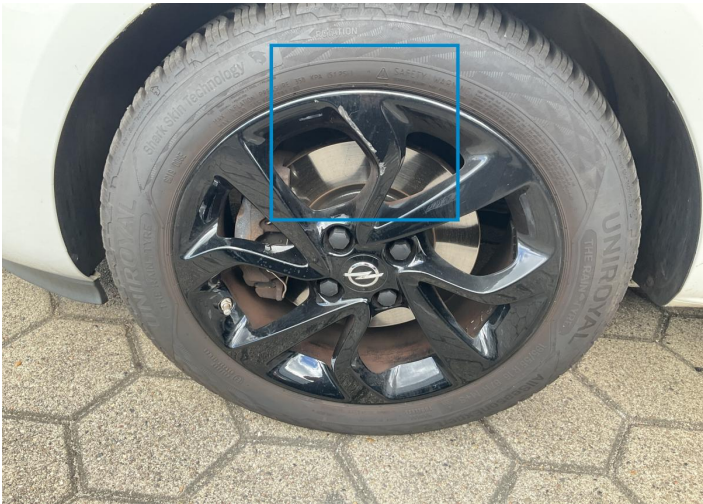
4. Rim / Front Left
Out of Bodywork / Scratch -

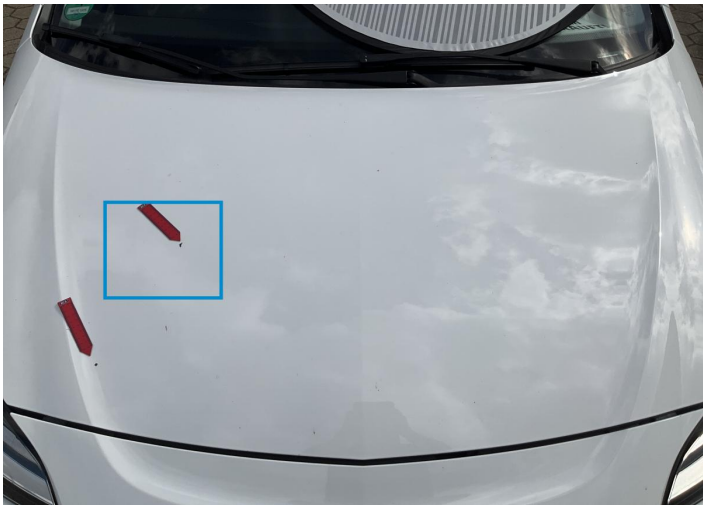
5. Hood
Paint / Stone Chip -

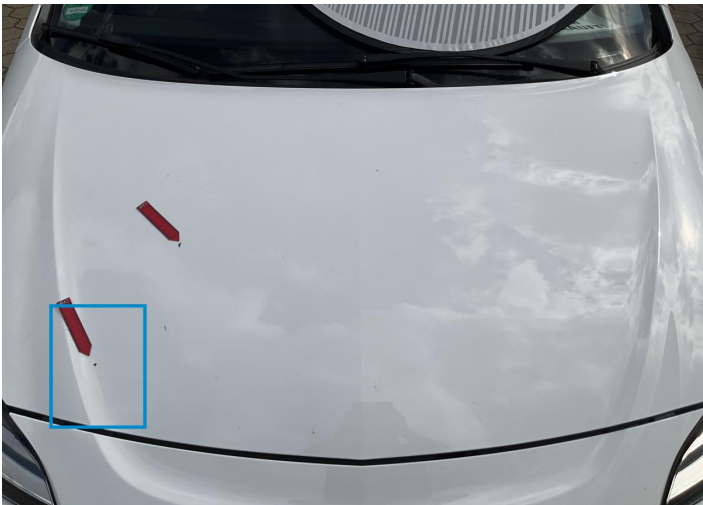
6. Hood
Paint / Stone Chip -

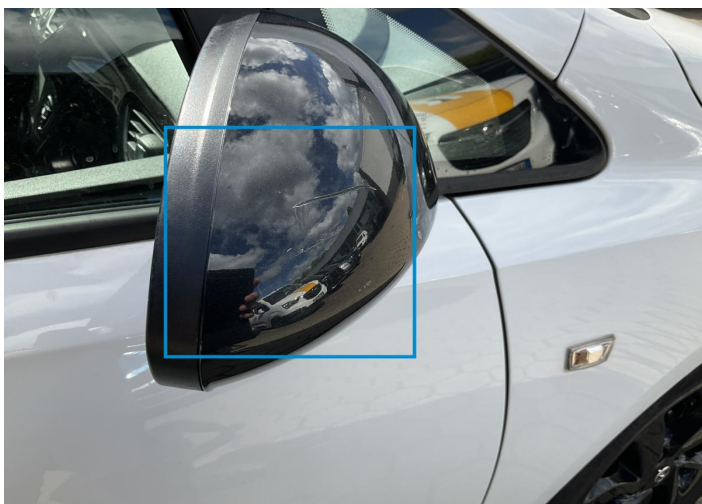
7. Mirror / Front Right
Paint / Scratch / Scuff -

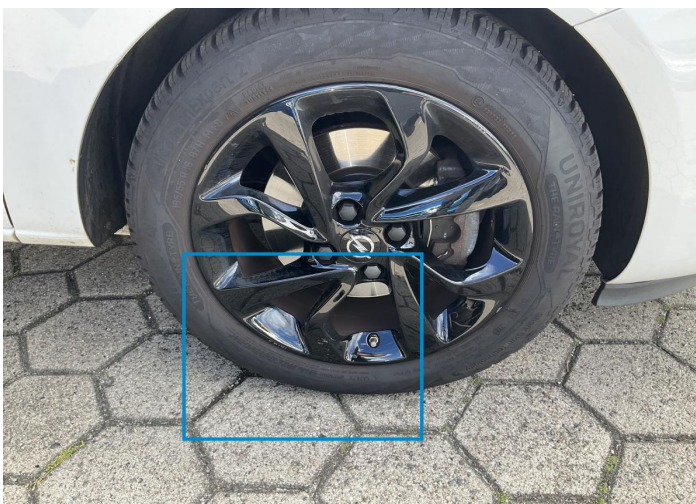
8. Rim / Front Right
Out of Bodywork / Scratch -

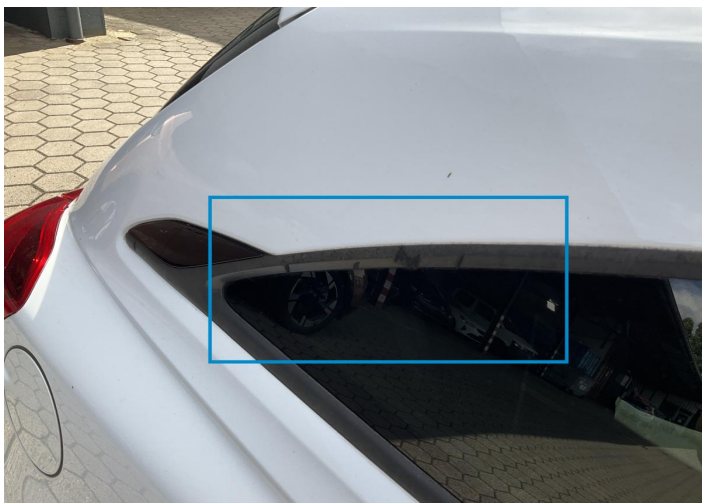
9. Window Cover / Back Right
Paint / Scratch / Scuff -

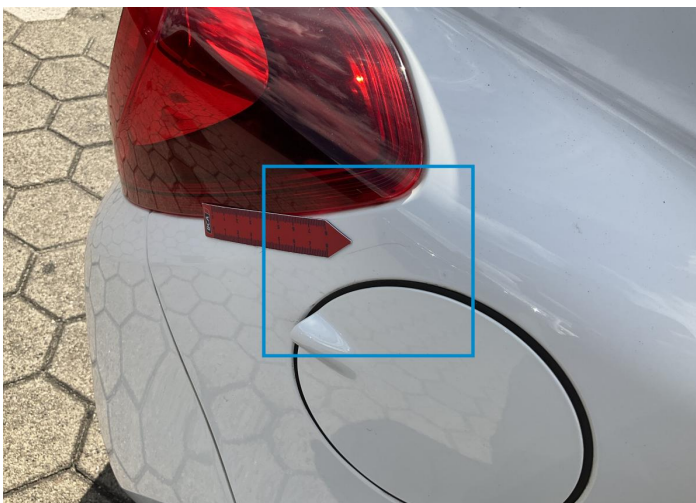
10. Fender / Back Right
Paint / Scratch / Scuff -

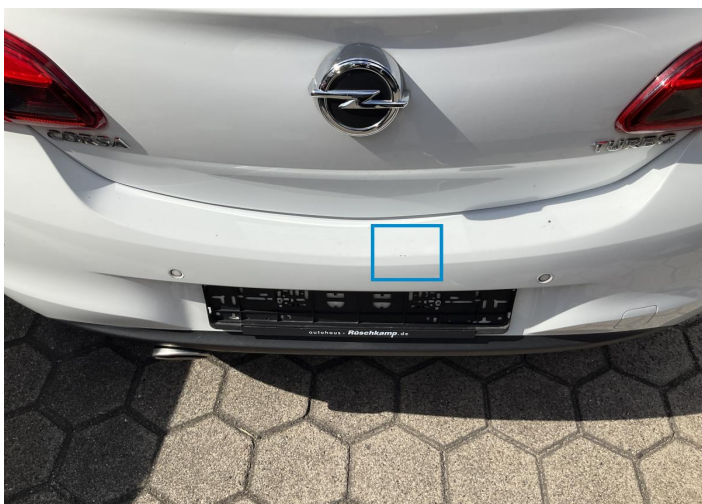
11. Bumper / Back
Paint / Scratch / Scuff -

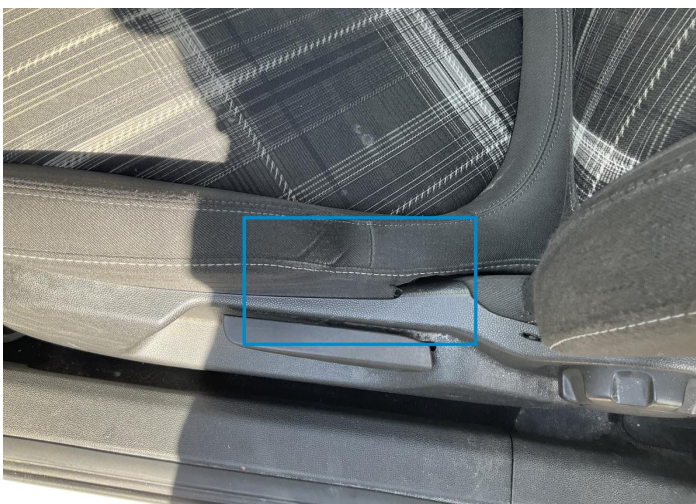
12. Seat / Front Left
Interior / Ripped -

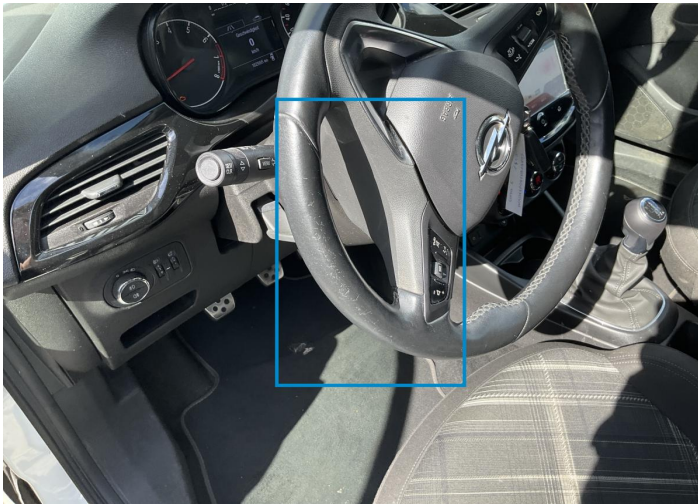
13. Steering Wheel / Front
Interior / Scraped -

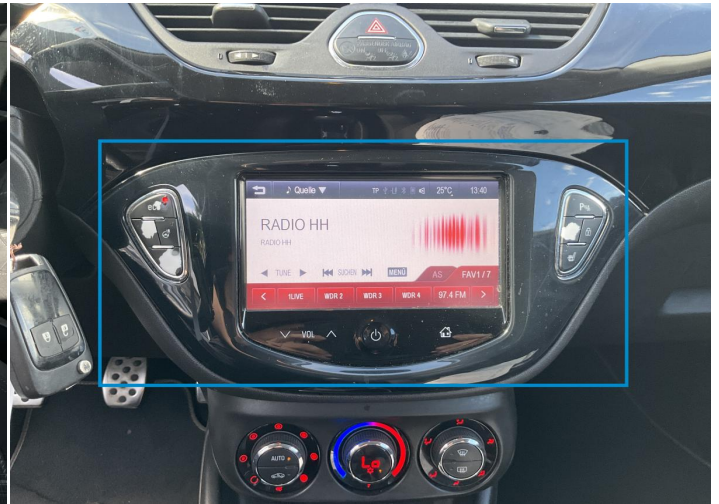
14. Center Console
Interior / Worn - out -
