## OPEL Corsa Corsa 1.4 Turbo (ecoFLEX) Start/Stop

VIN NO W0L0XEP08F6019893

### Inspection Report Summary

| Customer | BCA Online | Report Number | P20250903133143 |

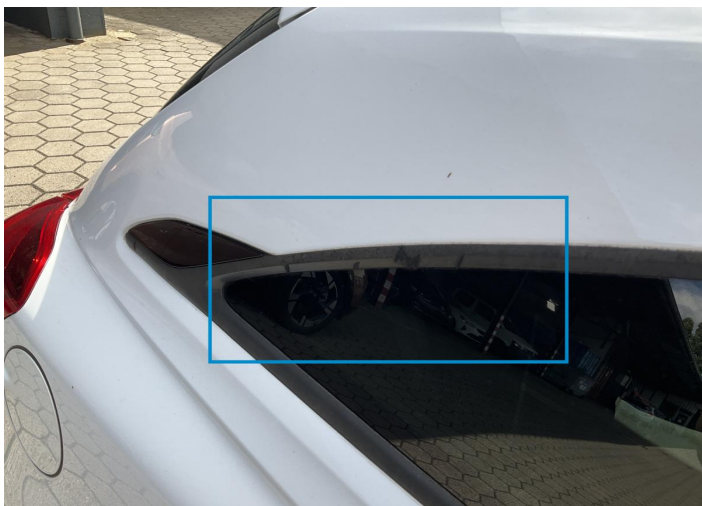
| Component | | Damage | Comments |
|---|---|---|---|
| 9 | Window Cover / Back Right | Paint / Scratch / Scuff | |

9. Window Cover / Back Right  
Paint / Scratch / Scuff -

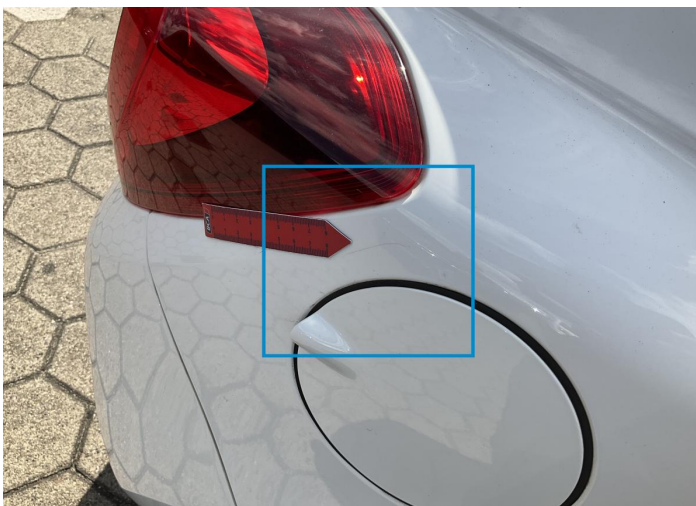
| Component | | Damage | Comments |
|---|---|---|---|
| 10 | Fender / Back Right | Paint / Scratch / Scuff | |

10. Fender / Back Right  
Paint / Scratch / Scuff -

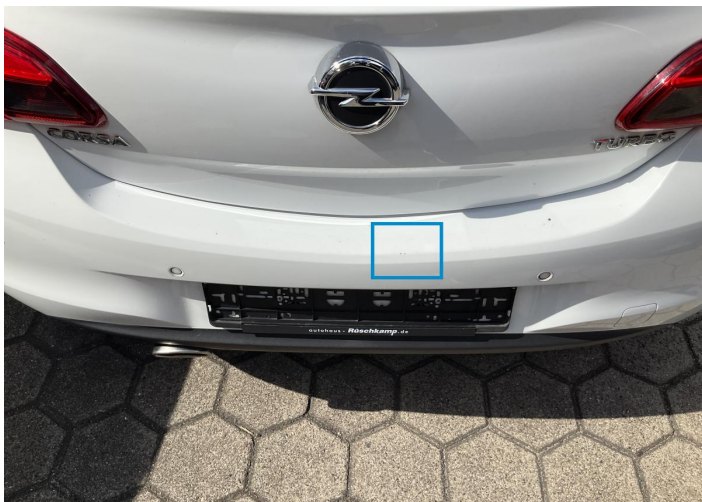
| Component | | Damage | Comments |
|---|---|---|---|
| 11 | Bumper / Back | Paint / Scratch / Scuff | |

11. Bumper / Back  
Paint / Scratch / Scuff -

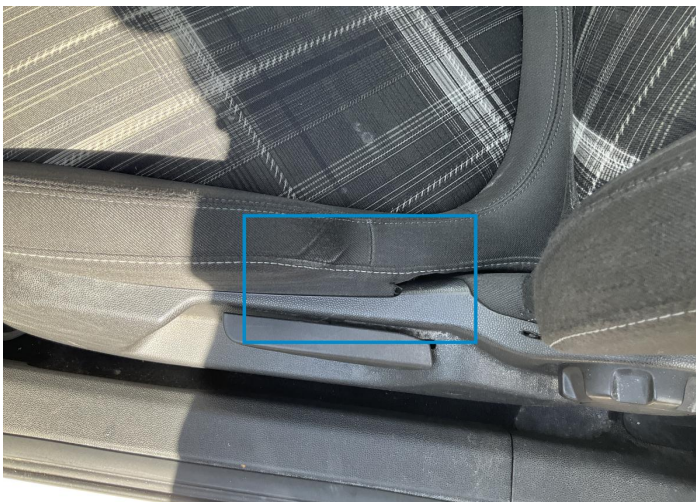
| Component | | Damage | Comments |
|---|---|---|---|
| 12 | Seat / Front Left | Interior / Ripped | |

12. Seat / Front Left  
Interior / Ripped -

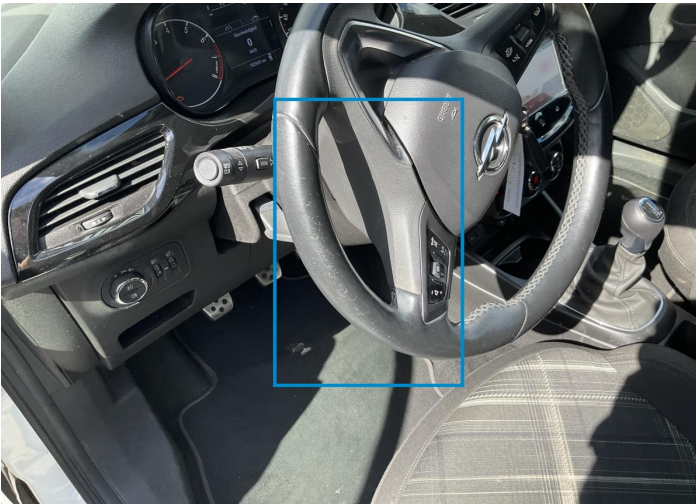
| 13 | Steering Wheel / Front | Interior / Scraped |

13. Steering Wheel / Front  
Interior / Scraped -
