OPEL CORSA

Corsa 1.4 90 ch Edition

VIN NO W0L0XEP68G4115474
Registration Number DZ832BG

Inspection Report Summary

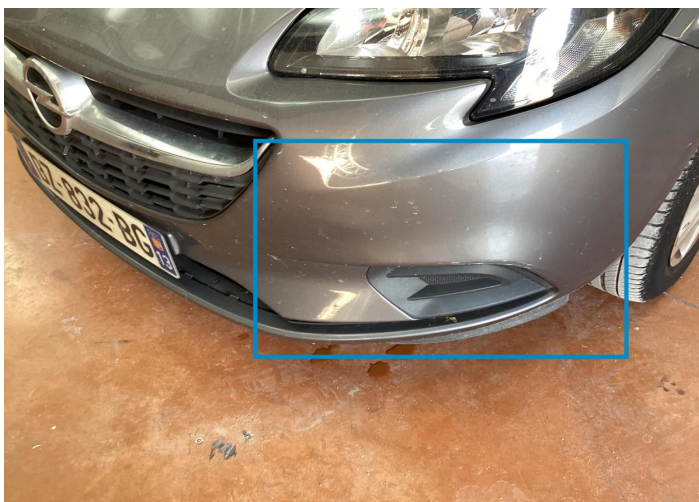
1. Shield / Front
Paint / Scratch / Line -

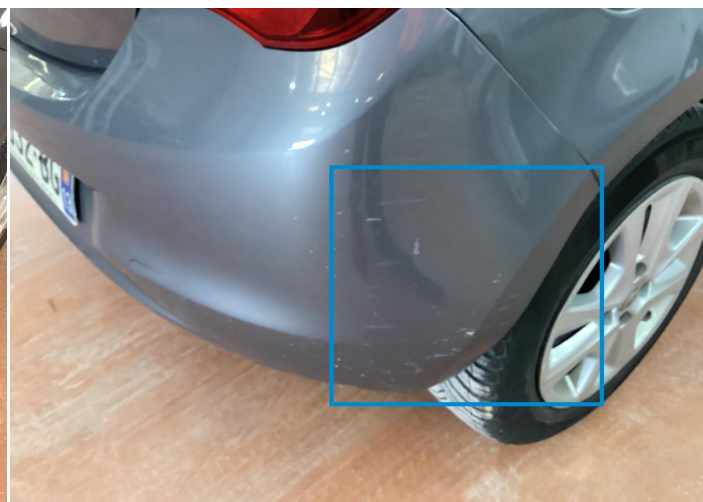
2. Shield / Back
Bodywork / Dent / Deformation -

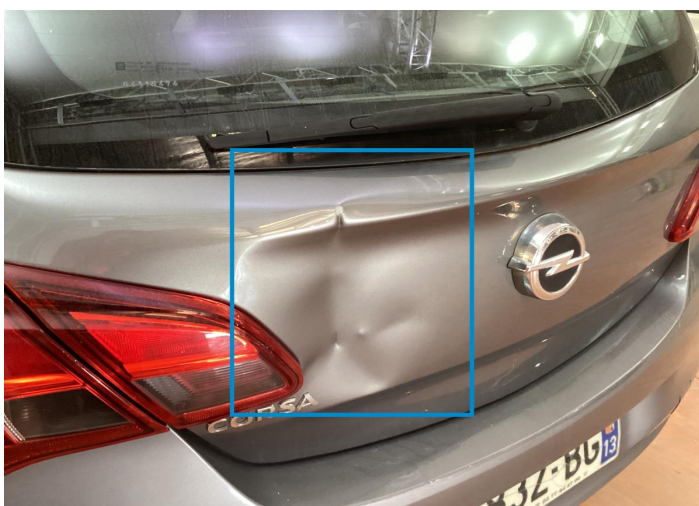
3. Tailgate
Bodywork / Dent / Deformation -

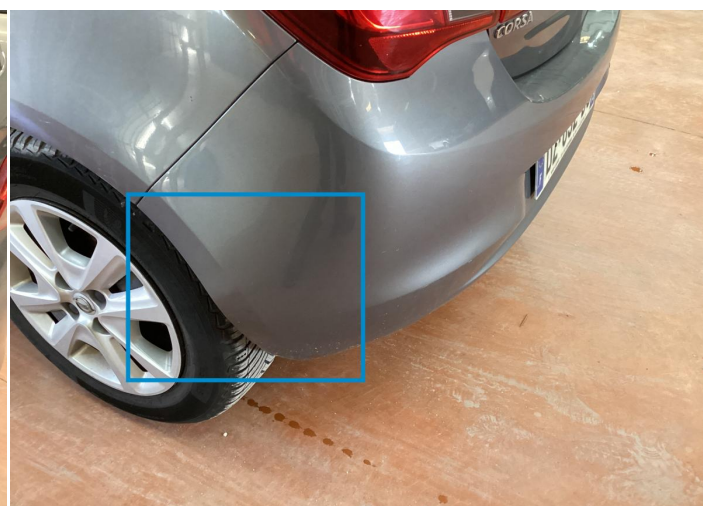
4. Shield / Back
Bodywork / Dent / Deformation -

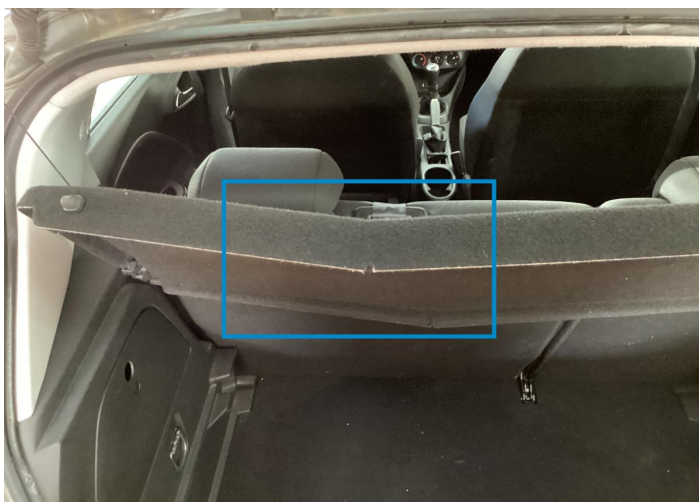
5. Luggage Space Cover / Back
Interior / Broken -

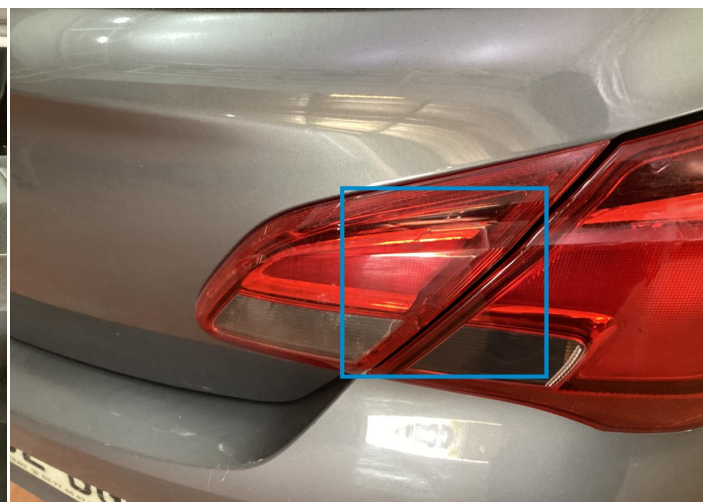
6. Back Light / Right
Glass Break -

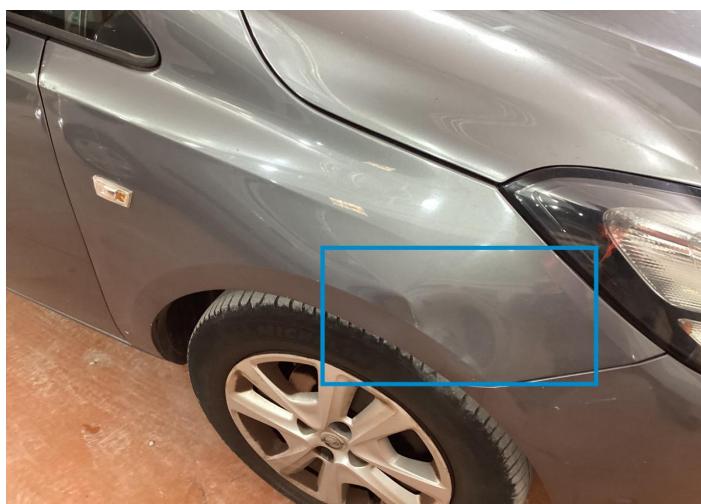
7. Fender / Front Right
Bodywork / Dent / Deformation -

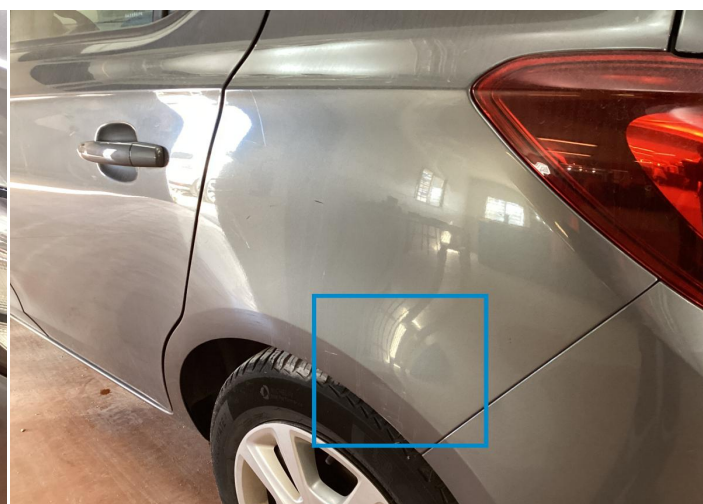
8. Fender / Back Left
Bodywork / Dent / Deformation -

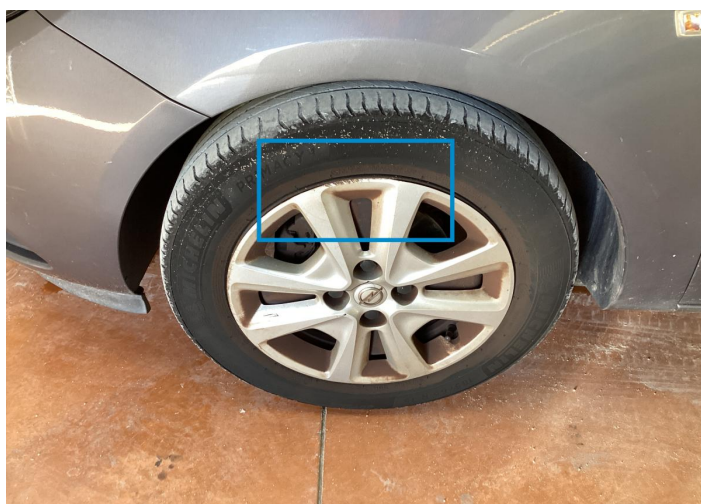
9. Hubcap / Front Left
Out of Bodywork / Breakage -

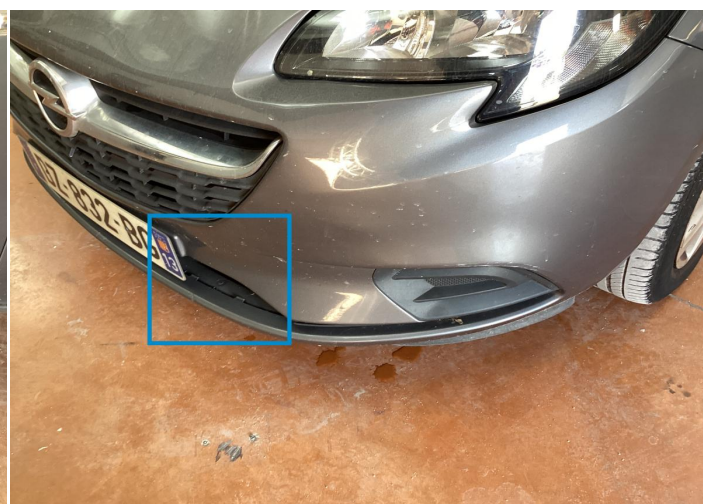
10. Shield / Front
Bodywork / Assembly -

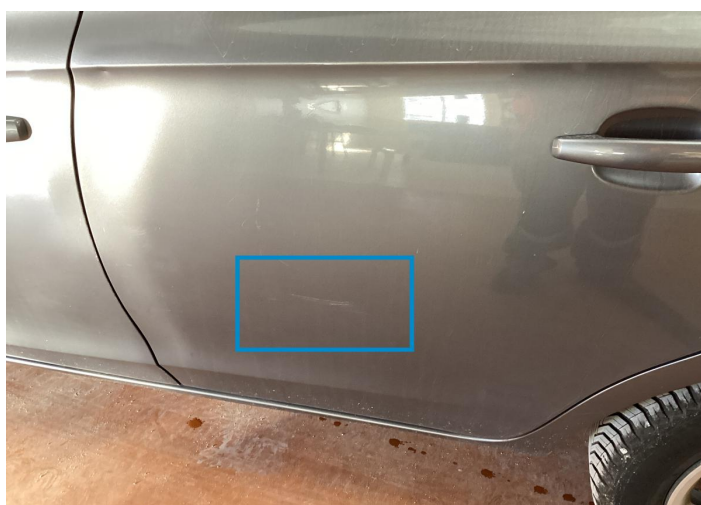
11. Door / Back Left
Paint / Scratch / Line -

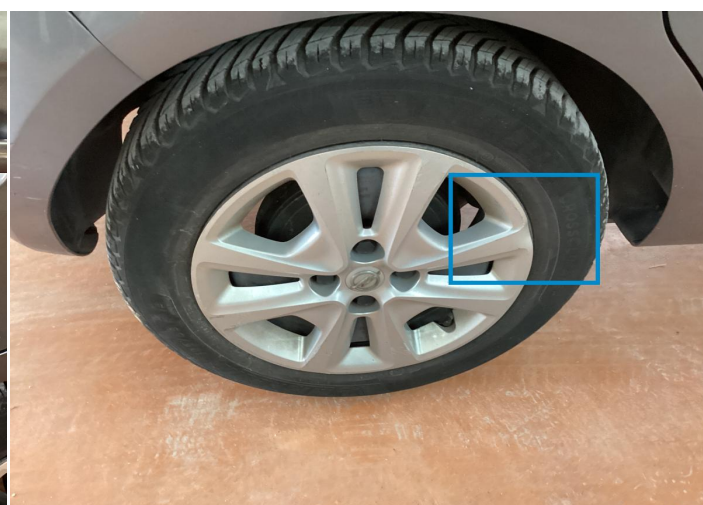
12. Hubcap / Back Right
Out of Bodywork / Breakage -

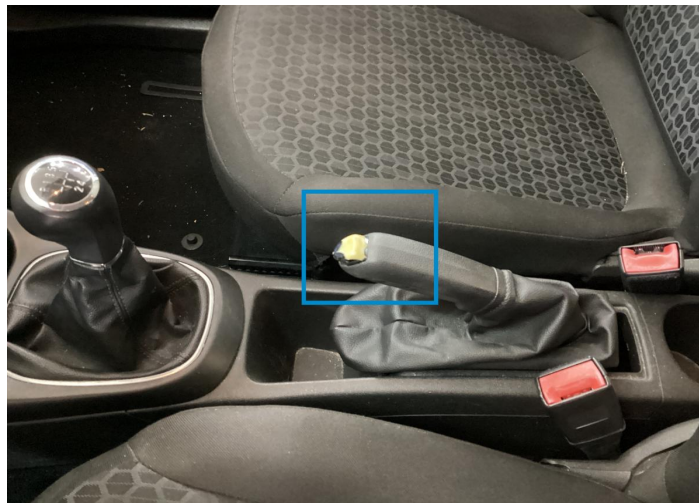
13. HandBrake Handle
Interior / Ripped -
