## OPEL Corsa Corsa 1.2

VIN NO W0L0XEP68G4131657

### Inspection Report Summary

| Customer | BCA Online | Report Number | P20250822123359 |

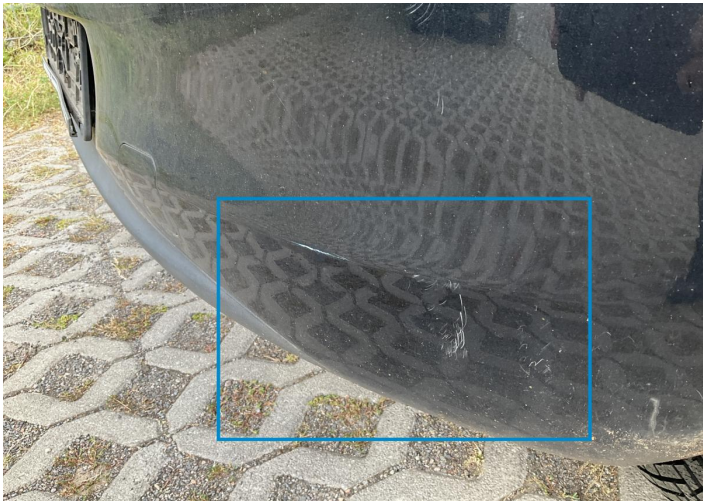
1. Bumper / Back  
Paint / Scratch / Scuff -

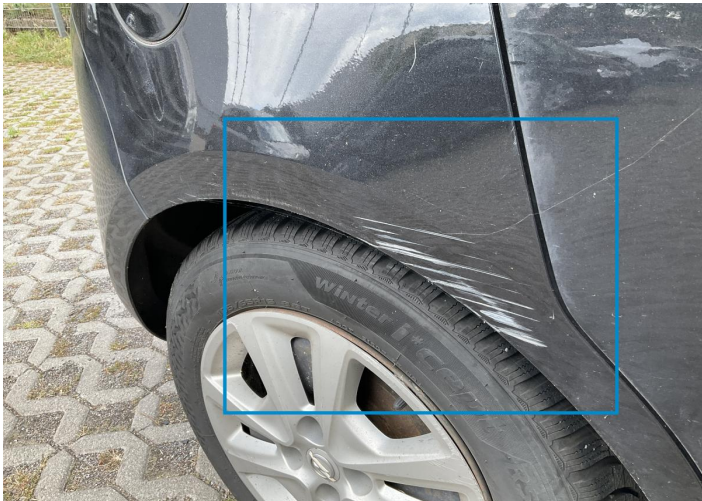
2. Side Panel / Back Right  
Paint / Scratch / Scuff -

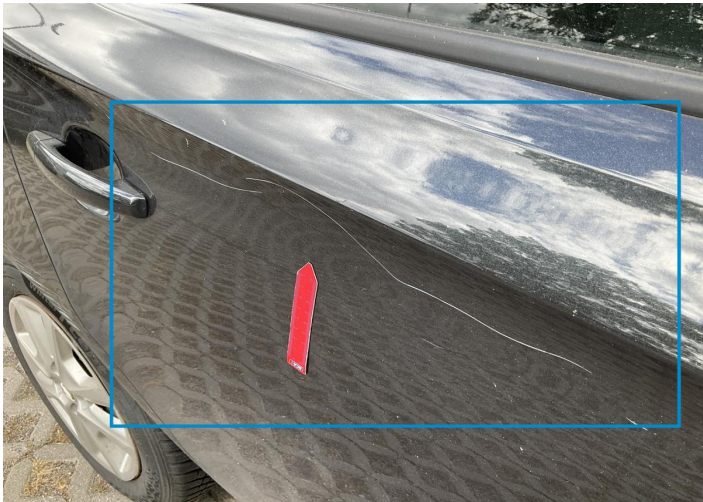
3. Door / Back Right  
Paint / Scratch / Scuff -

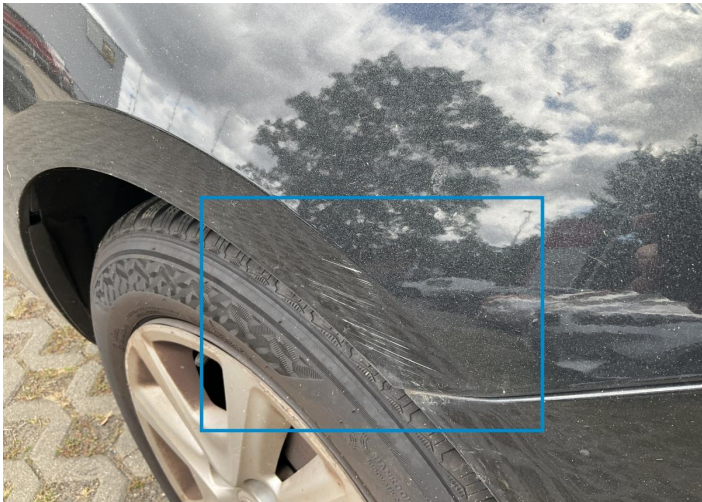
4. Fender / Front Right  
Paint / Scratch / Scuff -

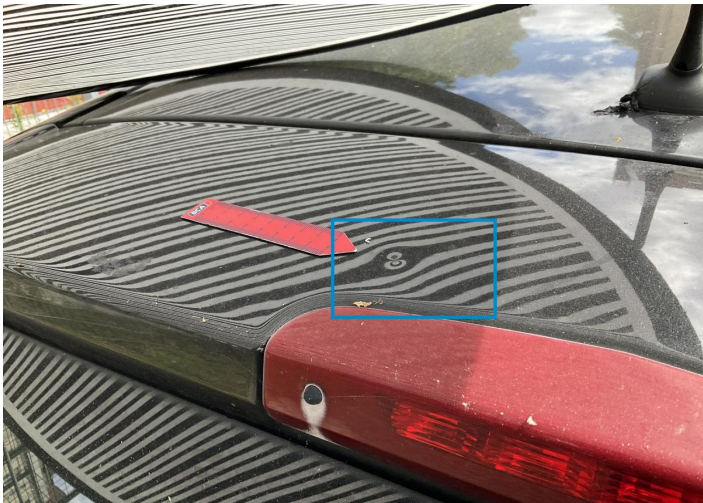
5. Tailgate  
Bodywork / Dent / Dent -

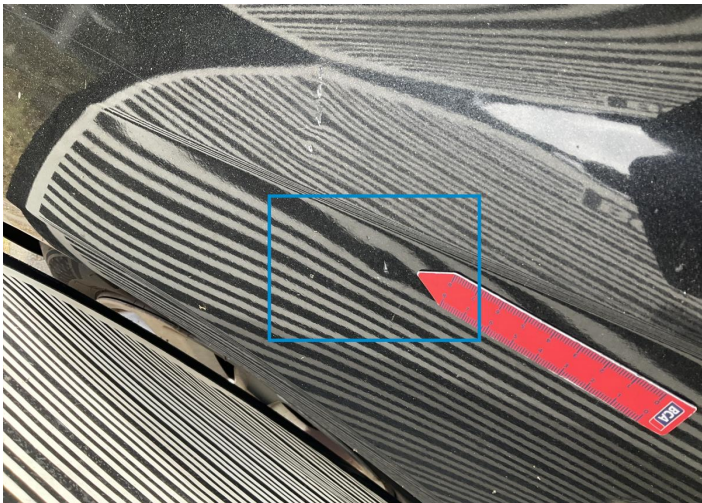
6. Fender / Front Left  
Bodywork / Dent / Dent -

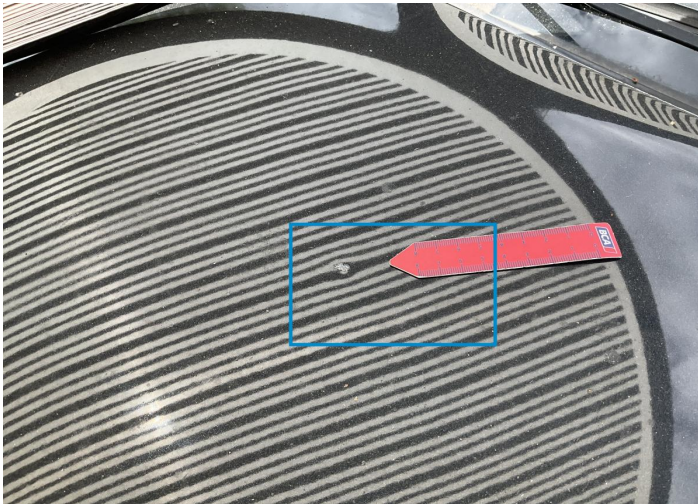
7. Hood  
Bodywork / Dent / Dent -

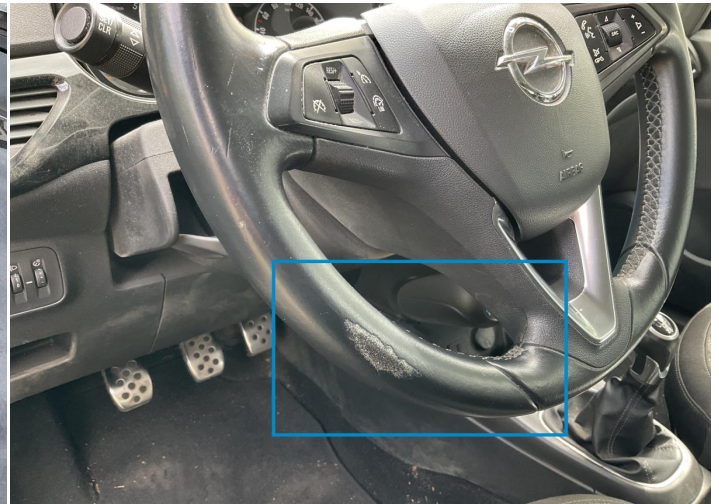
8. Steering Wheel / Front  
Interior / Worn - out -
