## OPEL Corsa Corsa 1.2

VIN NO W0L0XEP68G4131657

### Inspection Report Summary

| Customer | BCA Online | Report Number | P20250822123359 |

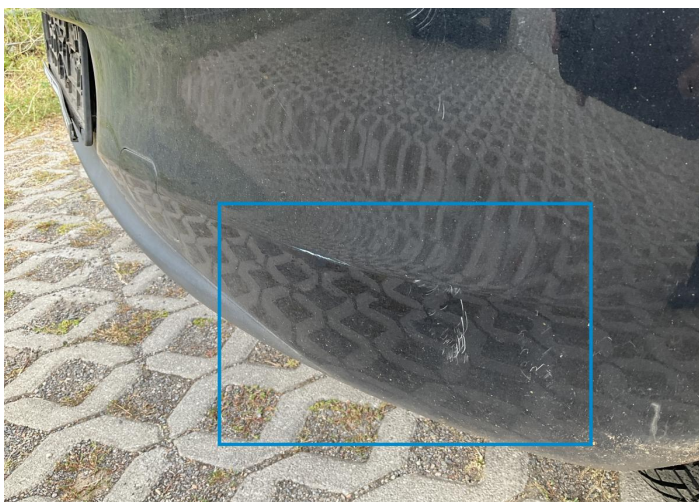
| Component | Damage | Comments |
|---|---|---|
| 1 Bumper / Back | Paint / Scratch / Scuff | |

1. Bumper / Back  
Paint / Scratch / Scuff -

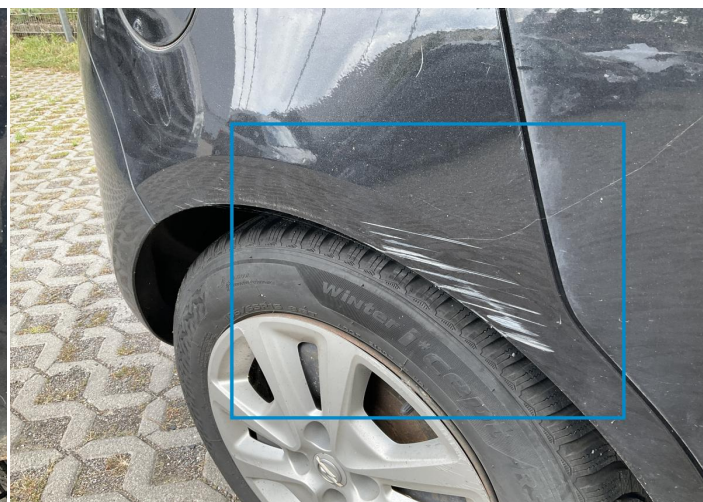
| Component | Damage | Comments |
|---|---|---|
| 2 Side Panel / Back Right | Paint / Scratch / Scuff | |

2. Side Panel / Back Right  
Paint / Scratch / Scuff -

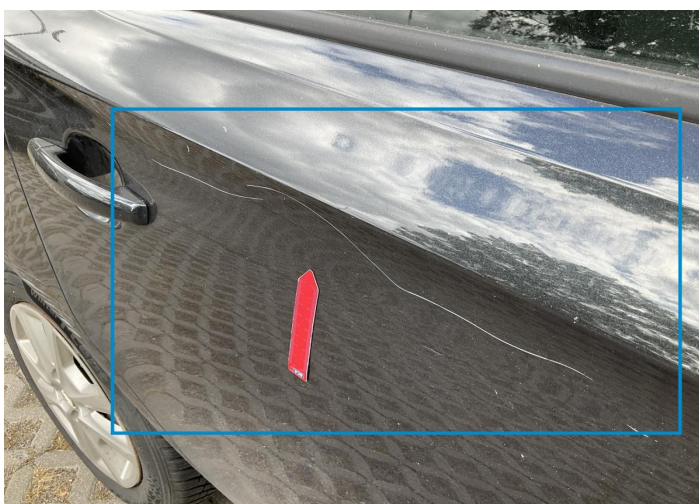
| Component | Damage | Comments |
|---|---|---|
| 3 Door / Back Right | Paint / Scratch / Scuff | |

3. Door / Back Right  
Paint / Scratch / Scuff -

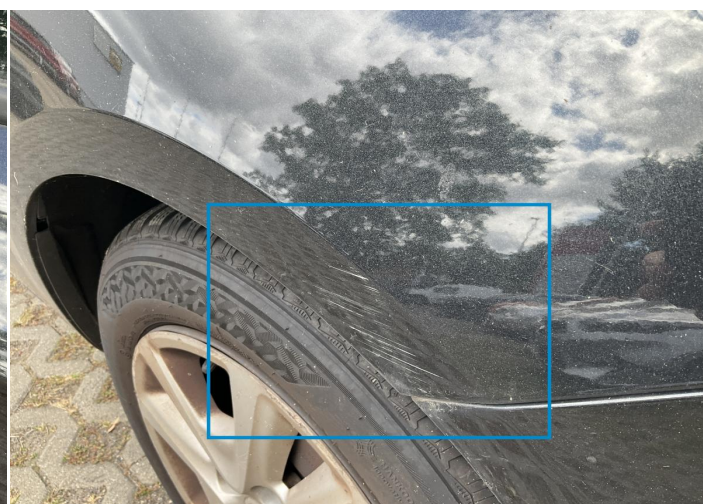
| Component | Damage | Comments |
|---|---|---|
| 4 Fender / Front Right | Paint / Scratch / Scuff | |

4. Fender / Front Right  
Paint / Scratch / Scuff -

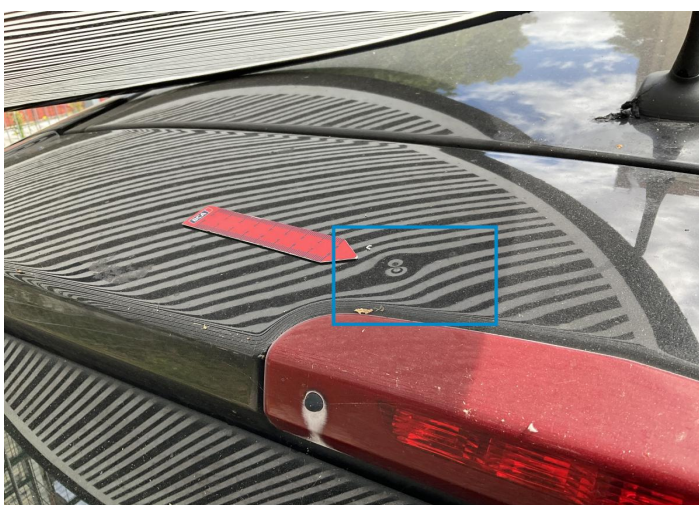
| Component | Damage | Comments |
|---|---|---|
| 5 Tailgate | Bodywork / Dent / Dent | |

5. Tailgate  
Bodywork / Dent / Dent -

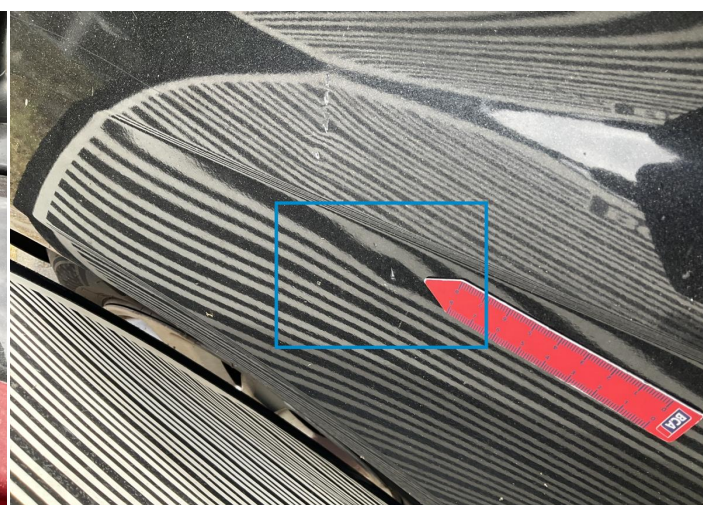
| Component | Damage | Comments |
|---|---|---|
| 6 Fender / Front Left | Bodywork / Dent / Dent | |

6. Fender / Front Left  
Bodywork / Dent / Dent -

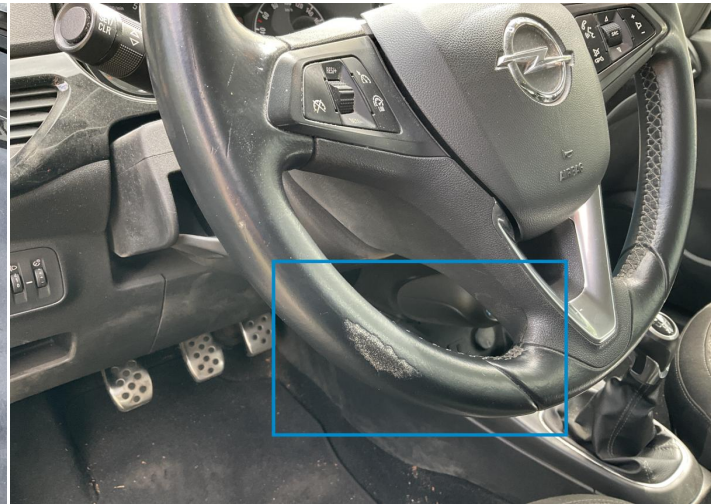
| Component | Damage | Comments |
|---|---|---|
| 8 Steering Wheel / Front | Interior / Worn - out | |

8. Steering Wheel / Front  
Interior / Worn - out -
