OPEL Astra

Astra 1.6 D (CDTI) Automatik Sports Tourer

VIN NO W0LBE8EG6G8059529

Inspection Report Summary

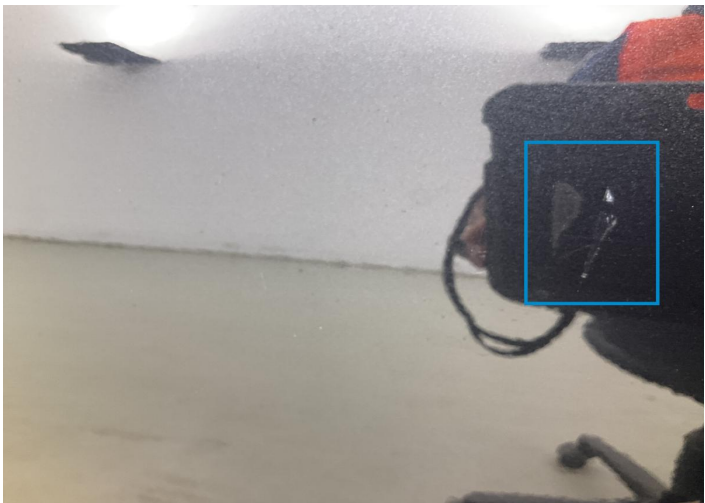
1. Door / Front Left
Paint / Scratch / Scuff -

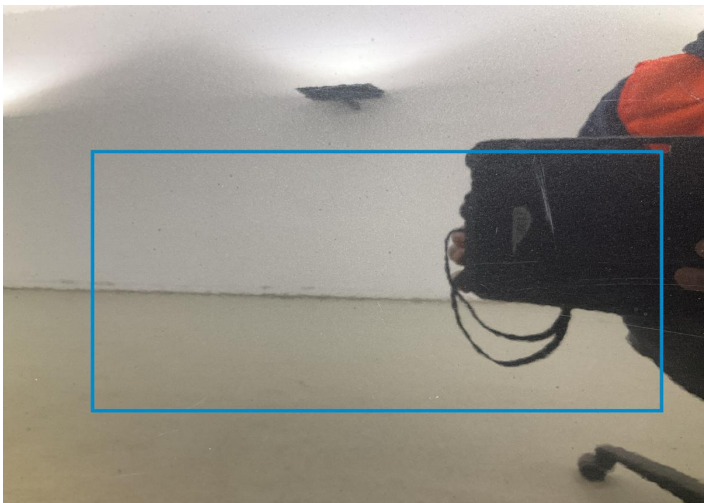
2. Door / Back Left
Paint / Scratch / Line -

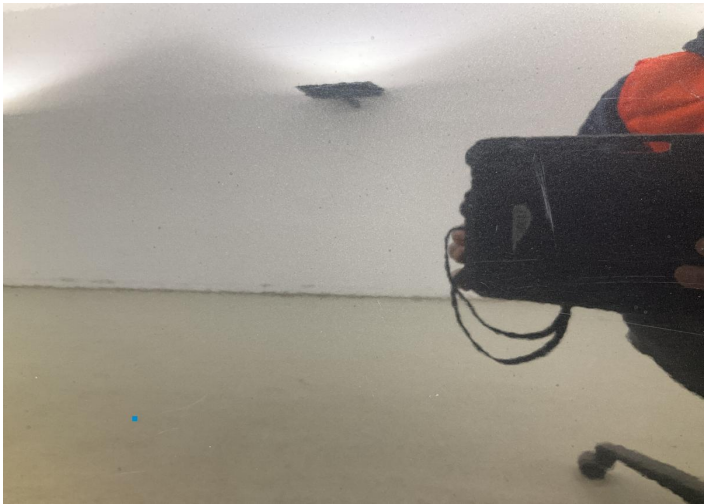
3. Door Handle / Back Left
Paint / Scratch / Line -

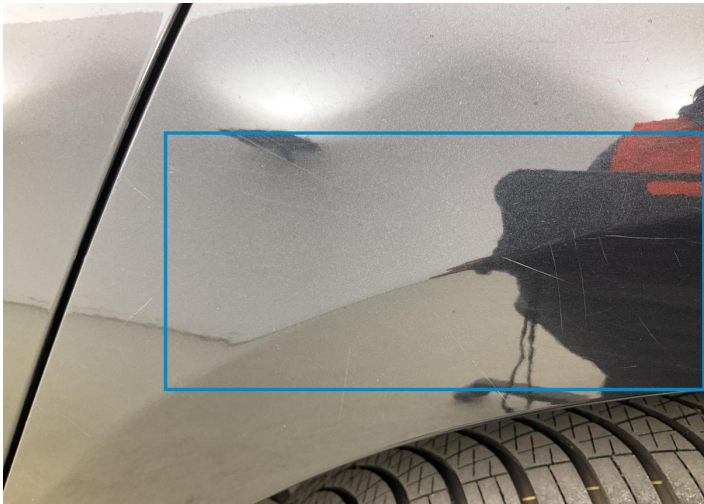
4. Side Panel / Back Left
Paint / Scratch / Scuff -

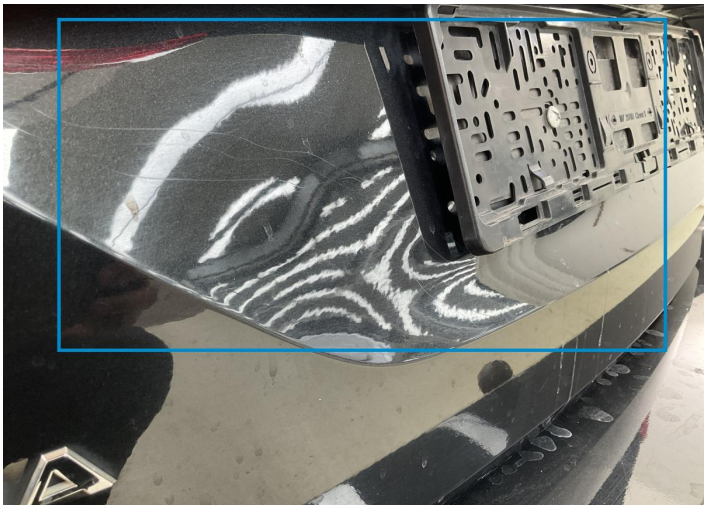
5. Tailgate
Paint / Scratch / Scuff -

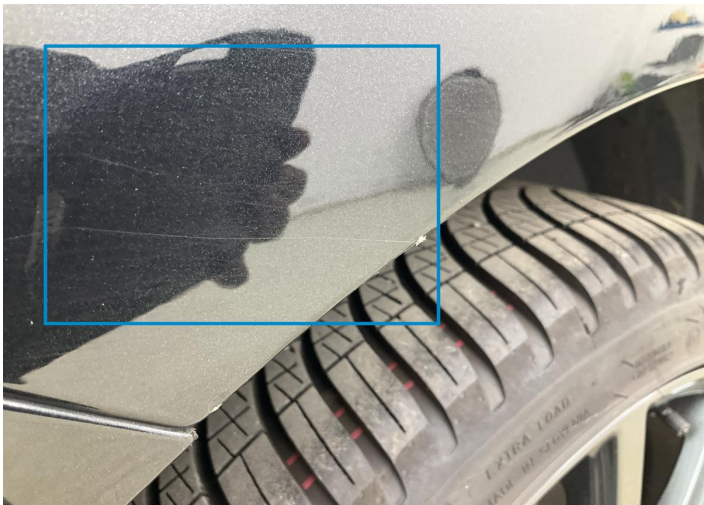
6. Side Panel / Back Right
Paint / Scratch / Scuff -

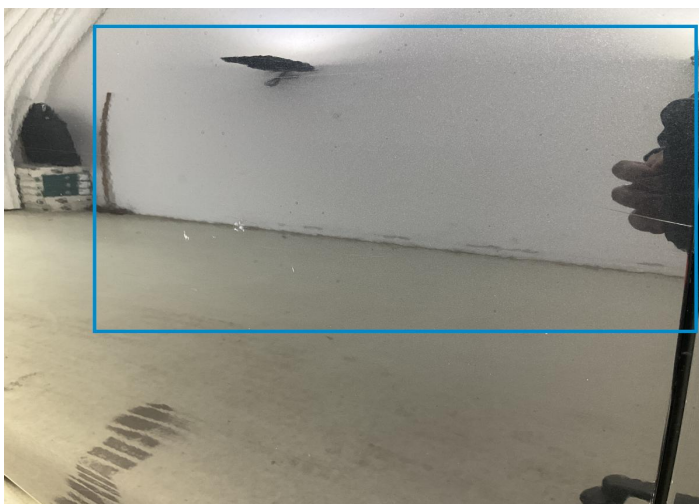
7. Door / Back Right
Paint / Scratch / Scuff -

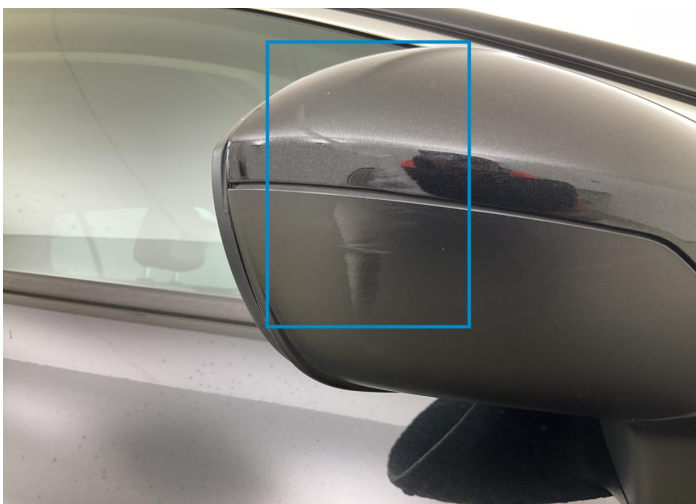
8. Mirror Shell / Front Right
Paint / Scratch / Scuff -

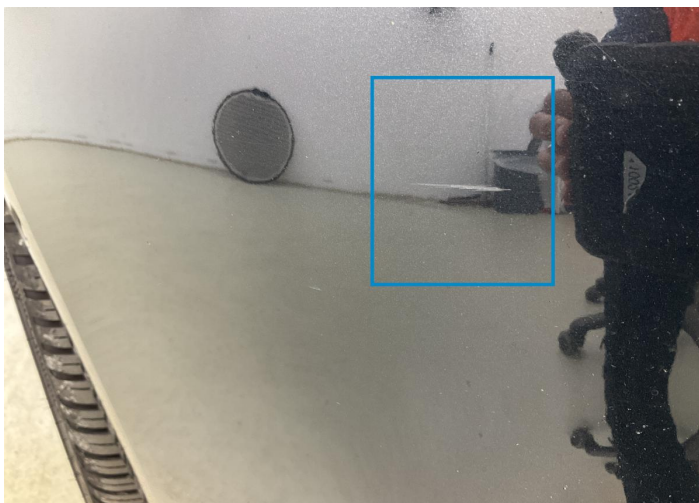
9. Bumper / Front
Paint / Scratch / Scuff -

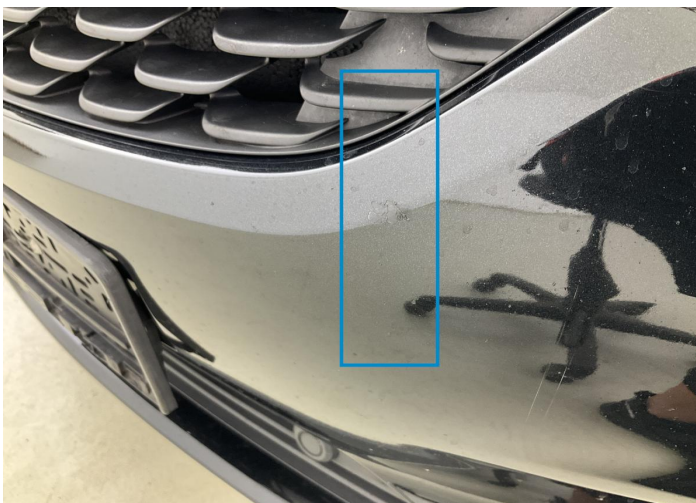
10. Bumper / Front
Paint / Chipping -

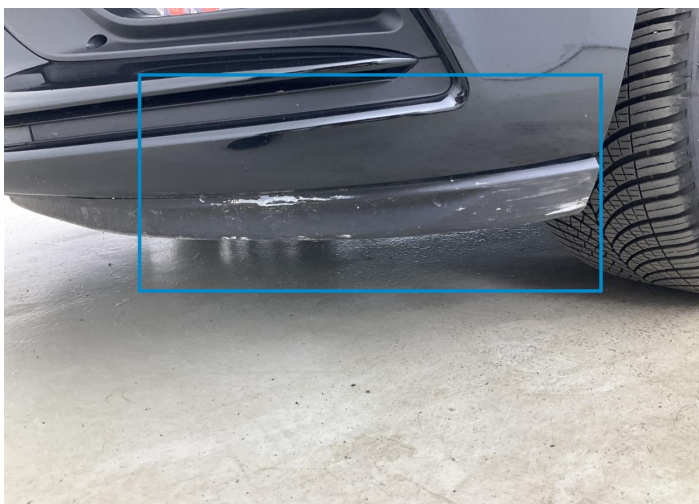
11. Bumper / Front
Paint / Scratch / Scuff -

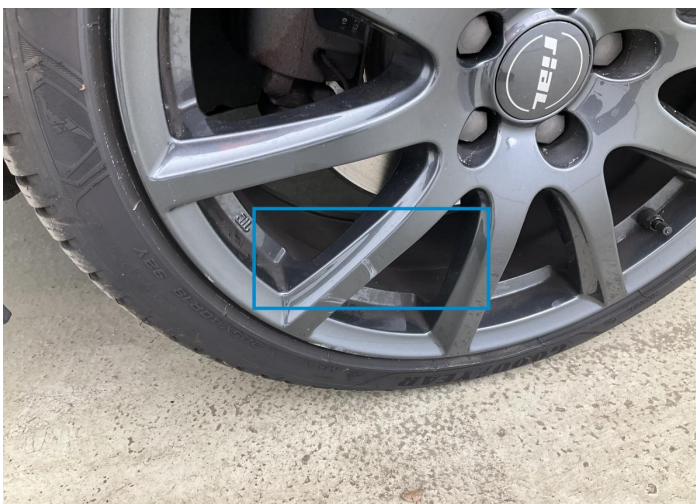
12. Rim / Front Left
Out of Bodywork / Scratch -

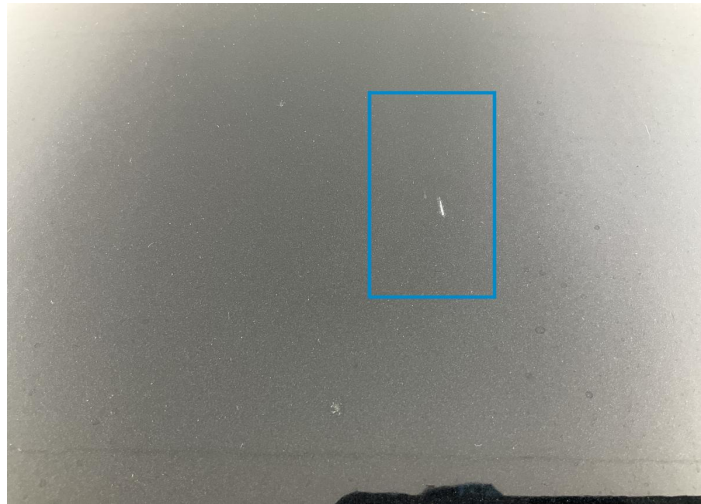
13. Hood
Paint / Scratch / Scuff -
