## status report

**customer:** BCA Autoauktionen GmbH  
**contract number:** 4002799981  
**reference:**

#### Opel Insignia A Sports Tourer Innovation

| Vehicle identification number | <b>W0LGT8E10G1073166</b> | mileage read: | <b>156321 km</b> |

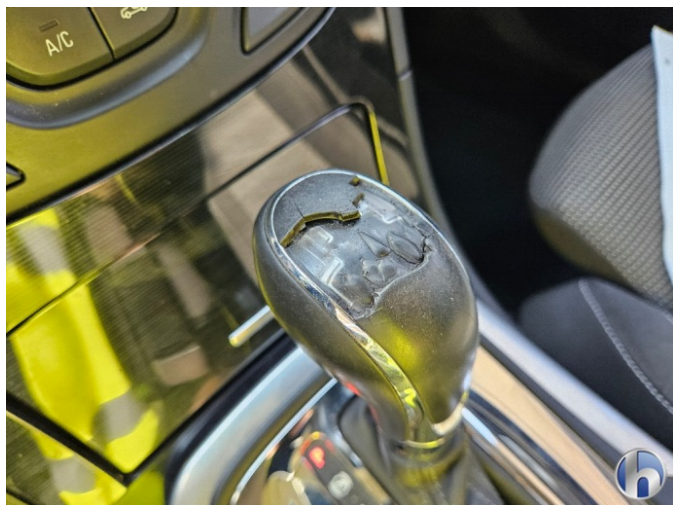
4. Schaltknäuf

| component | Damage | Rep kind |
|---|---|---|
| 4. Schaltknauf | Damaged | Replace |

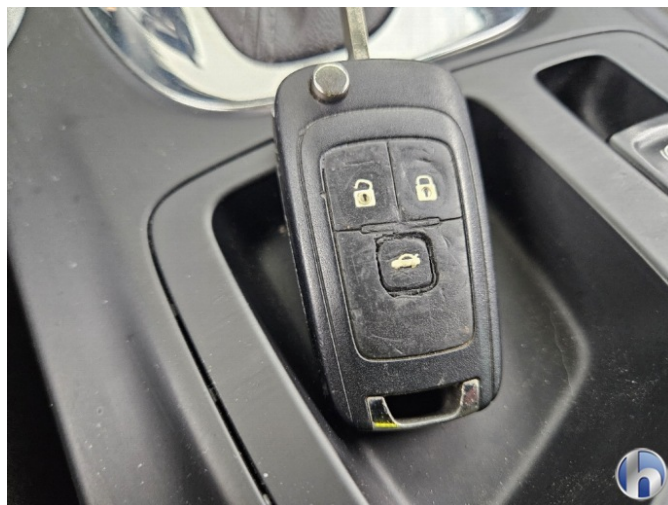
| component | Damage | Rep kind |
|---|---|---|
| 5. Key with remote control | Wear and tear | acceptable |

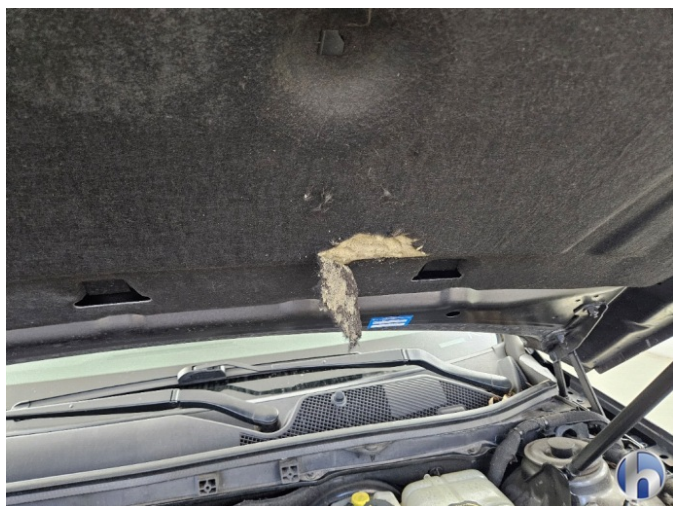
| Performed testing technology | |
|---|---|
| <b>reference:</b> | *Marderspuren im Motorraum; Oberflächenkratzer/Kratzer rundum |

| component | Damage | Rep kind |
|---|---|---|
| 6. motor insulation | Damaged | Replace |

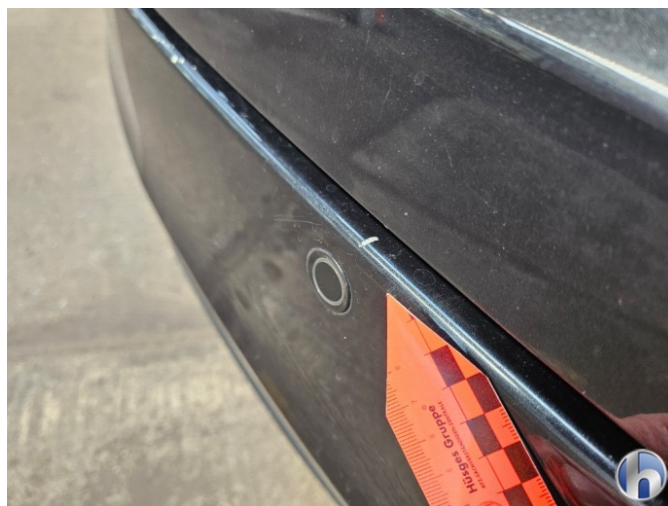
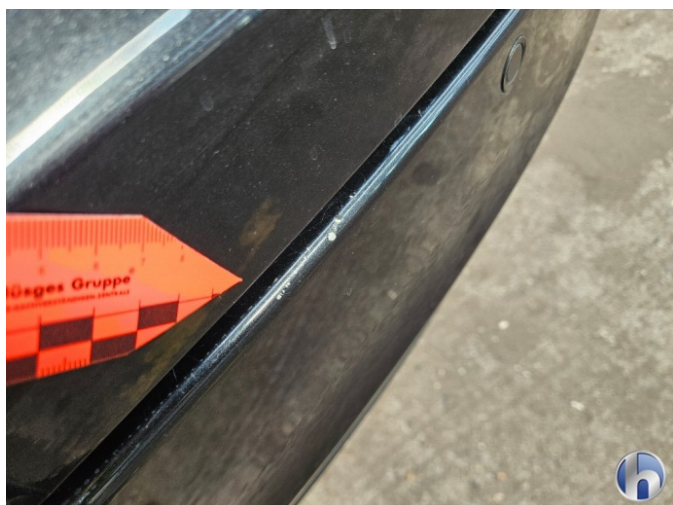
| component | Damage | Rep kind |
|---|---|---|
| 7. Rear bumper | Wear and tear | acceptable |

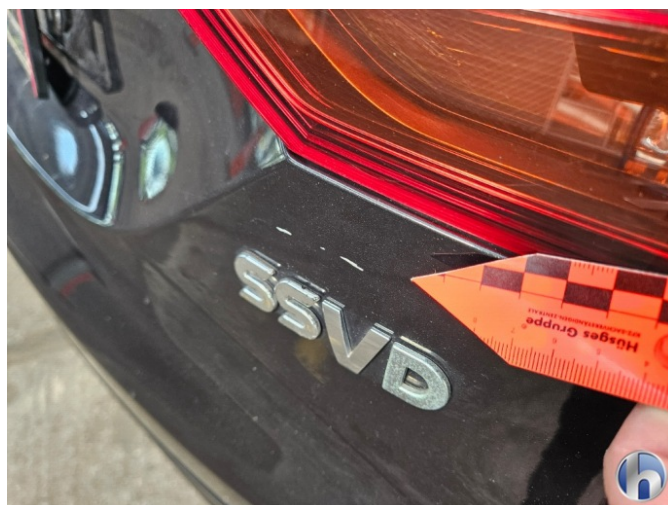
| component | Damage | Rep kind |
|---|---|---|
| 8. tailgate | Wear and tear | acceptable |

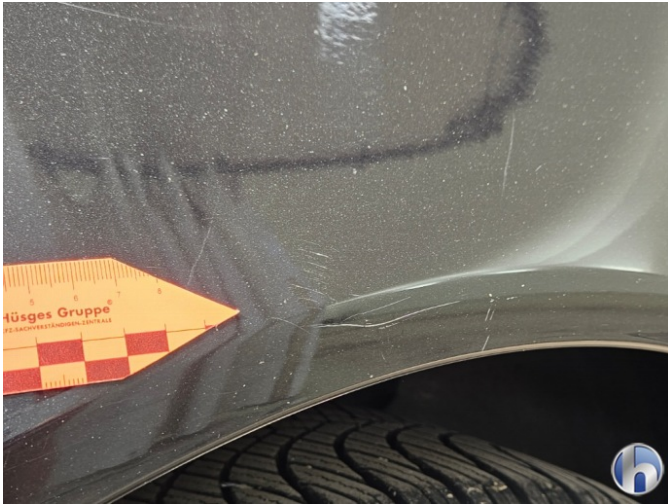
| component | Damage | Rep kind |
|---|---|---|
| 9. Sidewall - Rear - right | Scratch(es) | Smart repair |

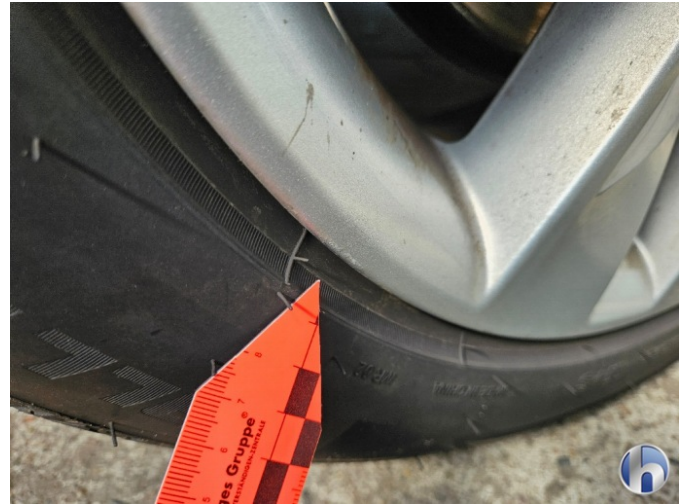
| component | Damage | Rep kind |
|---|---|---|
| 10. | Wear and tear | acceptable |

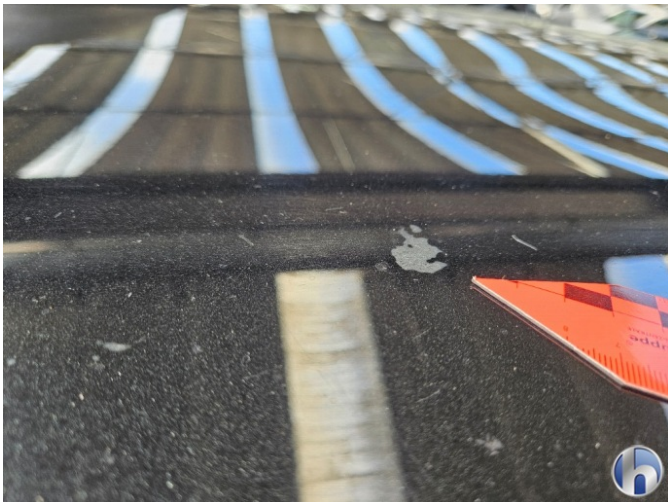
| component | Damage | Rep kind |
|---|---|---|
| 11. roof | | Paint |

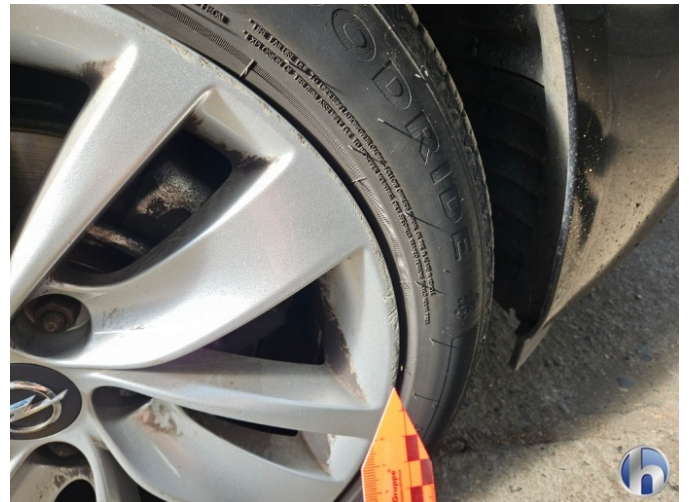
| component | Damage | Rep kind |
|---|---|---|
| 12. | Scratch(es) | Paint |

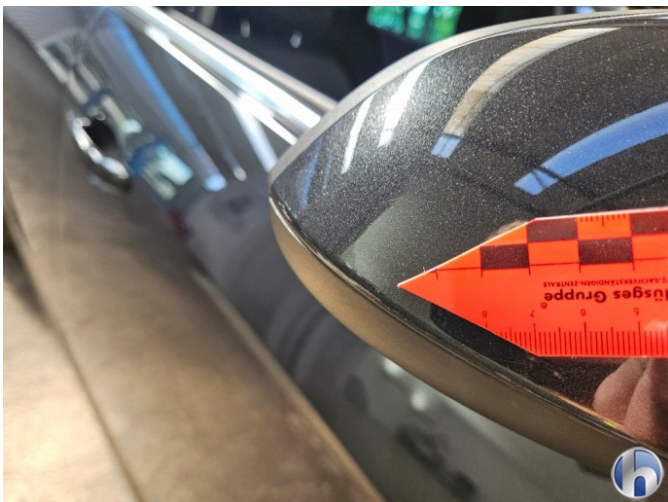
| component | Damage | Rep kind |
|---|---|---|
| 13. | Wear and tear | acceptable |

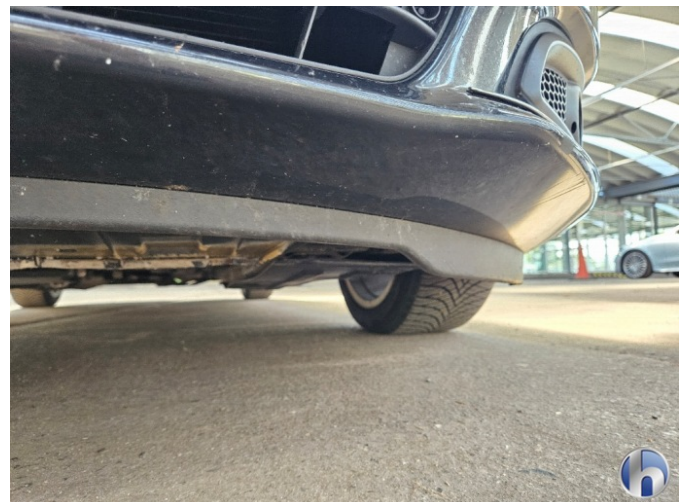
| component | Damage | Rep kind |
|---|---|---|
| 14. Front bumper | Wear and tear | acceptable |

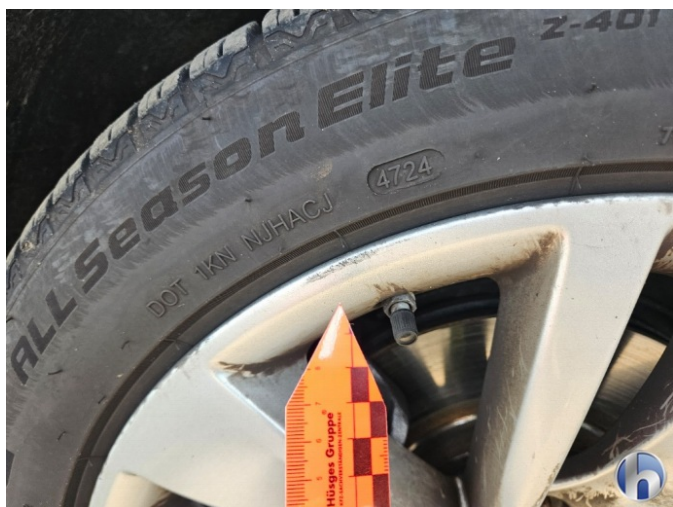
| component | Damage | Rep kind |
|---|---|---|
| 15. | Wear and tear | acceptable |

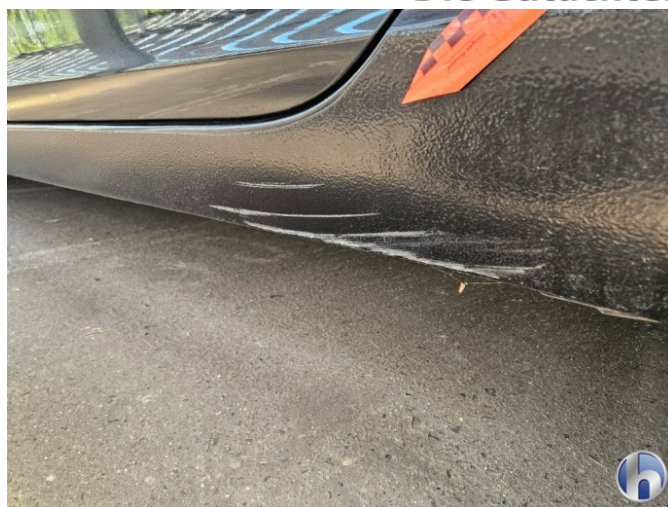
| component | Damage | Rep kind |
|---|---|---|
| 16. side skirt - left | Deformed | Refurbish and paint |

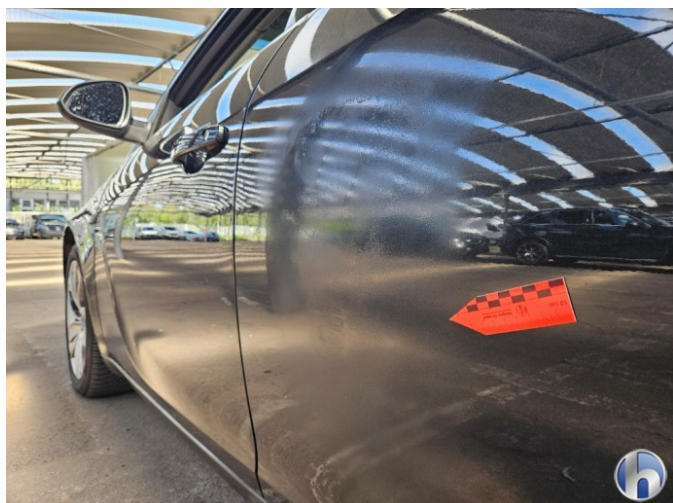
| component | Damage | Rep kind |
|---|---|---|
| 17. Rear door - left | Damaged | Refurbish and paint |

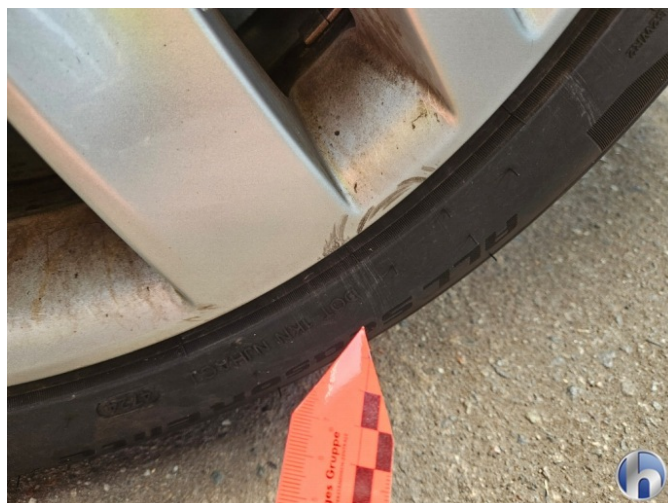
| component | Damage | Rep kind |
|---|---|---|
| 18. | Scratch(es) | Paint |

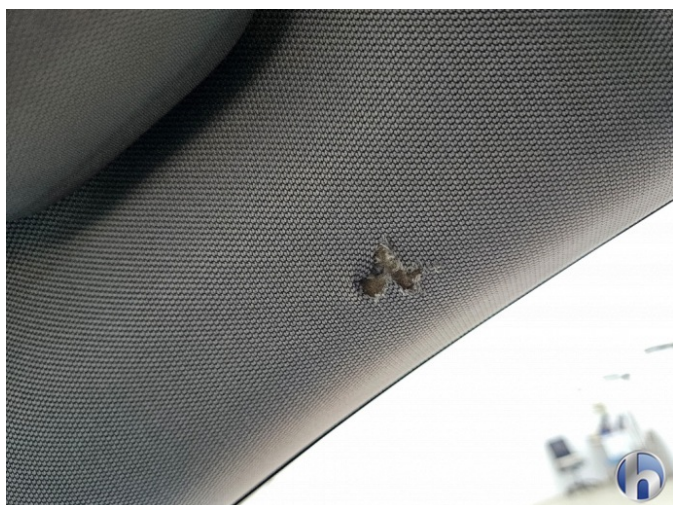
| component | Damage | Rep kind |
|---|---|---|
| 19. headlining | Damaged | Smart repair |
