OPEL Astra Astra 1.3 CDTI DPF ecoFLEX Sports TourerStart/Stop

VIN NO W0LPD8EA5C8017786
Registration Number A5C8017786

Inspection Report Summary

Customer	BCA Online	Report Number	P20250903105854
Inspection Date / Place	2025-09-03 / Dello Bremen	Cosmetic Grade	5

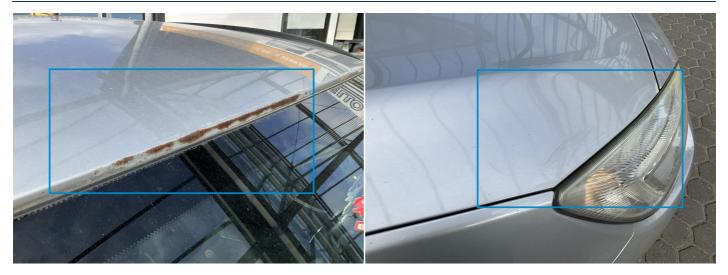
1. Roof Paint / Chipping -

2. Hood Paint / Scratch / Scuff -

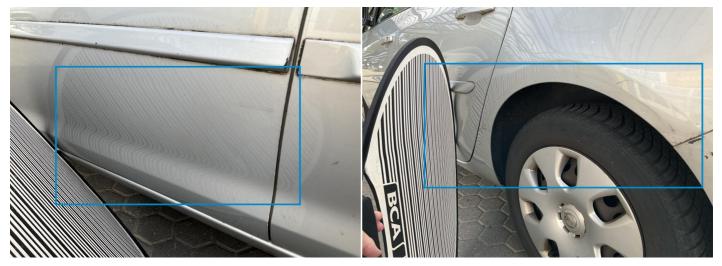
3. Door / Front Left Bodywork / Dent / Dent -

4. Fender / Back Left Bodywork / Dent / Dent -

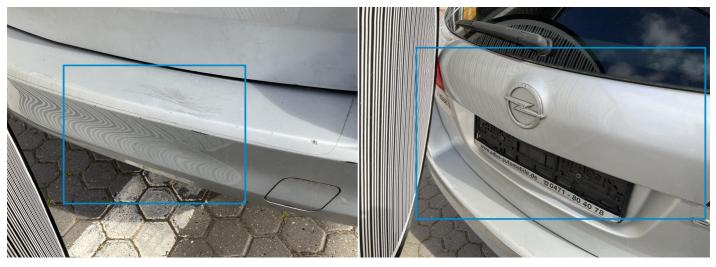
5. Bumper / Back Bodywork / Breakage -

6. Tailgate Bodywork / Dent / Dent -

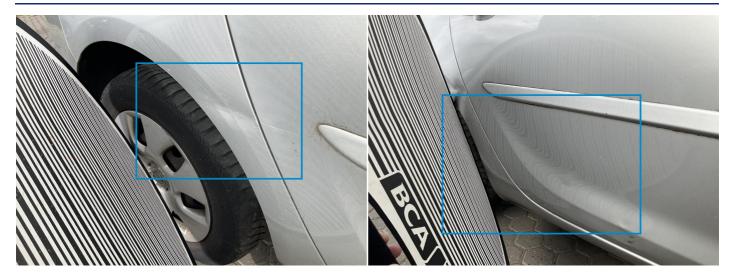
7. Fender / Back Right Bodywork / Dent / Dent -

8. Door / Back Right Bodywork / Dent / Dent -

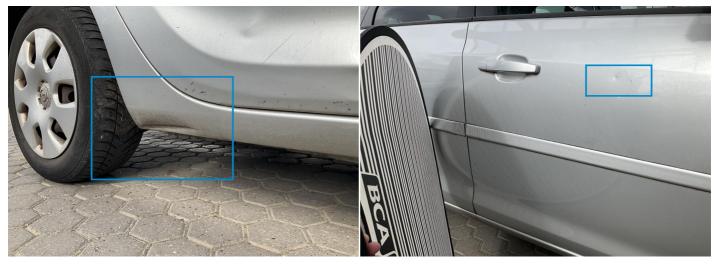
9. Rocker Panel / Center Right Bodywork / Dent / Dent -

10. Door / Front Right Bodywork / Dent / Dent -

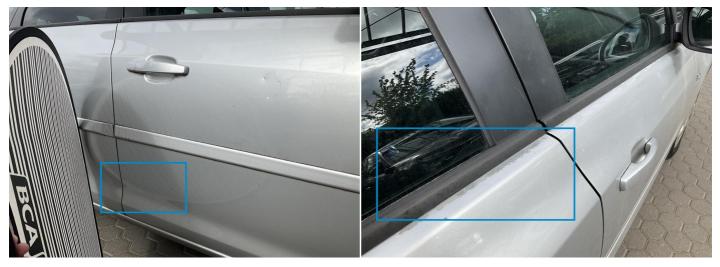
11. Door / Front Right Bodywork / Dent / Dent -

12. Door / Back Right Paint / Poor Previous Repair -

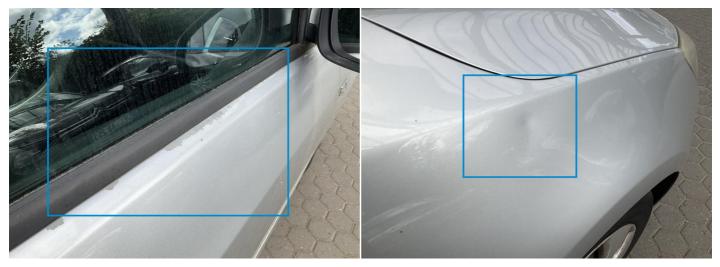
13. Door / Front Right
Paint / Poor Previous Repair -

14. Fender / Front Right Bodywork / Dent / Dent -

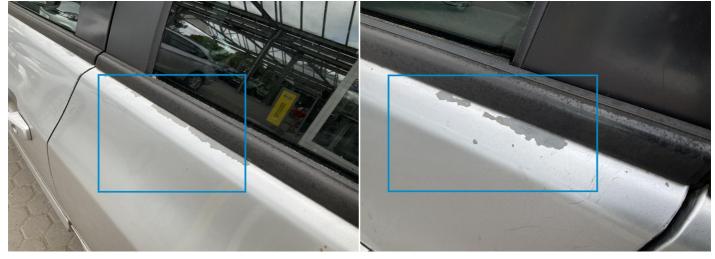
15. Door / Back Left Paint / Poor Previous Repair -

16. Door / Front Left Paint / Poor Previous Repair -

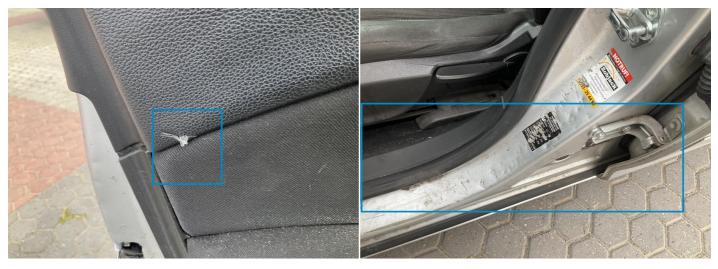
17. Panel Filling / Front Left Interior / Worn - out -

Bodywork / Dent / Dent -
