OPEL Astra Astra 2.0 CDTI DPF Sports Tourer

VIN NO W0LPD8EN6D8020376 Registration Number N6D8020376

Inspection Report Summary

| Customer | BCA Online | Report Number | P20250908120120 |

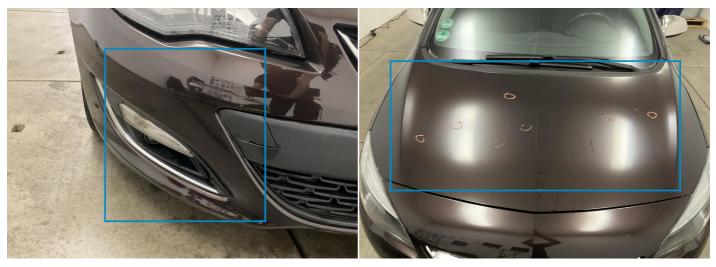
| | Component | Damage | Comments |
|---|---|---|---|
| 1 | Corner Bumper / Front Right | Bodywork / Breakage / Hole | |
| 2 | Hood | Bodywork / Dent / Dent | |

1. Corner Bumper / Front Right Bodywork / Breakage / Hole -

2. Hood Bodywork / Dent / Dent -

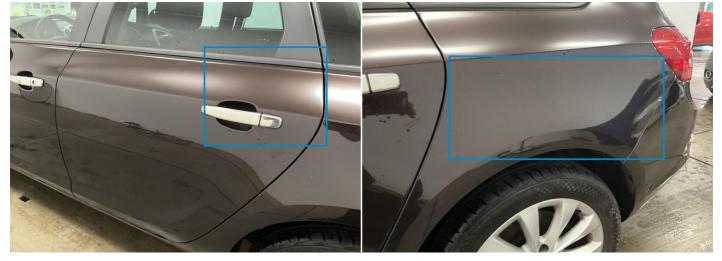
| | Component | Damage | Comments |
|---|---|---|---|
| 3 | Door / Back Left | Paint / Scratch / Scuff | |
| 4 | Side Panel / Back Left | Paint / Scratch / Scuff | |

3. Door / Back Left Paint / Scratch / Scuff -

4. Side Panel / Back Left Paint / Scratch / Scuff -

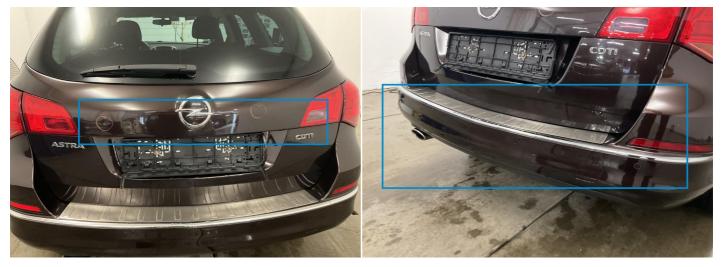
| | Component | Damage | Comments |
|---|---|---|---|
| 5 | Tailgate | Bodywork / Dent / Dent | |
| 6 | Bumper / Back | Paint / Scratch / Scuff | |

5. Tailgate Bodywork / Dent / Dent -

6. Bumper / Back Paint / Scratch / Scuff -

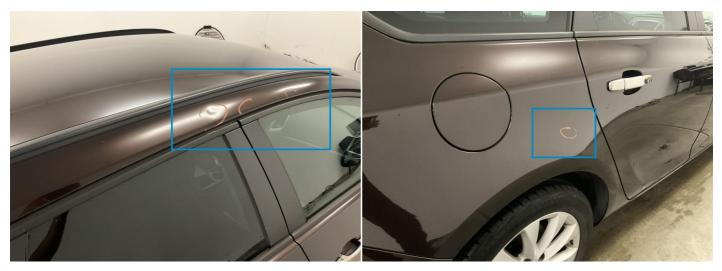
| | Component | Damage | Comments |
|---|---|---|---|
| 7 | Roof | Bodywork / Dent / Dent | |
| 8 | Side Panel / Back Right | Bodywork / Breakage / Hole | |

7. Roof Bodywork / Dent / Dent -

8. Side Panel / Back Right Bodywork / Breakage / Hole -

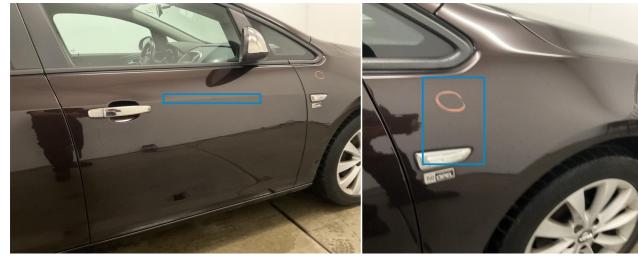
| | Component | Damage | Comments |
|---|---|---|---|
| 9 | Door / Front Right | Paint / Scratch / Scuff | |

9. Door / Front Right Paint / Scratch / Scuff -

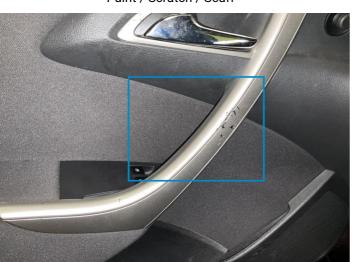
| | Component | Damage | Comments |
|---|---|---|---|
| 10 | Fender / Front Right | Bodywork / Dent / Dent | |
| 11 | Panel Filling / Front Left | Interior / Scratched | |

11. Panel Filling / Front Left Interior / Scratched -

10. Fender / Front Right Bodywork / Dent / Dent -
