# OPEL Zafira

## Zafira Tourer 1.4 Turbo

VIN NO W0LPD9EC4G1117352  
Registration Number C4G1117352

### Inspection Report Summary

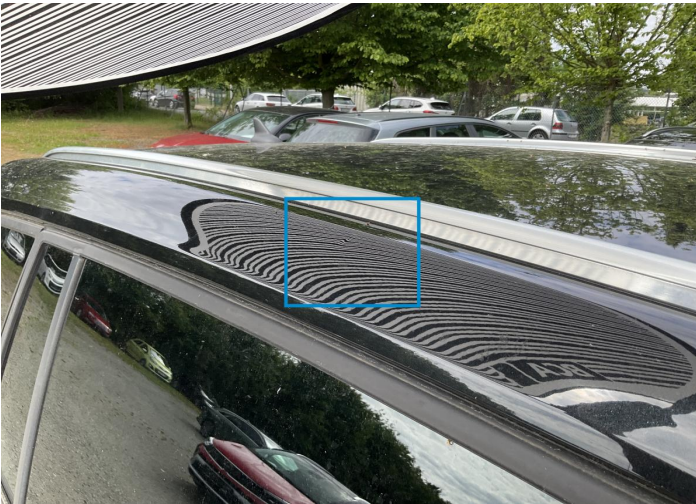
| Component | Damage | Comments |
|---|---|---|
| 1 Roof | Bodywork / Dent / Dent | |

1. Roof  
Bodywork / Dent / Dent -

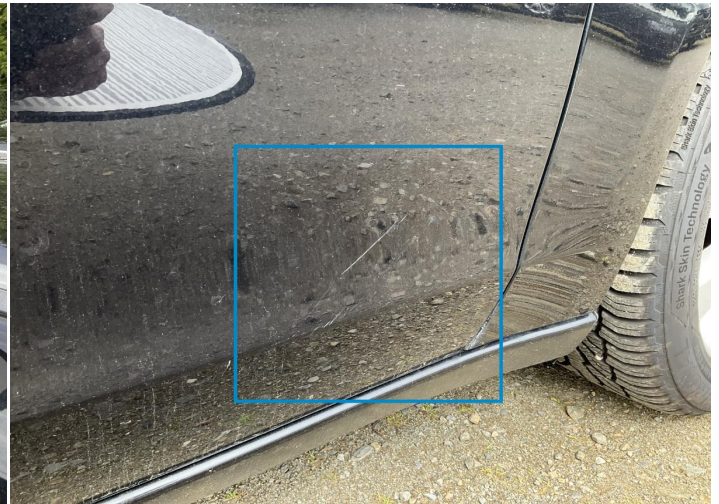
| Component | Damage | Comments |
|---|---|---|
| 2 Door / Front Right | Paint / Scratch / Scuff | |

2. Door / Front Right  
Paint / Scratch / Scuff -

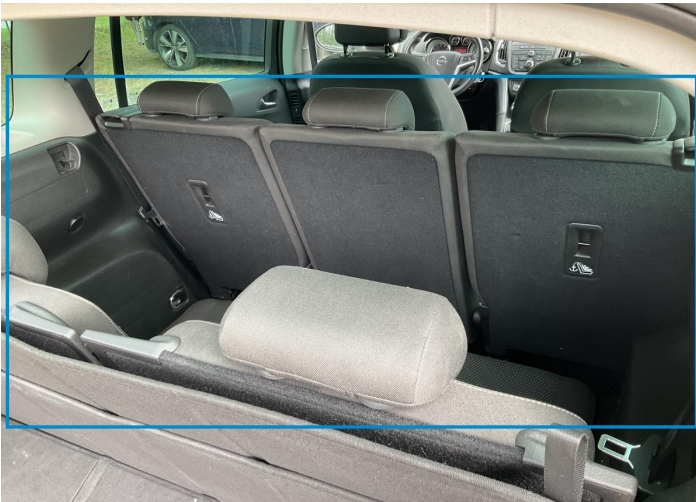
| Component | Damage | Comments |
|---|---|---|
| 3 Luggage Space Cover / Back | Interior / Missing | |

3. Luggage Space Cover / Back  
Interior / Missing -

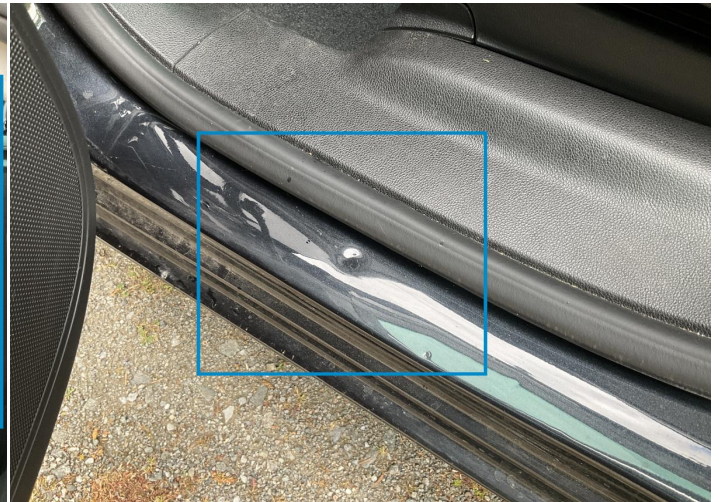
| Component | Damage | Comments |
|---|---|---|
| 4 Rocker Panel / Center Left | Bodywork / Dent / Dent | |

4. Rocker Panel / Center Left  
Bodywork / Dent / Dent -
