## OPEL Corsa

### Corsa 1.4 Turbo (ecoFLEX) Start/Stop

VIN NO W0V0XEP68J4261812  
Registration Number 68J4261812

### Inspection Report Summary

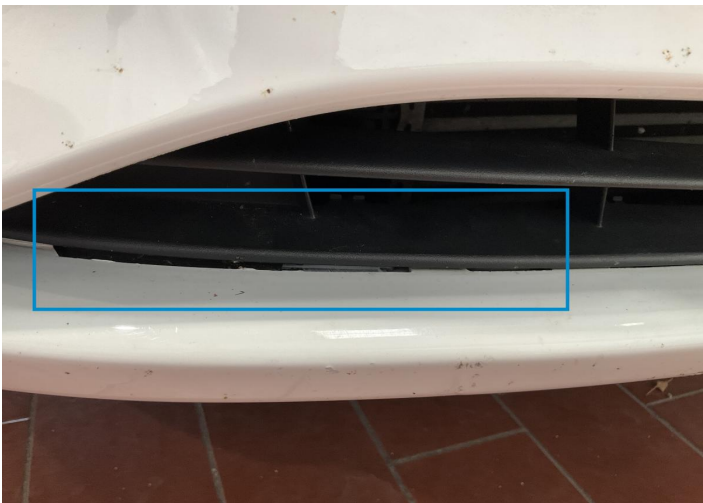
| Component | Damage | Comments |
|---|---|---|
| 2 Blade/spoiler / Front | Bodywork / Breakage | |

2. Blade/spoiler / Front Bodywork / Breakage -

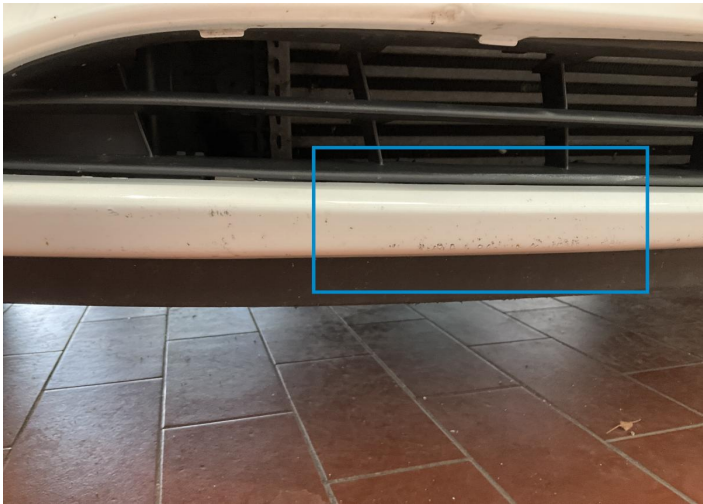
| Component | Damage | Comments |
|---|---|---|
| 3 Bumper / Front | Paint / Scratch / Scuff | |

3. Bumper / Front Paint / Scratch / Scuff -

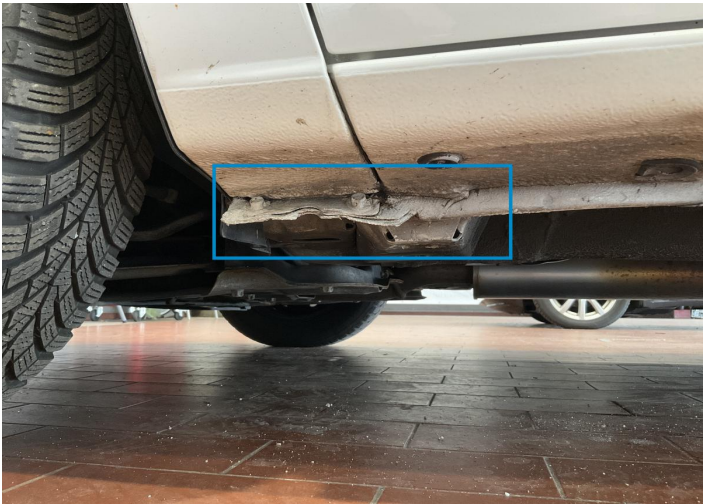
| Component | Damage | Comments |
|---|---|---|
| 4 Rocker Panel / Center Left | Bodywork / Dent / Dent | |

4. Rocker Panel / Center Left Bodywork / Dent / Dent -

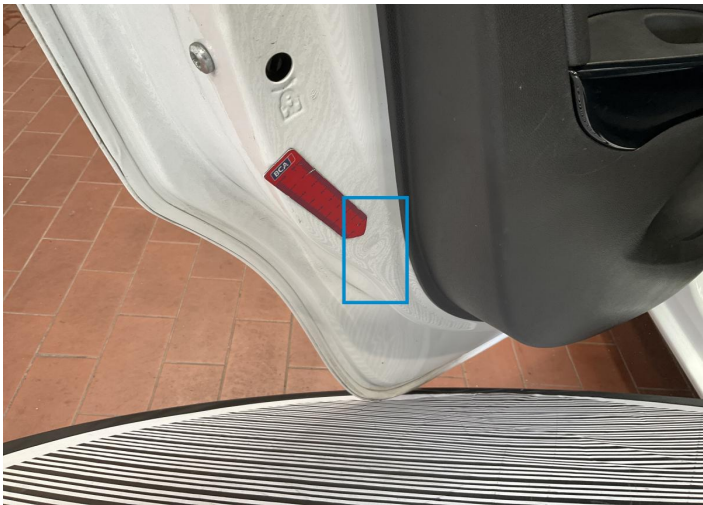
| Component | Damage | Comments |
|---|---|---|
| 5 Door / Back Left | Bodywork / Dent / Dent | |

5. Door / Back Left Bodywork / Dent / Dent -

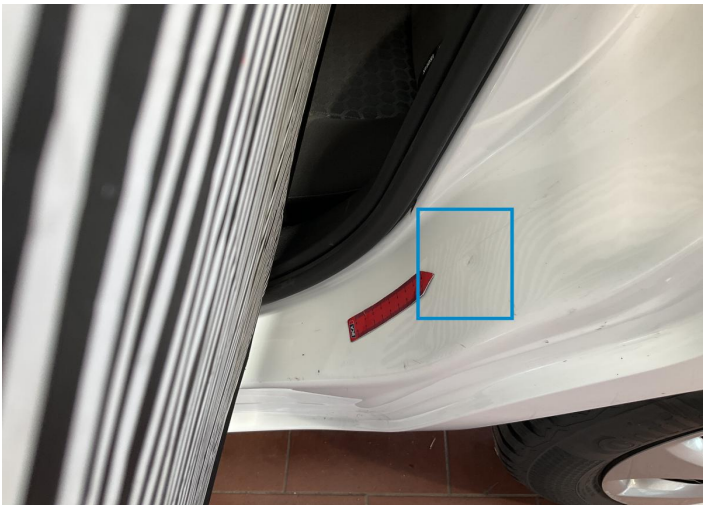
| Component | Damage | Comments |
|---|---|---|
| 6 Door Edge / Back Left | Bodywork / Dent / Dent | |

6. Door Edge / Back Left Bodywork / Dent / Dent -

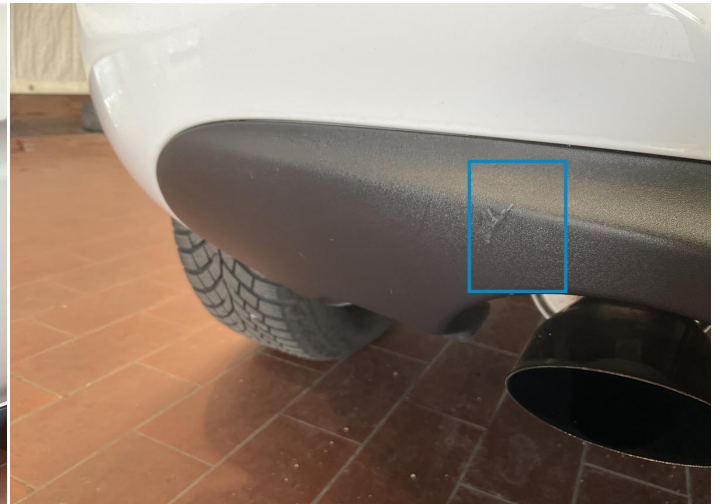
| Component | Damage | Comments |
|---|---|---|
| 8 Bumper / Back | Paint / Scratch / Line | |

8. Bumper / Back  
Paint / Scratch / Line -
